CLOSURE REPORT

Trunk 10A (06/12/23) Unit Letter K, S35 T26N R12W San Juan County, New Mexico

New Mexico EMNRD OCD Incident ID No. NAPP2316425574

Ensolum Project No. 05A1226241

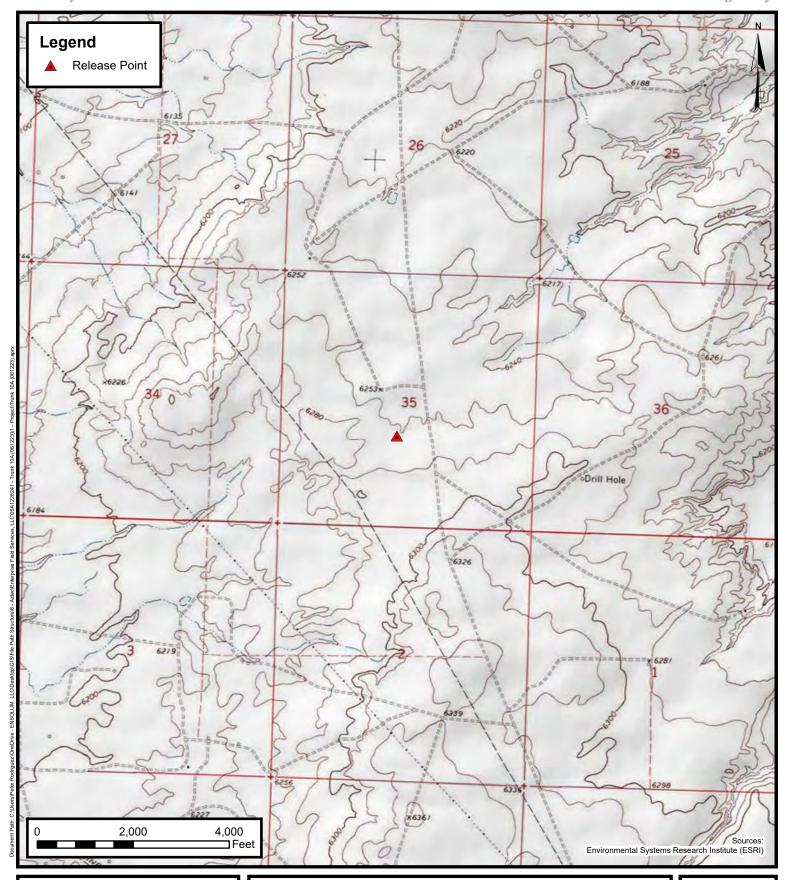
1

A Topographic Map depicting the location of the Site is included as Figure 1, and a Site Vicinity Map is included as Figure 2 in Appendix A.

Topographic Map

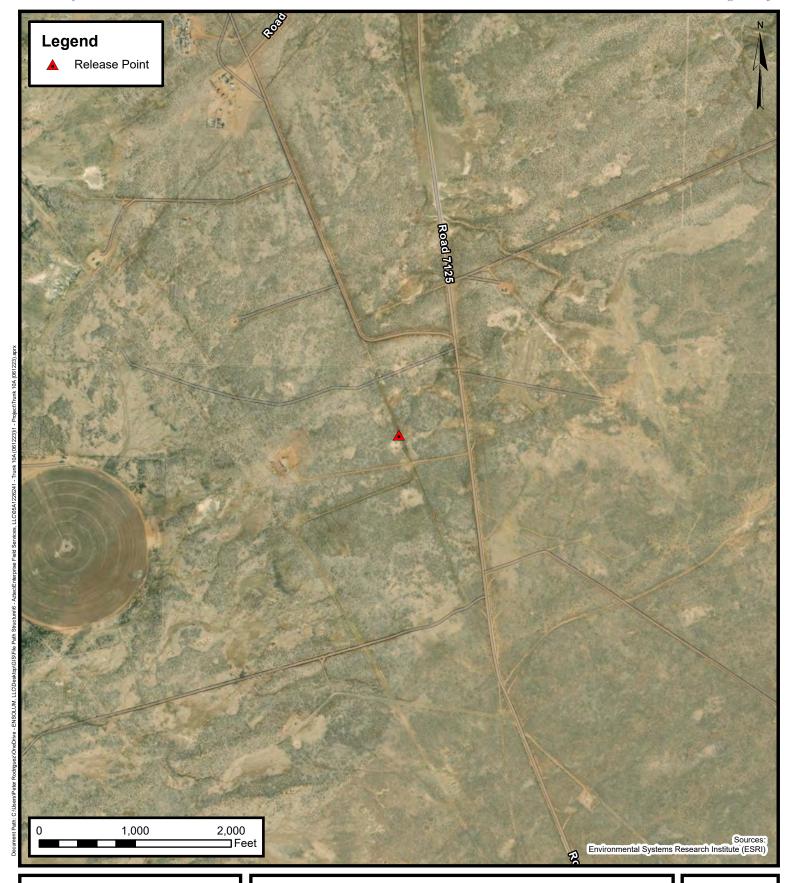
FIGURE 2

Site Vicinity Map

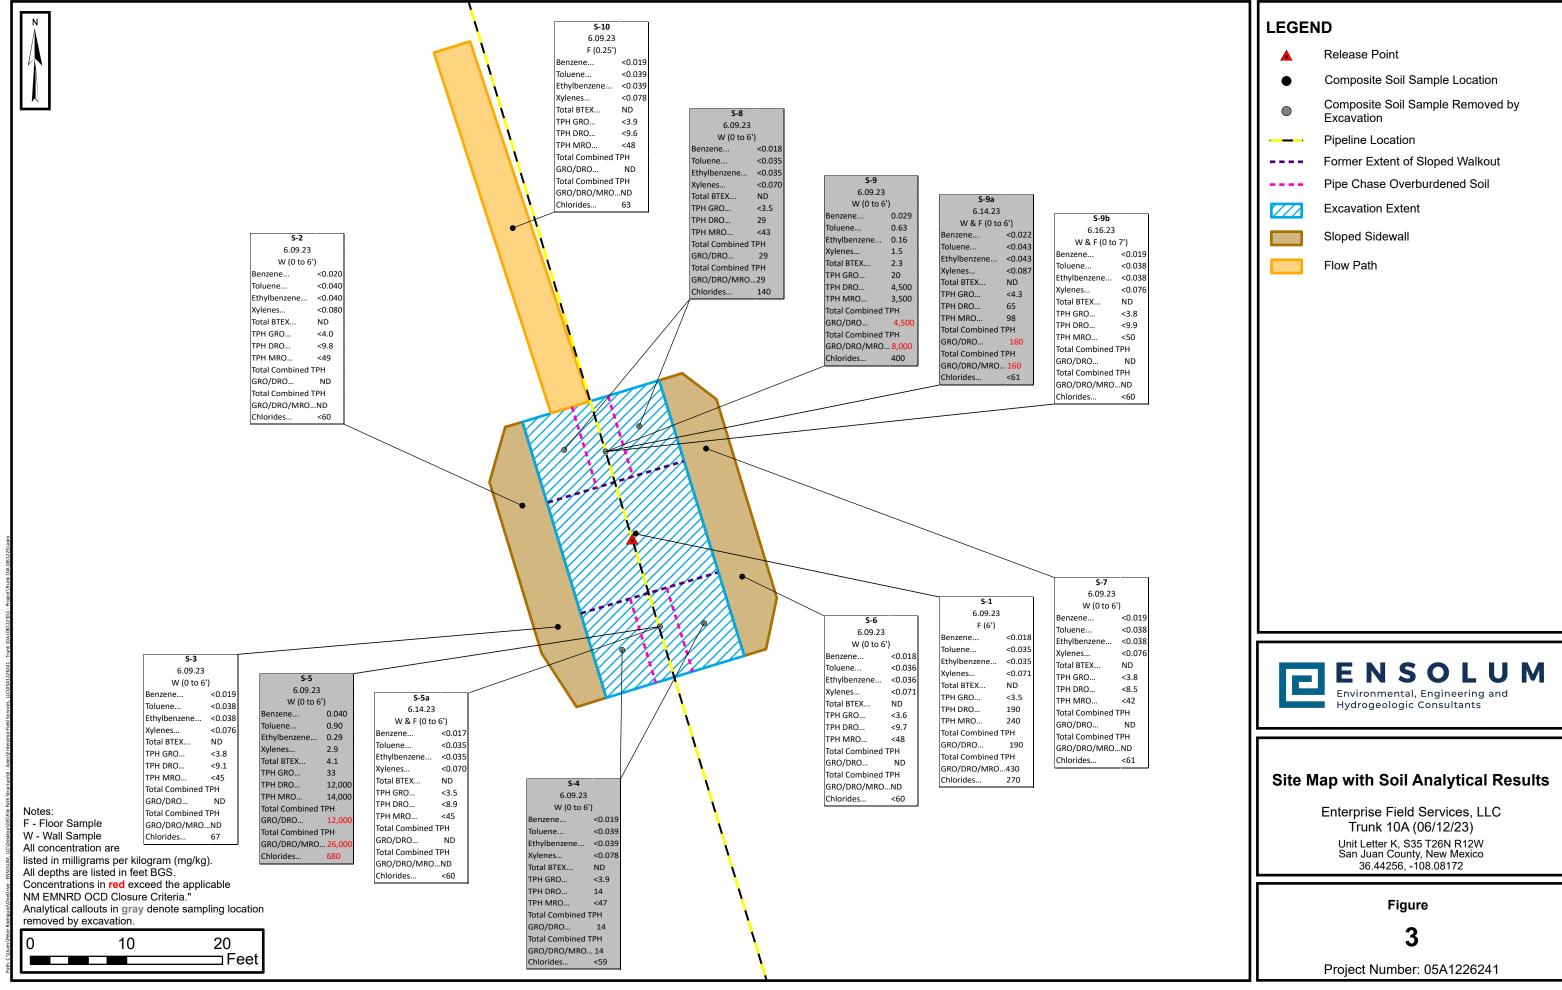
The final excavation measured approximately 30 feet long and 25 feet wide at the maximum extents. The maximum depth of the excavation measured approximately 7 feet bgs. The flow path measured approximately 39 feet long and 4 feet wide. The lithology encountered during the completion of remediation activities consisted primarily of silty sand underlain by weathered sandstone.

Figure 3 is a map that identifies approximate soil sample locations and depicts the approximate dimensions of the excavation with respect to the pipeline (**Appendix A**). Photographic documentation of the field activities is included in **Appendix D**.

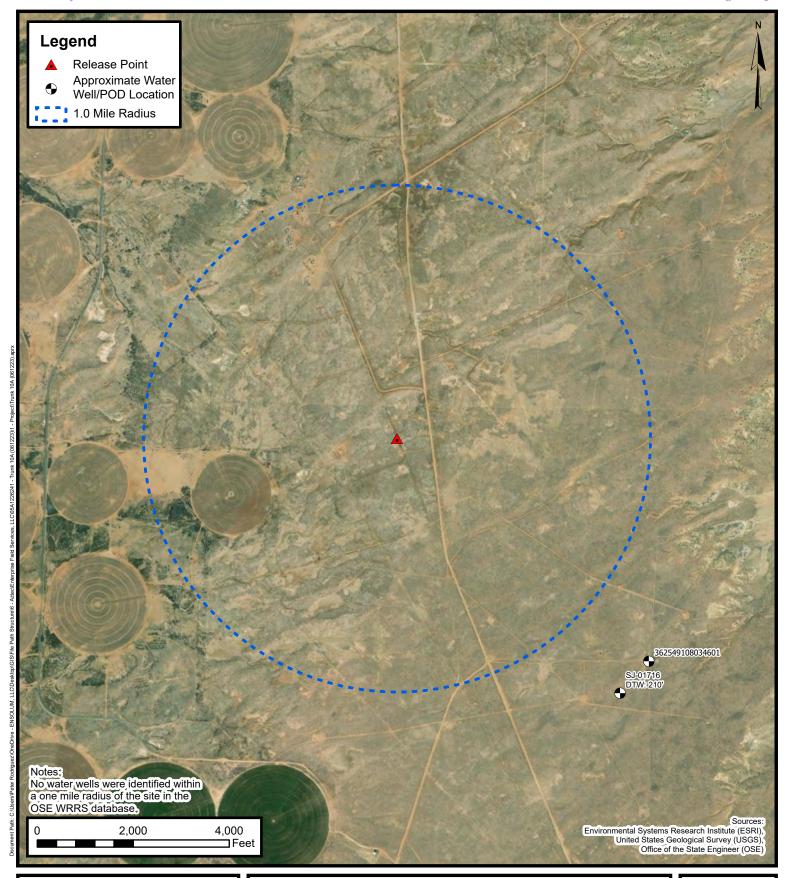
The NM Office of the State Engineer (OSE) tracks the usage and assignment of water rights and water well installations and records this information in the Water Rights Reporting System (WRRS) database. Water wells and other points of diversion (PODs) are each assigned POD numbers in the database (which is searchable and includes an interactive map). No PODs were identified in the same Public Land Survey System (PLSS) section as the Site. One POD (SJ-01716) was identified in an adjacent PLSS section. Documentation for SJ-01716 indicates a depth to water of 210 feet below grade surface (bgs). This POD is located approximately 1.3 miles southeast of the Site and approximately 18 feet higher in elevation than the Site (Figure A, Appendix B).

1.0 Mile Radius Water Well/ Pod Location Map

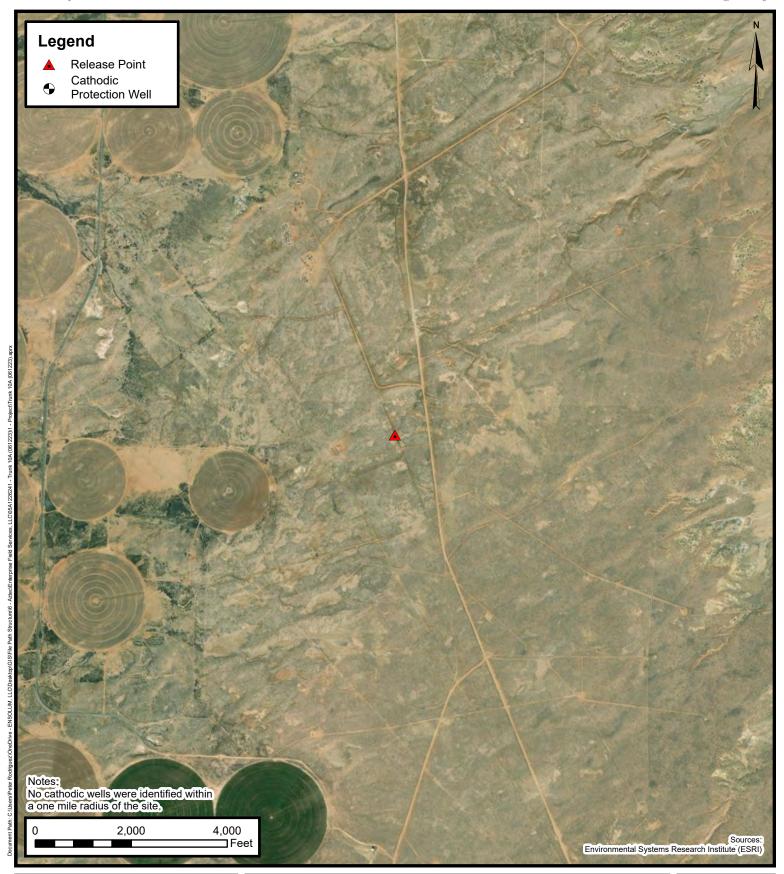
В

- No cathodic protection wells (CPWs) were identified in the NM EMNRD OCD imaging database in the same PLSS section as the Site or in the adjacent PLSS sections Figure B (Appendix B).

Cathodic Protection Well Recorded Depth to Water Enterprise Field Services, LLC

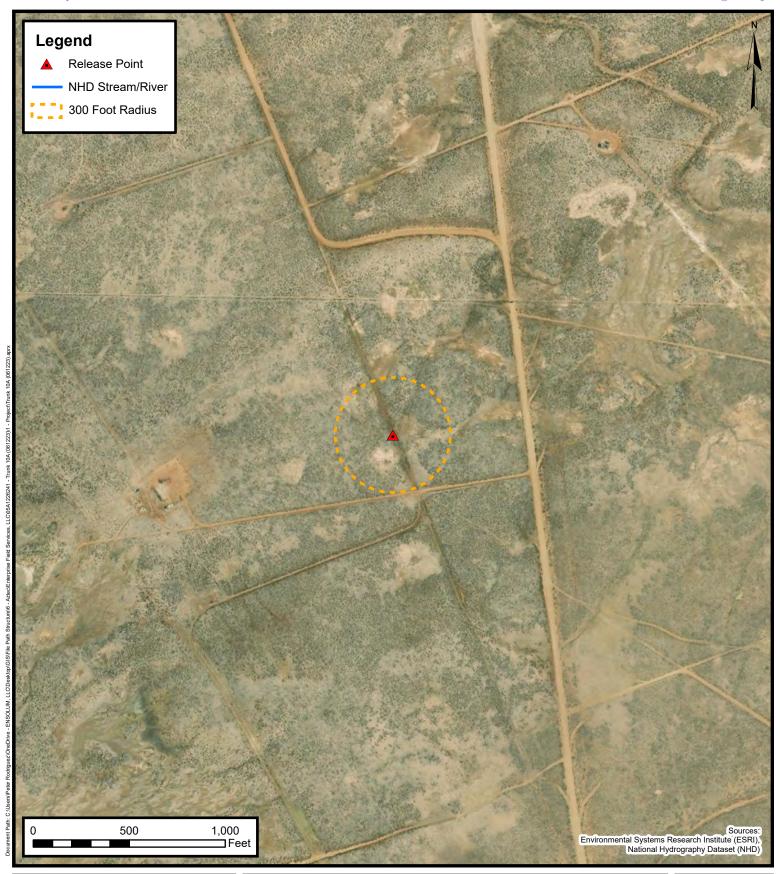
- The Site is not located within 300 feet of a NM EMNRD OCD-defined continuously flowing watercourse or significant watercourse (**Figure C**, **Appendix B**).

300 Foot Radius Watercourse and Drainage Identification

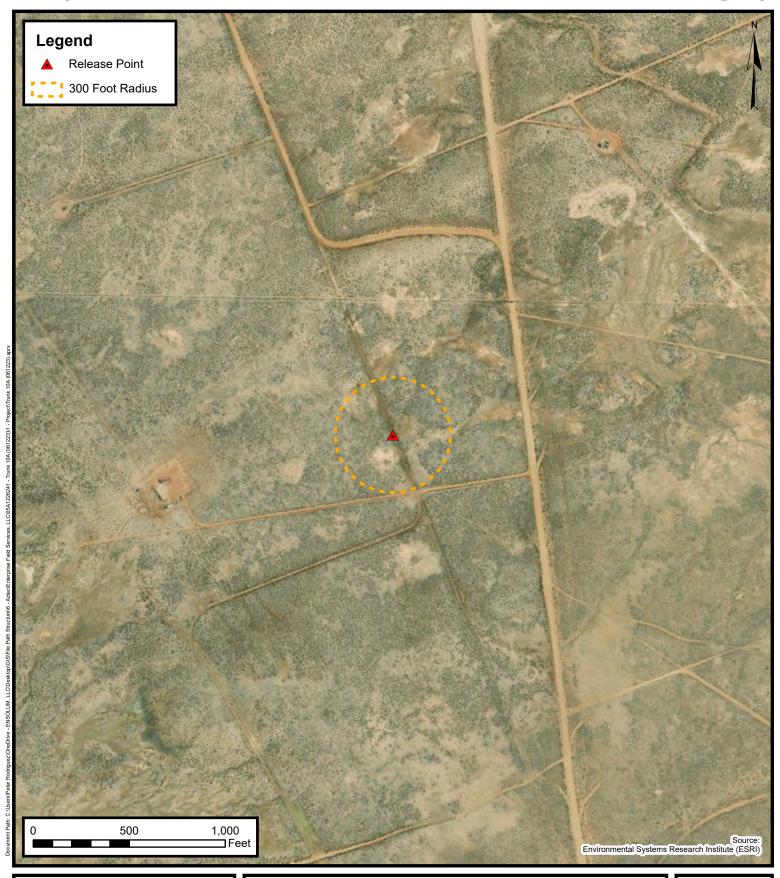
- The Site is not located within 200 feet of a lakebed, sinkhole, or playa lake.
- The Site is not located within 300 feet of a permanent residence, school, hospital, institution, or church (Figure D, Appendix B).

300 Foot Radius Occupied Structure Identification

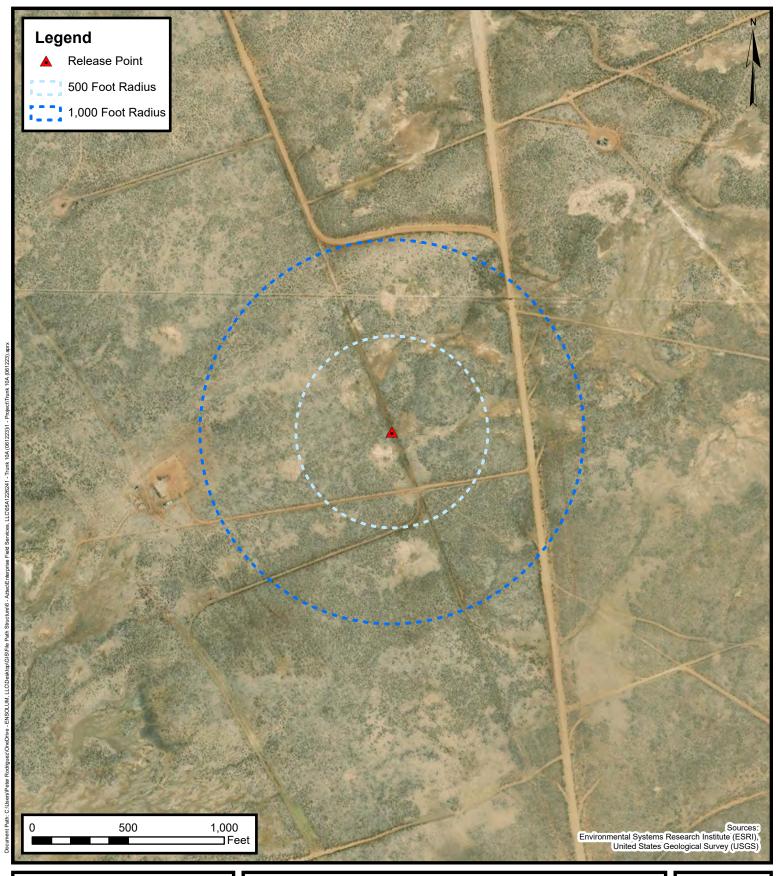
- No springs, or private domestic freshwater wells used by less than five households for domestic or stock watering purposes were identified within 500 feet of the Site (Figure E, Appendix B).

- No freshwater wells or springs were identified within 1,000 feet of the Site (Figure E, Appendix B).
- The Site is not located within incorporated municipal boundaries or within a defined municipal fresh water well field covered under a municipal ordinance adopted pursuant to New Mexico Statutes Annotated (NMSA) 1978, Section 3-27-3.

Water Well and Natural Spring Location

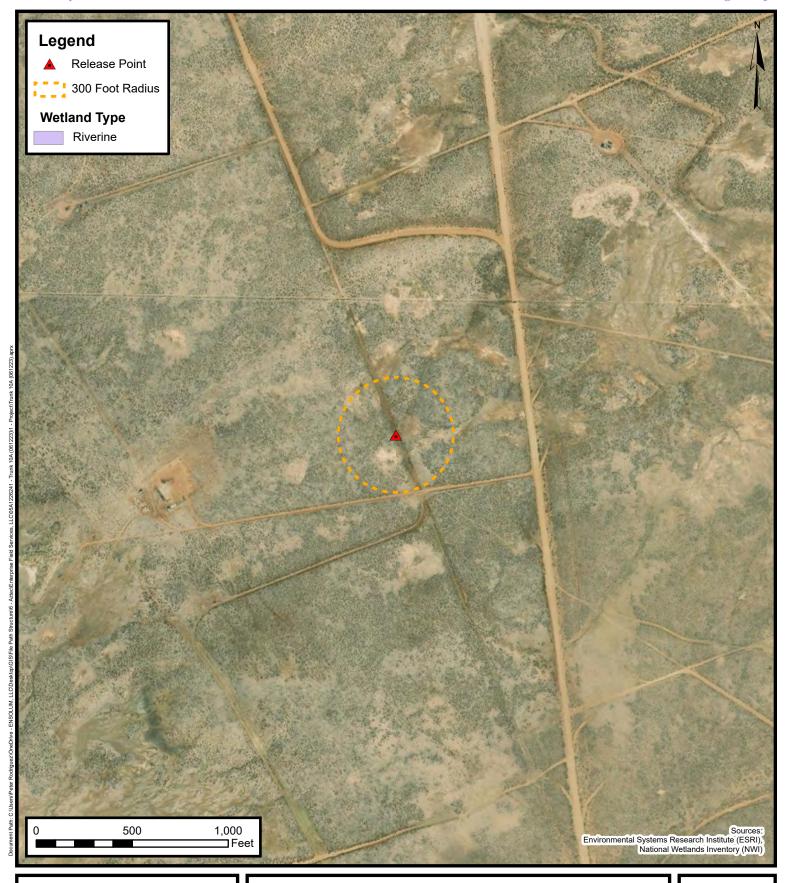
FIGURE **F**

- Based on information identified in the U.S. Fish & Wildlife Service National Wetlands Inventory Wetlands Mapper, the Site is not within 300 feet of a wetland (Figure F, Appendix B).

Wetlands

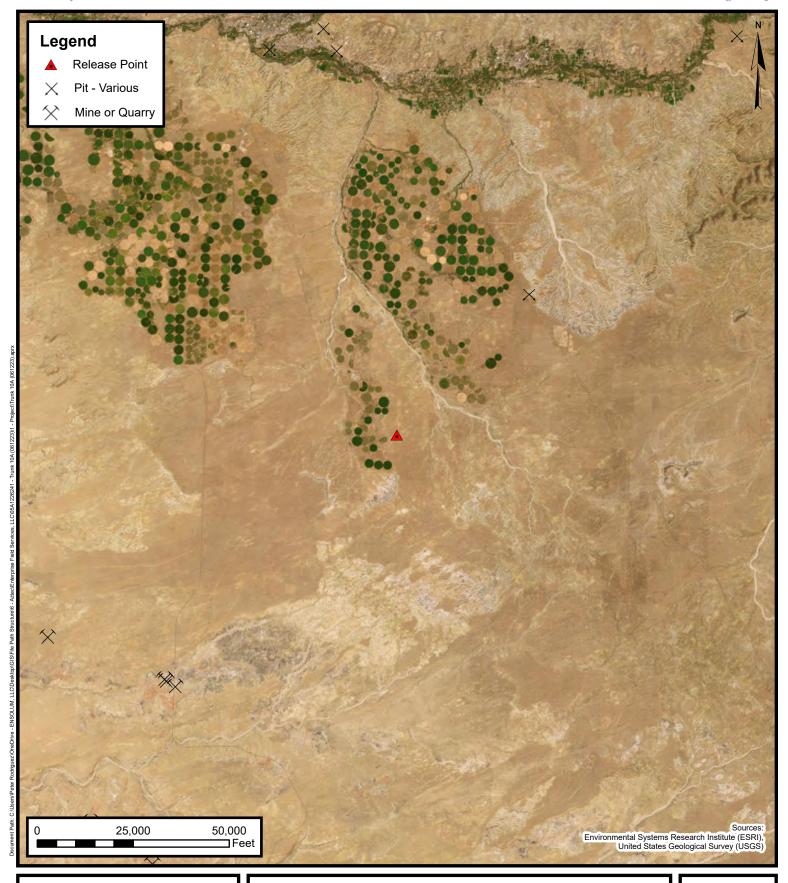
- Based on information identified in the NM Mining and Minerals Division's Geographic Information System (GIS) Maps and Mine Data database, the Site is not within an area overlying a subsurface mine (Figure G, Appendix B).

Mines, Mills, and Quarries

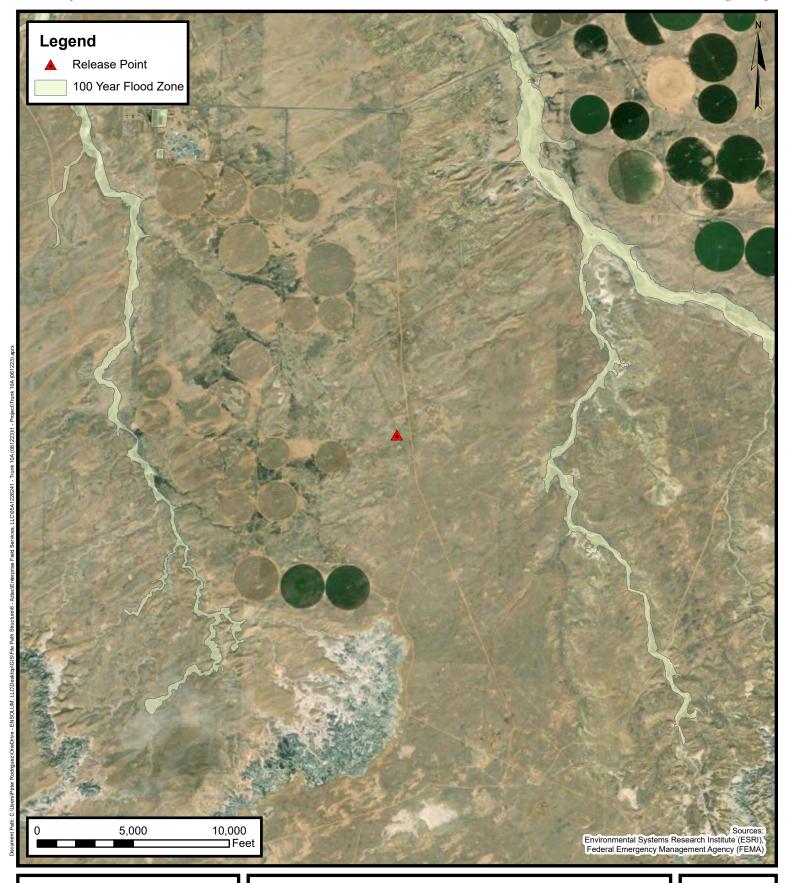
- The Site is not located within an unstable area per Paragraph (6) of Subsection U of 19.15.2.7 NMAC.
- Based on information provided by the Federal Emergency Management Agency (FEMA)
 National Flood Hazard Layer (NFHL) geospatial database, the Site is not within a 100-year
 floodplain (Figure H, Appendix B).

100-Year Flood Plain Map

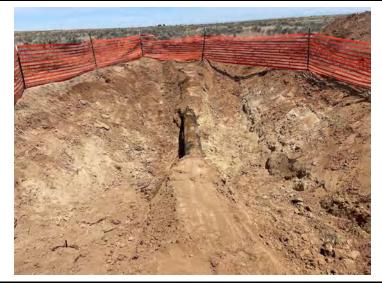
Photograph 1

Photograph Description: View of the excavation (first sampling event).

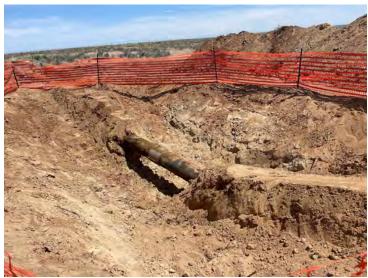
Photograph 2

Photograph Description: View of the excavation (first sampling event).

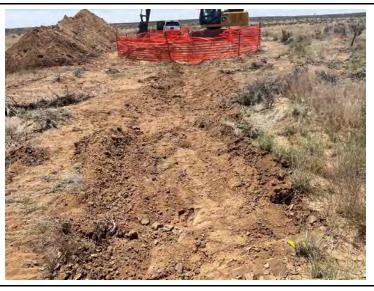
Photograph 3

Photograph Description: View of the scraped flow path (first sampling event).

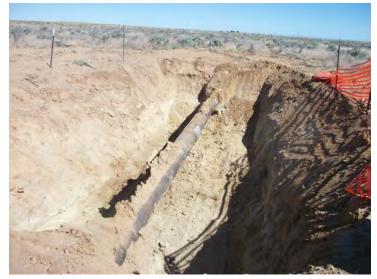
Photograph 4

Photograph Description: View of the excavation (second sampling event).

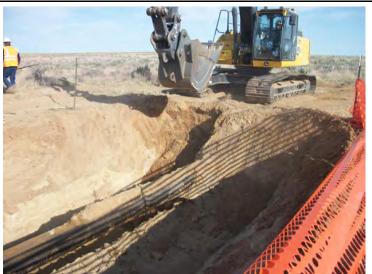
Photograph 5

Photograph Description: View of the inprocess excavation activities.

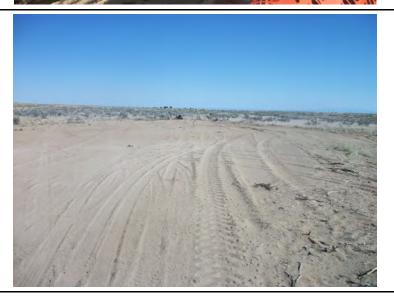
Photograph 6

Photograph Description: View of the site after initial restoration.

The excavation was backfilled with imported fill and then contoured to the surrounding topography.
