Executive Summary – Incident #nAPP2320149561

Hilcorp removed a below ground tank (BGT) at the Romero Gas Com A #1 wellsite (API 30-045-25509) on February 8, 2023. The closure sample results were above permit limits and above the NMOCD action criteria in NMAC 19.15.29 Table 1 for total petroleum hydrocarbons (TPH).

Lat: 36.695036 Long: -107.873901 Romero Gas Com A #1 Wellsite

API: 30-045-25509

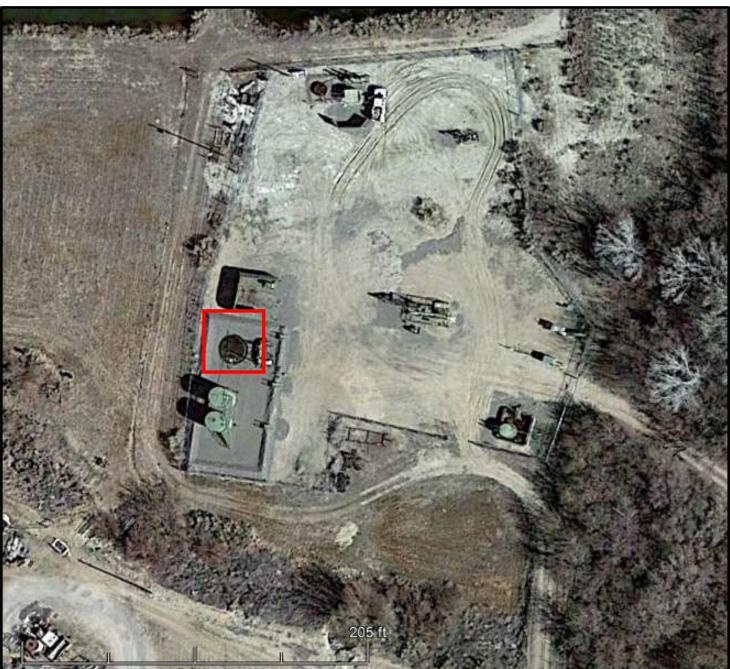
Scaled Site Map

Historic Release Area

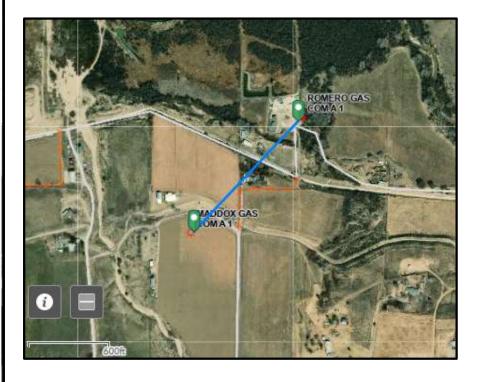
Estimated depth to groundwater at the Romero Gas Com A #1 wellsite is <50'. Note siting criteria for the Maddox Gas Com A #1, which is ~1,100' SW of the Romero Gas Com A #1 wellsite.

Within defined municipal fresh water well field		No		Topo map pdf, Aerial pdf, Mines and Quarrie Map pdf,i-Waters Ground Water Data Map pdf, FEMA flood zone map pdf		
Wetland within 500'		No	Mining Activity:	None		
Within unstable area		No				
Within 100 year flood	No	o-FEMA Zone 'X'

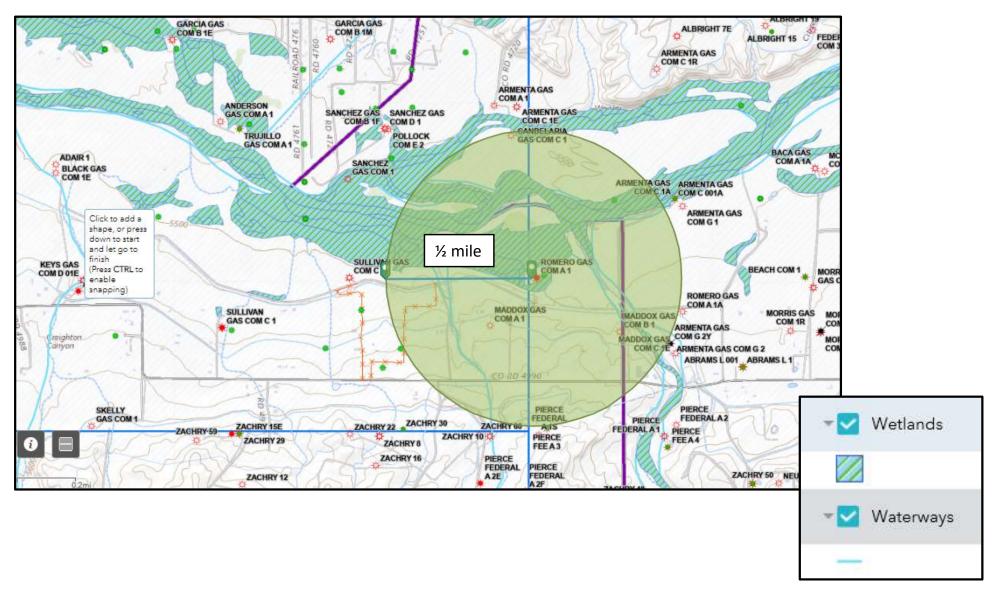
Determination of water sources and significant watercourses within ½ mile of the lateral extent of the release

Note 1: Release point is not within 300 ft of a continuously flowing watercourse or other significant water course.

Note 2: The lateral extents of the release point are within 300 feet of a mapped wetland.

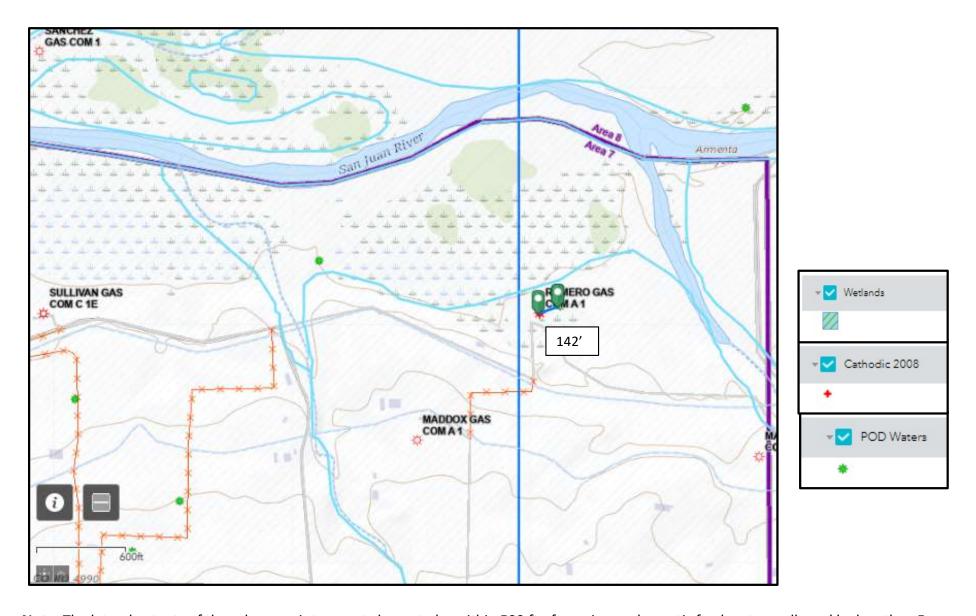
Distance to mapped water wells.

Note: The lateral extents of the release point are not shown to be within 500 ft of a spring or domestic freshwater well used by less than 5 households (or stock watering) but are within 1,000 ft of any freshwater water well or spring.

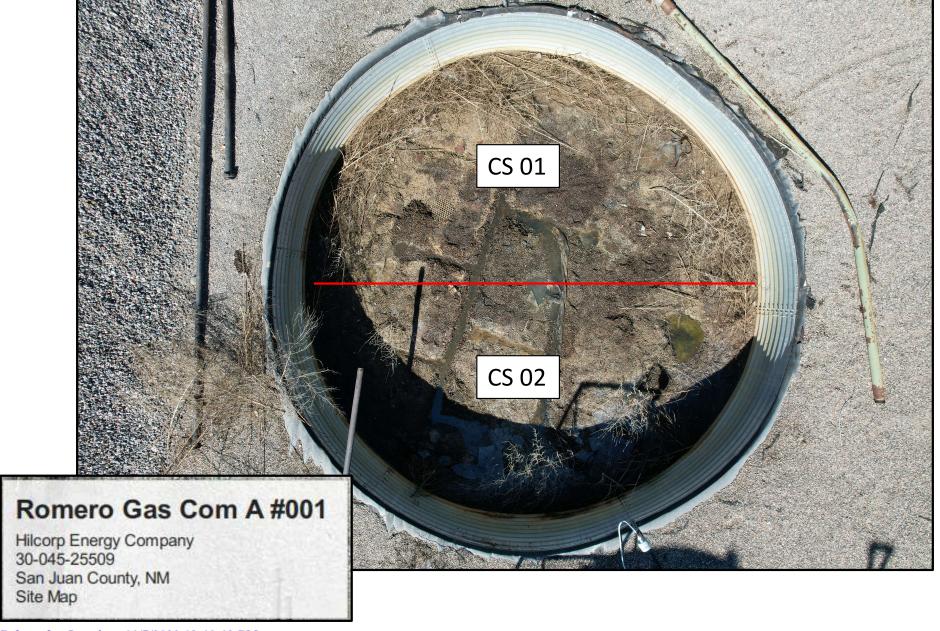
Field Sample Diagram

Two 5-point composite samples were collected on 6/2/2023 and 6/28/2023.

Confirmation samples were collected on 6/1/2023 and 6/28/2023 by Ensolum. Composite Sample (CS) 01 was over closure standards on 6/1/2023. Additional impacted soil was removed, and the final sample collected at CS 01 on 6/28/2023 was below NMOCD 19.15.29.12.D Table 1 closure criteria.
