## Remediation Report and Deferment Request

Mimosa 24 Fed 1H  
Eddy County, New Mexico  
API # 30-015-40626  
**Incident # nAPP2200659729**

Subject: **Remediation Report and Deferment Request**  
Mimosa 24 Fed 1H  
Eddy County, New Mexico  
API # 30-015-40626  
**Incident # nAPP2200659729**

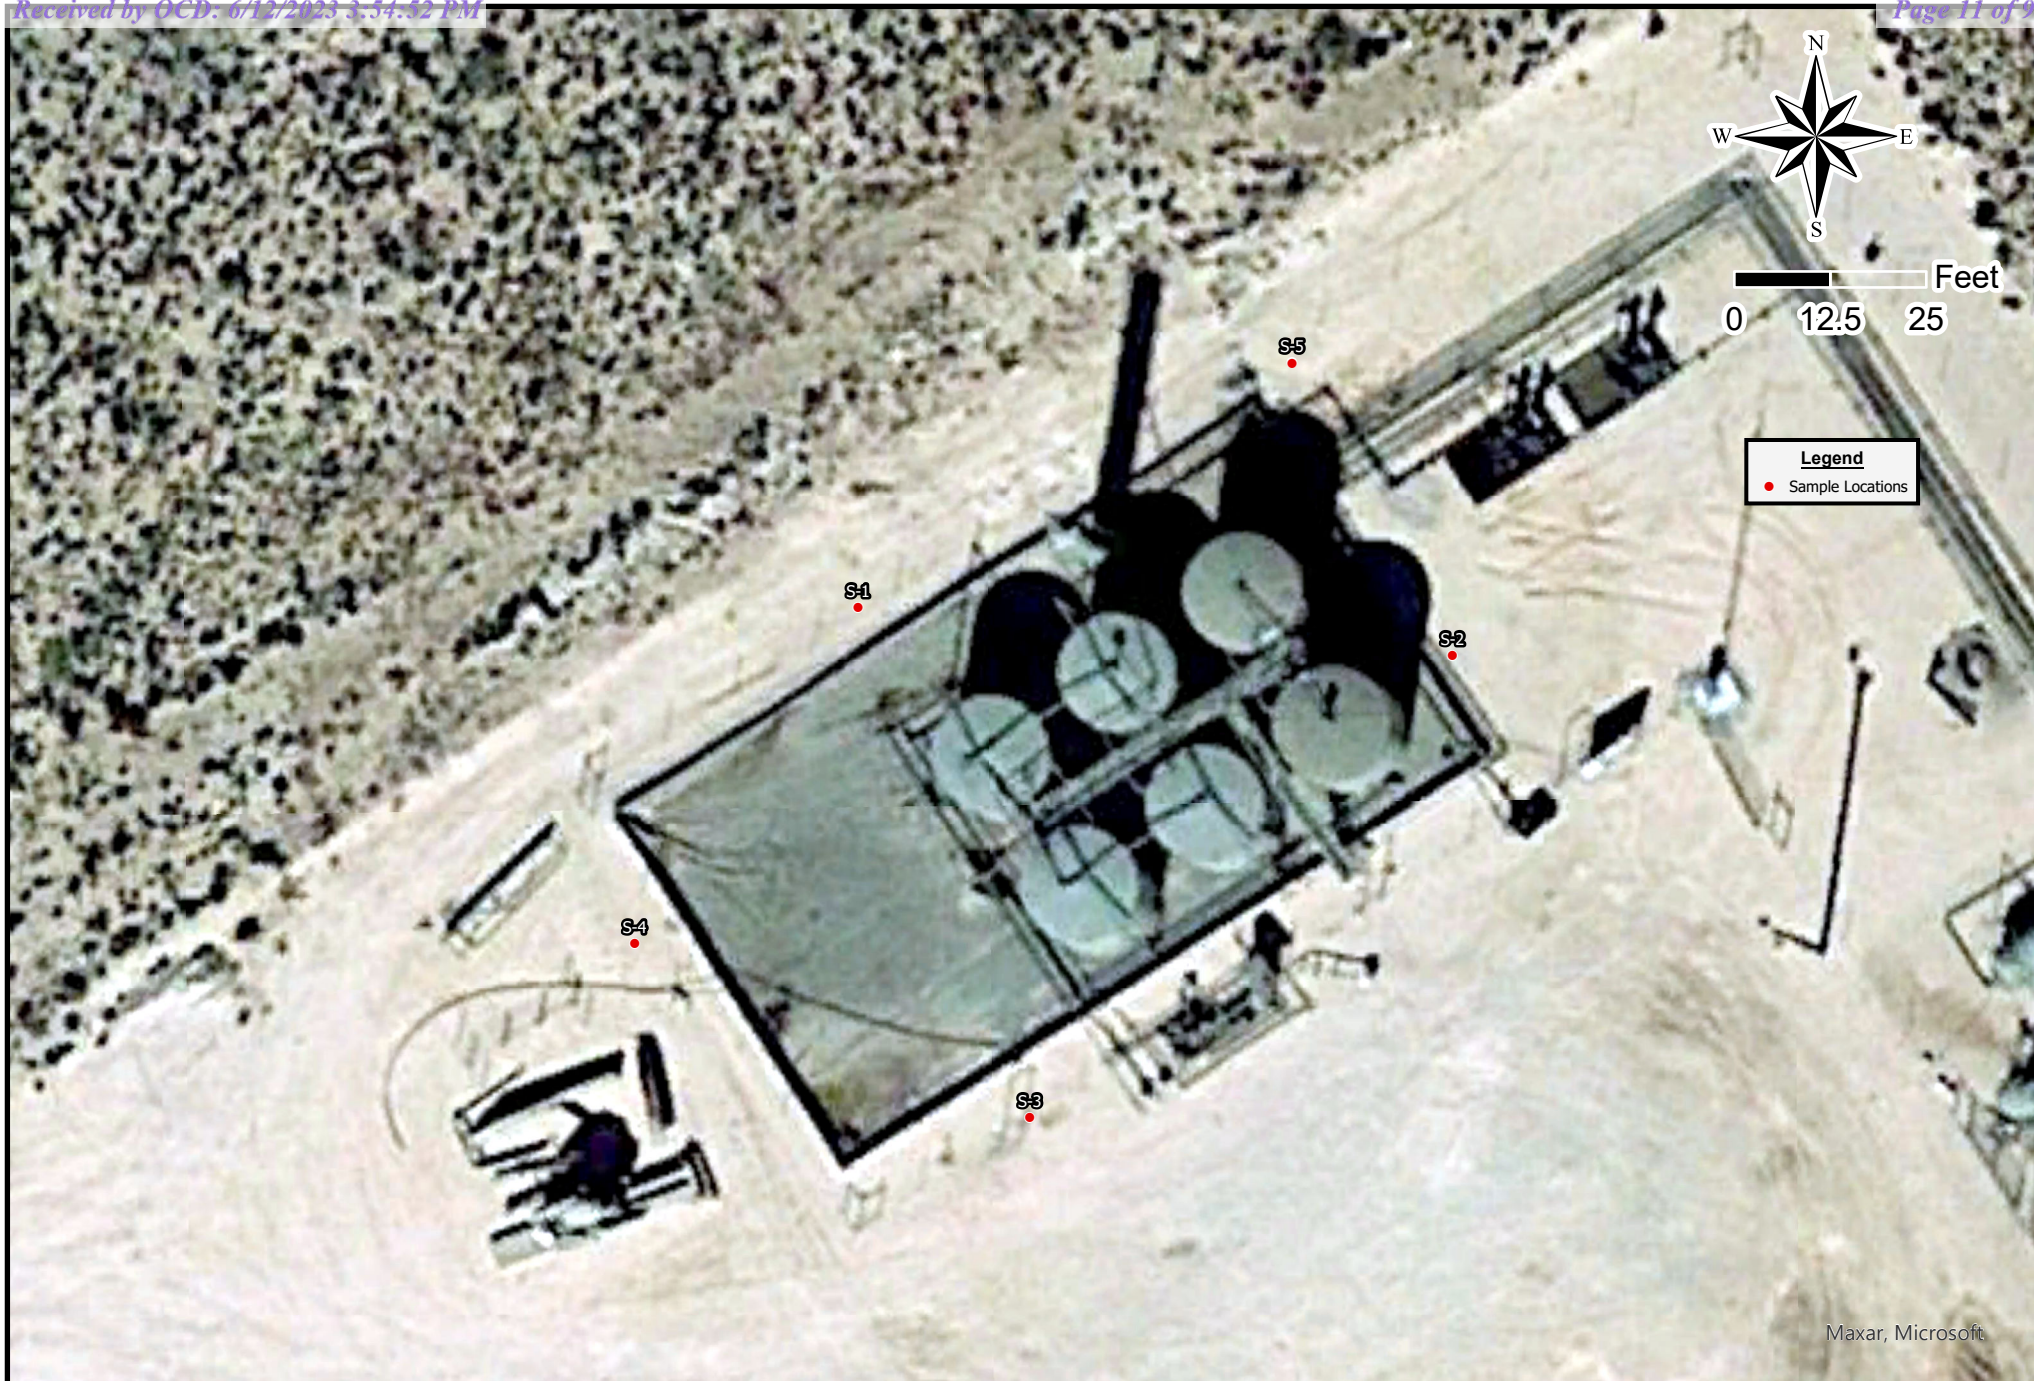
Devon Energy Production Company  
Mimosa 24 Fed 1H  
Eddy County, New Mexico  
Incident # nAPP2200659729  
Figure 1 - Site Assessment Map

On March 24, 2022, soil samples were collected from the site at five (5) locations. An inspection of the tank battery liner was also completed while onsite. The integrity of the containment was noted as compromised in the northeast corner with staining observed on the pad. All samples were transported via chain of custody to Cardinal Laboratories, for analysis of Total Chlorides (SM4500Cl-B), Total Petroleum Hydrocarbons (TPH, EPA Method 8015M) and Volatile Organics, BTEX (EPA Method 8021B).

Results from the initial sampling event are presented on the following data table and the complete laboratory reports can be found in [Appendix V](#). Site assessment sample locations are shown on the attached Figure 1 in [Appendix I](#).

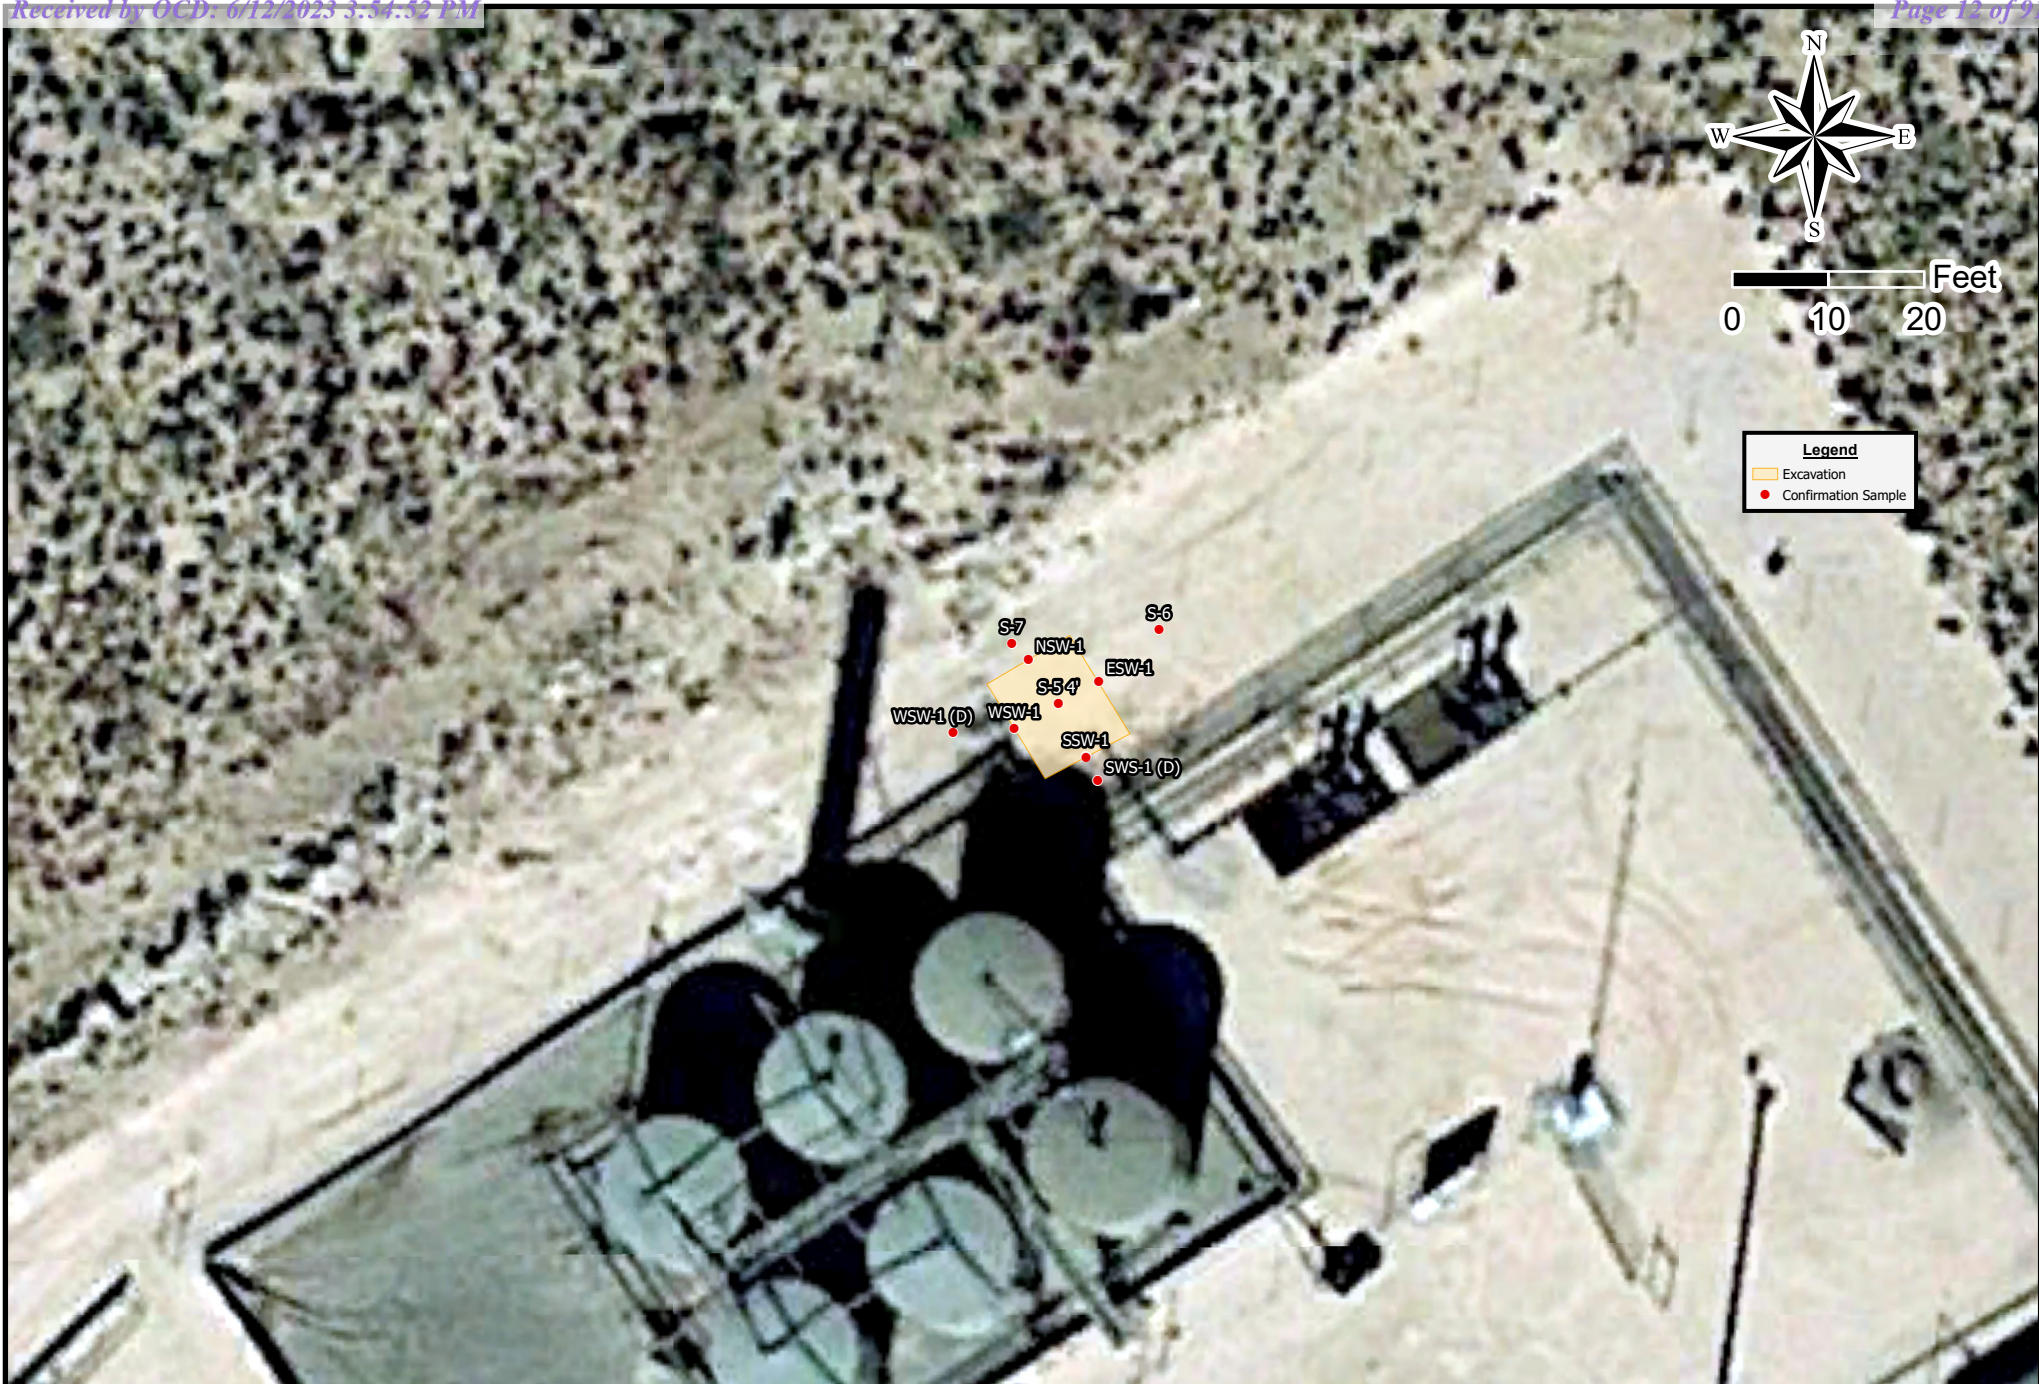
Devon Energy Production Company  
Mimosa 24 Fed 1H  
Eddy County, New Mexico  
Incident # nAPP2200659729  
Figure 2 - Confirmation Sample Map

Upon client authorization, excavation activities were completed on May 19, 2022. Confirmation samples were collected on May 19, 2022, and June 13, 2022, to confirm that NMOCD closure criteria had been met, the results of which can be found in the following data table. The sidewall samples, SSW-1 and WSW-1, could not be advanced further due to accessibility and structural integrity issues. Upon NMOCD request, horizontal delineation sidewall samples (SWS-1 (D) and WSW-1 (D)) were collected to verify the boundaries of the release in these two areas outside of the excavated area. Confirmation and delineation sample locations and excavation dimensions can be found on the confirmation sample map (Figure 2) in [Appendix I](#). Confirmation samples were transported with the chain of custody to Eurofins Laboratories Inc., for analysis of Total Chlorides (EPA Method 300.0), Total Petroleum Hydrocarbons (TPH, EPA Method 8015B NM) and Volatile Organics (BTEX, EPA Method 8021B). Horizontal delineation sidewall samples were delivered with the chain of custody to Cardinal Laboratories. Complete laboratory reports for the remediation efforts are attached in [Appendix V](#).

- The impacted area was excavated to a depth of 4 feet bgs. Vertical confirmation analytical results were achieved at sample location S-5A.
- The removal of impacted soils along the south side wall of the excavation (soil sample SSW-1) and west side wall (soil sample WSW-1) could not be advanced further due to accessibility and existing infrastructure. See Figure 2. Horizontal delineation samples of SWS-1 (D) and WSW-1 (D) were subsequently collected to ensure the areas outside of the excavation and infrastructure areas were not impacted from the release.

- The liner was subsequently repaired and confirmed by inspection on August 8, 2022. Photographic documentation is presented in [Appendix IV](#).
- Pursuant to NMOCD guidance, confirmation soil samples were collected at 200 square foot intervals and analyzed for TPH, BTEX and Total Chlorides to insure NMOCD closure criteria had been met, to the extent practicable.

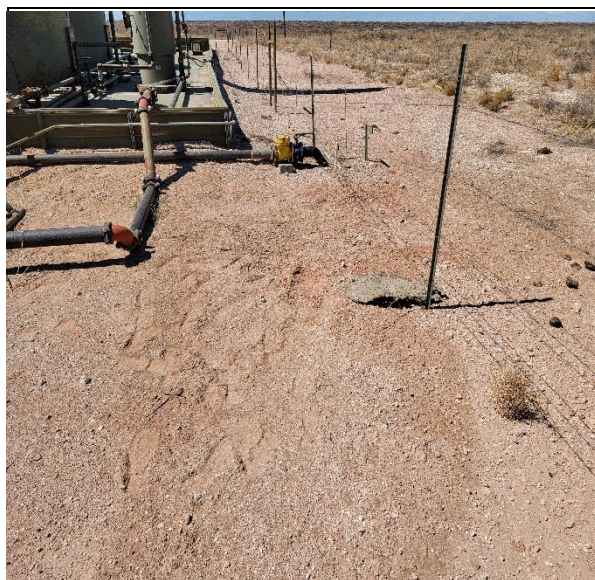
**Photograph No.1 Description:**

On December 26, 2021, approximately 5.6 barrels (bbls) of produced water were discharged into the containment with some fluid spray to the pad area from a leak on the water transfer pump. A vacuum truck was dispatched and five (5) bbls of produced water were recovered from the containment. The release was reported to the NMOCD and was assigned incident # nAPP2200659729.

View of release area.

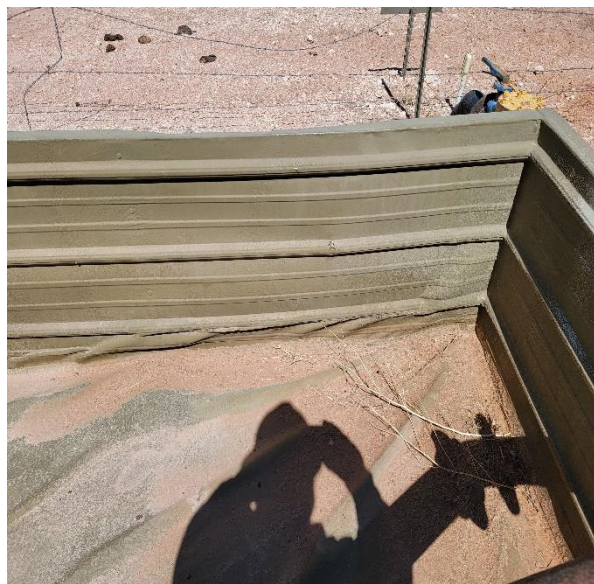
**Photograph No.2 Description:**

View of impaired liner adjacent to the release area.

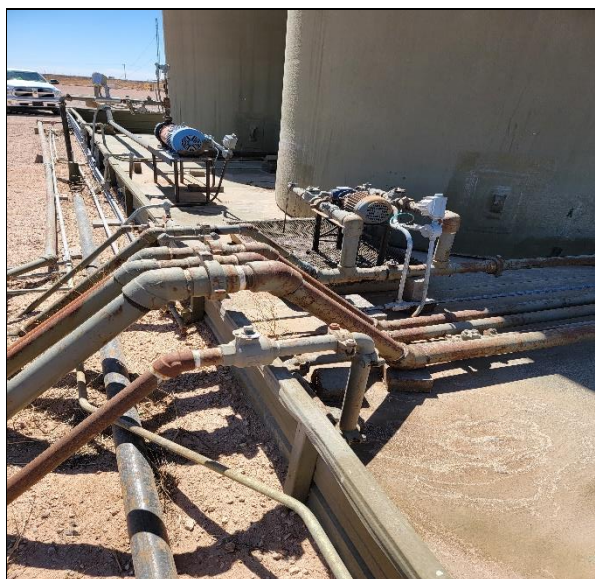
**Photograph No.3 Description:**

View of lined secondary containment.

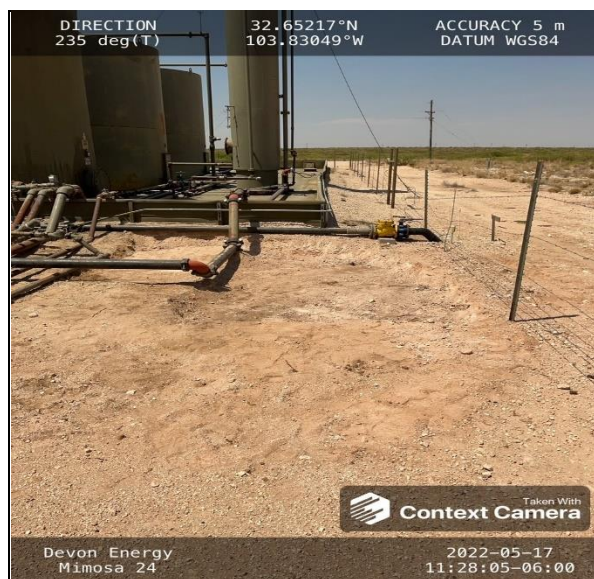
**Photograph No.4 Description:**

View of release area with surface scrape completed.

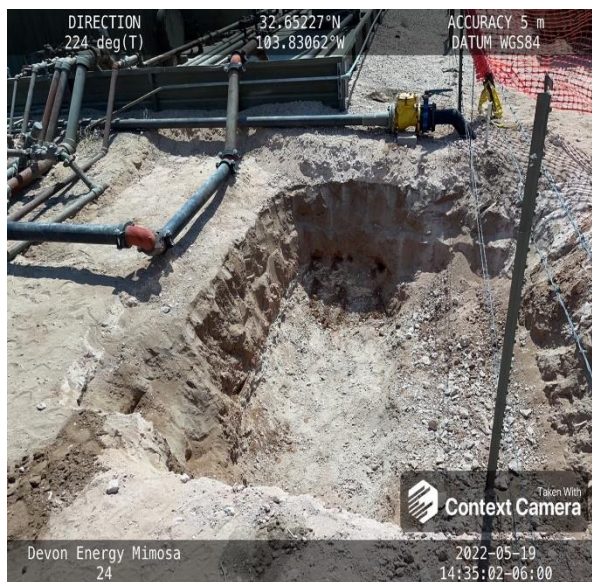
**Photograph No.5 Description:**

Excavation area

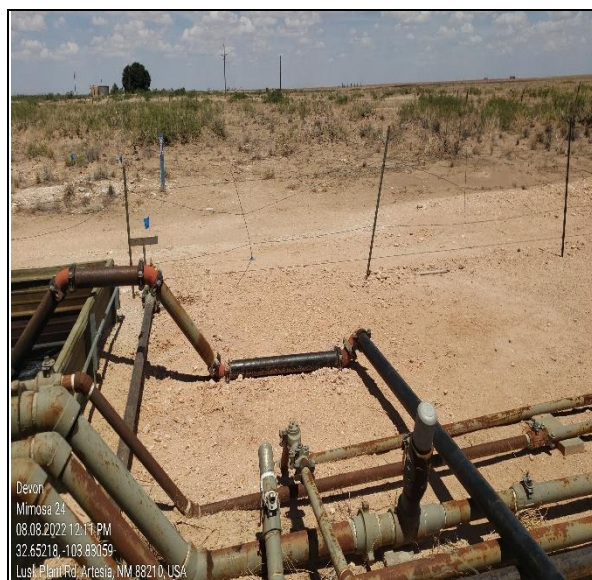
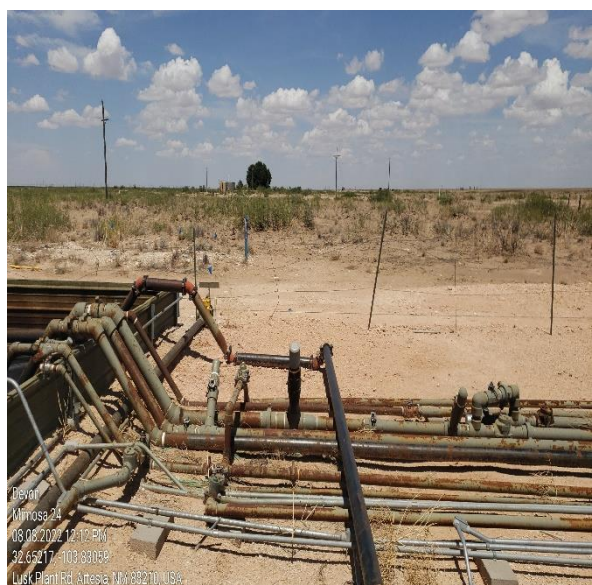
View of backfilled excavation.

- The excavated areas on the well pad were backfilled with new caliche, machine compacted and contoured to match the surrounding location.
- Approximately 36 cubic yards of excavated material was transported to R360, a NMOCD approved solid waste disposal facility.

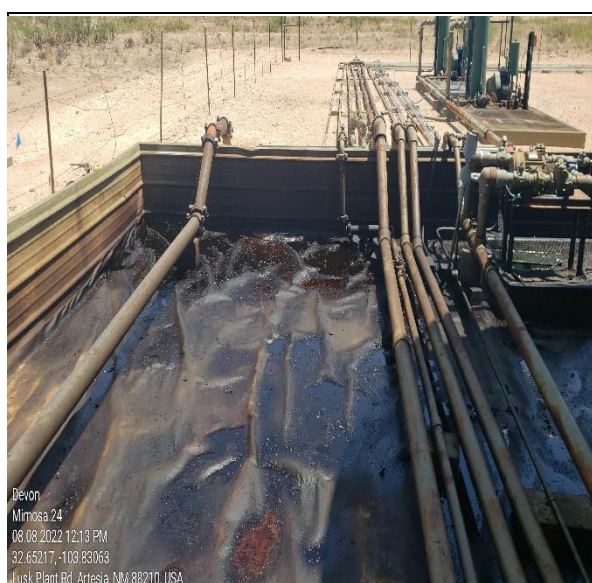
**Photograph No.8 Description:**

View of corner liner repair.
