Closure

Cause of Release:
A 3-inch poly flowline burst.

Based on laboratory analytical results and field activities conducted to date, Etech recommends Spur Energy Partners, LLC, provide copies of this *Remediation Summary and Soil Closure Request* to the appropriate agencies and request closure be granted to the Foster Eddy #10 site.

Figure 2
 Aerial Proximity Map
 Spur Energy Partners, LLC
 Foster Eddy #10
 GPS: 32.8354, -103.8951
 Eddy County

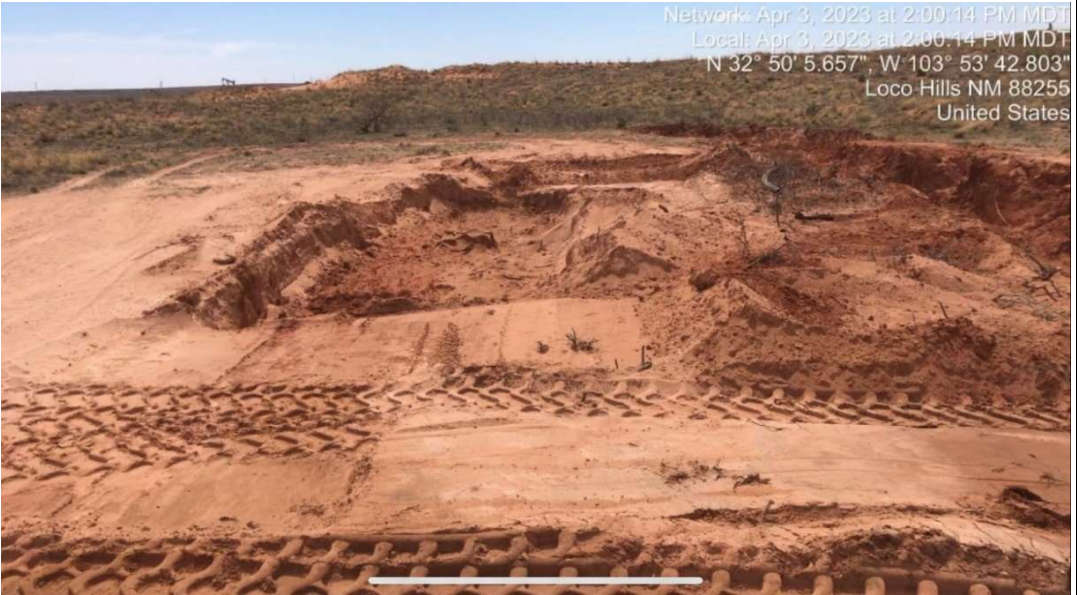
Photo Number: 2

Photo Direction: East	
Photo Description: View of excavated area.

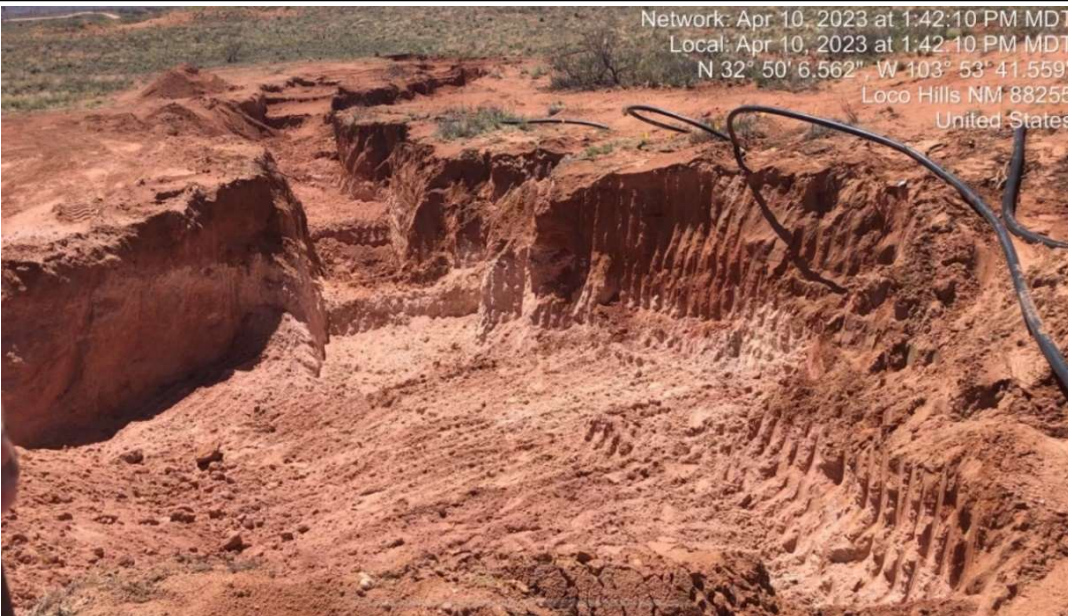
Photo Number: 3

Photo Direction: South	
Photo Description: View of excavated area.

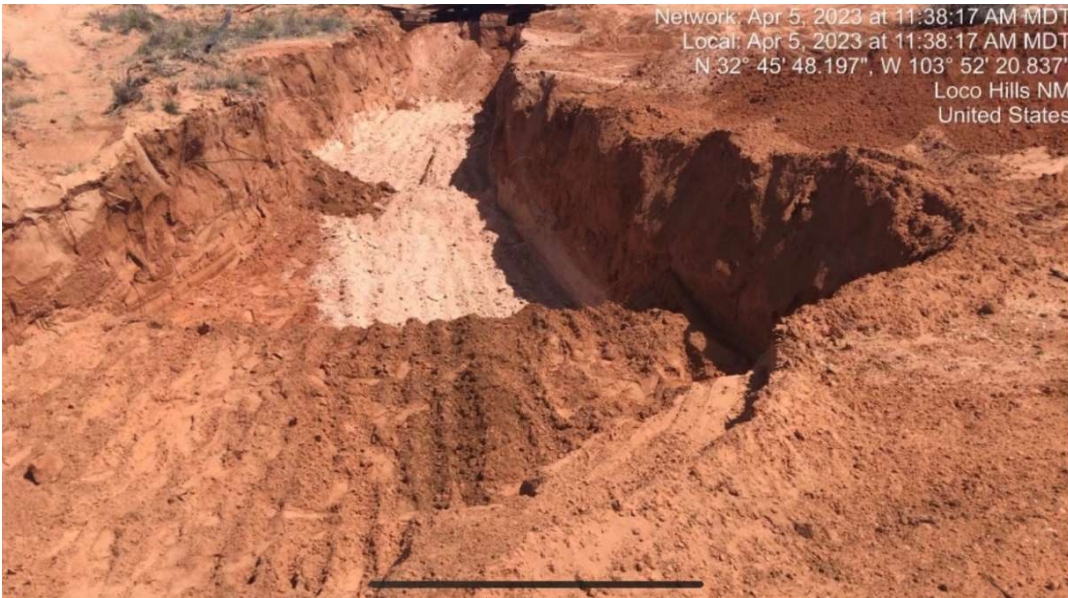
Photo Number: 4

Photo Direction: North	
Photo Description: View of excavated area.

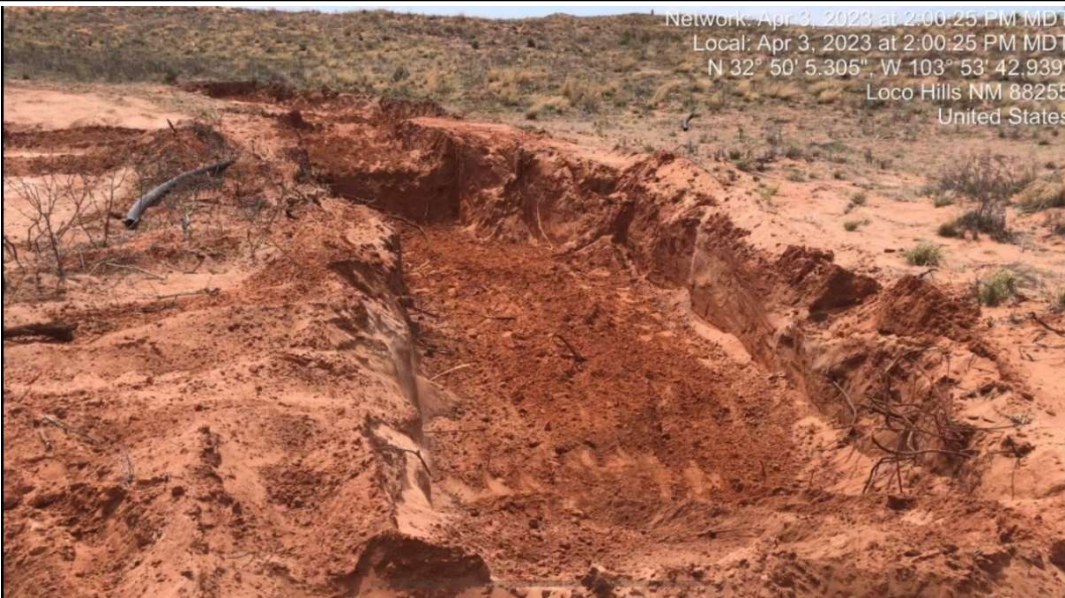
Photo Number: 5

<p>Network: Apr 3, 2023 at 2:00:25 PM MDT Local: Apr 3, 2023 at 2:00:25 PM MDT N 32° 50' 5.305", W 103° 53' 42.939" Loco Hills NM 88255 United States</p>
Photo Direction: North	
Photo Description: View of excavated area.

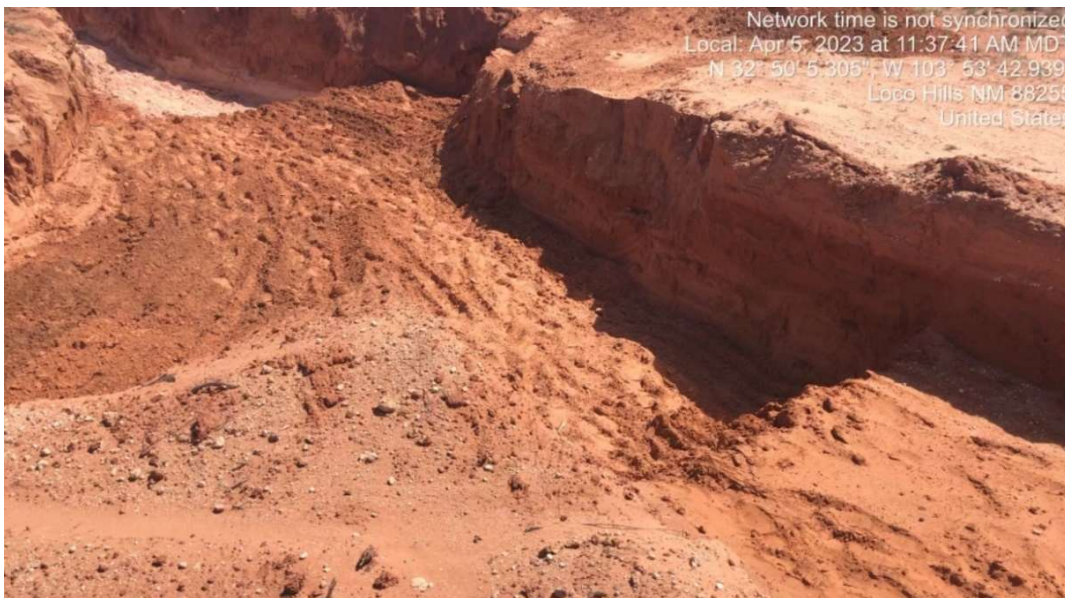
Photo Number: 6

<p>Network time is not synchronized Local: Apr 5, 2023 at 11:37:41 AM MDT N 32° 50' 5.305", W 103° 53' 42.939" Loco Hills NM 88255 United States</p>
Photo Direction: South	
Photo Description: View of excavated area.

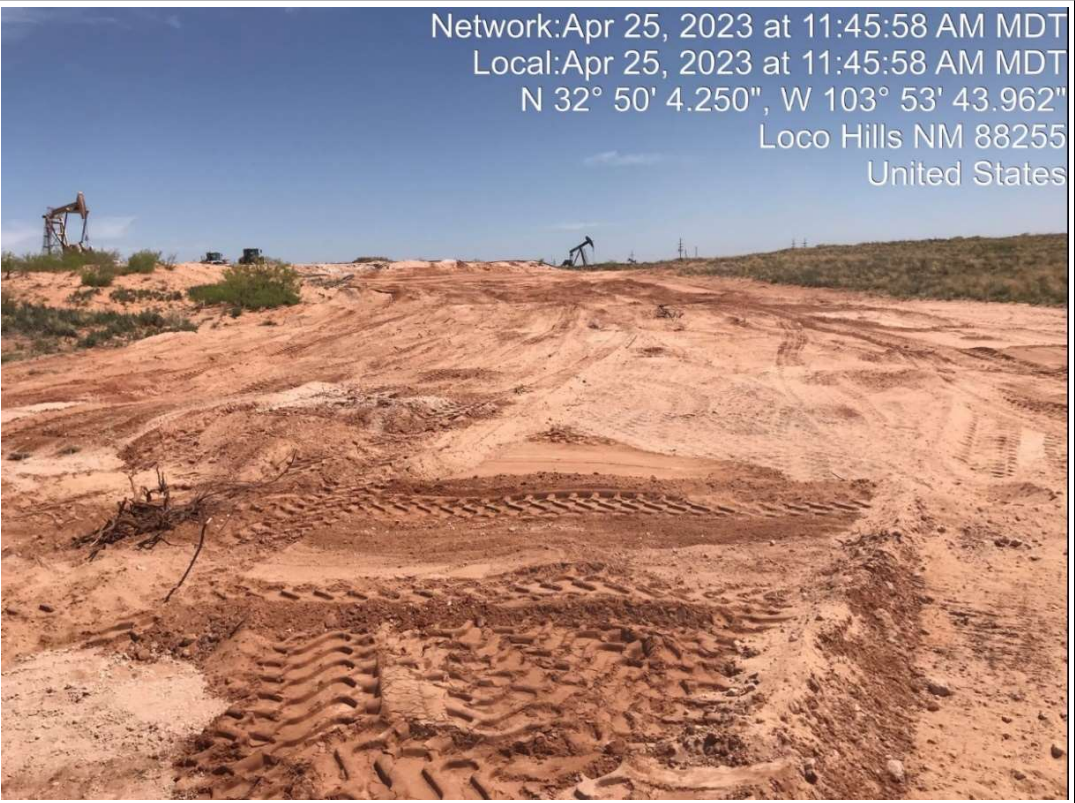
Photo Number: 7	<div>Network: Apr 25, 2023 at 11:45:58 AM MDT Local: Apr 25, 2023 at 11:45:58 AM MDT N 32° 50' 4.250", W 103° 53' 43.962" Loco Hills NM 88255 United States</div>

Photo Direction: North	
Photo Description: View of remediated area after backfill and regrading.

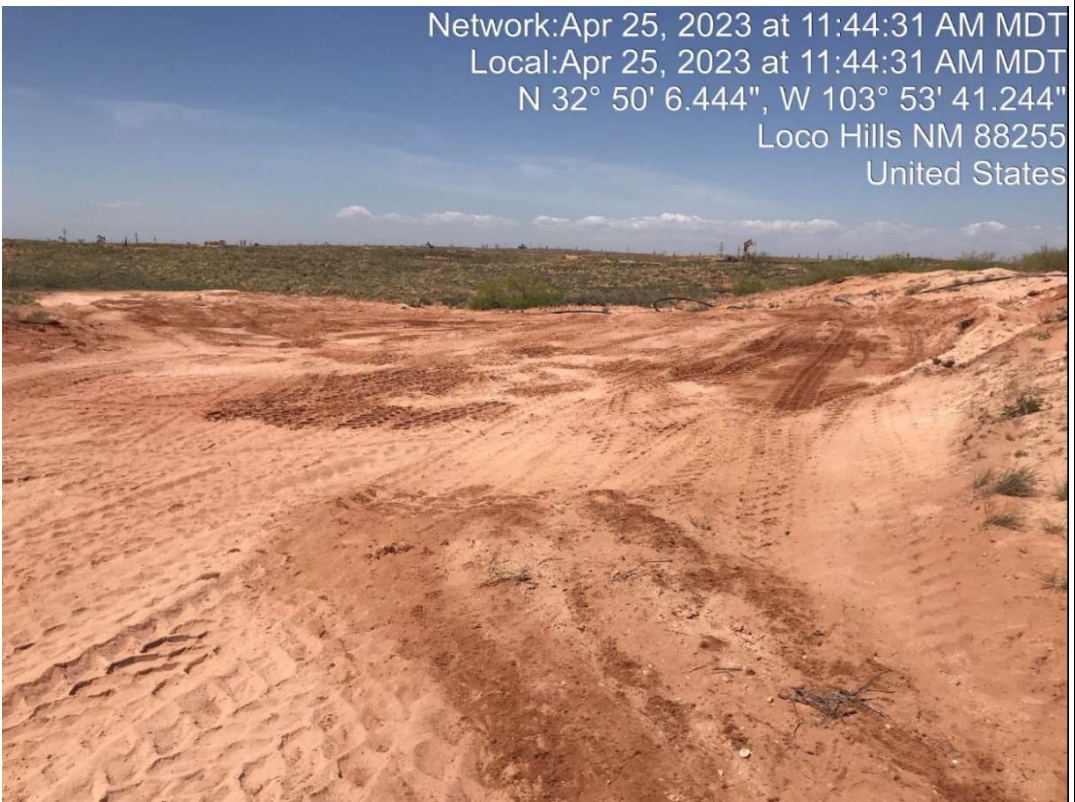
Photo Number: 8	<div>Network: Apr 25, 2023 at 11:44:31 AM MDT Local: Apr 25, 2023 at 11:44:31 AM MDT N 32° 50' 6.444", W 103° 53' 41.244" Loco Hills NM 88255 United States</div>

Photo Direction: South	
Photo Description: View of remediated area after backfill and regrading.
