## Release Notification

Site Name Federal I Com #103	Site Type Gas Well
Date Release Discovered 12/01/2022	API# (if applicable) 30-045-32587

# Federal I Com 103

## Site Characterization and Remediation Plan

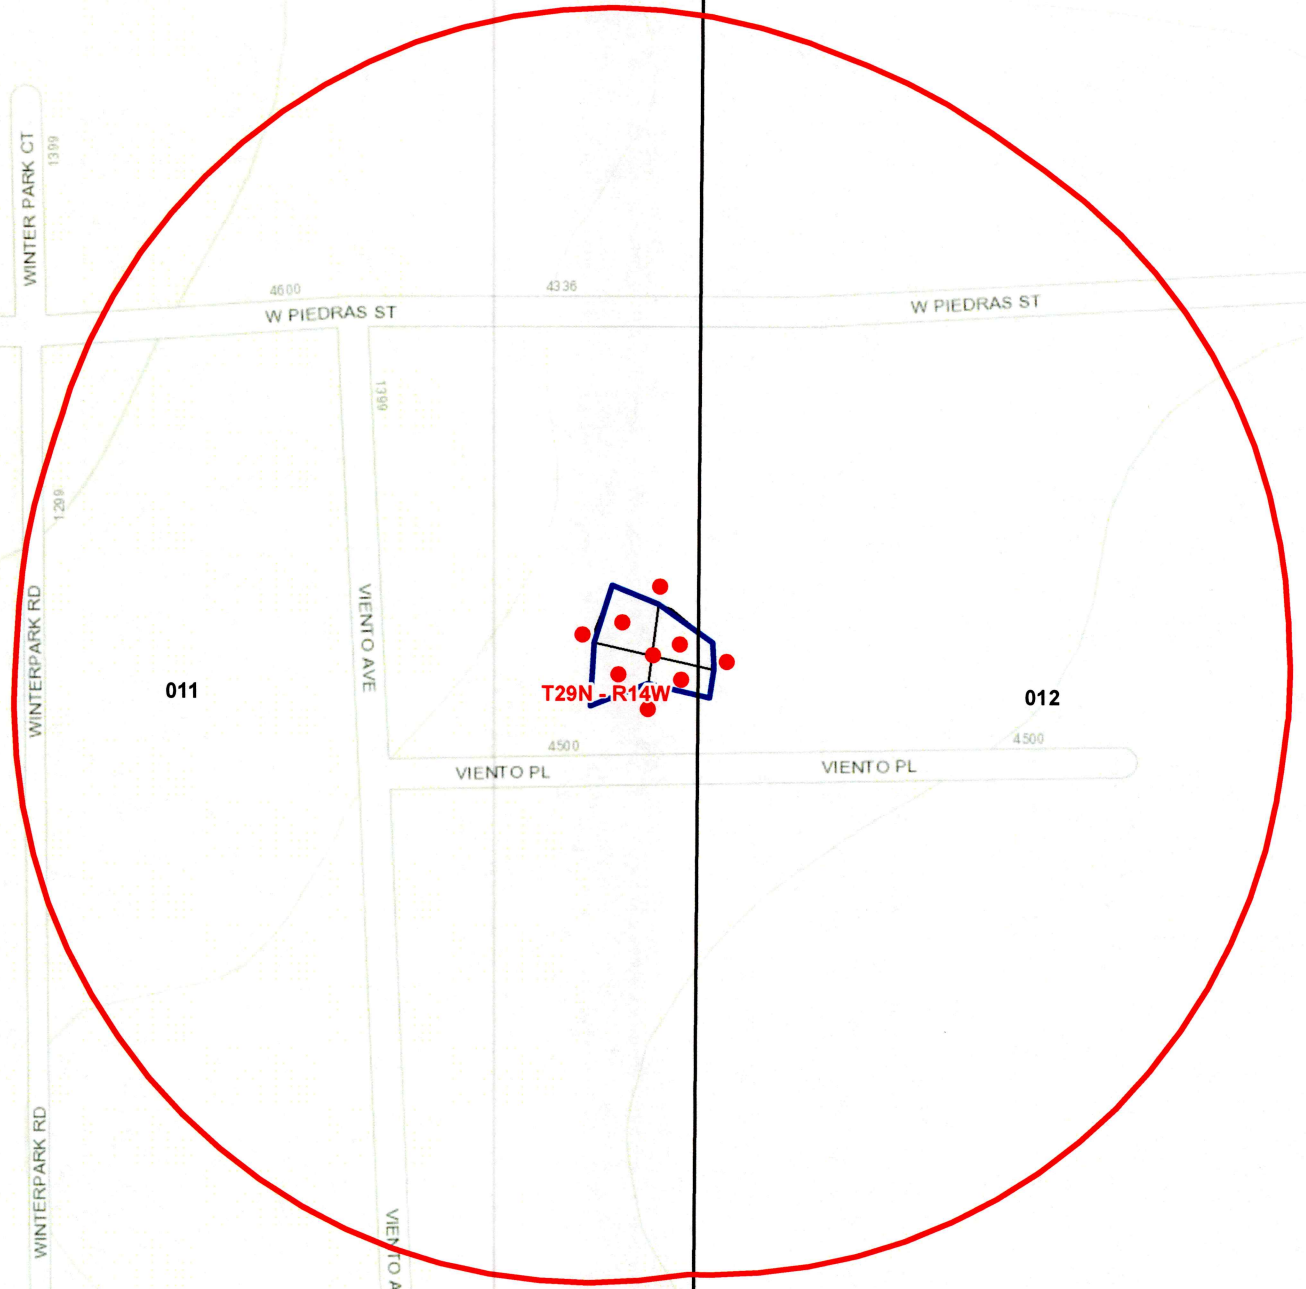
**Map 3** is a topographical map of the surrounding area.
