**Re: Closure Request
Muy Wayno Recycling Facility
Incident Number NVV2002451789
Eddy County, New Mexico**

Ensolum, LLC (Ensolum), on behalf of XTO Energy, Inc. (XTO), has prepared the following *Closure Request* as a follow-up to the *Deferral Request* dated March 26, 2020. This *Closure Request* provides an update to the previously conducted excavation and soil sampling activities at the Muy Wayno Recycling Facility (Site). Removal of a lined tank containment allowed for completion of remediation. Based on the additional remediation activities described below, XTO is submitting this *Closure Request* and requesting no further action and closure for Incident Number NVV2002451789.

XTO Energy, Inc.
Closure Request
Muy Wayno Recycling Facility Pond

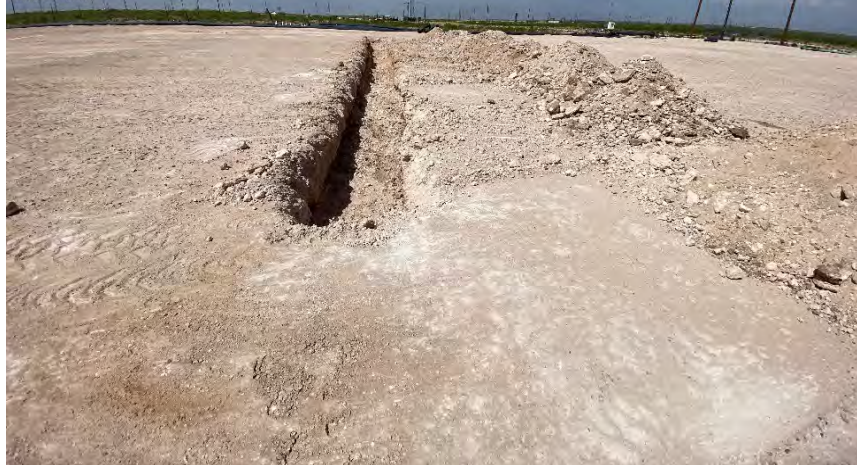
Photograph 1

Description: View of excavation facing northeast.

During April 2023, Ensolum personnel were at the Site to oversee excavation activities to remove the impacted soil remaining in-place in the former tank containment area, as indicated by original excavation sidewall sample SW04 collected from ground surface to 2.5 feet bgs. The location of the tank containment, deferral area, and sidewall soil sample SW04 are depicted on Figure 2. Excavation activities were performed using a backhoe and transport vehicles. To direct excavation activities, soil was screened for volatile organic compounds (VOCs) utilizing a calibrated photoionization detector (PID) and chloride using Hach® chloride QuanTab® test strips. The excavation was completed to a depth of 2.5 feet bgs. Photographic documentation of the excavation activities is included in Appendix A.

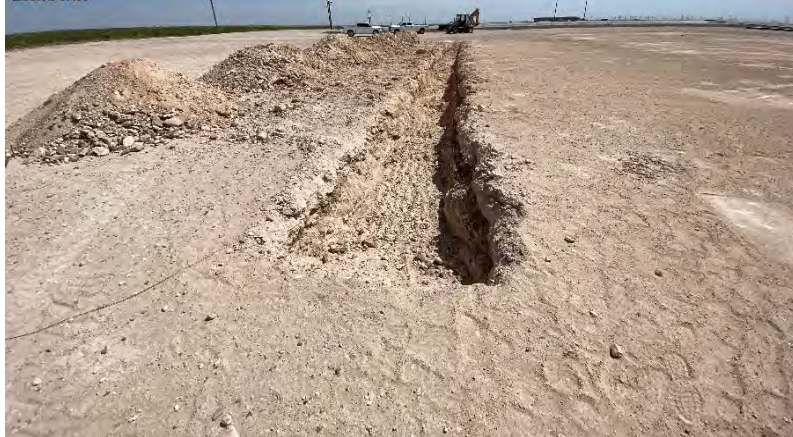
Photograph 2

Description: View of excavation facing southeast.
