**Re: Revised Release Characterization and Deferral Request
ConocoPhillips (Heritage COG Operating LLC)
On behalf of Spur Energy Partners, LLC
Patton 5 Fee #002H Tank Battery Release
Unit Letter D, Section 5, Township 19 South, Range 26 East
Eddy County, New Mexico
Incident ID# nAB1801851398**

Revised Release Characterization and Deferral Request
October 4, 2023

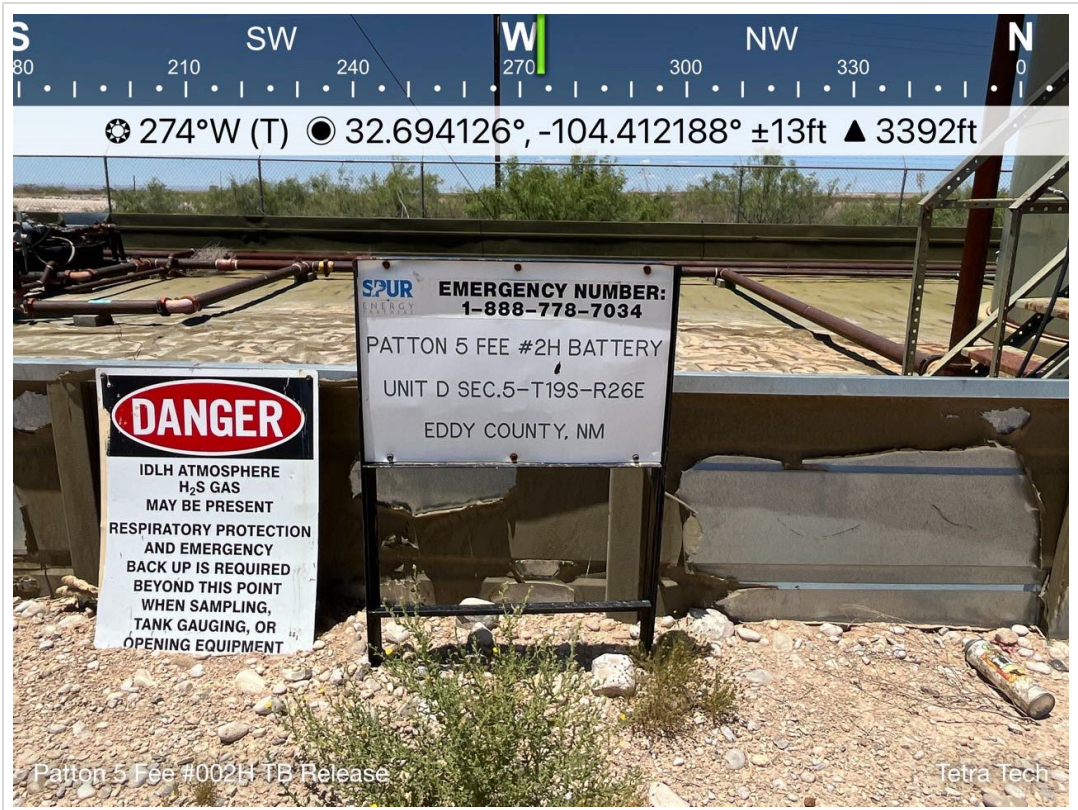
TETRA TECH, INC. PROJECT NO. 212C-MD-02856	DESCRIPTION	View of Site Signage.	1
	SITE NAME	Patton 5 Fee #002H TB Release	7/3/2023

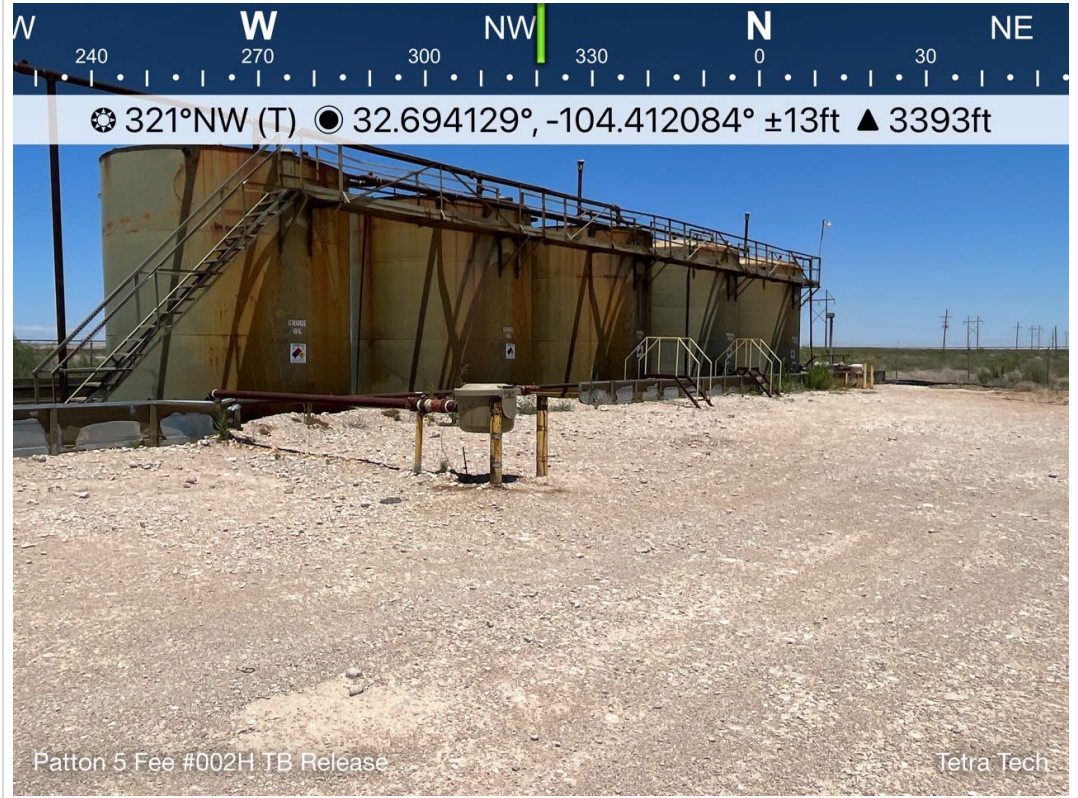
TETRA TECH, INC. PROJECT NO. 212C-MD-02856	DESCRIPTION	View northwest. View of production equipment and historical release area.	2
	SITE NAME	Patton 5 Fee #002H TB Release	7/3/2023

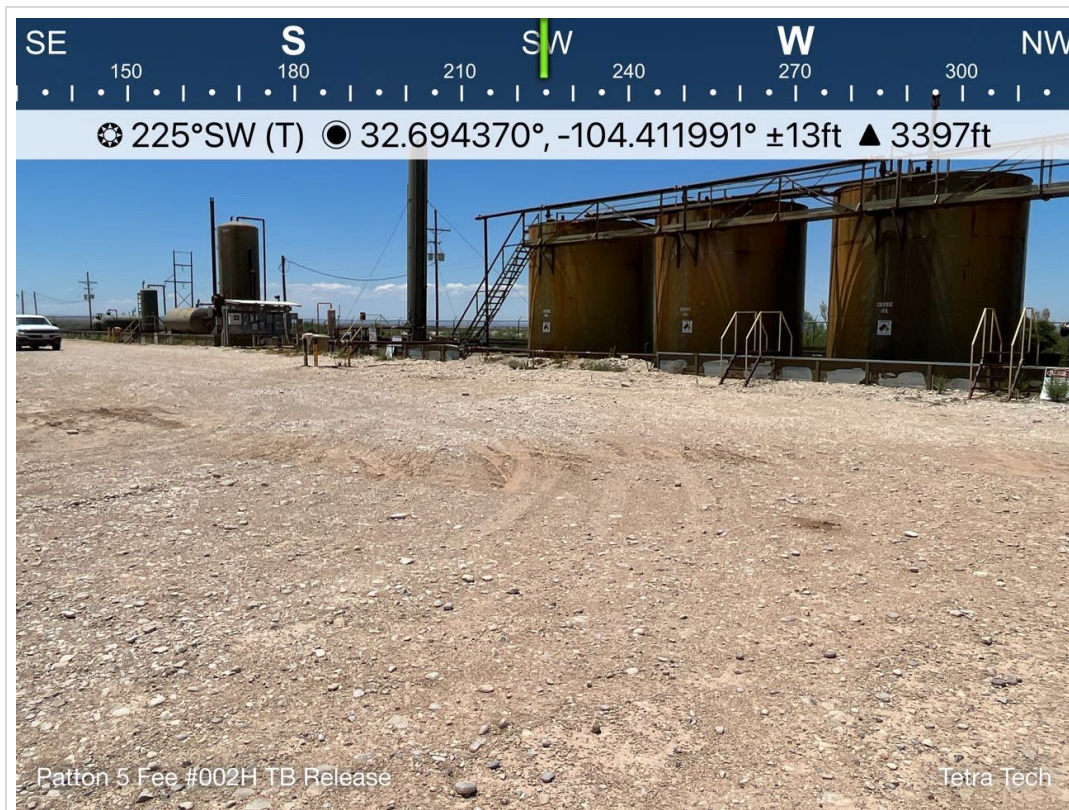
TETRA TECH, INC. PROJECT NO. 212C-MD-02856	DESCRIPTION	View southwest. View of historic release area and production equipment.	3
	SITE NAME	Patton 5 Fee #002H TB Release	7/3/2023

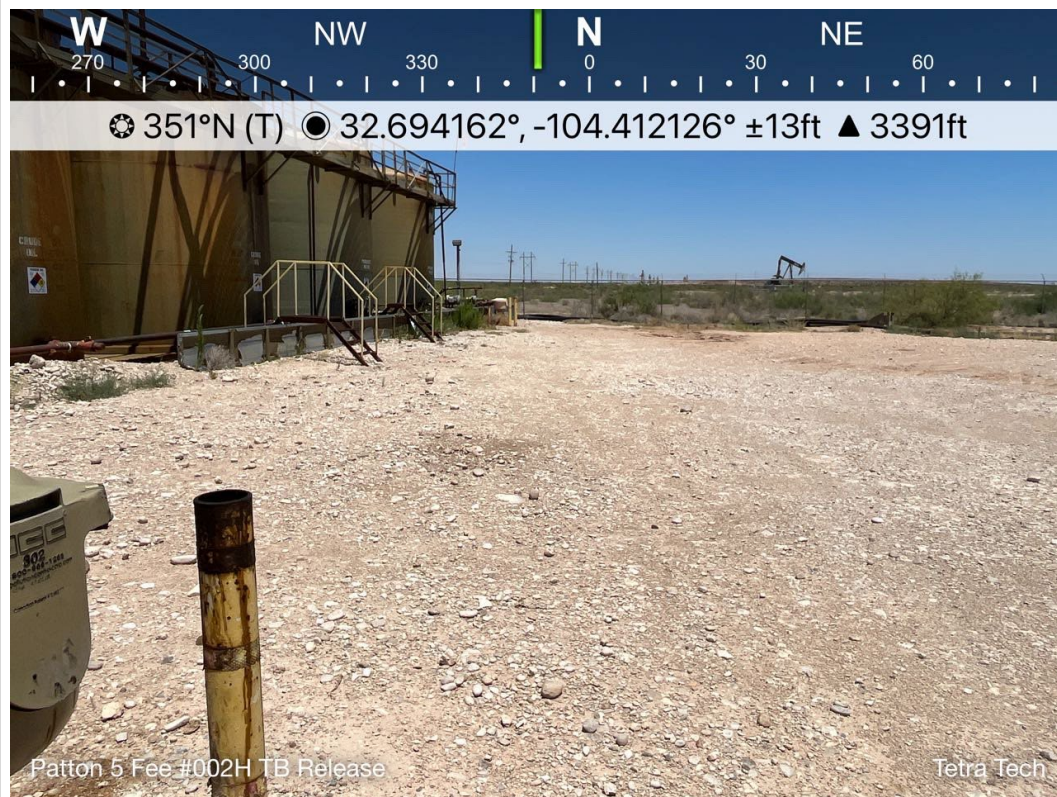
TETRA TECH, INC. PROJECT NO. 212C-MD-02856	DESCRIPTION	View north. View of historic release area. View of production equipment.	4
	SITE NAME	Patton 5 Fee #002H TB Release	7/3/2023

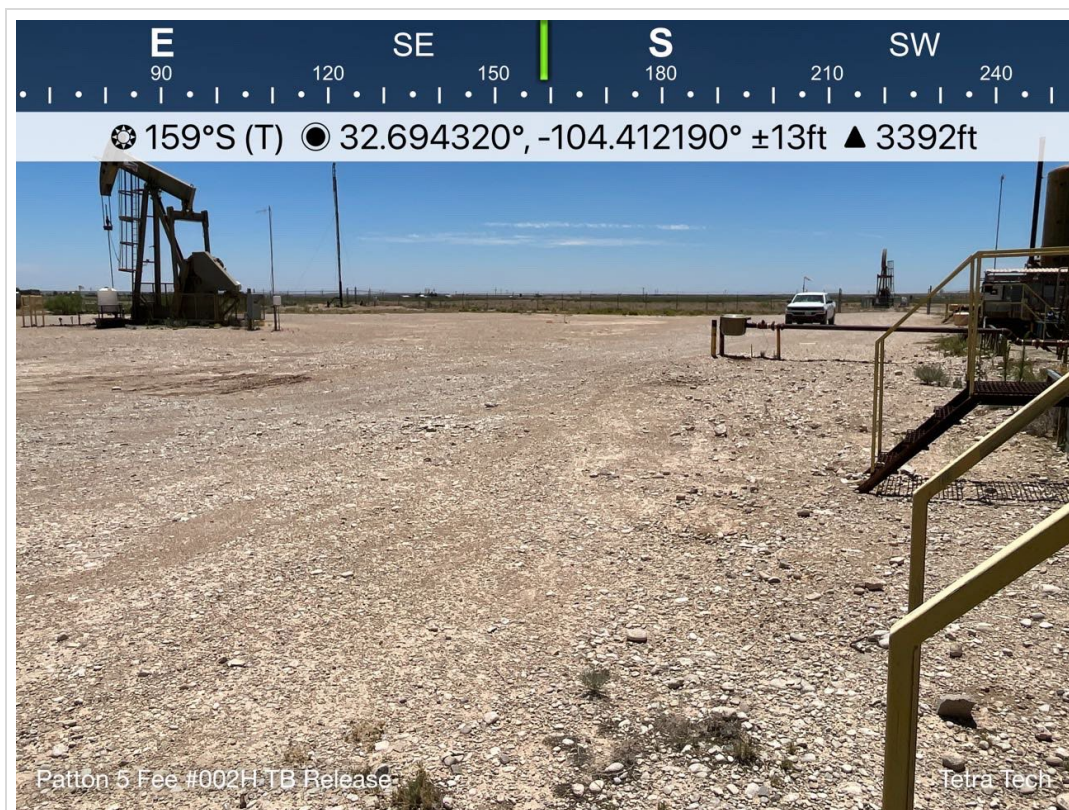
TETRA TECH, INC. PROJECT NO. 212C-MD-02856	DESCRIPTION	View southeast. View of current pad conditions and historical release area.	5
	SITE NAME	Patton 5 Fee #002H TB Release	7/3/2023

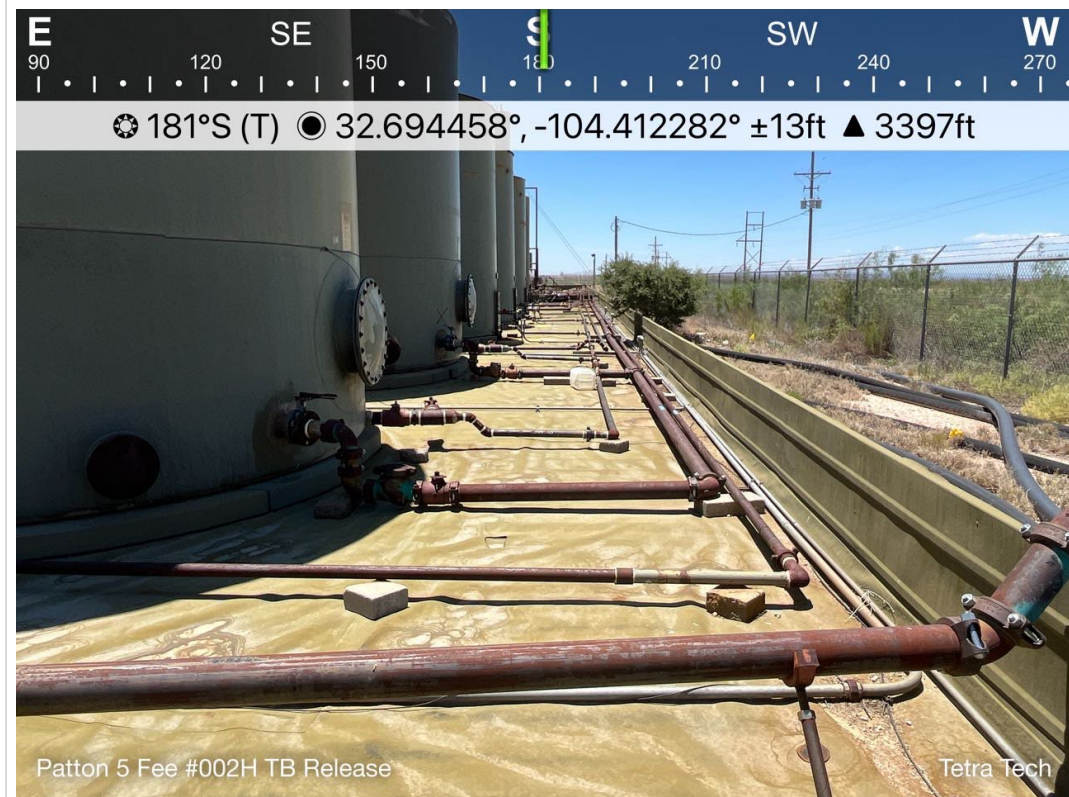
TETRA TECH, INC. PROJECT NO. 212C-MD-02856	DESCRIPTION	View south. View of inside the tank battery of historic release area. Liner present and intact.	6
	SITE NAME	Patton 5 Fee #002H TB Release	7/3/2023

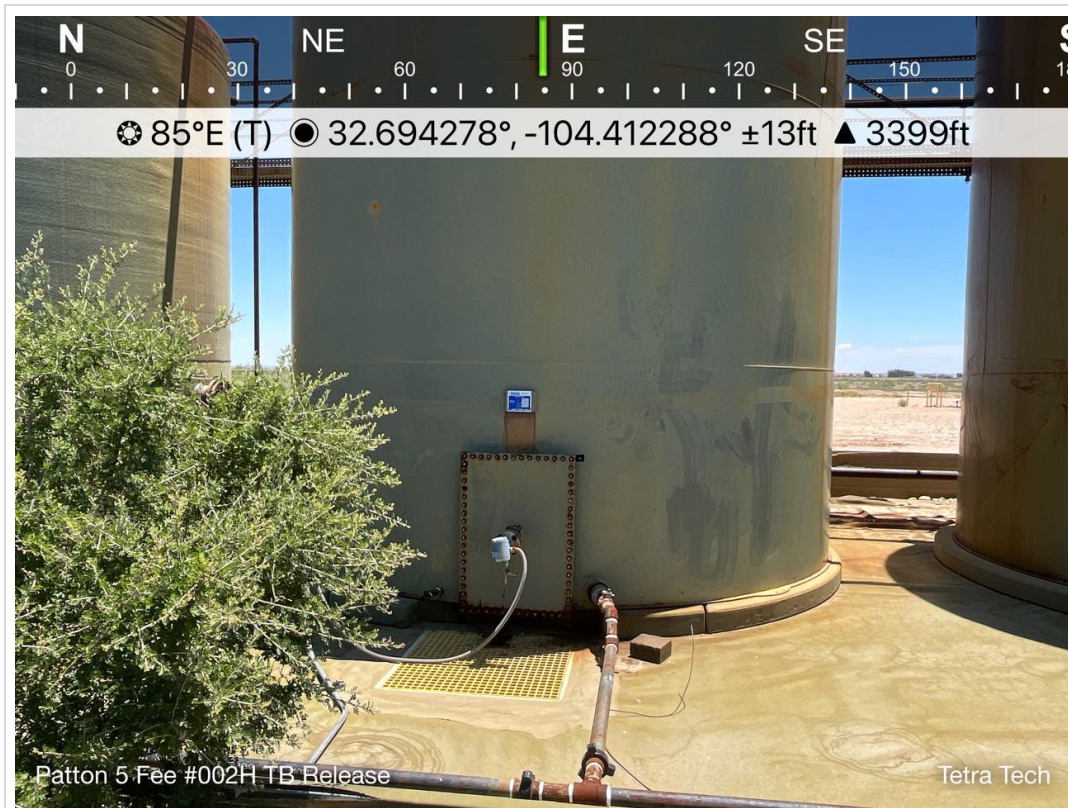
TETRA TECH, INC. PROJECT NO. 212C-MD-02856	DESCRIPTION	View east. View of inside the tank battery. Liner present and intact.	7
	SITE NAME	Patton 5 Fee #002H TB Release	7/3/2023

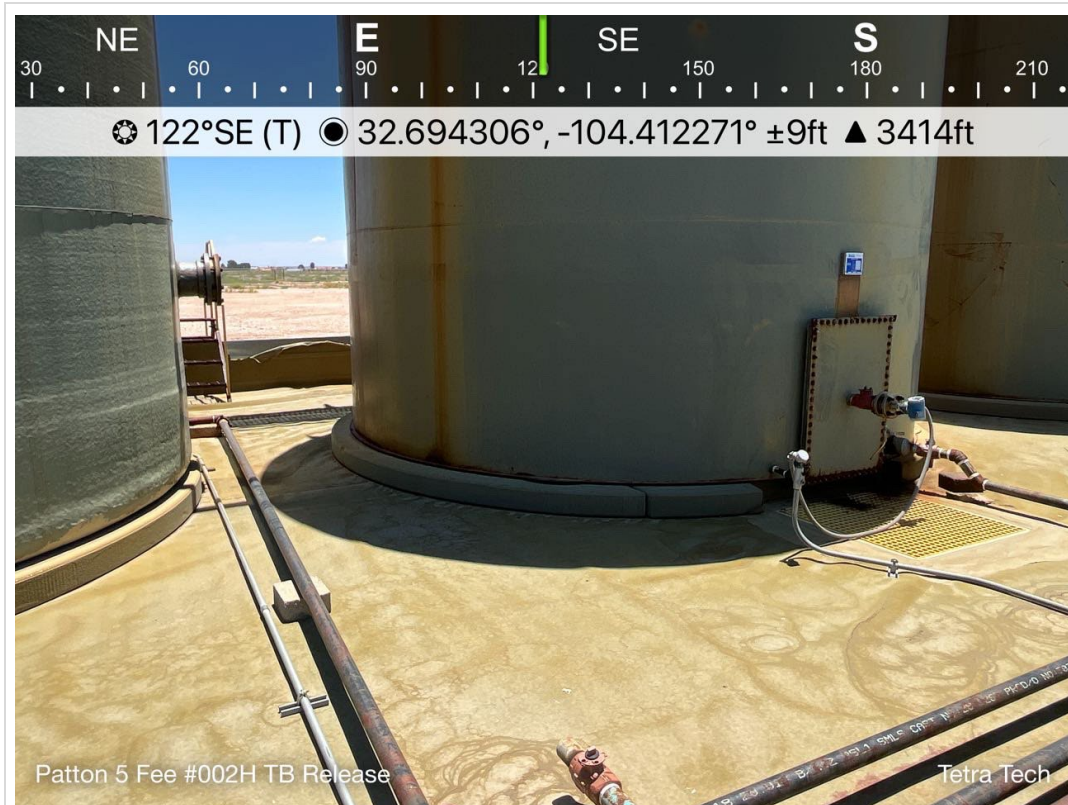
TETRA TECH, INC. PROJECT NO. 212C-MD-02856	DESCRIPTION	View southeast. View of production equipment. Liner present and intact.	8
	SITE NAME	Patton 5 Fee #002H TB Release	7/3/2023

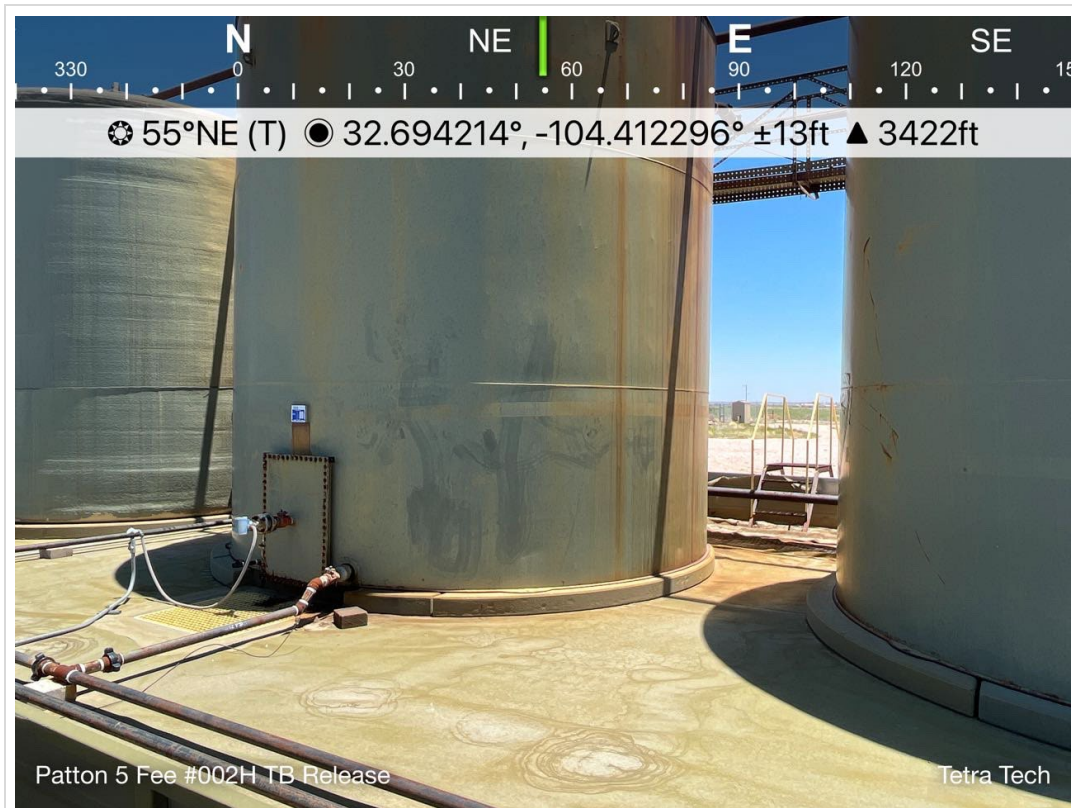
TETRA TECH, INC. PROJECT NO. 212C-MD-02856	DESCRIPTION	View northeast. View of intact liner. Production equipment present.	9
	SITE NAME	Patton 5 Fee #002H TB Release	7/3/2023

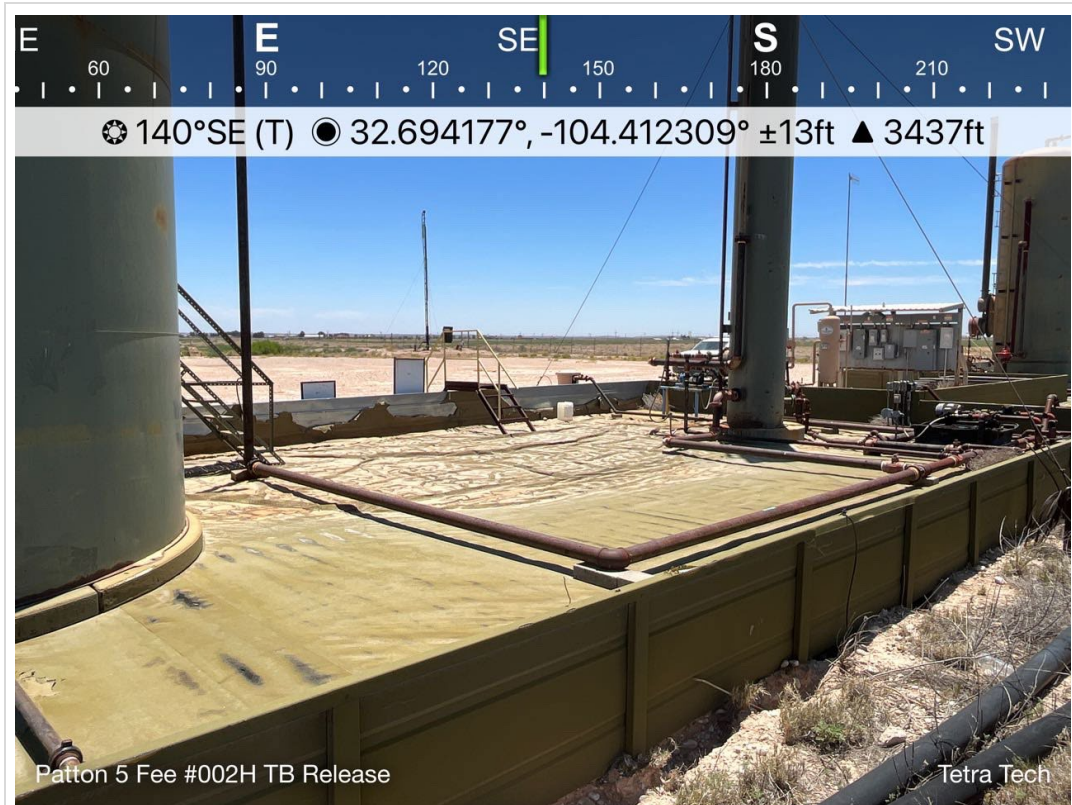
TETRA TECH, INC. PROJECT NO. 212C-MD-02856	DESCRIPTION	View southeast. View of production equipment. Liner present and intact.	10
	SITE NAME	Patton 5 Fee #002H TB Release	7/3/2023

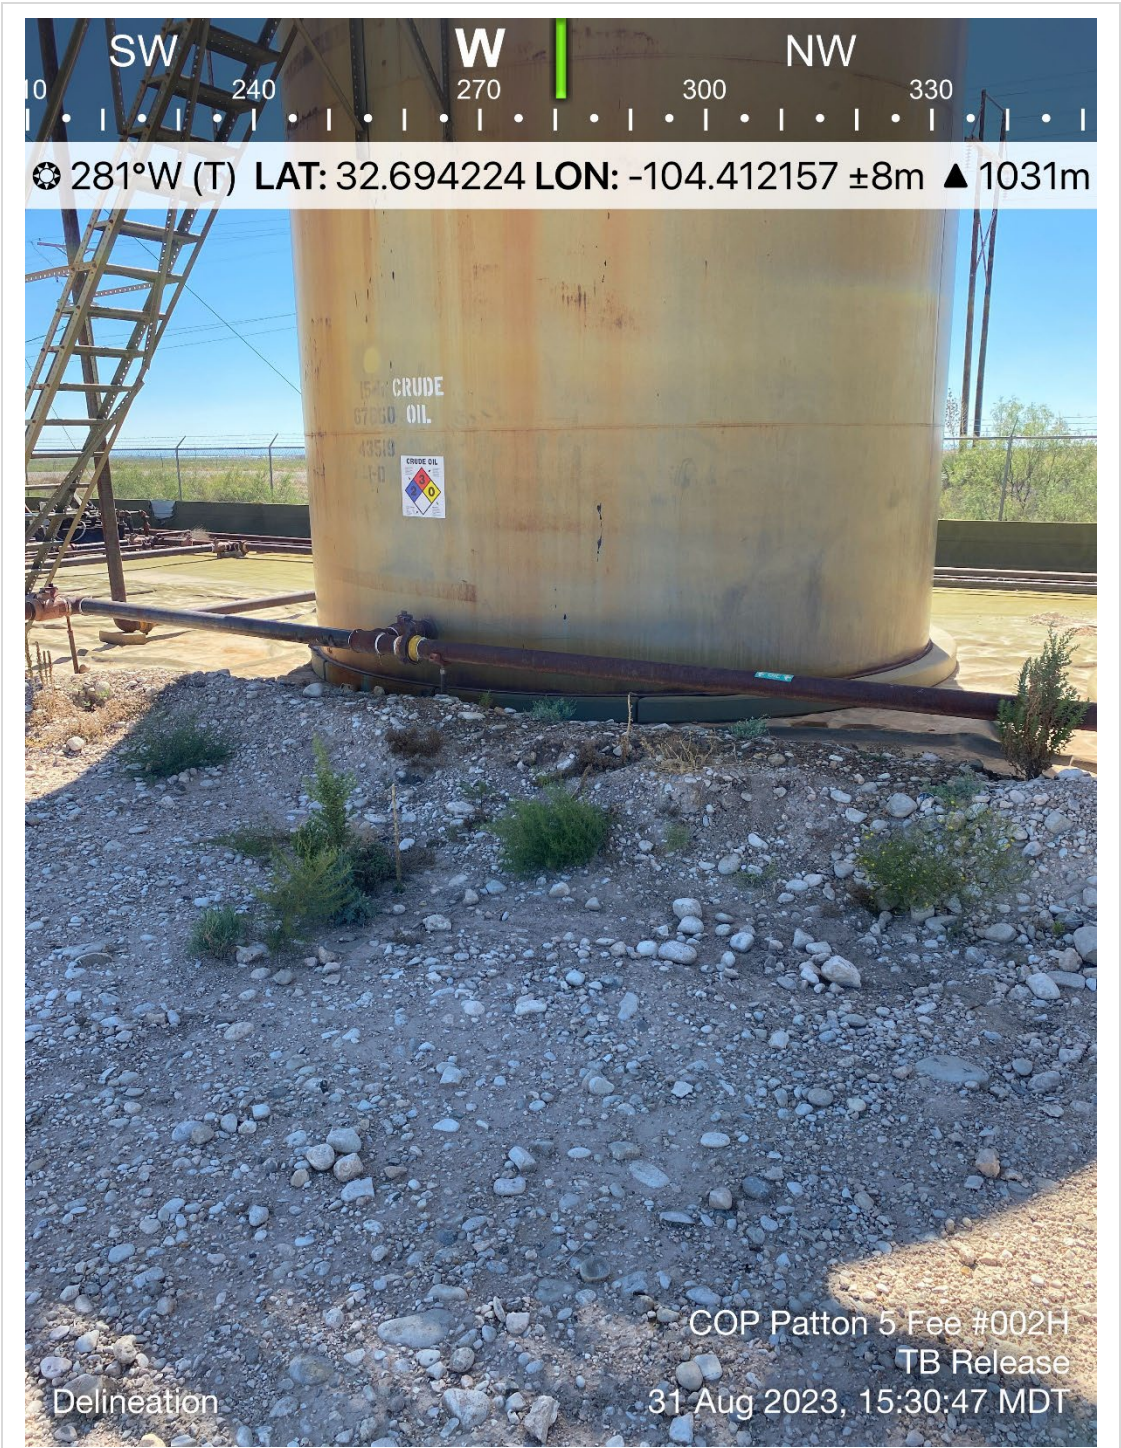
Additional sampling and a liner inspection were conducted at the Site in August 2023 to comply with comments provided by NMOCD with the Deferral Request rejection. The analytical results associated with the additional sampling at the AH-3 location indicate that the area is no longer impacted with TPH above Site RRALs. This change is attributed to natural degradation of TPH due to the age of the release. A similar trend has been observed in the areas of T-1/AH-23-1 and T-2/AH-23-2. Additionally, photographs of the liner at the earthen bermed wall of the containment indicate that the liner and berm are intact as of August 2023.

TETRA TECH, INC. PROJECT NO. 212C-MD-02856	DESCRIPTION	View west. View dirt bermed wall of tank battery.	12
	SITE NAME	Patton 5 Fee #002H TB Release	8/31/2023

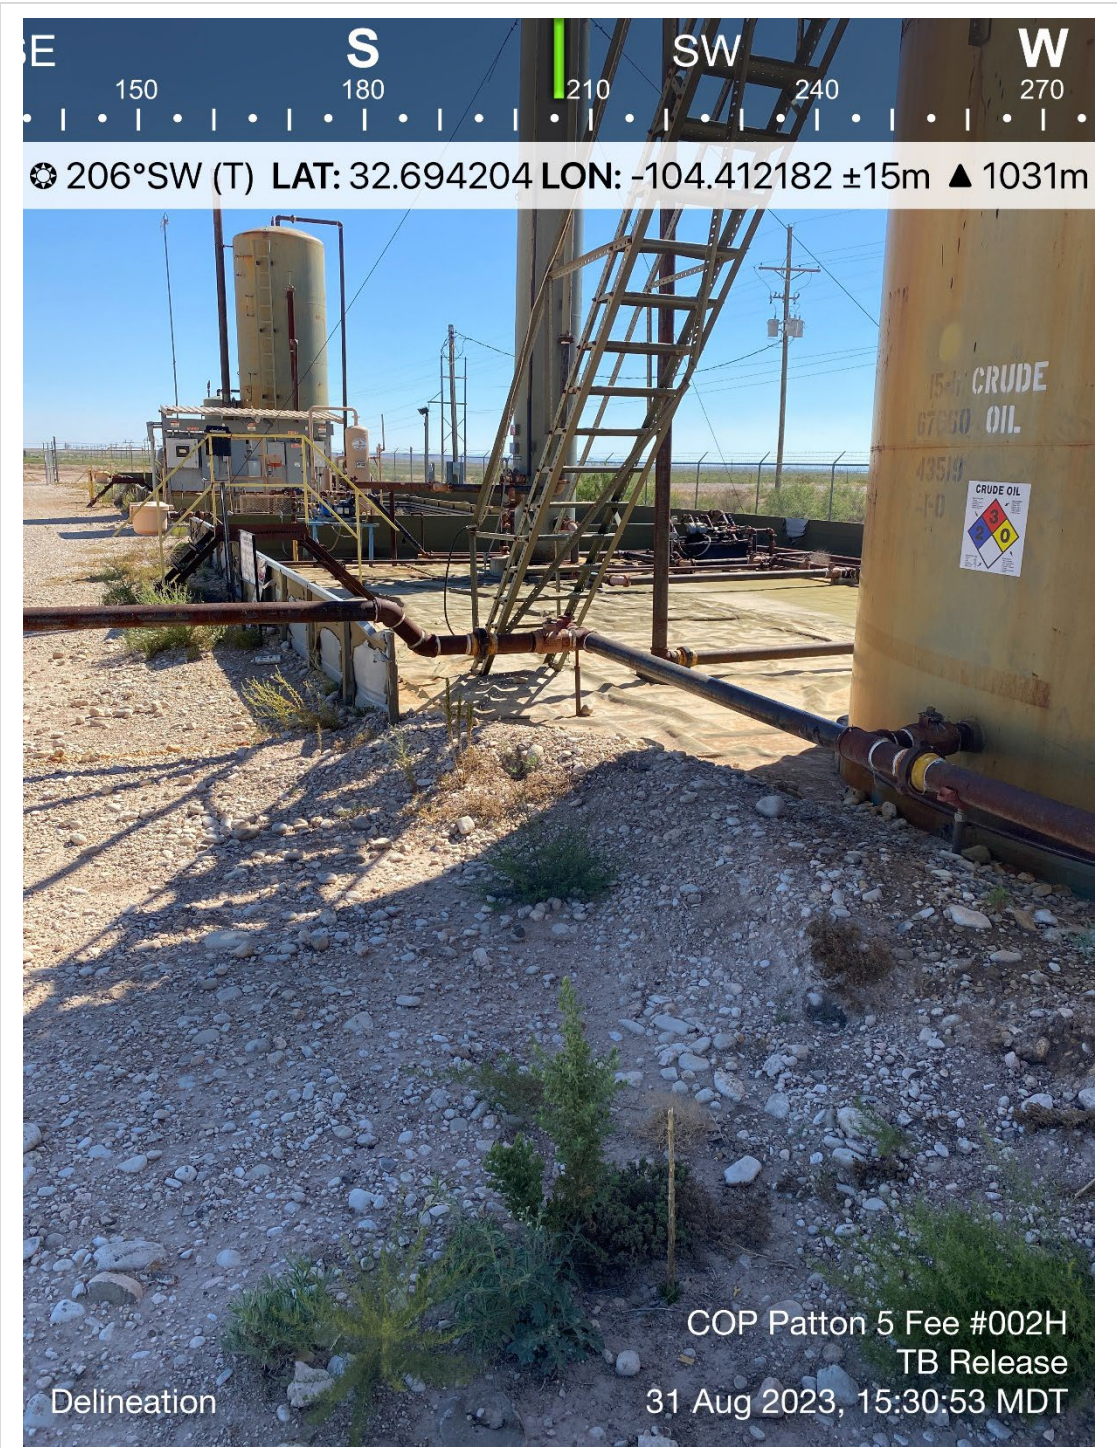
TETRA TECH, INC. PROJECT NO. 212C-MD-02856	DESCRIPTION	View southwest. View dirt bermed wall of tank battery.	13
	SITE NAME	Patton 5 Fee #002H TB Release	8/31/2023
