Closure

Re: Site Assessment, Remediation, and Closure Report
State S 19 #4
API No. 30-015-24273
GPS: Latitude 32.8146667 Longitude -104.1111374
UL "O", Sec. 19, T17S, R29E
Eddy County, NM
NMOCD Ref. No. NAPP2104927763

State S 19 #4
API# 30-015-24273
Eddy County, NM
Site Map

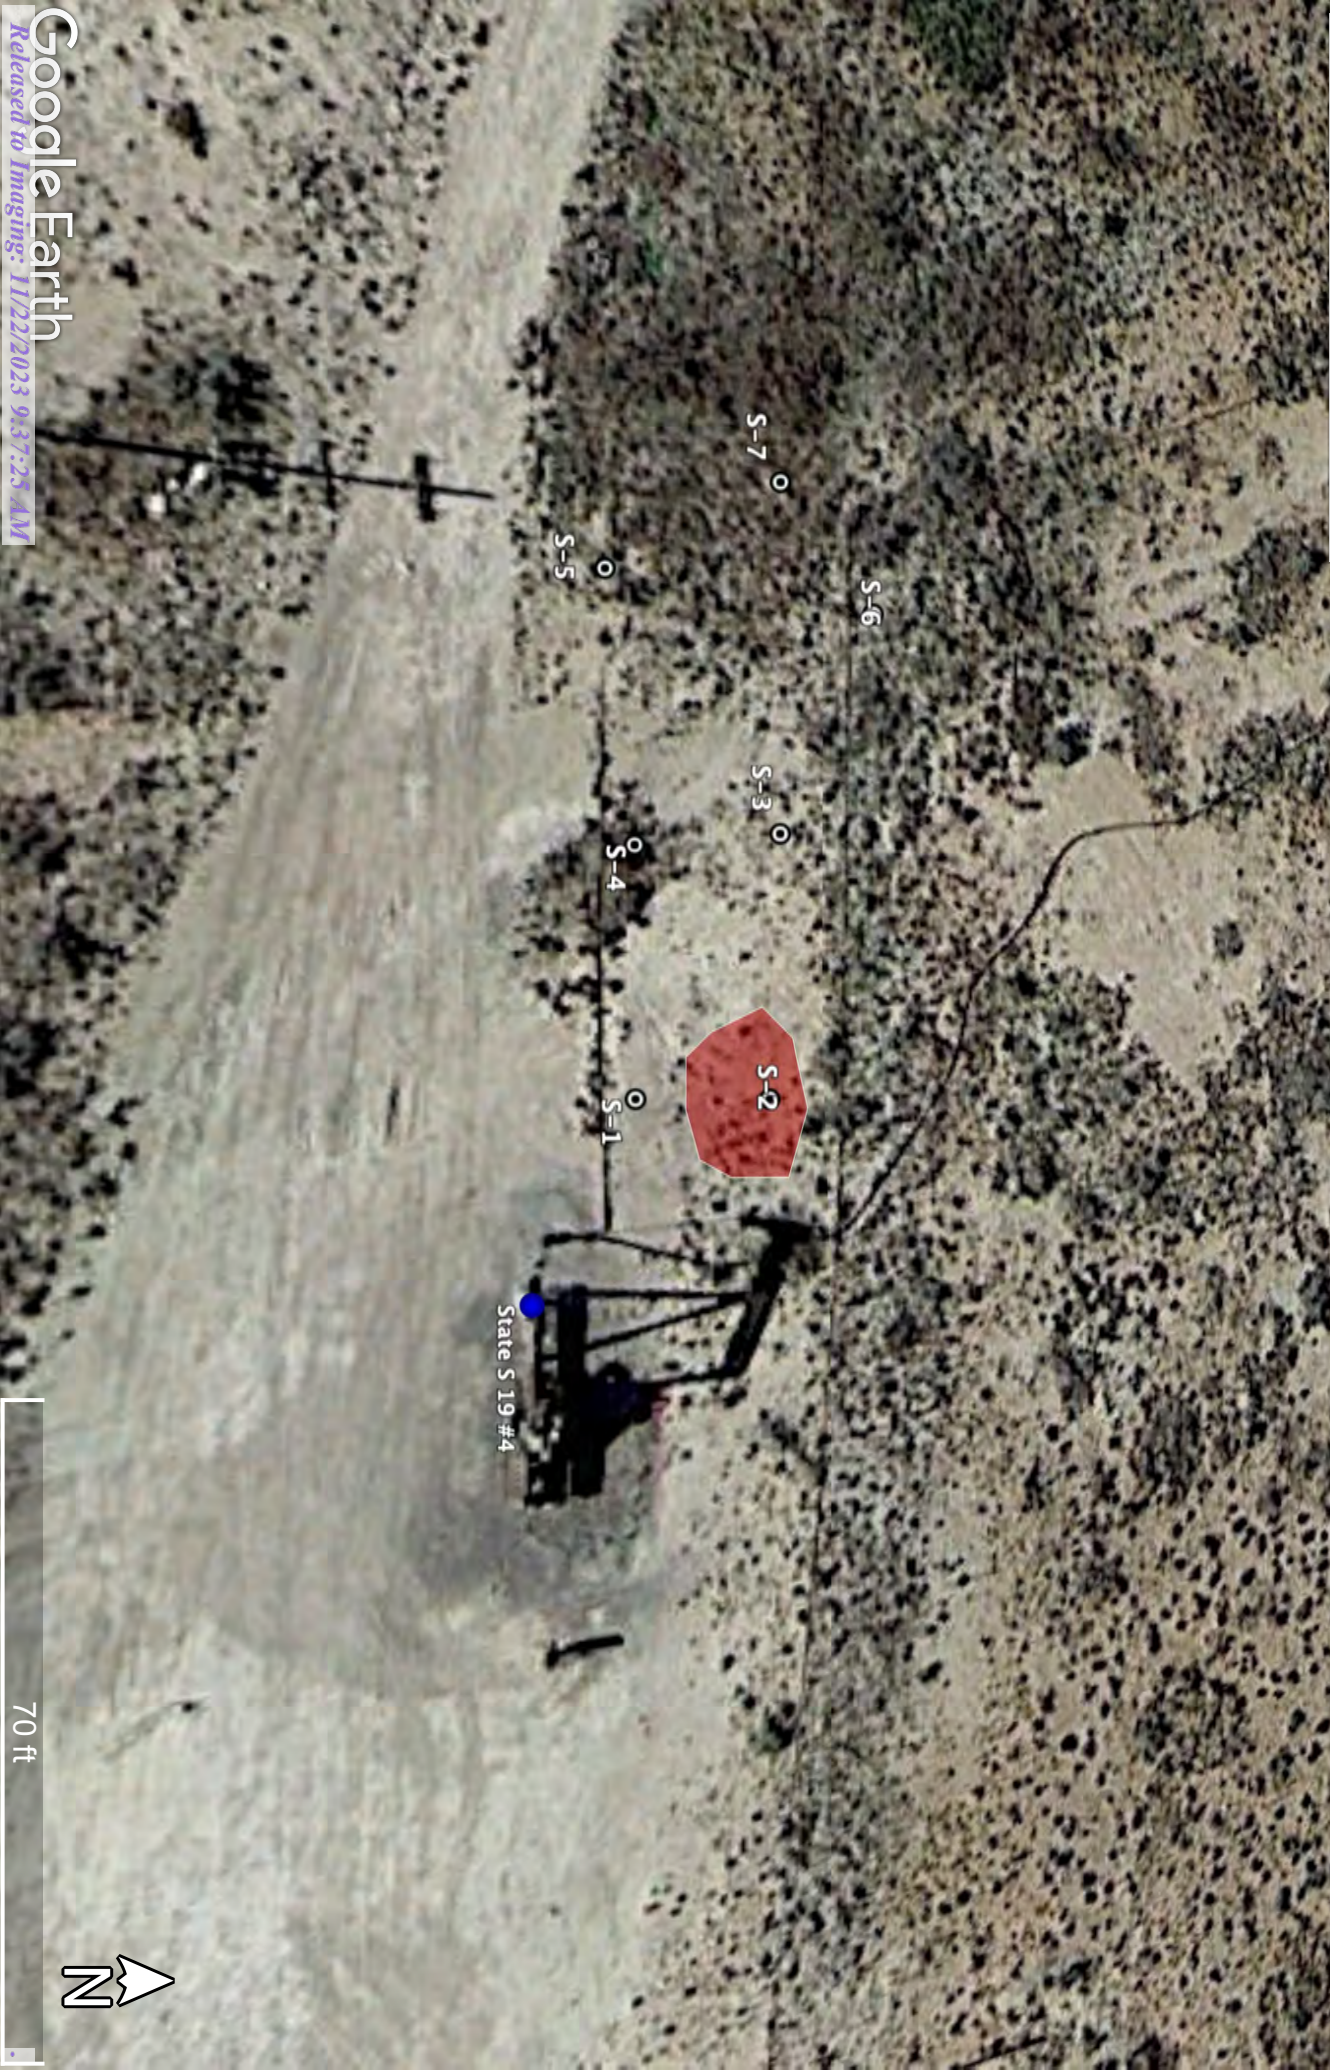
- Legend**
- Excavation Area
 - Samples

All Laboratory analytical reports are provided in Appendix E. A Site Map & Sample Maps are provided in Figures #1, #5, and #6.

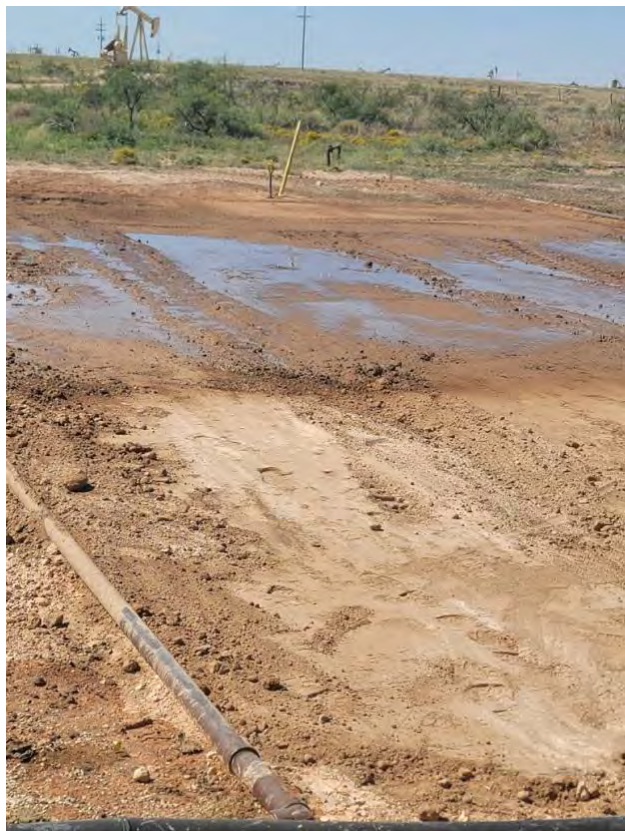
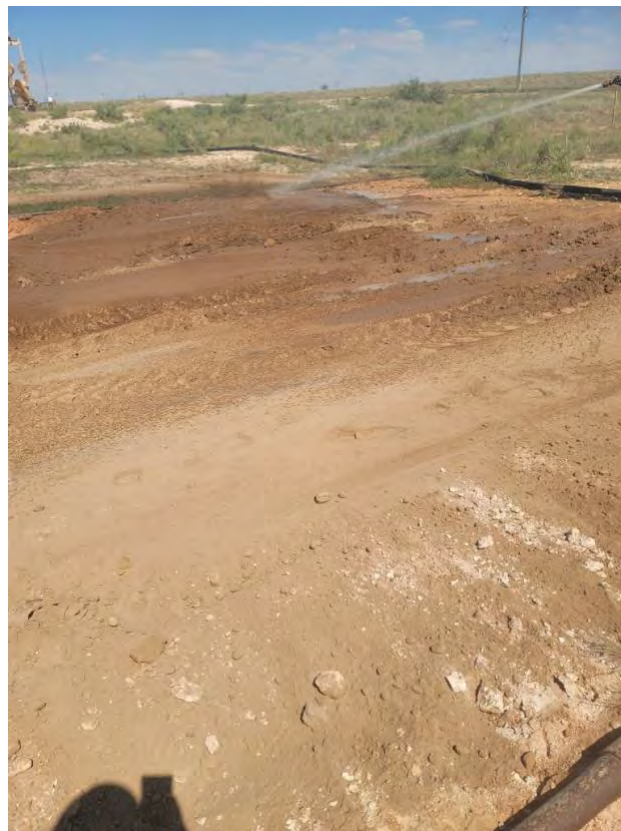
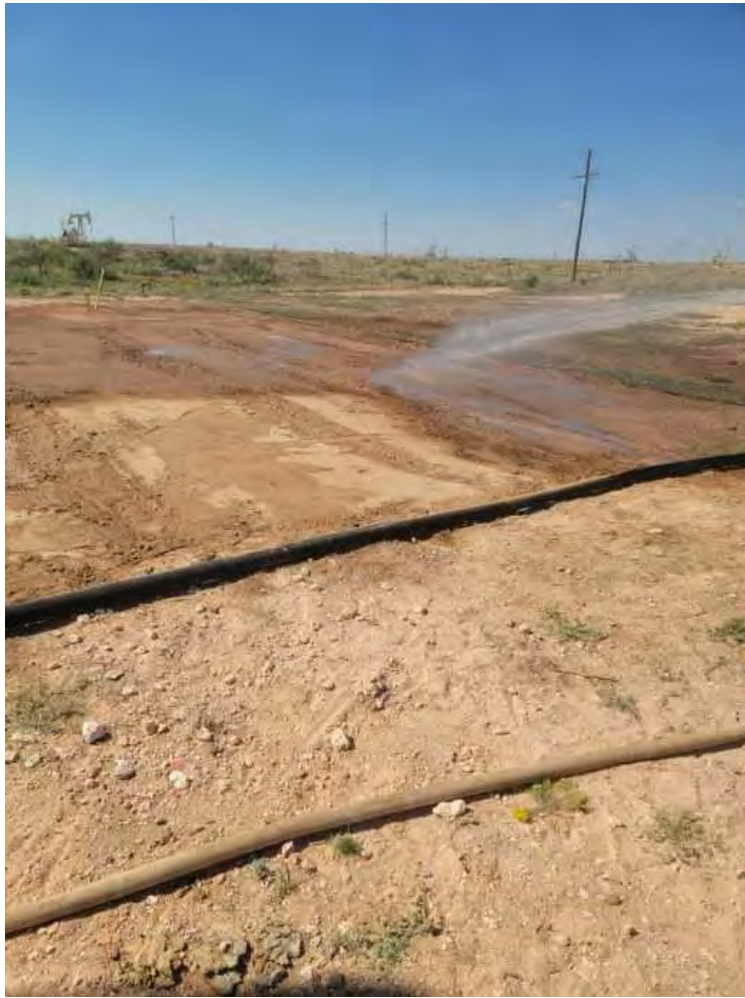
Completed

Unfortunately, after this project was completed, we were compiling the data and necessary documentation for the closure of this project the operator who dug this out left the company. He had taken the initial, and during photos that we were unable to obtain, so the only photos we have to attach to the report are the completed photos.

- These laboratory analytical results indicated concentrations were below NMOCD Closure Criteria.
- All excavated soils were temporarily stockpiled on-site atop a poly liner during the project. It was later transported to Lea Land, an NMOCD-approved waste disposal facility.
- After receiving laboratory analytical results below the closure criteria, the excavated areas were backfilled with “like” material obtained from Lea Land. The affected area was then contoured and machine-compacted to match the surrounding grade.
