Site Assessment/Characterization

Betelgeuse 19 Federal #006H

<p>SITE LOCATION MAP DEVON ENERGY BETELGEUSE 19 FEDERAL #006H EDDY COUNTY, NEW MEXICO 32.6484909, -103.8992157</p>	<p>

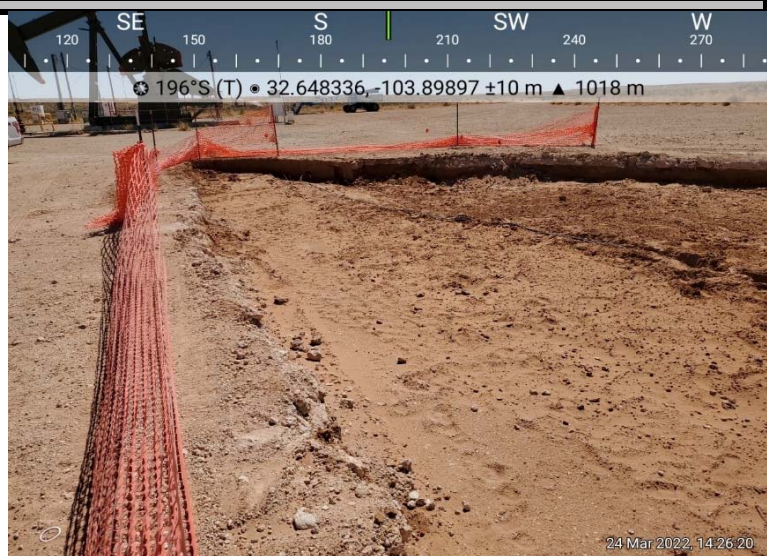
Photograph No. 2

Description:
View of excavation.

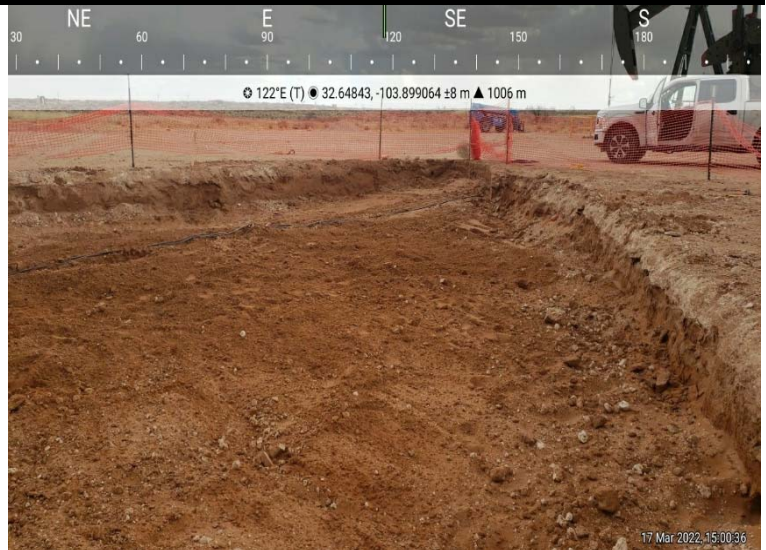
**Photograph No. 5**

Description:
View of excavation.

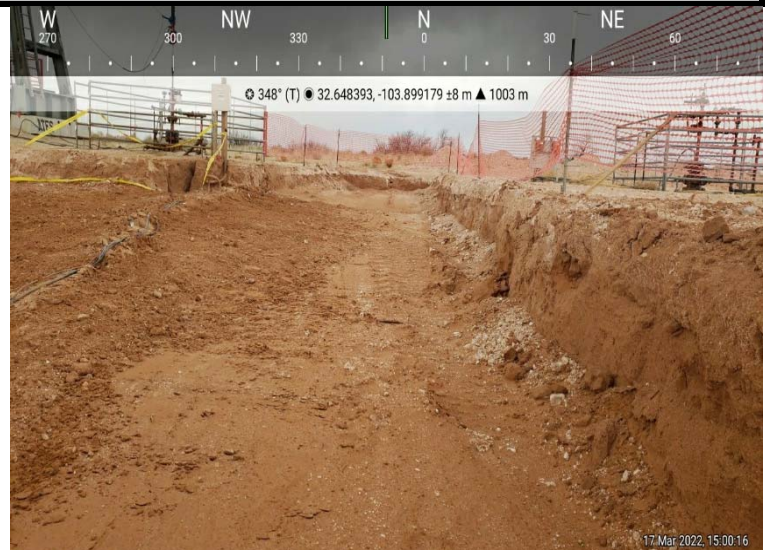
**Photograph No. 6**

Description:
View of excavation.
