CLOSURE REPORT

B-6 Lateral

**Unit D, S09, T21S, R27E
32.50007° N, 104.199338° W
Eddy County, New Mexico
NMOCD Incident ID: nAPP2315233794**

July 10, 2023
Ensolum Project No. 03B1226248

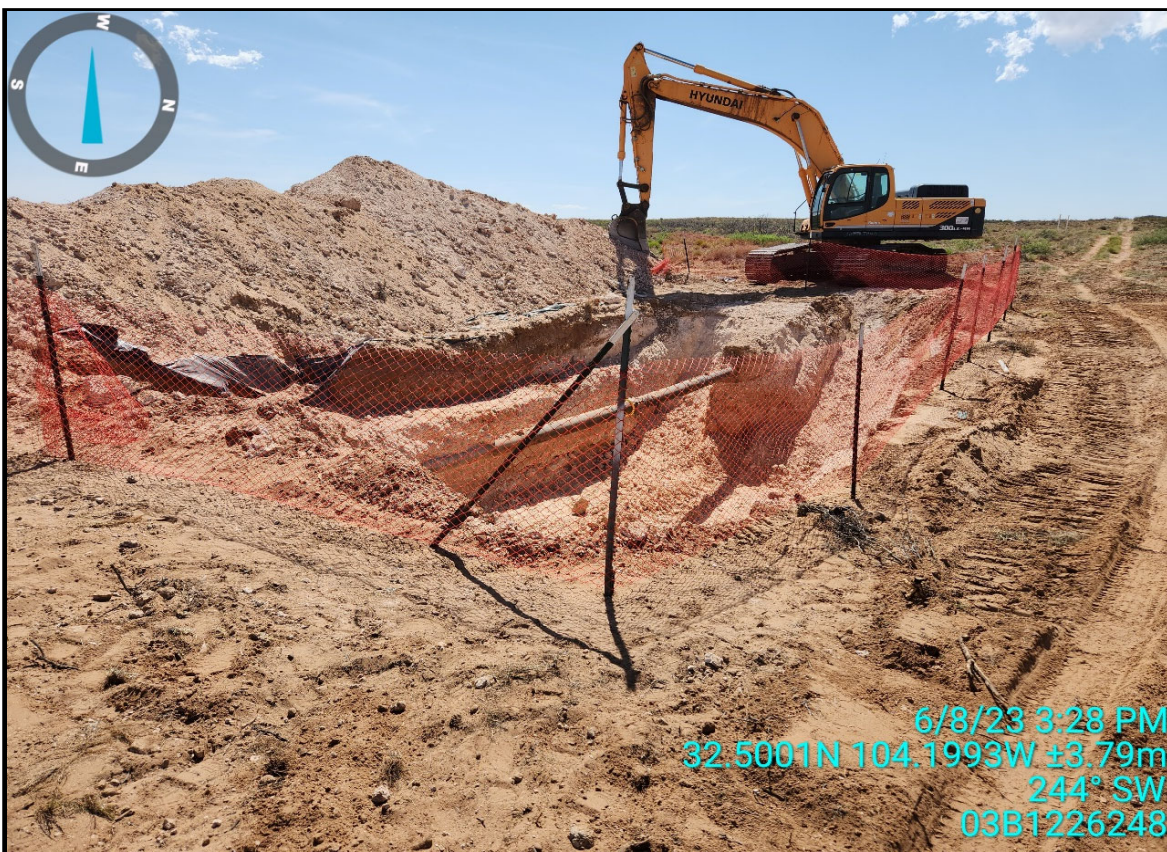
View of the final excavation area and soil stockpile (June 8, 2023), facing west.

The final excavation area measured approximately 40 feet long and 20 to 35 feet wide at the maximum extents, with a depth of 10 feet bgs.

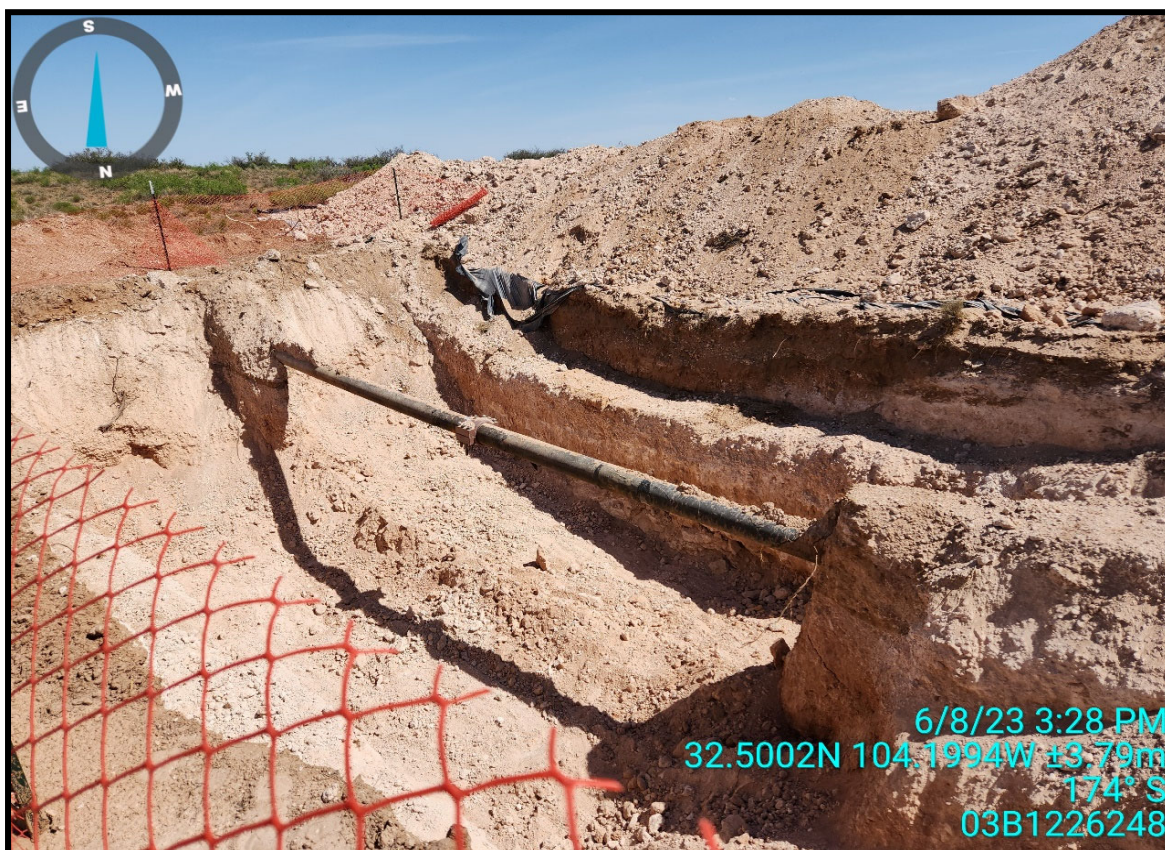
View of the final excavation area and soil stockpile (June 8, 2023), facing south.
