Release Assessment and Closure

Bindel 4 Fee #001

Section 04, Township 23 South, Range 27 East

Vertex File Number: 23E-05497

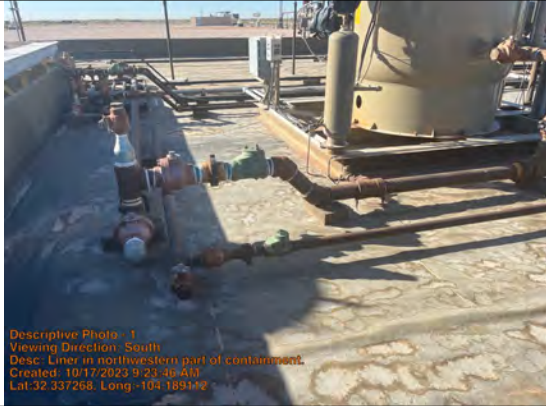
Descriptive Photo - 1
Viewing Direction: South
Desc: Liner in northwestern part of containment.
Created: 10/17/2023 9:23:36 AM
Lat:32.337268, Long:-104.189112

Liner in northwestern part of containment.

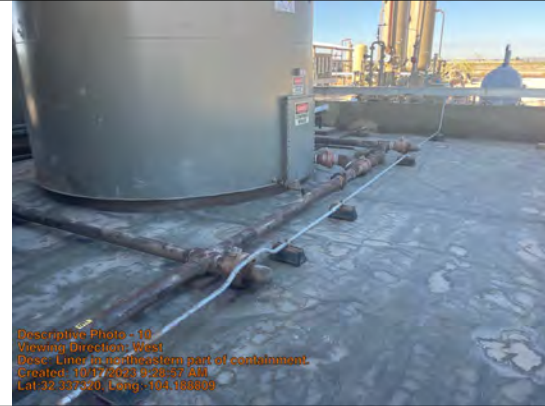
Descriptive Photo - 10
Viewing Direction: West
Desc: Liner in northeastern part of containment.
Created: 10/17/2023 8:28:27 AM
Lat:32.337330, Long:-104.188809

Liner in northeastern part of containment.

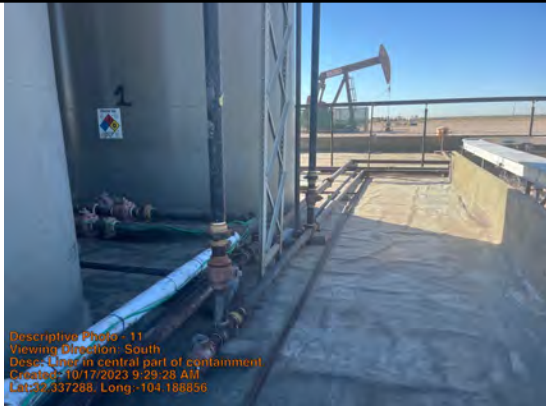
Descriptive Photo - 11
Viewing Direction: South
Desc: Liner in central part of containment.
Created: 10/17/2023 9:29:28 AM
Lat:32.337288, Long:-104.188856

Liner in central part of containment.

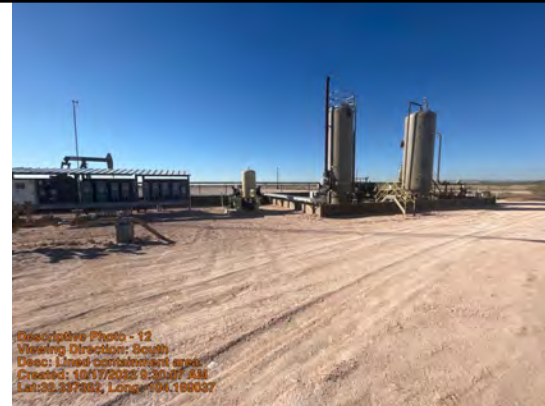
Descriptive Photo - 12
Viewing Direction: South
Desc: Lined containment area.
Created: 10/17/2023 8:20:57 AM
Lat:32.337362, Long:-104.189037

Western Lined containment area.

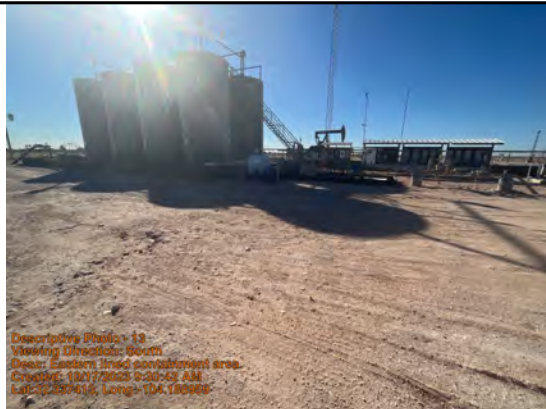
Descriptive Photo - 1
Viewing Direction: South
Desc: Eastern lined containment area.
Created: 10/17/2023 8:20:02 AM
Lat:32.337418, Long:-104.189255

Eastern lined containment area.

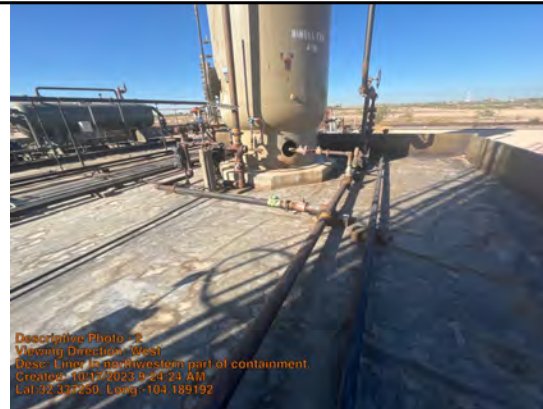
Descriptive Photo - 2
Viewing Direction: West
Desc: Liner in northwestern part of containment.
Created: 10/17/2023 9:24:24 AM
Lat:32.337250, Long:-104.189192

Liner in northwestern part of containment.

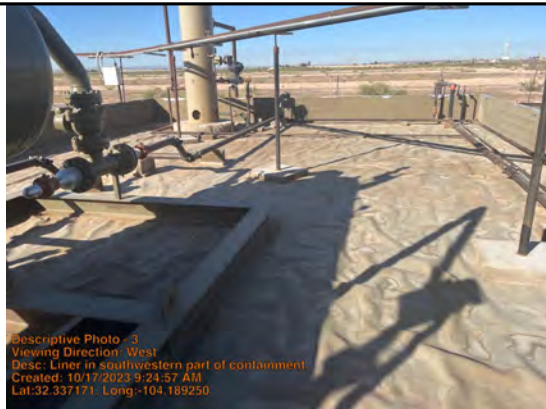
Descriptive Photo - 3
Viewing Direction: West
Desc: Liner in southwestern part of containment.
Created: 10/17/2023 9:24:57 AM
Lat:32.337171, Long:-104.189250

Liner in southwestern part of containment.

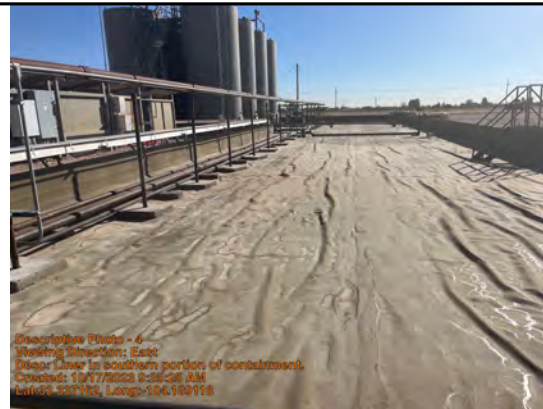
Descriptive Photo - 4
Viewing Direction: East
Desc: Liner in southern portion of containment.
Created: 10/17/2023 8:28:06 AM
Lat:32.337182, Long:-104.189118

Liner in southern portion of containment.
