RE: Release Investigation, and Closure Report
Arrowhead Compressor Station
Unit N, Section 10, Township 18 South, Range 29 East
32.75645°, -104.06462 °
Eddy County, New Mexico
Terracon Project No. KH237025

Frontier Field Services, LLC
Arrowhead Compressor Station
32.75645°, -104.06462°
NMOCD Reference # nAPP2305949229
Terracon Project # KH237025

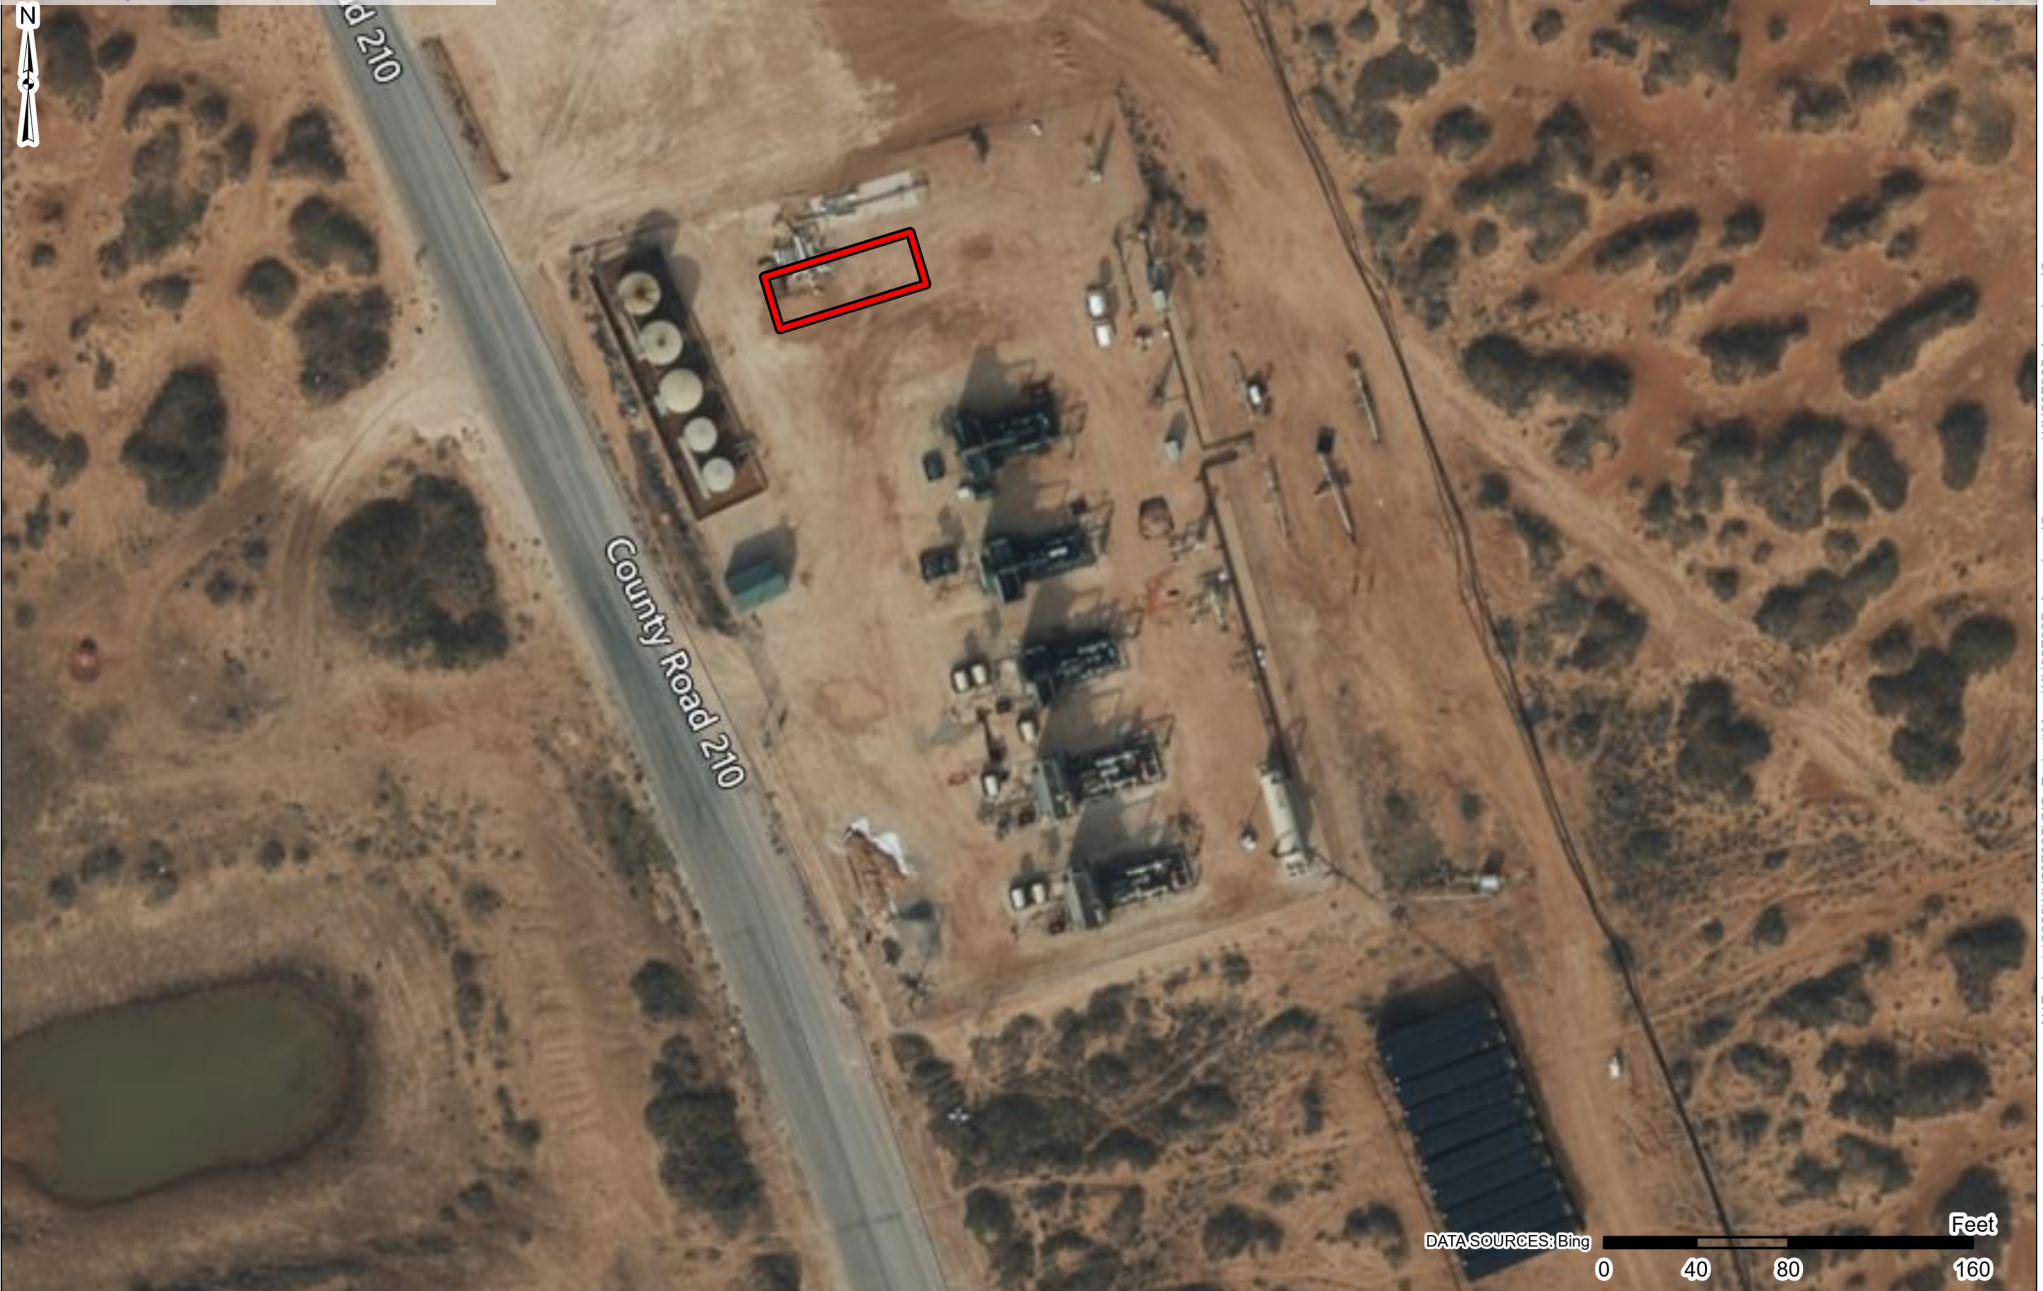
2

Excavation Boundary

Site Map
Arrowhead Compressor Station
-104.0646974, 32.7564017
Eddy County, New Mexico

On March 24, 2023, and March 29, 2023, Terracon mobilized to the site to meet Gandy's personnel, who performed soil remediation activities. The areas exhibiting visual impacts were excavated to a depth of approximately 4 to 8 feet bgs.

Approximately 360 cubic yards of soil were excavated and stockpiled atop a polyethylene liner pending waste characterization and disposal under an approved Form C-138. Excavation efforts ceased based on the removal of visually impacted material. Excavated materials were disposed of at Lea Land Landfill.

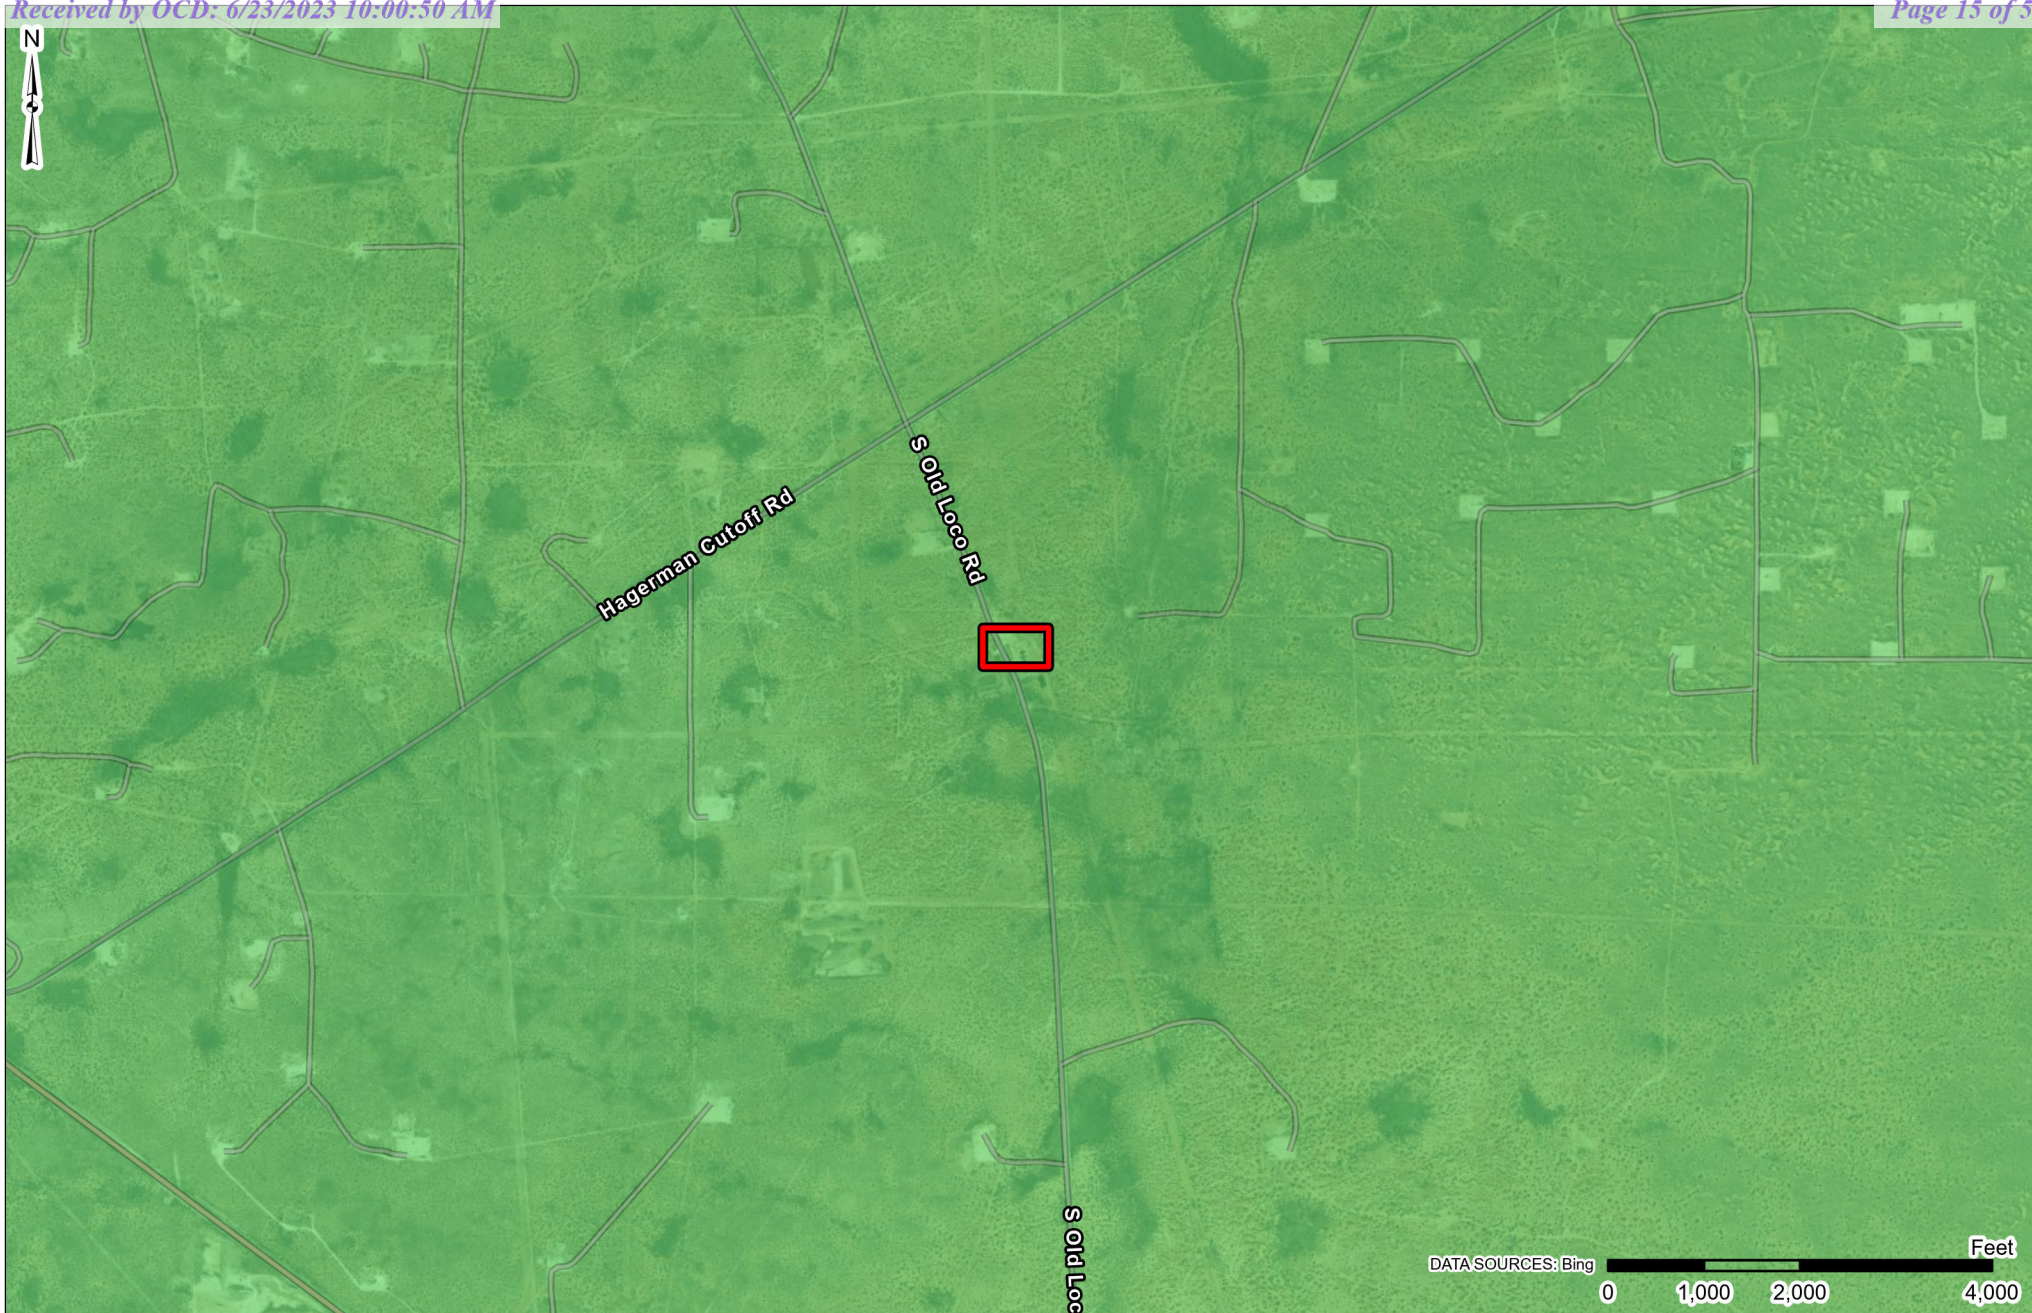
Karst Characterization CFO Karst Potential Map – (Exhibit 6 in Appendix A)	Terracon evaluated data from the BLM Carlsbad Field Office's publicly available spatial data, and Karst map designations in reference to the site location. The site appears to be within a low-level Karst risk area. Based on site observations within the extent of the release margins, the potential for Karst formations in this specific area is of low potential, as illustrated in Exhibit 6. Restrictive features were not encountered from surface to 60 inches below grade surface (bgs) within the release margins. The full extent of release quantities and excavation activities did not extend greater than 60 inches bgs.

Cave Karst Public UCP Map

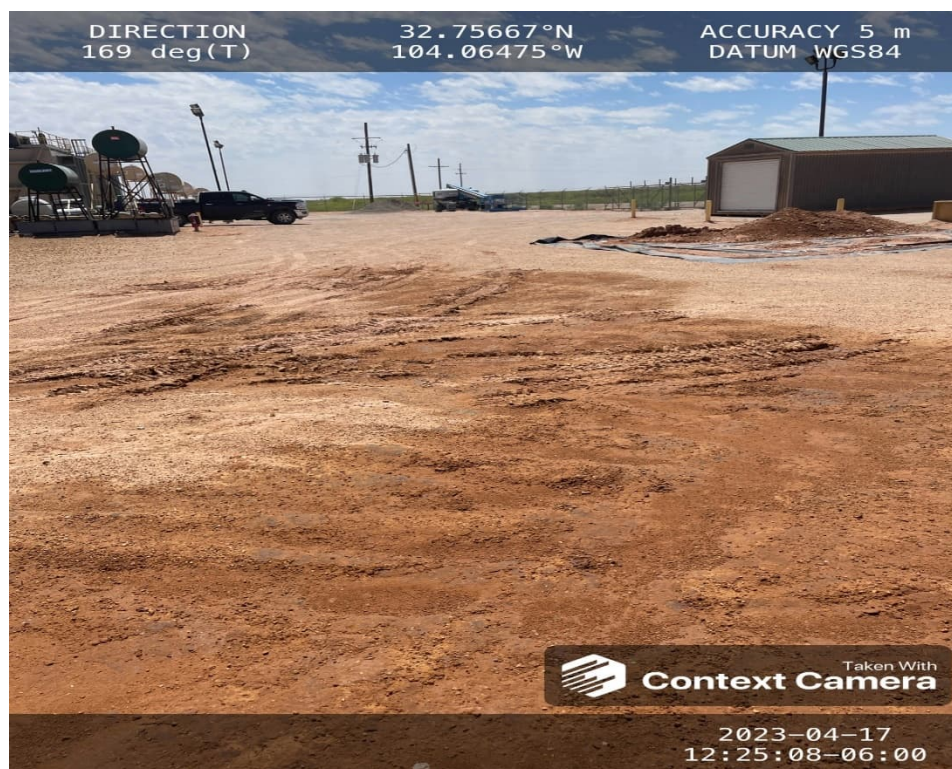
Type of discharge	The documented condensate release occurred in an open ROW, state-owned, native pastureland area. Soils at the site are affected at the surface and beyond the depth of the pipeline.	
Quantity of spilled material	Total Fluids: N/A	Natural Gas: 35.65 Mcf
Site characteristics	Relatively flat with drainage following the natural ground surface.	
Immediate corrective actions	The damaged pipeline was closed in at the nearest isolation valve, blown down, and clamped. A backhoe was utilized to excavate impacted soils around the corroded dump line to repair the source of the release.

PHOTO 1: View of staining prior to the excavation.

Corrosion of dump line caused weak spot.

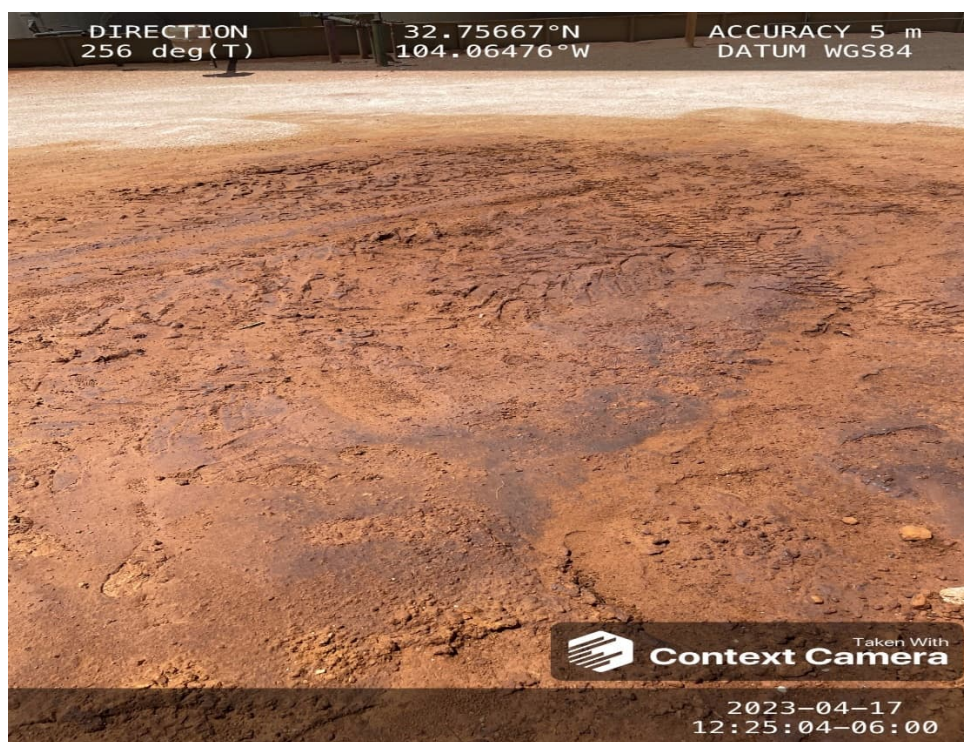
PHOTO 2: View of the staining prior to the excavation.

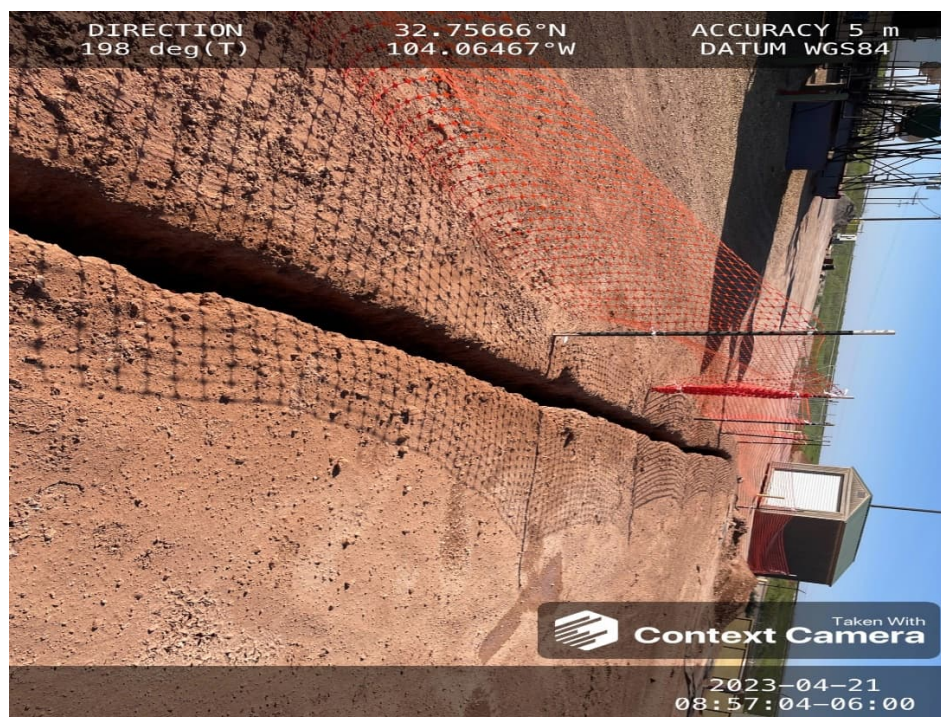
PHOTO 3: View of the hydro-vac spotting of lines.

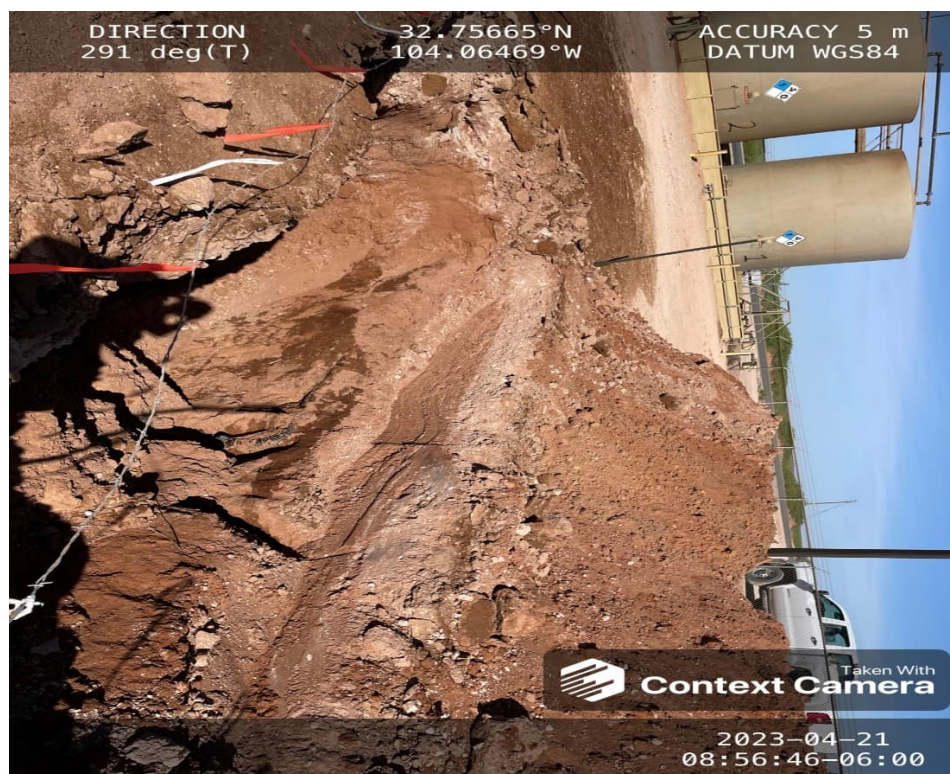
PHOTO 4: View of the northern extent during the excavation.

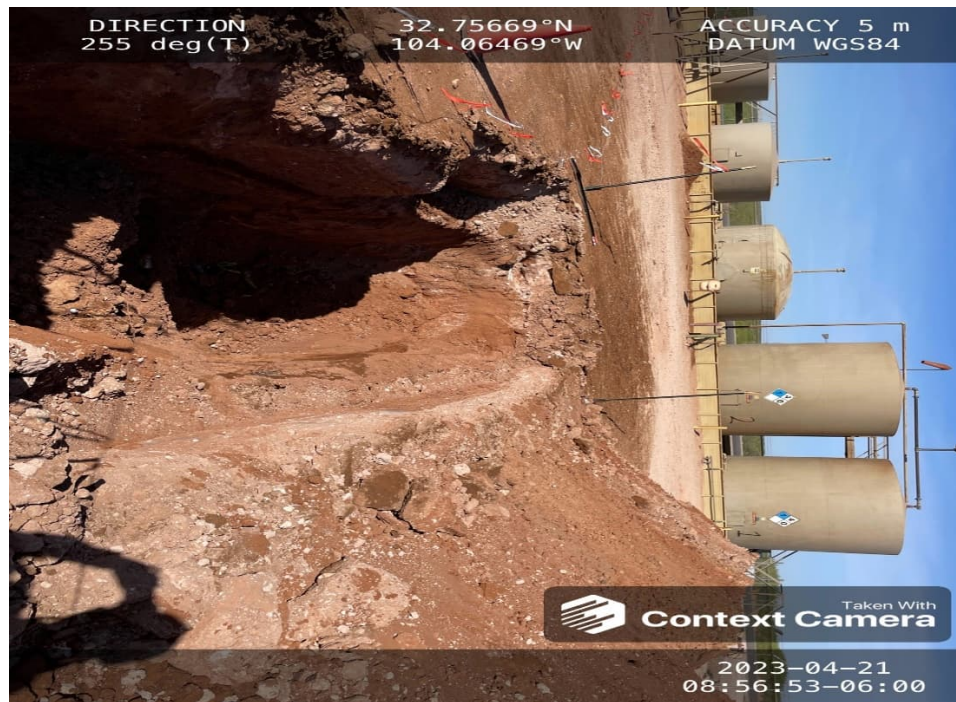
PHOTO 5: View of the western extent of the excavation.

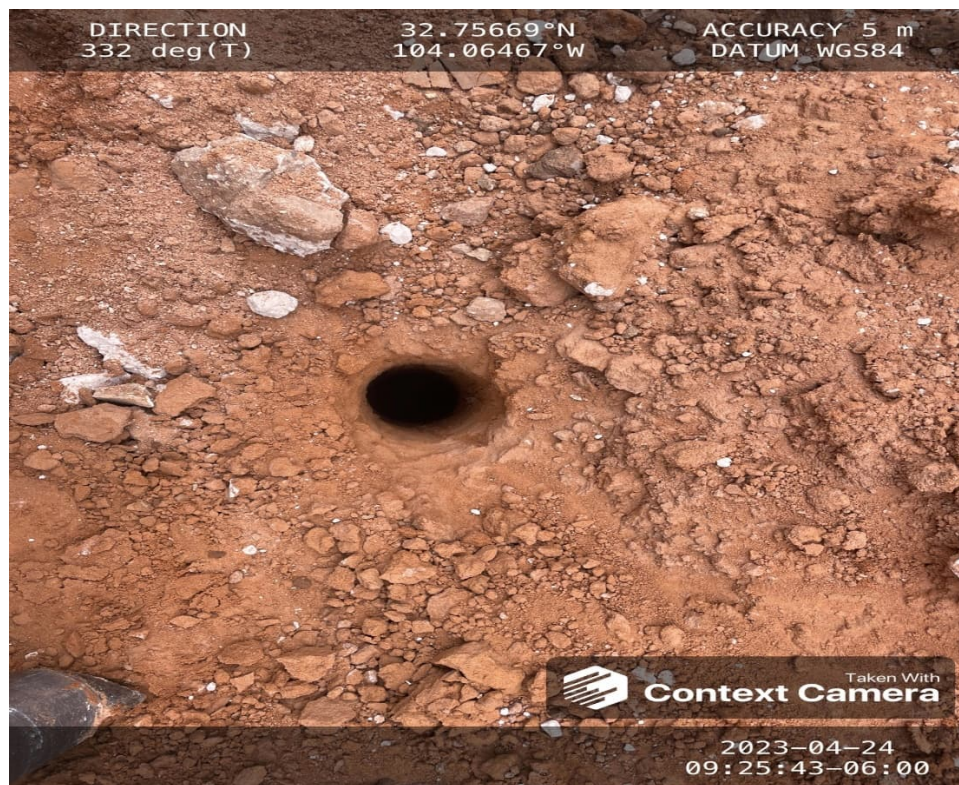
PHOTO 6: View of hand auger vertical floor delineation.
