Incident ID	nAPP2315760661
District RP	
Facility ID	
Application ID

Site Assessment/Characterization

Based on laboratory analytical results and field activities conducted to date, Etech recommends Mewbourne Oil Company provide copies of this *Remediation Summary & Soil Closure Request* to the appropriate agencies and request closure be granted to the Jennings Riser release site.

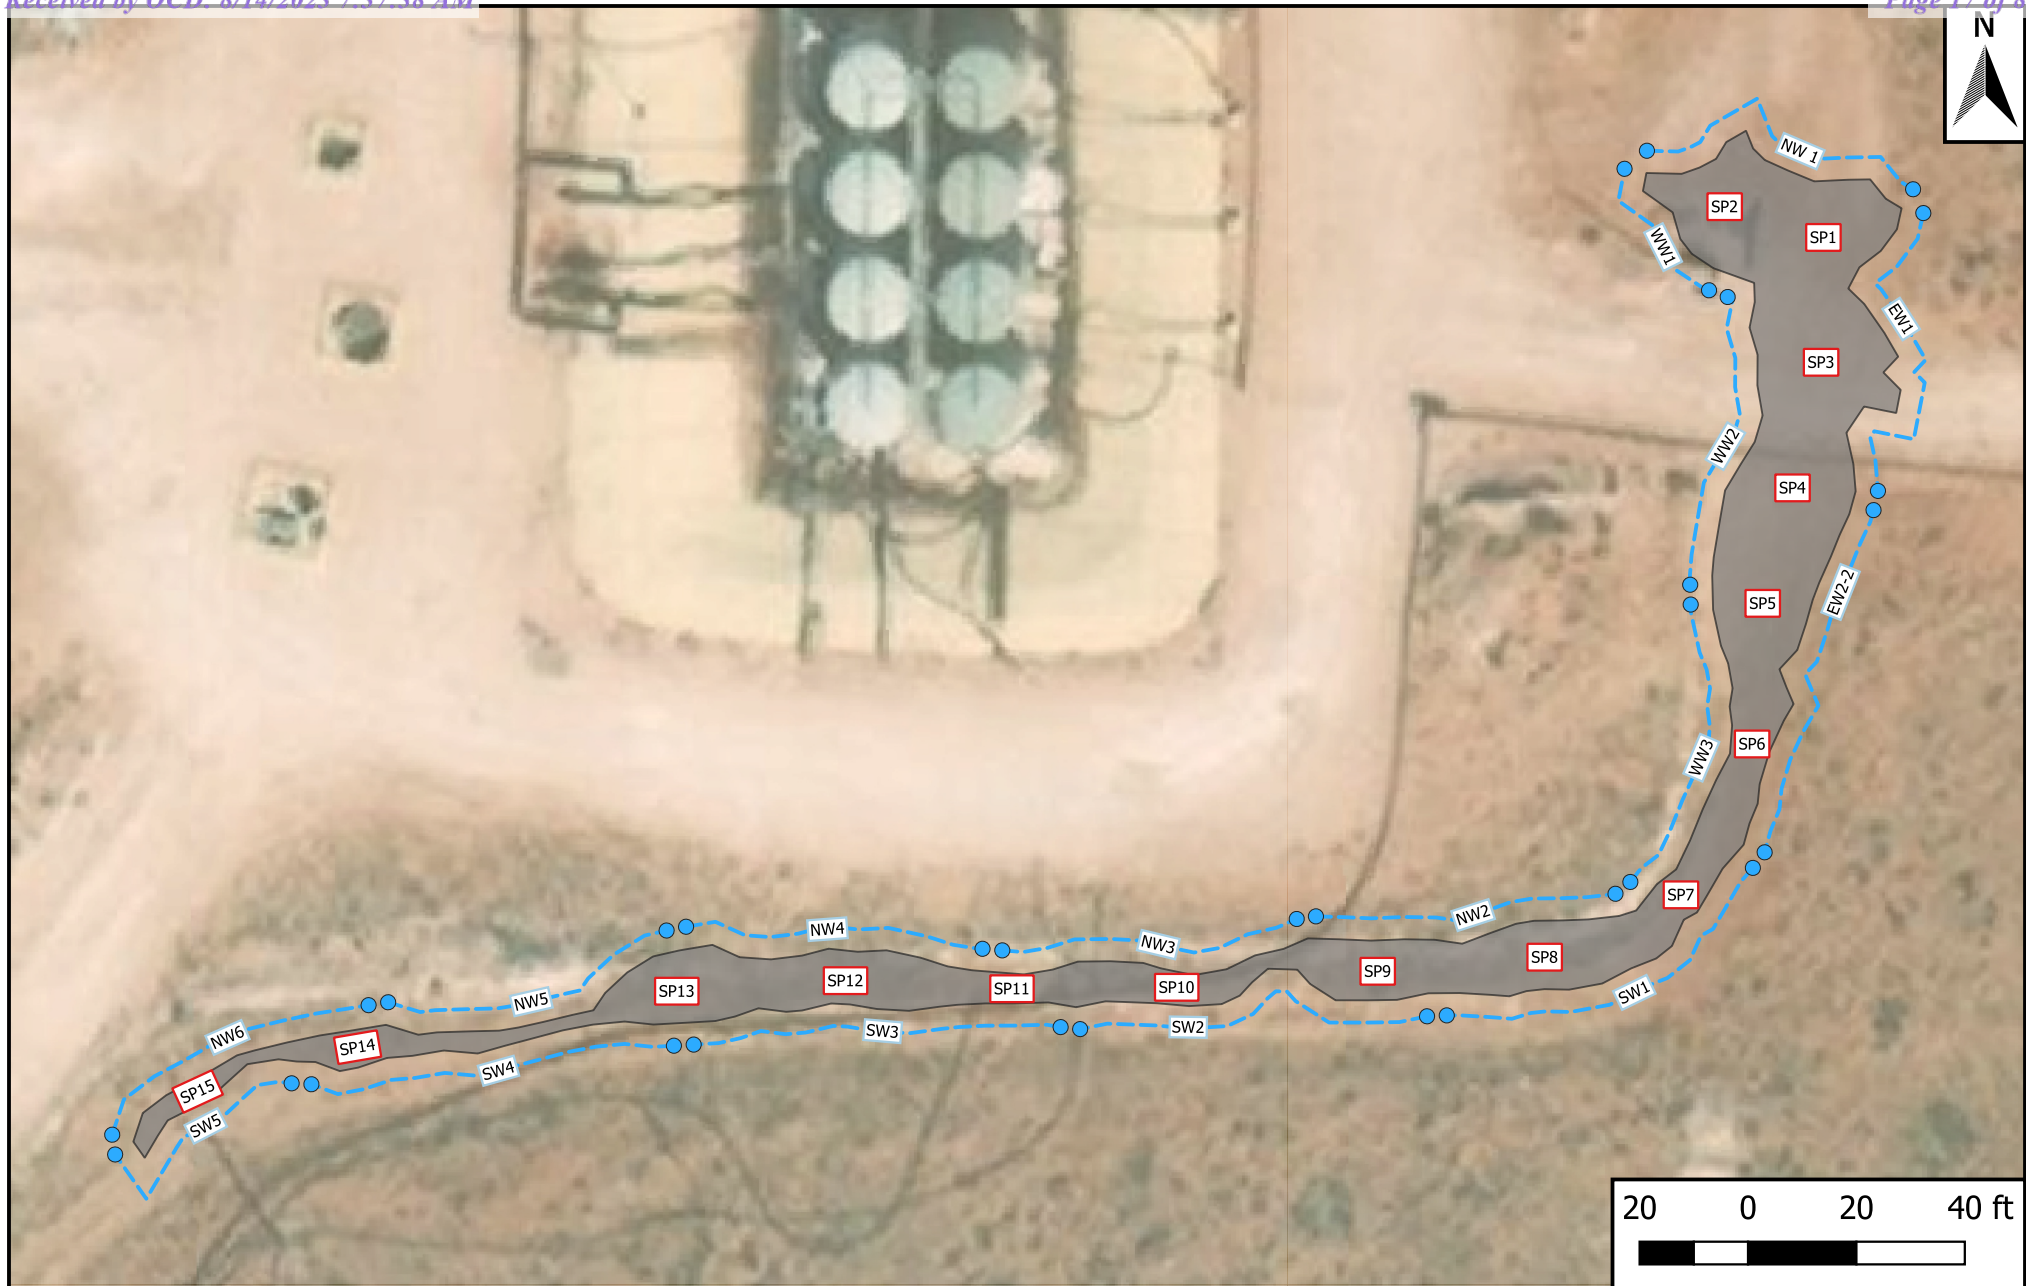
Figure 3

Site & Sample Location Map

- Excavation Extent
- Composite Floor Sample
- Composite Wall Sample

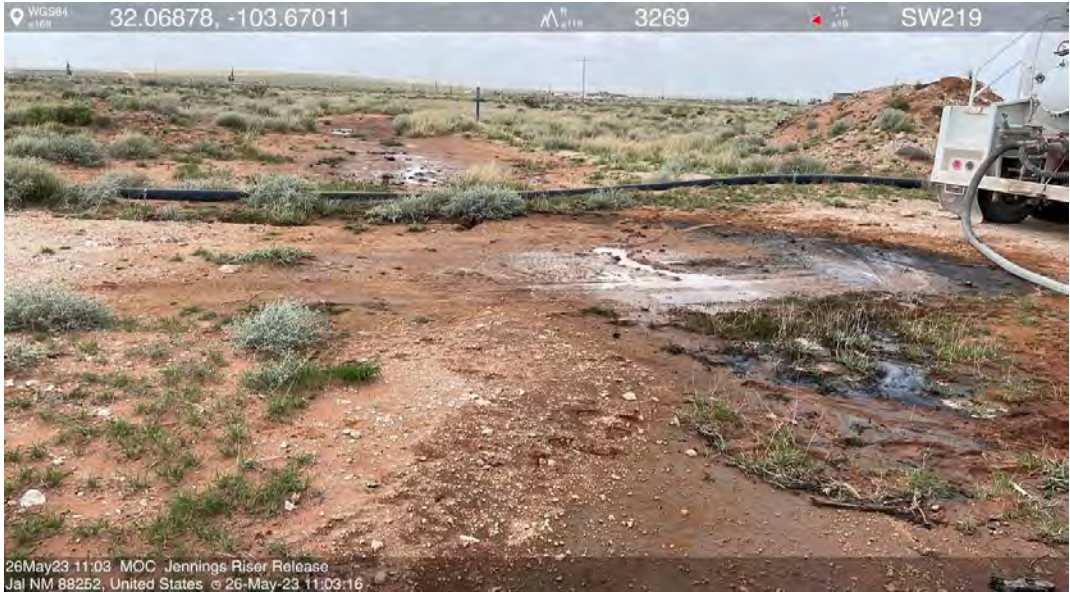
Photo Number: 1

Photo Direction: Southwest	
Photo Description: View of the affected area.

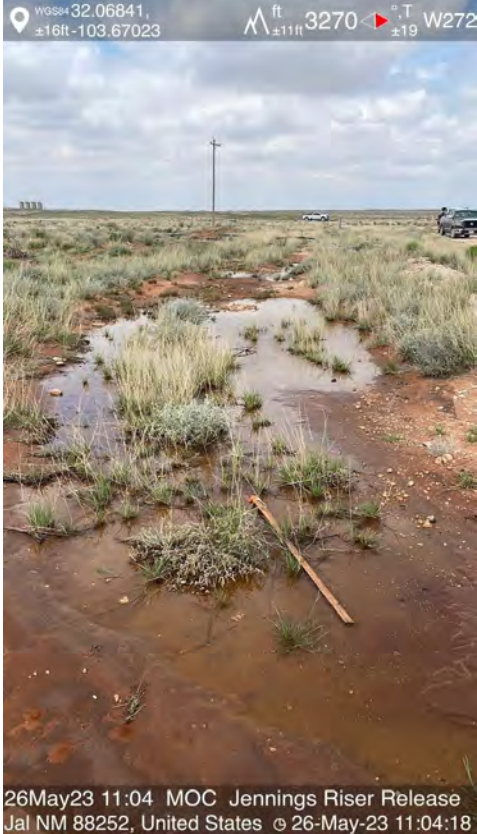
Photo Number: 3

Photo Direction: West	
Photo Description: View of the affected area.

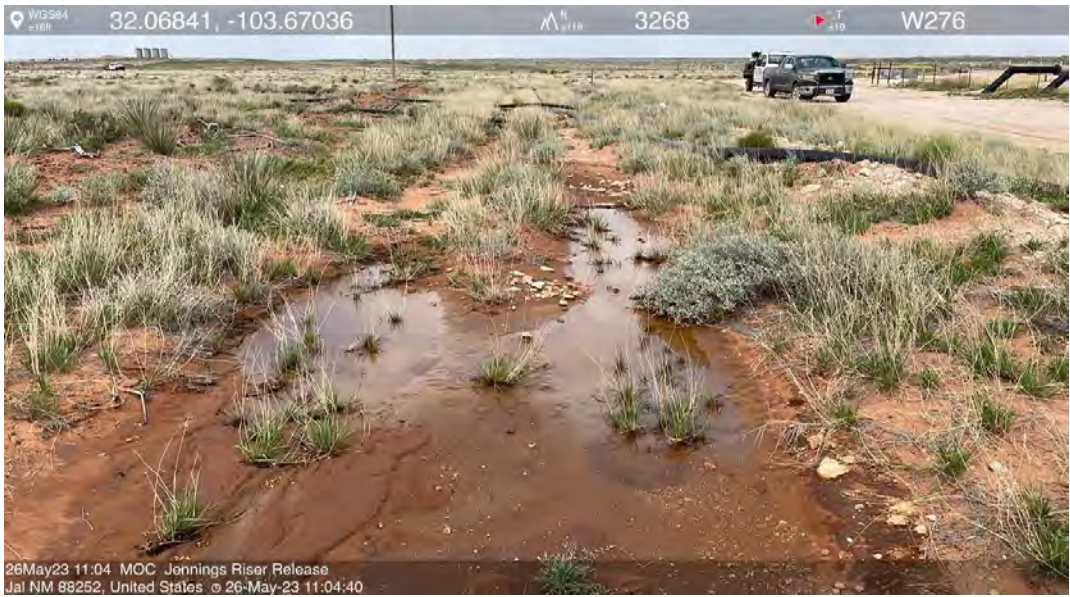
Photo Number: 4

Photo Direction: West	
Photo Description: View of the affected area.

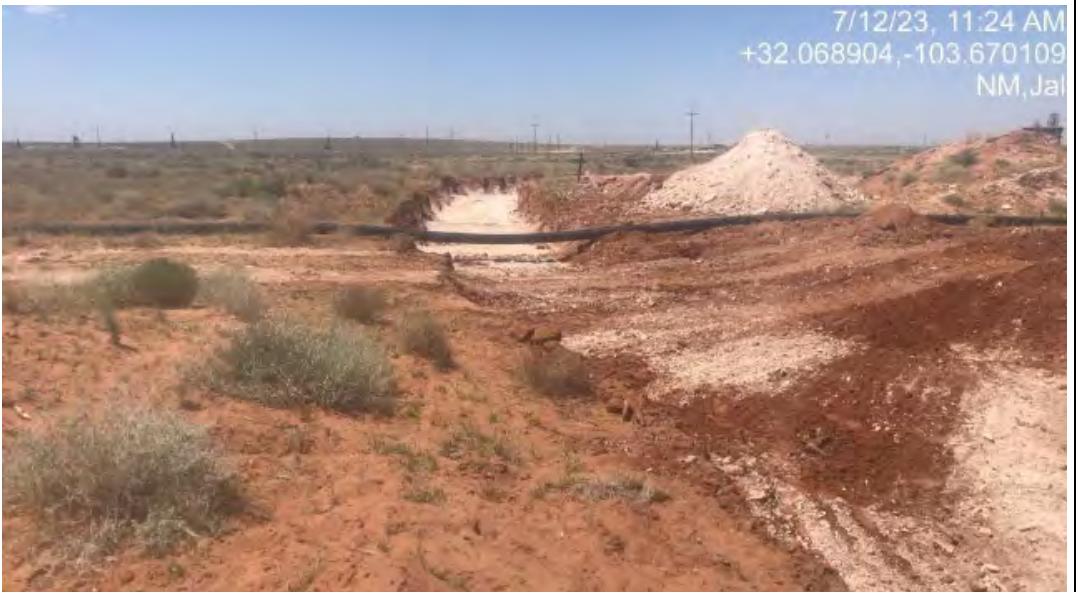
Photo Number: 8

<p>7/12/23, 11:24 AM +32.068904,-103.670109 NM, Jal</p>
Photo Direction: South	
Photo Description: View of the excavated area.

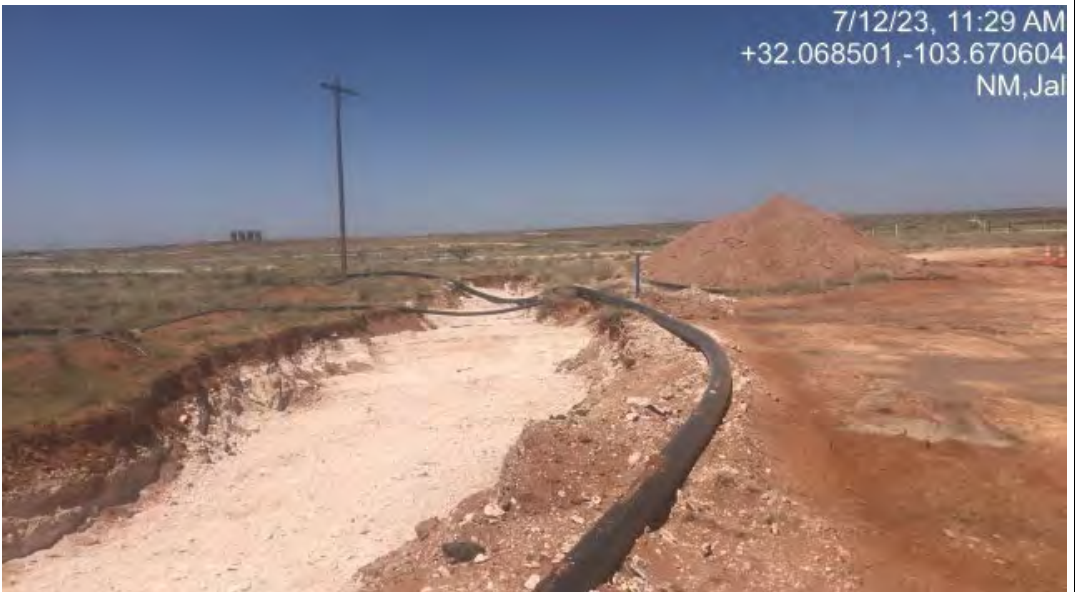
Photo Number: 10

<p>7/12/23, 11:29 AM +32.068501,-103.670604 NM, Jal</p>
Photo Direction: West	
Photo Description: View of the excavated area.

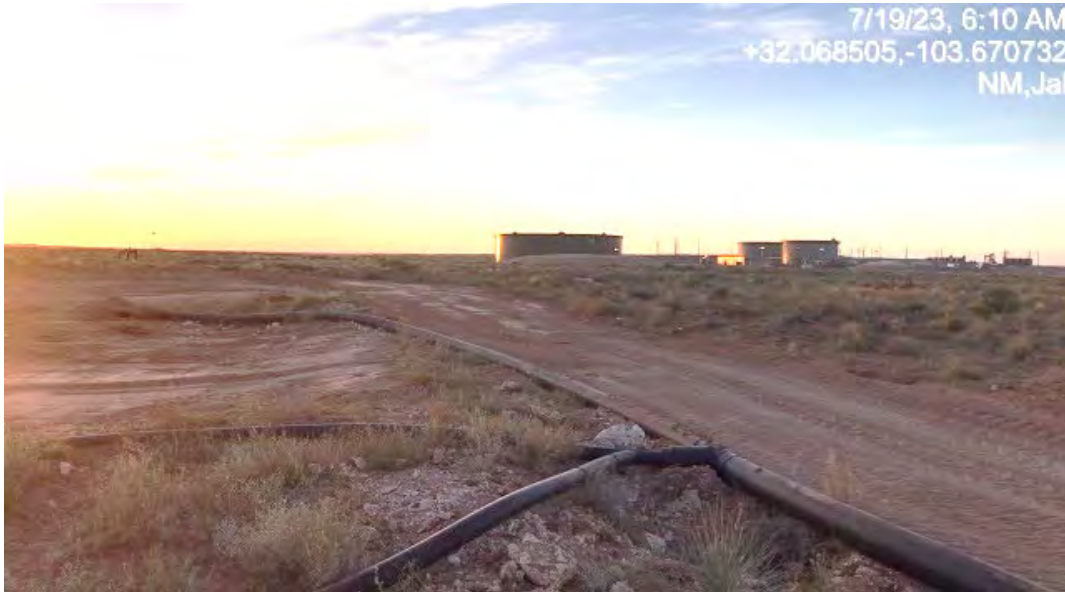
Photo Number: 13

<p>7/19/23, 6:10 AM +32.068505,-103.670732 NM, Jal</p>
Photo Direction: Southeast	
Photo Description: View of the remediated area after backfill and regrading.
