Closure Report

Voni South Booster Station
Eddy County, New Mexico
API ID # 30-025-26547
Incident # NAPP2318630086

Subject: **Closure Report**
Voni South Booster Station
Eddy County, New Mexico
Incident # NAPP2318630086

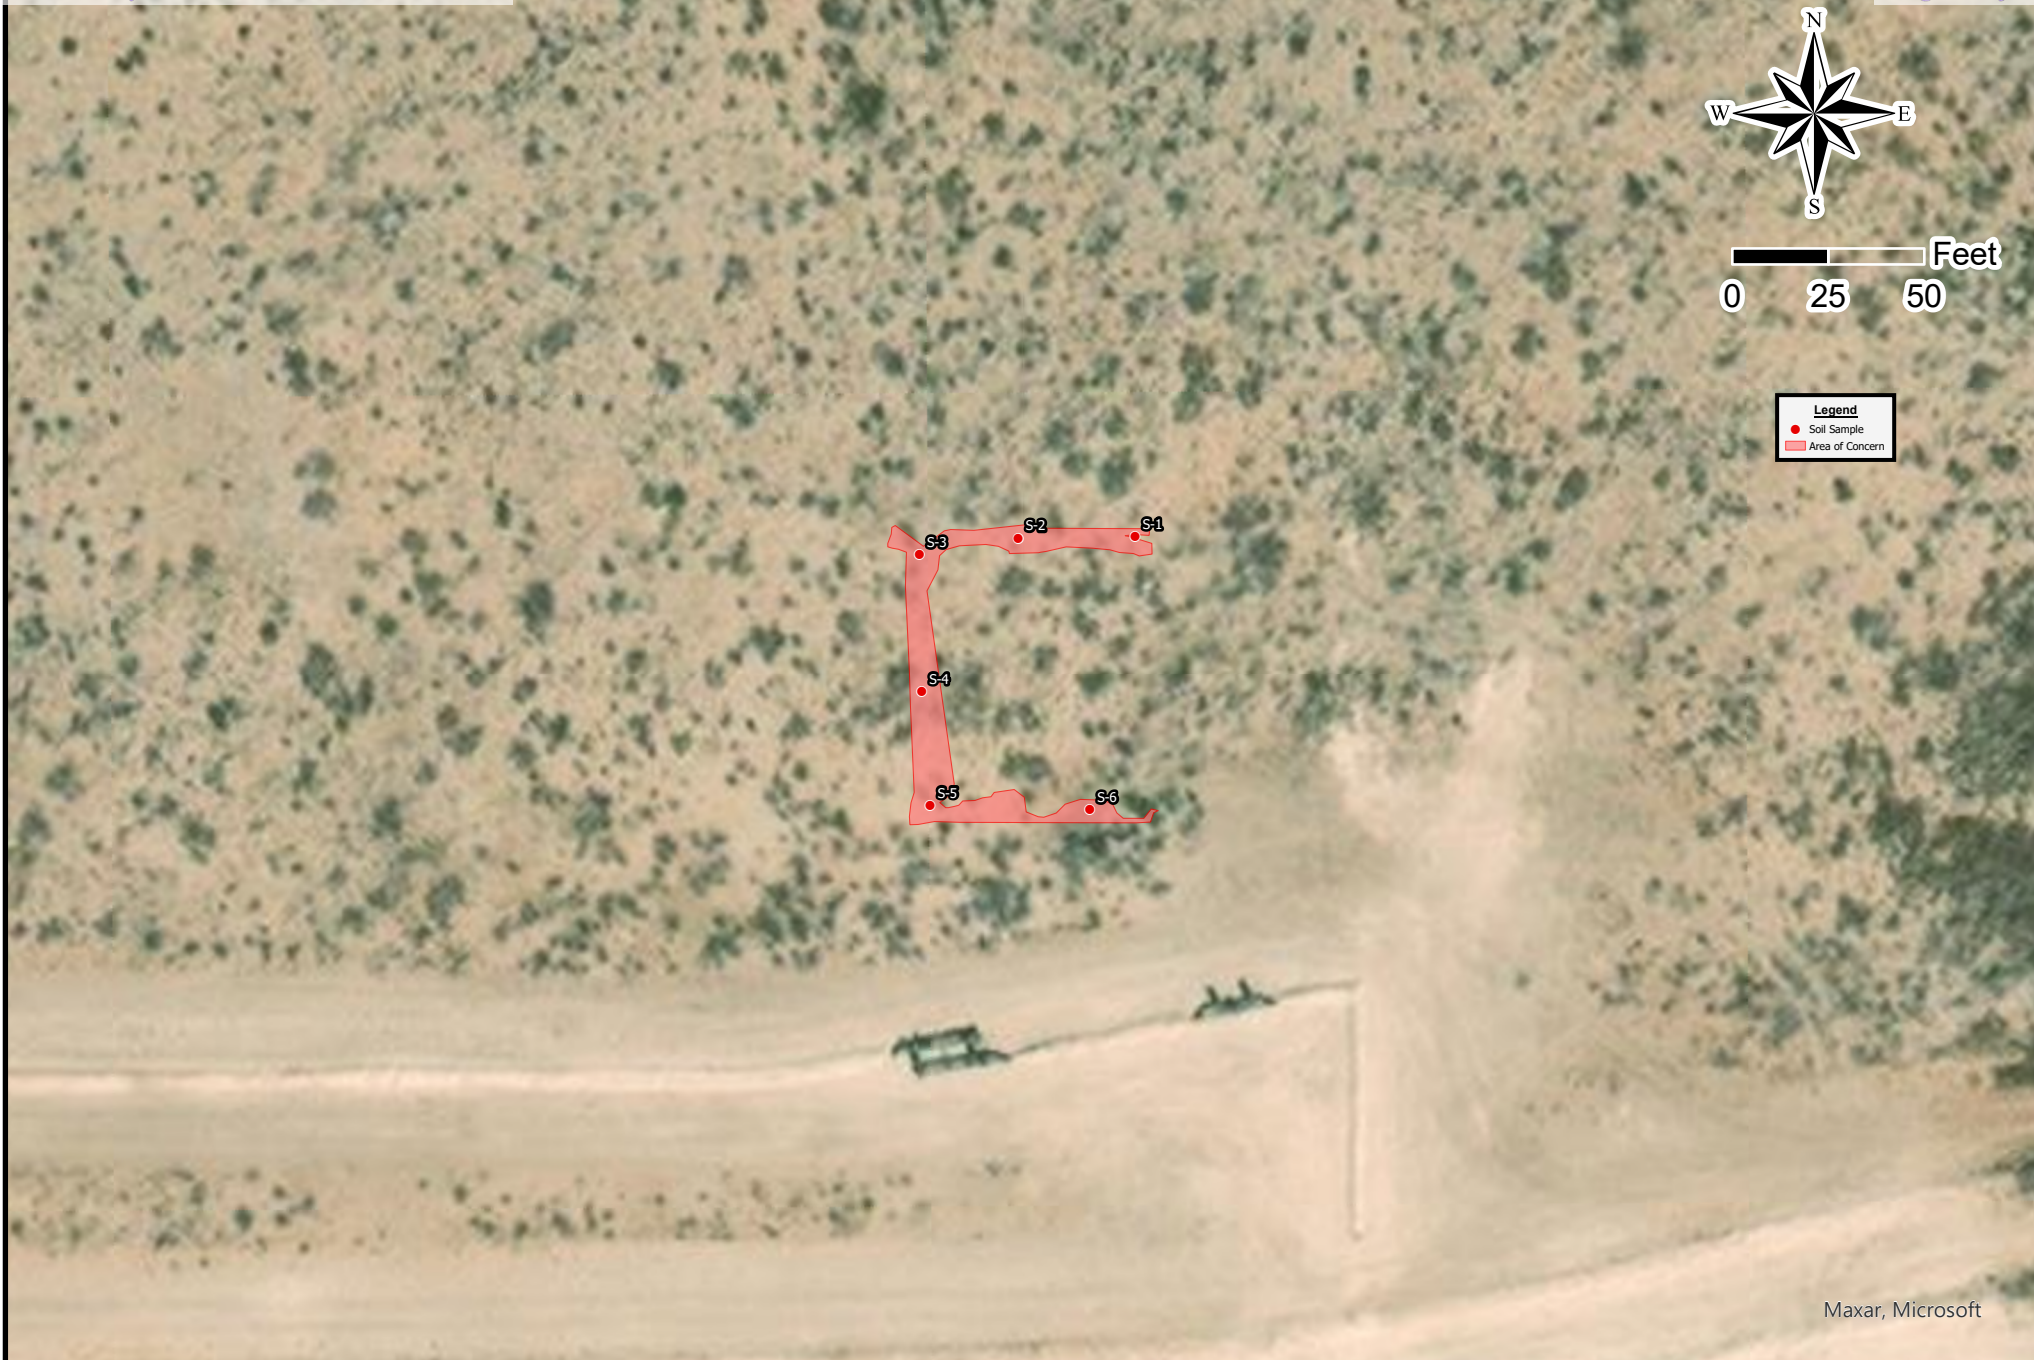
Matador Production Co.
Voni Booster Map
Lea County, NM
Assessment Map

On July 7, 2023, upon client authorization, Talon mobilized personnel to the site to conduct an initial site assessment. The impacted area was photographed, soil samples were collected utilizing a hand auger, and the area was mapped. All soil samples were properly packaged in laboratory provided glassware, preserved on ice in the custody of Talon personnel, and transported to Cardinal Analytical Laboratory for analysis of Total Chlorides (SM4500Cl-B), Total Petroleum Hydrocarbons (TPH, EPA Method 8015M) and Volatile Organics (BTEX, EPA Method 8021B). Sample locations are shown on the attached Figure 1 in [Appendix I](#), and the results of the sampling event are presented below in Table 1.

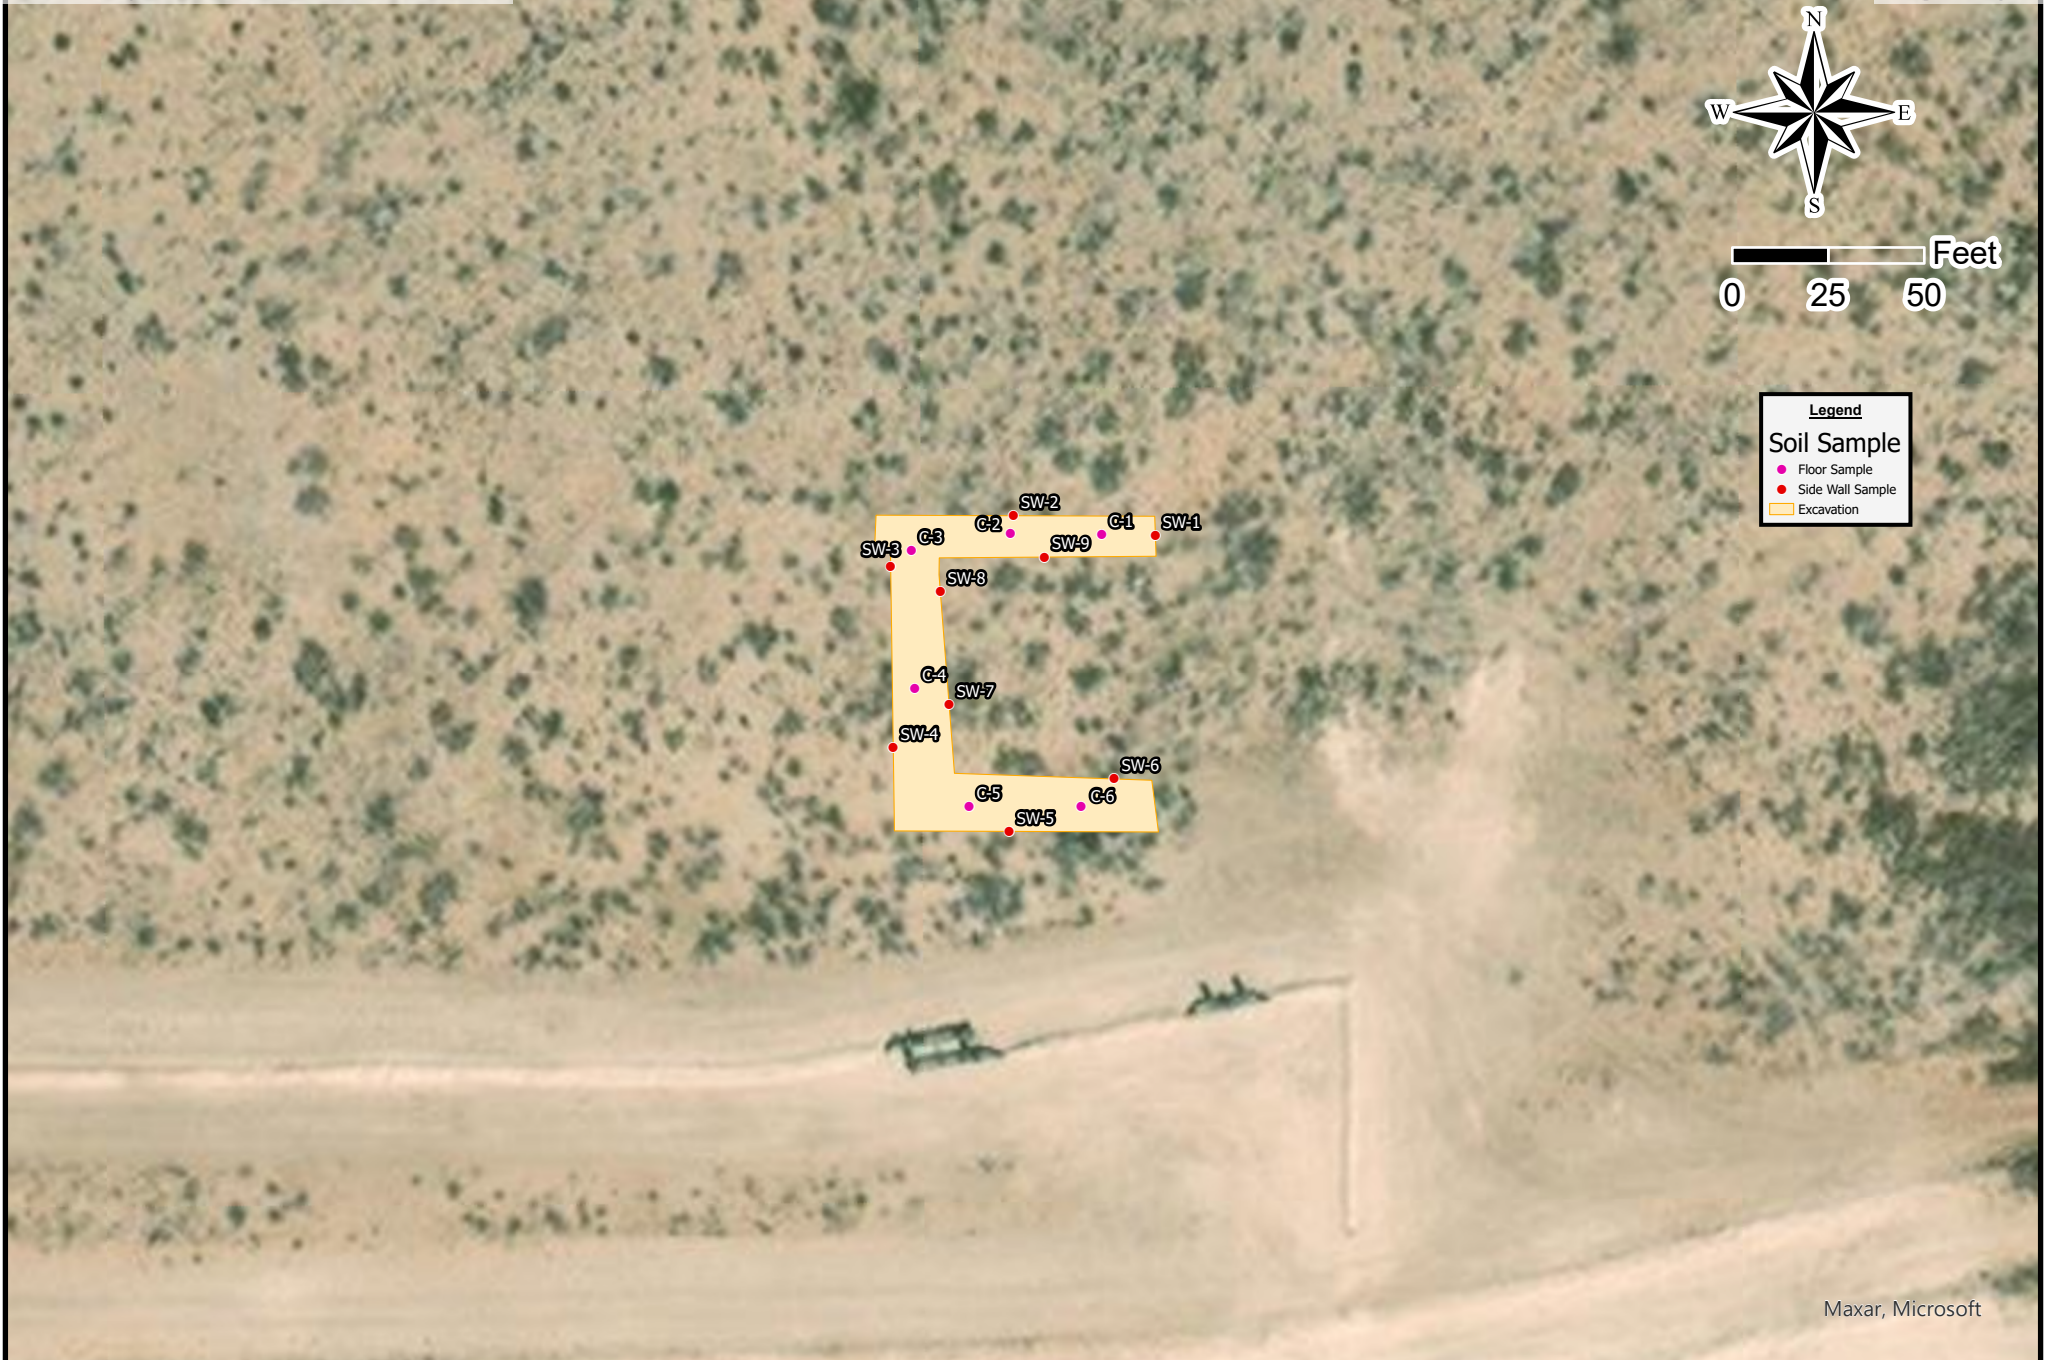
Matador Production Co.
Voni Booster Map
Lea County, NM
Excavation Map

- The impacted areas on location were excavated to minimum depth of 1 foot bgs and a maximum of 2 feet bgs. Talon field titrated soil samples for total chlorides to guide the vertical and horizontal extents of the excavation process.
- Pursuant to NMOCD guidance, confirmation soil samples were collected at 200 square foot intervals and analyzed for TPH, BTEX and Total Chlorides to insure all areas had reached NMOCD closure criteria.
- The excavated areas on the well pad were backfilled with new caliche, machine compacted, and contoured to match the surrounding location.
- Photographic documentation is provided in [Appendix IV](#).
- Copies of the Final C-141s are presented in [Appendix III](#).

On August 8, 2023, Talon Returned to location and removed impacted soils at S-1 through S-6. The samples were transported with the chain of custody to Cardinal Laboratories, for analysis of Total Chlorides (SM4500Cl-B), Total Petroleum Hydrocarbons (TPH, EPA Method 8015M) and Volatile Organics (BTEX, EPA Method 8021B). The soil sample results from the laboratory analytical are summarized below. Sample locations are illustrated on Figure 2 in [Appendix I](#) and complete laboratory analytical reports are presented in [Appendix V](#).

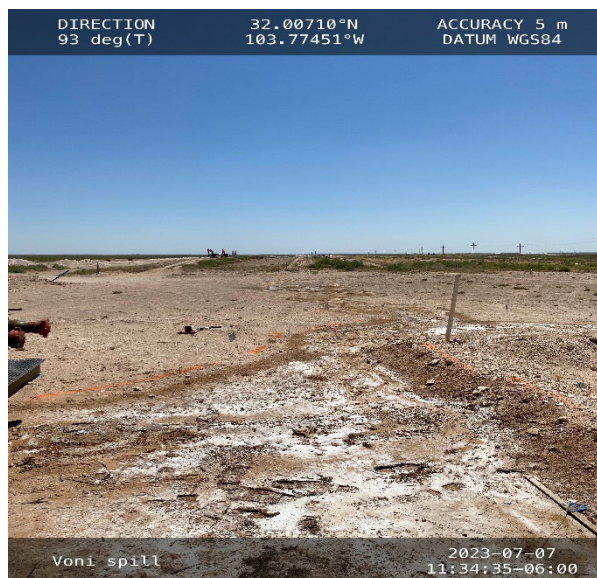
Photograph No.1 Description:

Voni booster – release.

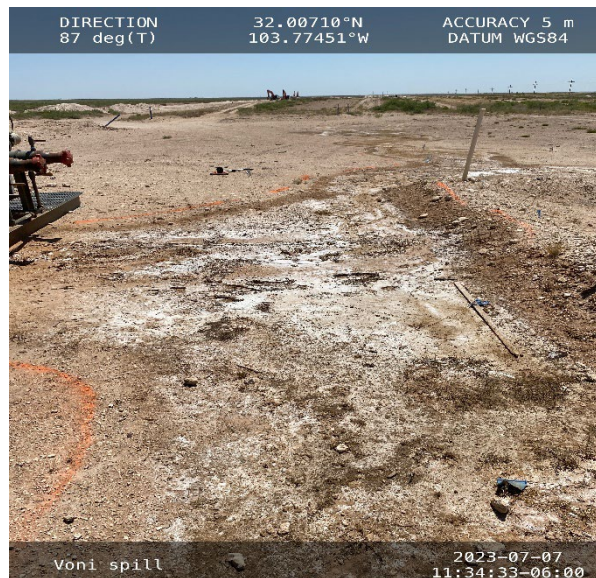
Photograph No.2 Description:

Voni booster – release.

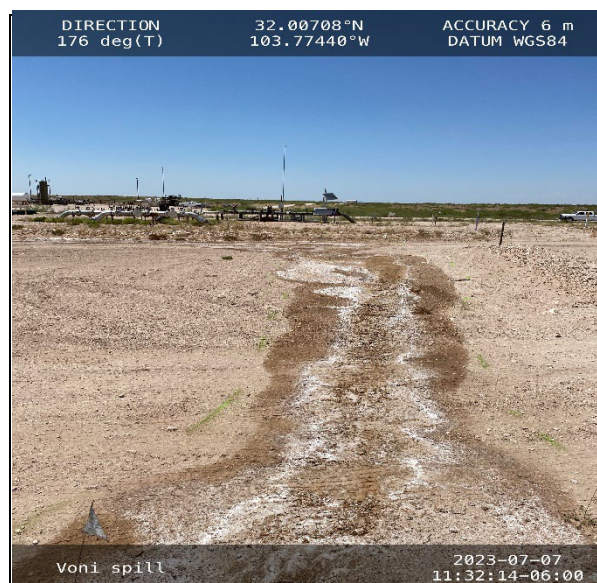
Photograph No.3 Description:

Voni booster – release away from booster.

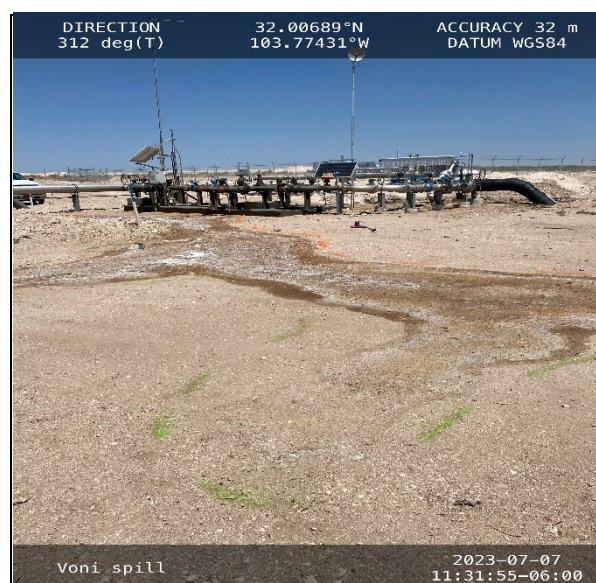
Photograph No.4 Description:

Voni booster – release near booster.

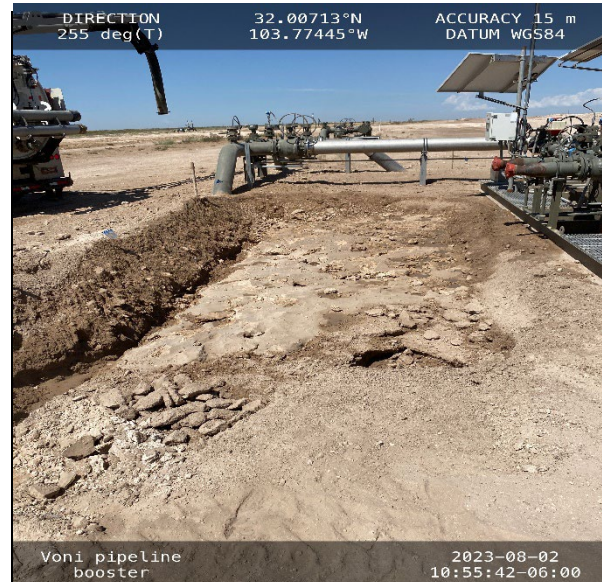
Photograph No.6 Description:

Voni booster – Excavation near manifold.

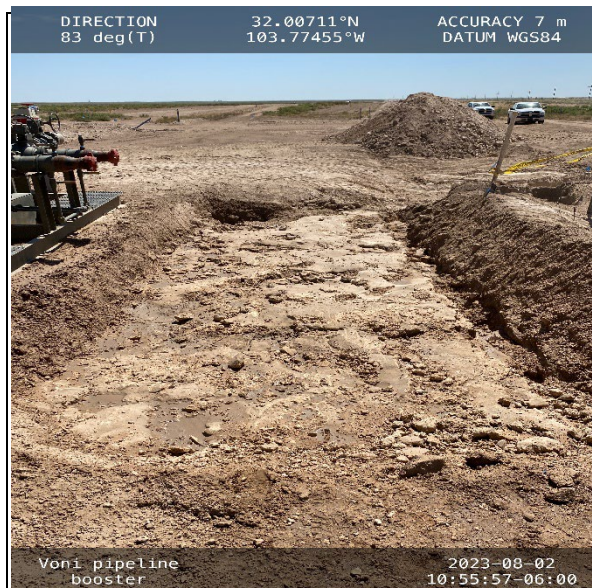
Photograph No.7 Description:

Voni booster – Excavation near manifold.
