CLOSURE REPORT

Gallegos Com #5E (08/16/23)
Unit Letter K, S32 T26N R11W
San Juan County, New Mexico

New Mexico EMNRD OCD Incident ID No. NAPP2322931994

November 9, 2023

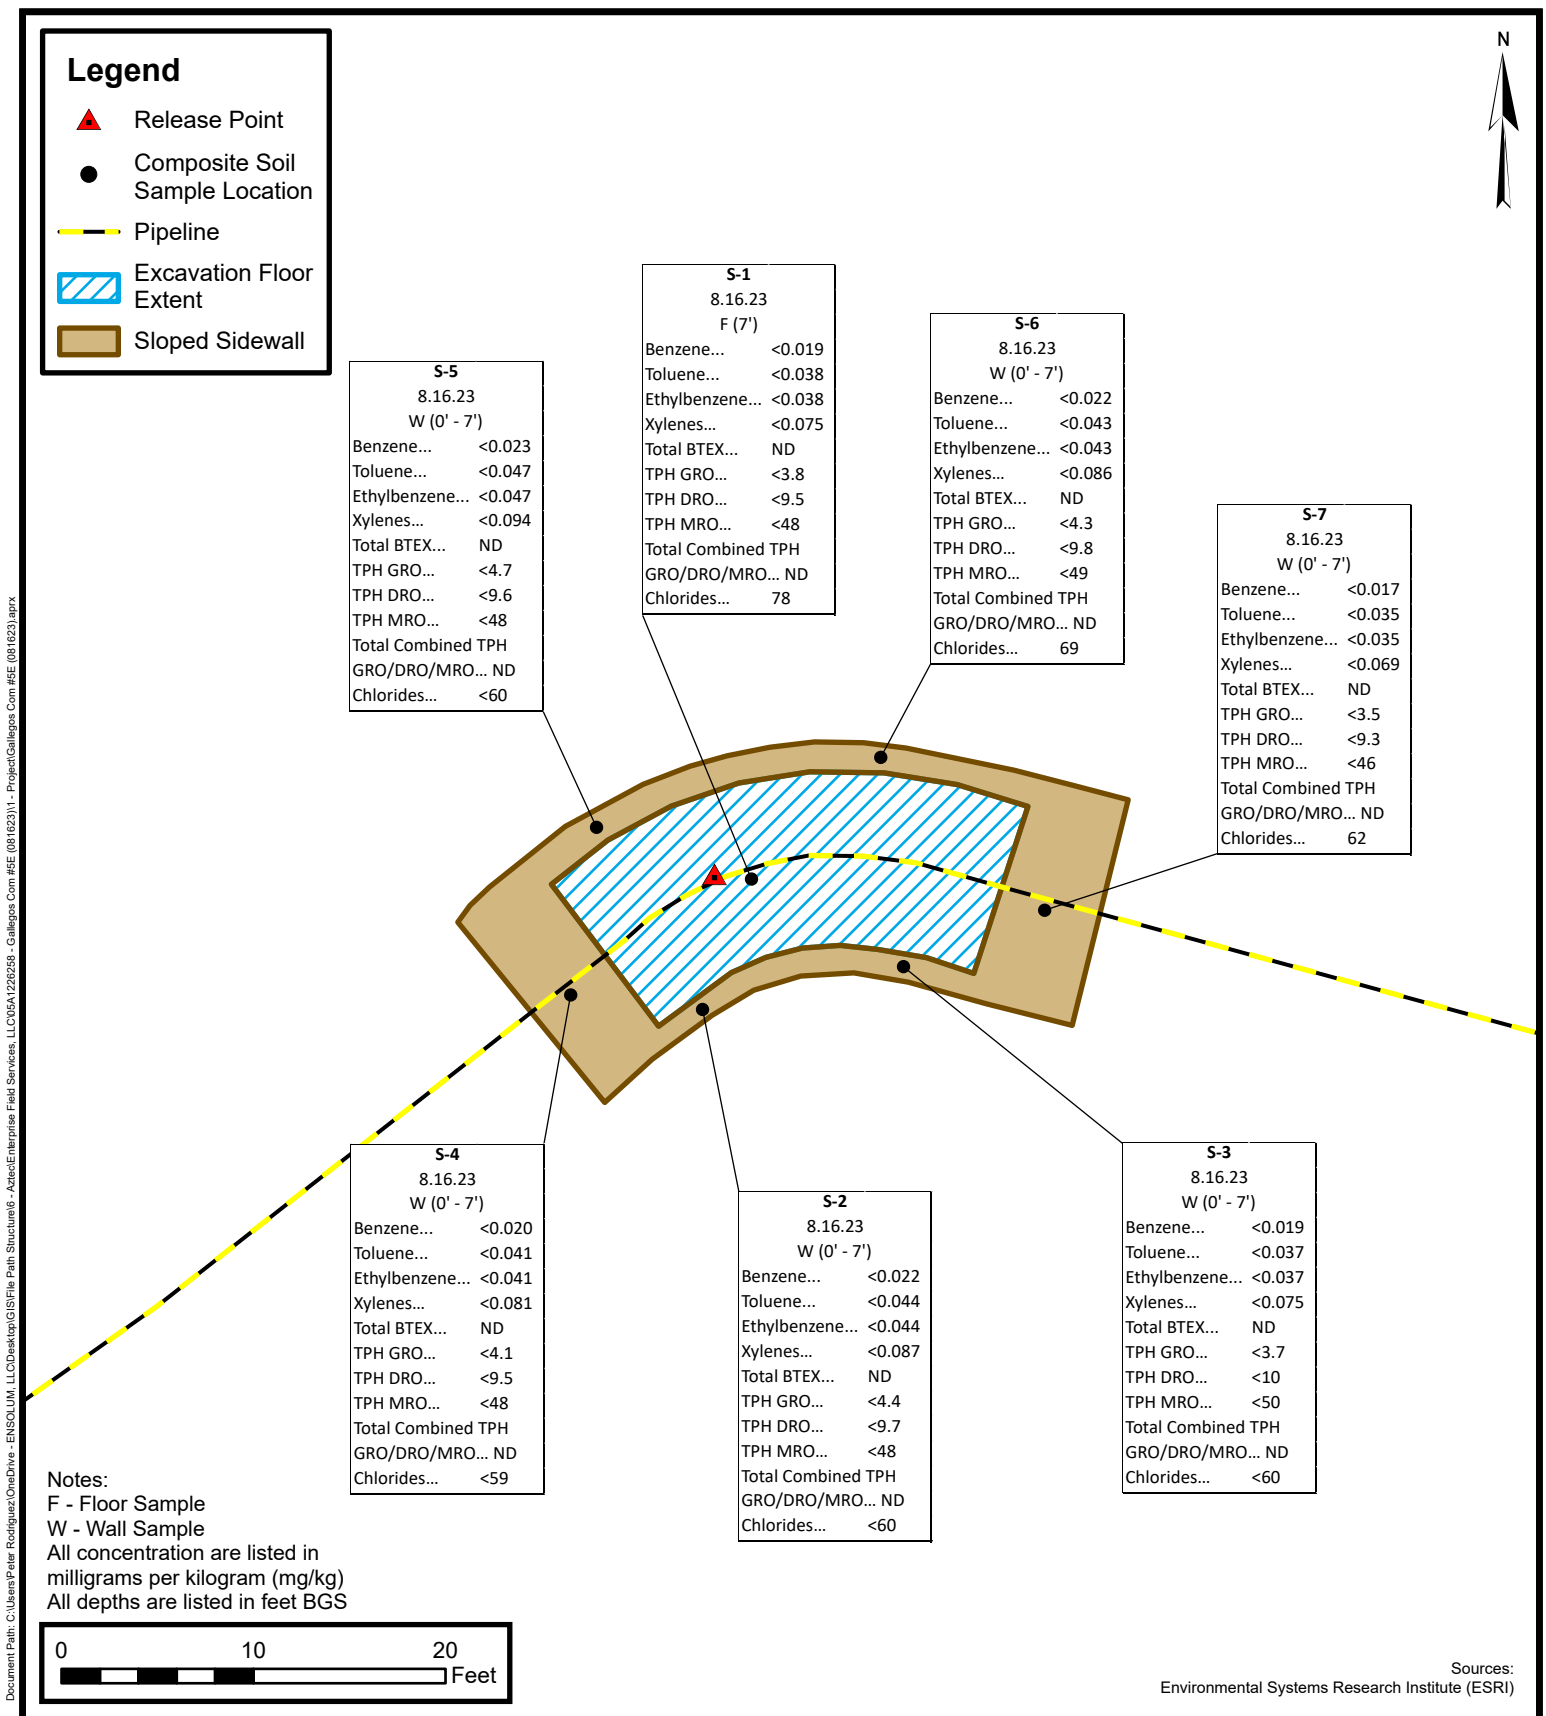
FIGURE
3

The final excavation measured approximately 32 feet long and 12 feet wide at the maximum extents. The maximum depth of the excavation measured approximately 7 feet bgs. The lithology encountered during the completion of remediation activities consisted primarily of silty sand underlain by weathered sandstone.

Figure 3 is a map that identifies approximate soil sample locations and depicts the approximate dimensions of the excavation with respect to the pipeline (**Appendix A**). Photographic documentation of the field activities is included in **Appendix D**.

Site Map with Soil Analytical Results

Ensolum's soil sampling program included the collection of seven composite soil samples (S-1 through S-7) from the excavation for laboratory analysis. The composite samples were comprised of five aliquots each and represent an estimated 200 square foot (ft²) sample area or less per guidelines outlined in Section D of 19.15.29.12 NMAC. Hand tools were utilized to obtain fresh aliquots from each area of the excavation. Regulatory correspondence is provided in **Appendix E**.

On August 16, 2023, sampling was performed at the Site. The NM EMNRD OCD was notified of the sampling event although no representative was present during sampling activities. Composite soil sample S-1 (7') was collected from the floor of the excavation. Composite soil samples S-2 (0' to 7'), S-3 (0' to 7'), S-4 (0' to 7'), S-6 (0' to 7'), and S-7 (0' to 6') were collected from the sloped walls of the excavation.

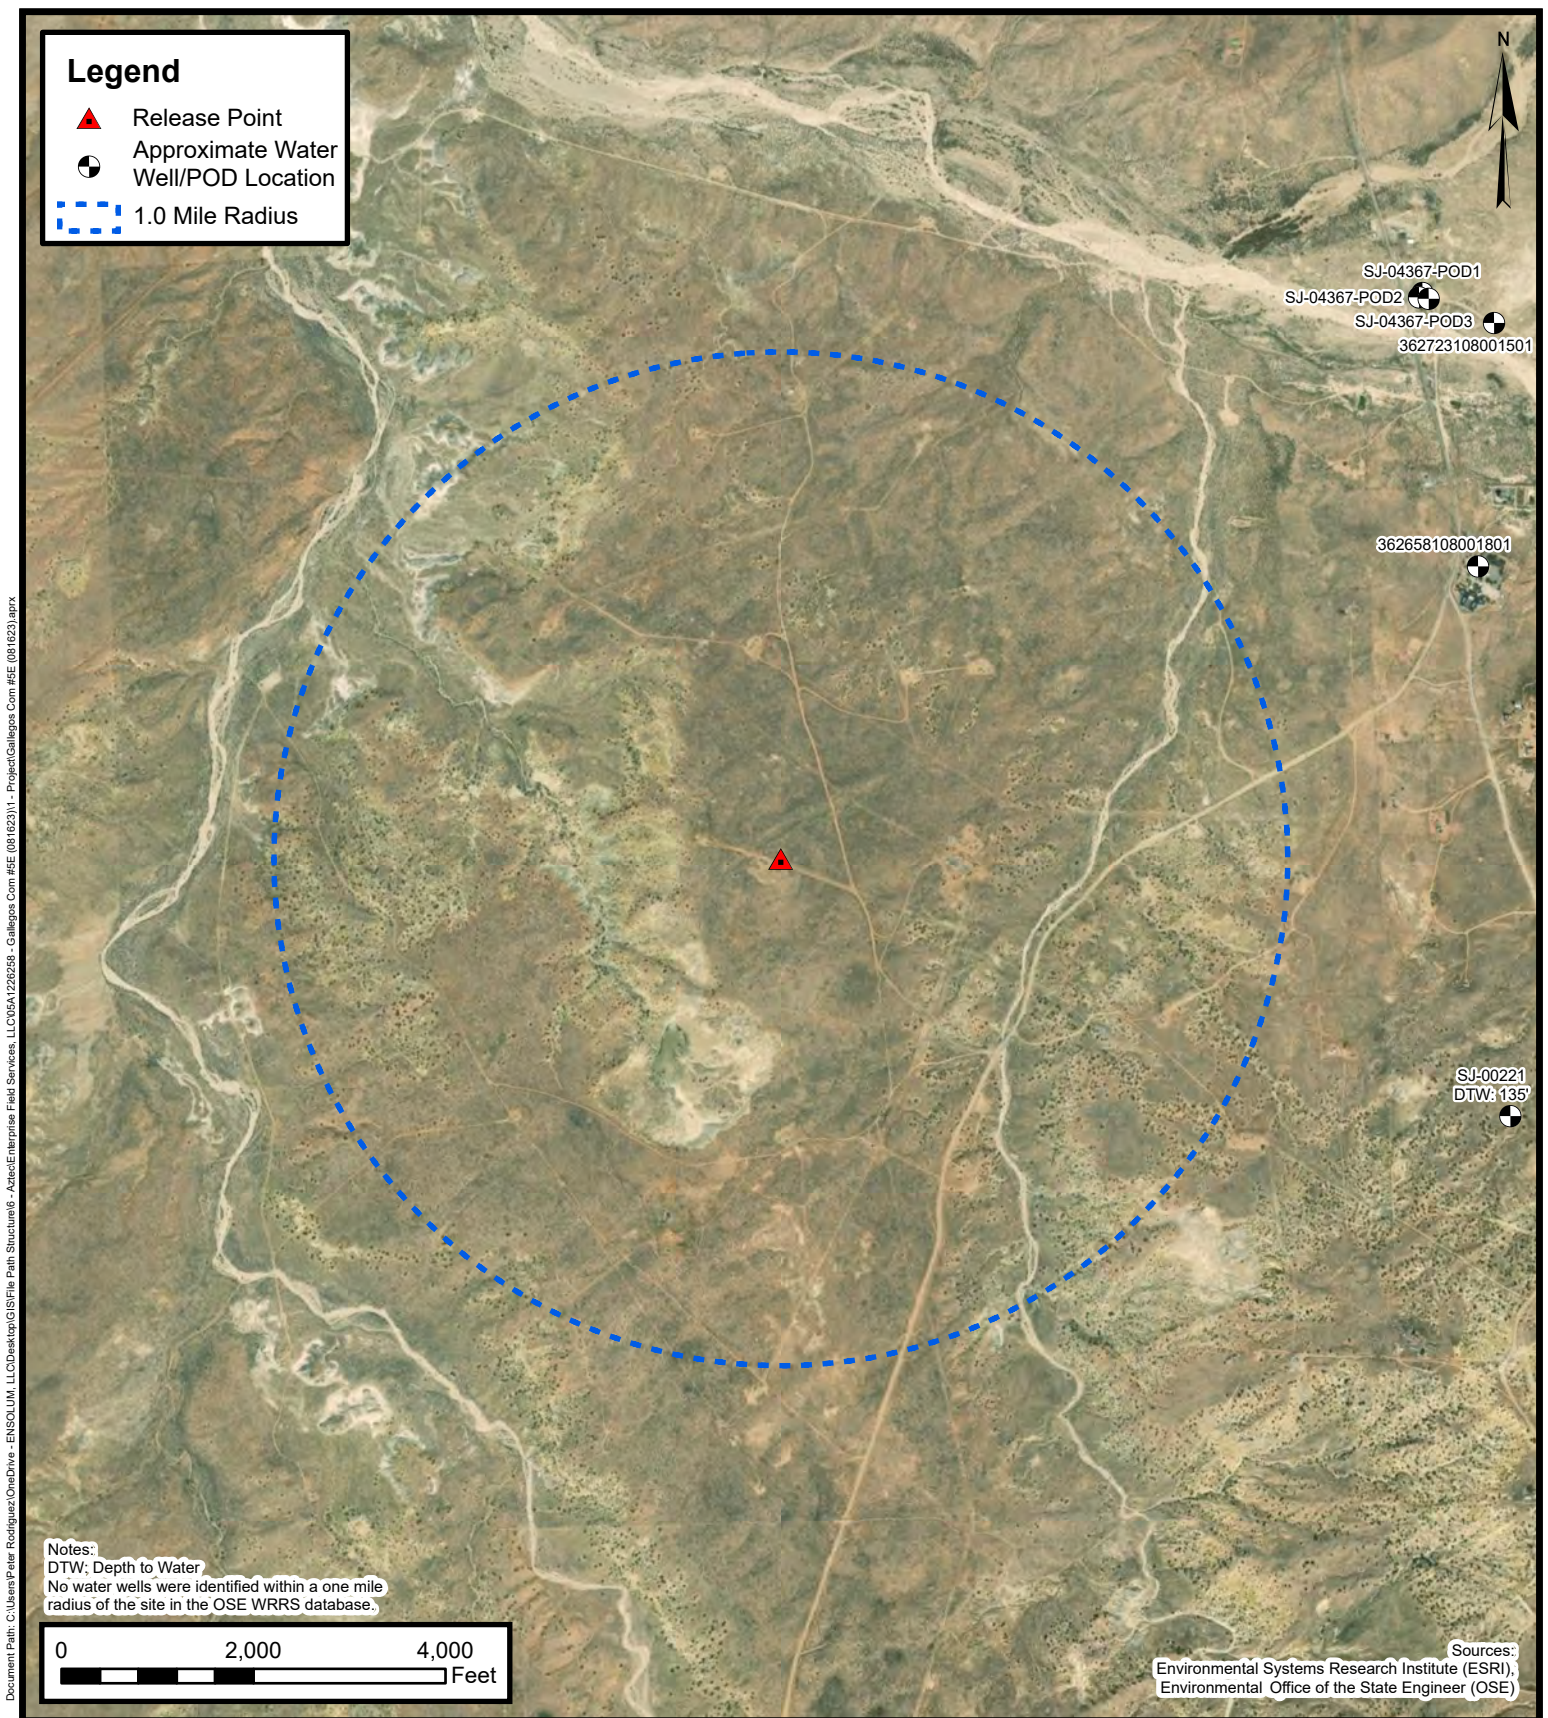
FIGURE
A

- The NM Office of the State Engineer (OSE) tracks the usage and assignment of water rights and water well installations and records this information in the Water Rights Reporting System (WRRS) database. Water wells and other points of diversion (PODs) are each assigned POD numbers in the database (which is searchable and includes an interactive map). No PODs were identified in the same Public Land Survey System (PLSS) section as the Site. One POD (SJ-00221) was identified in an adjacent PLSS section. Documentation for SJ-00221 indicates a depth to water of 135 feet below grade surface (bgs). This POD is located approximately 1.5 miles southeast of the Site and approximately 27 feet higher in elevation than the Site (**Figure A**, **Appendix B**).

1.0 Mile Radius Water Well/POD Location Map

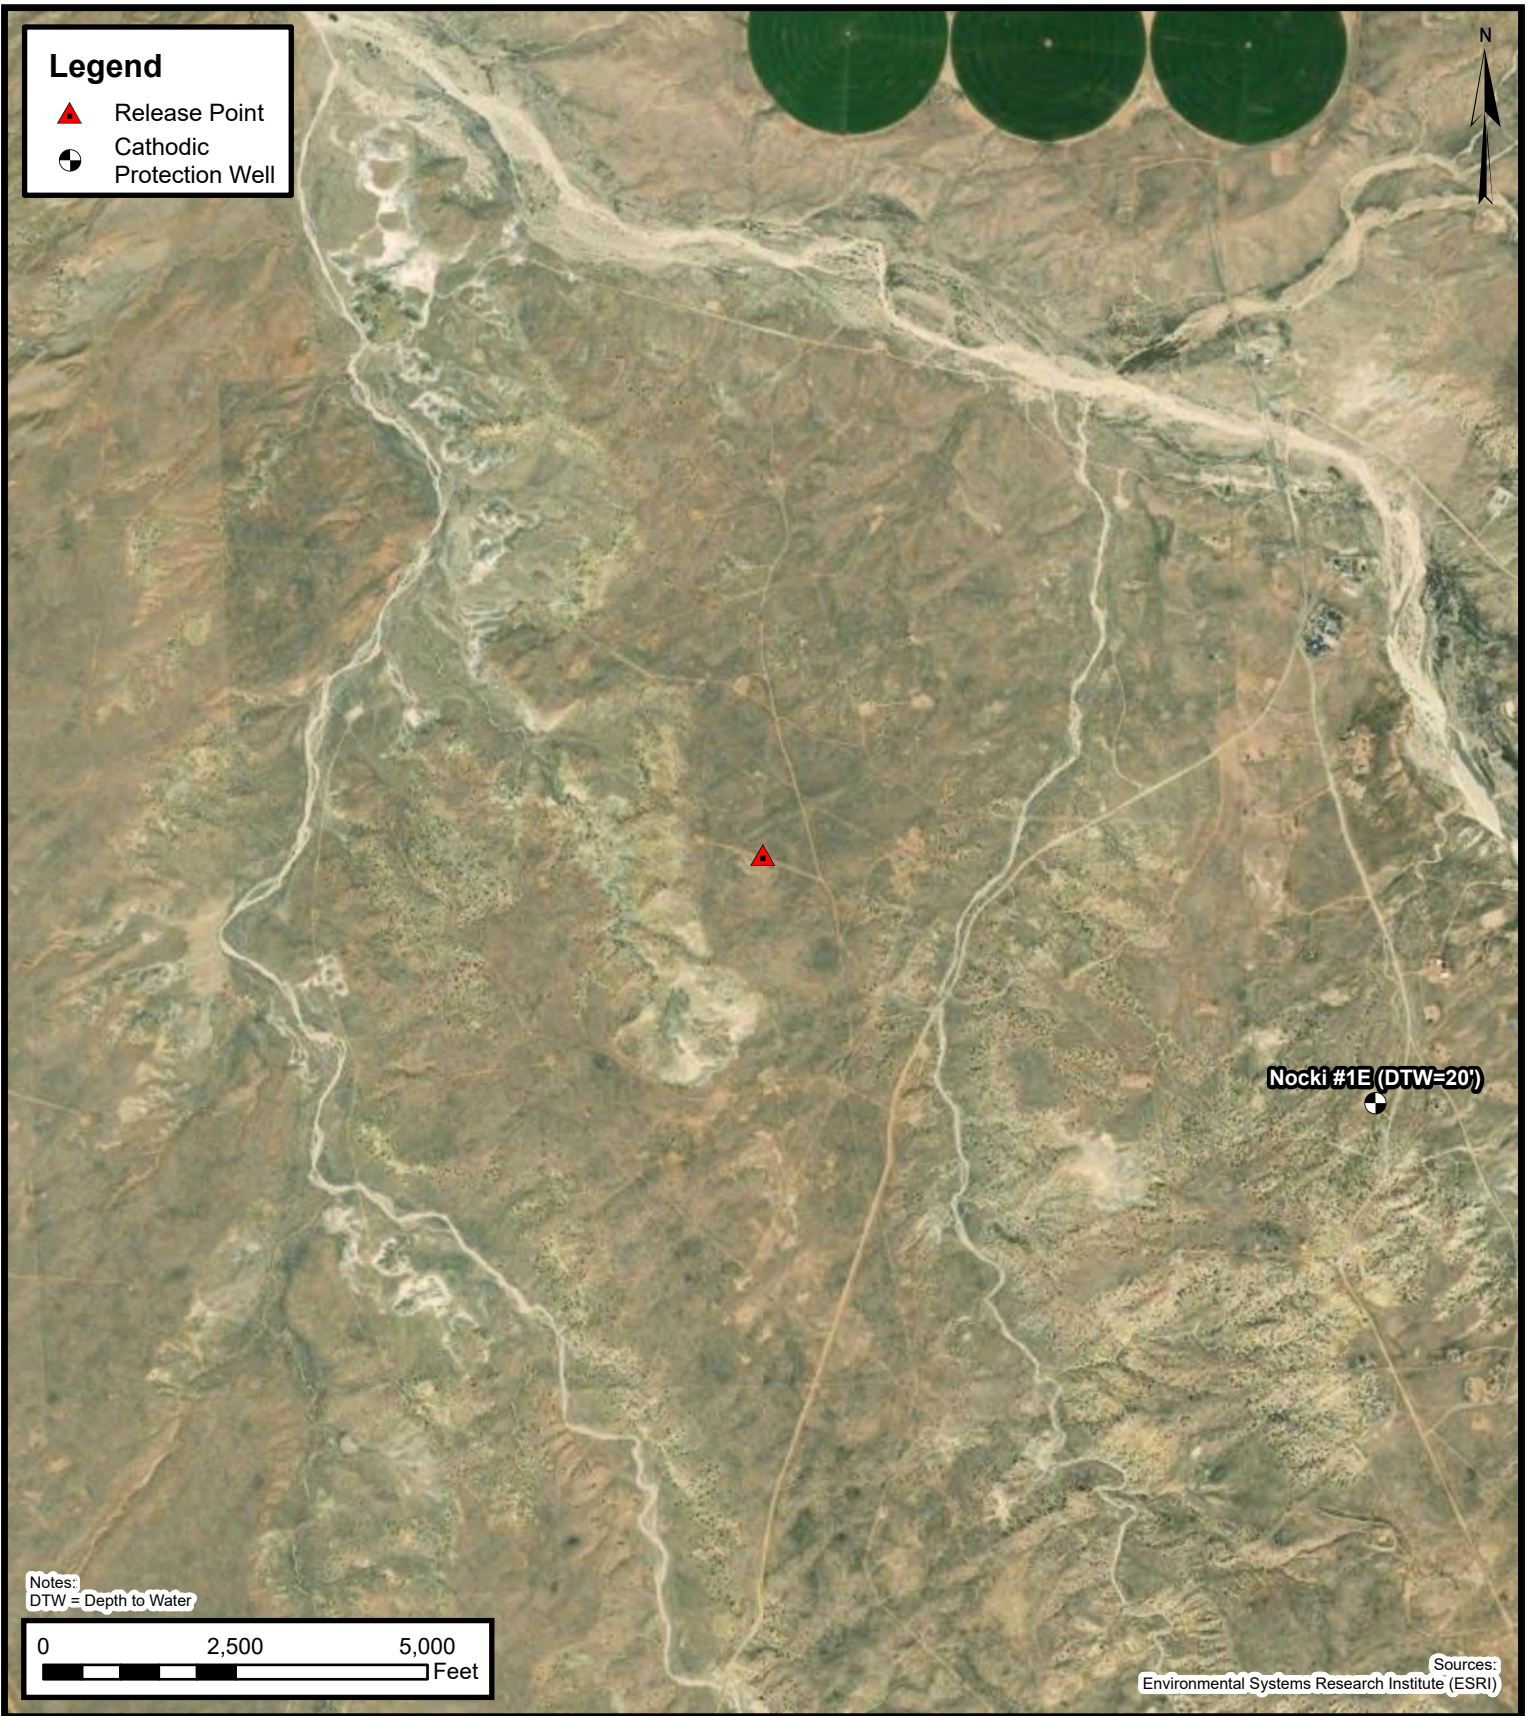
**FIGURE
B**

- One cathodic protection well (CPW) was identified in the NM EMNRD OCD imaging database in the adjacent PLSS section. This CPW is depicted on **Figure B (Appendix B)**. Documentation for the cathodic protection well located near the Nocki #1E well location indicates a depth to water of 20 feet bgs. This cathodic protection well is located approximately 1.6 miles southwest of the Site and is approximately 66 feet higher in elevation than the Site.

Cathodic Protection Well Recorded Depth to Water

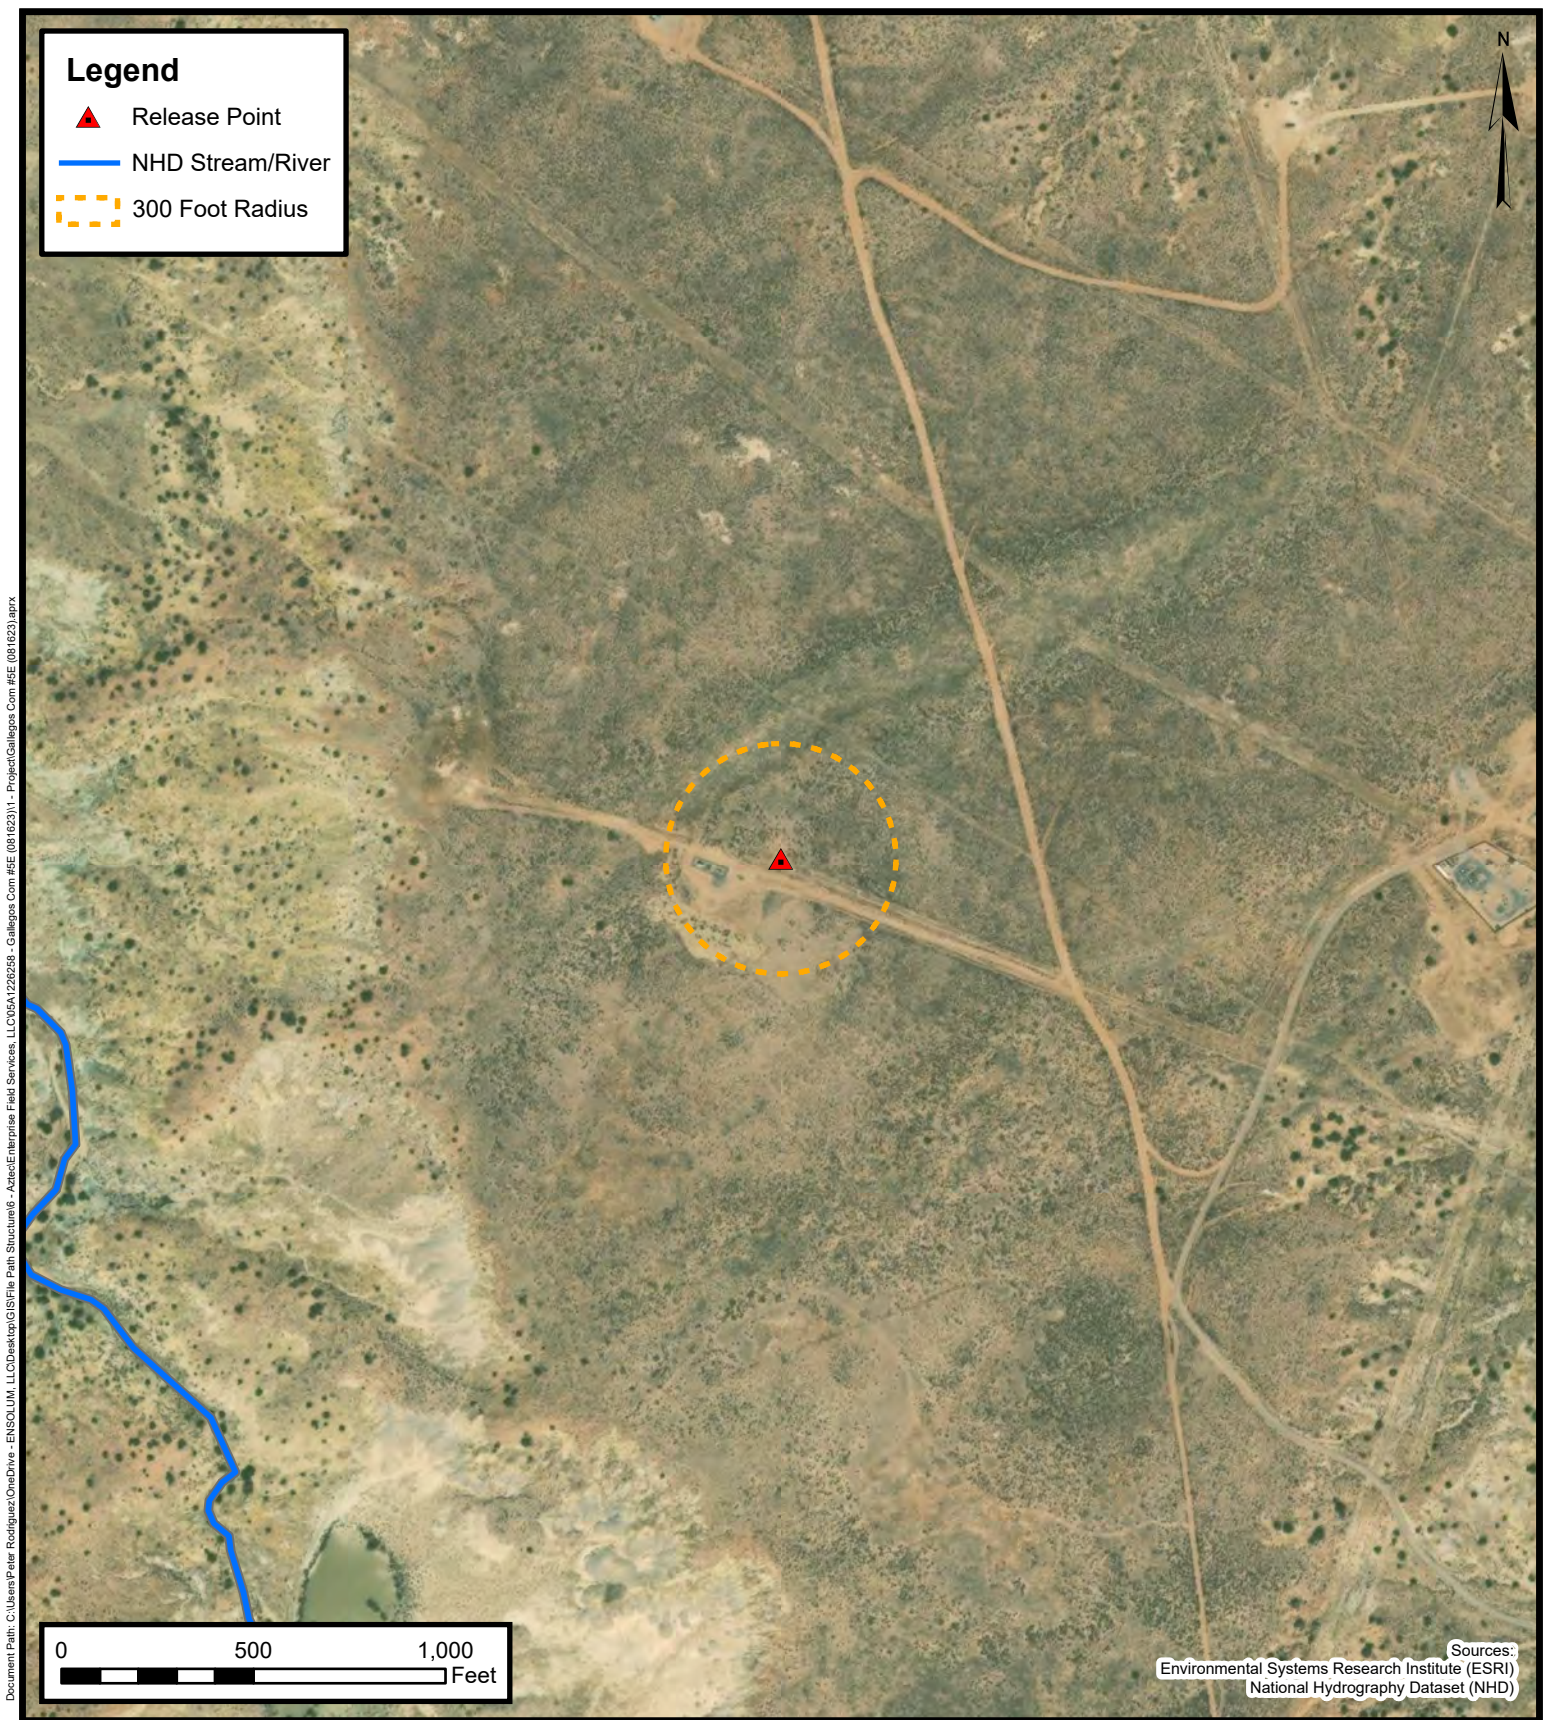
FIGURE
C

- The Site is not located within 300 feet of a NM EMNRD OCD-defined continuously flowing watercourse or significant watercourse (**Figure C, Appendix B**).

300 Foot Radius Watercourse and Drainage Identification

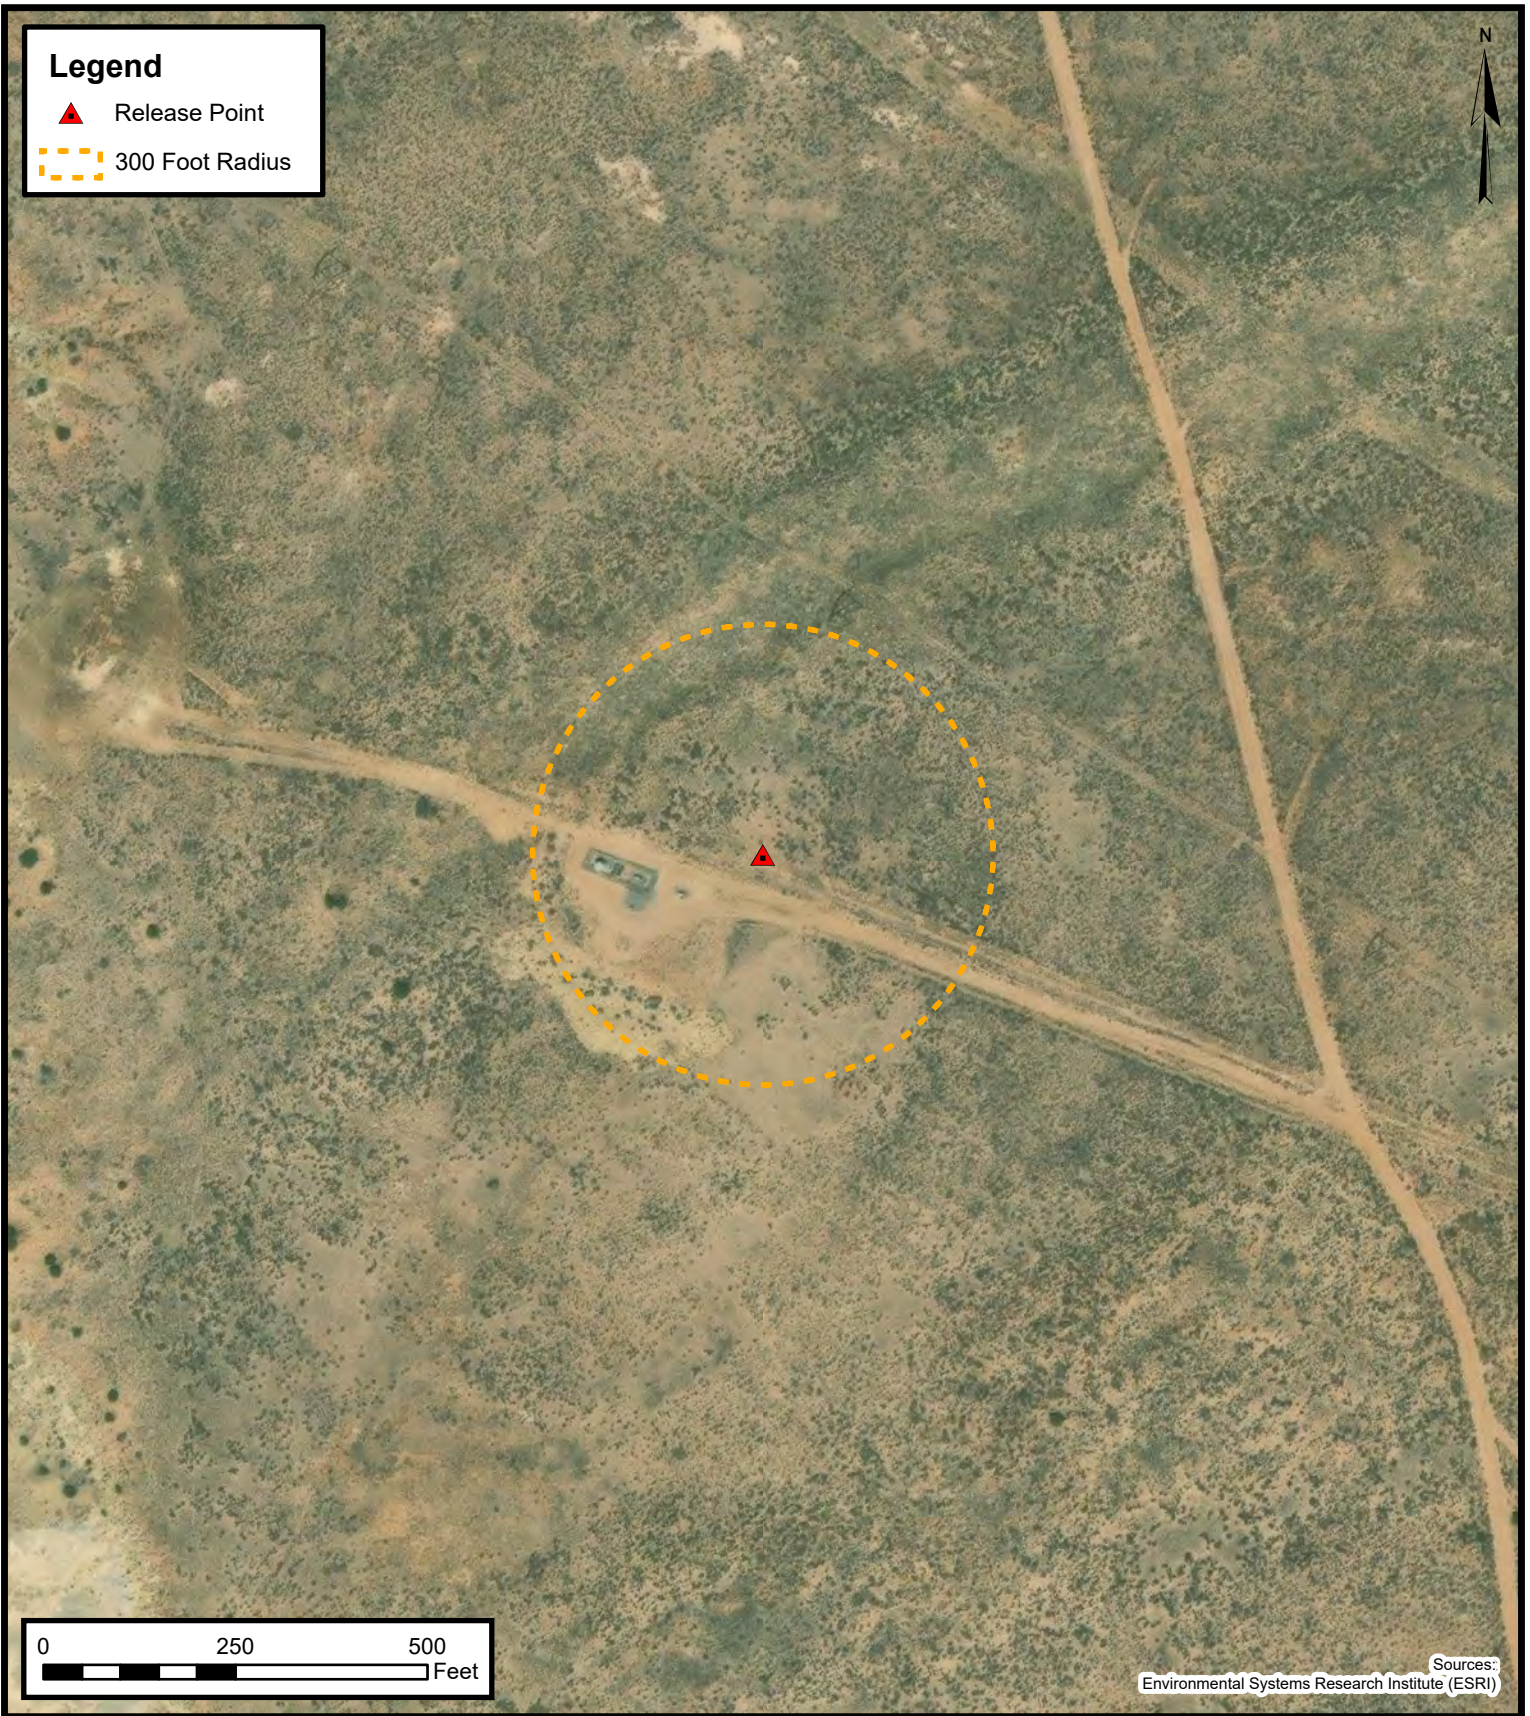
**FIGURE
D**

- The Site is not located within 200 feet of a lakebed, sinkhole, or playa lake.
- The Site is not located within 300 feet of a permanent residence, school, hospital, institution, or church (**Figure D, Appendix B**).

**300 Foot Radius Occupied
Structure Identification**

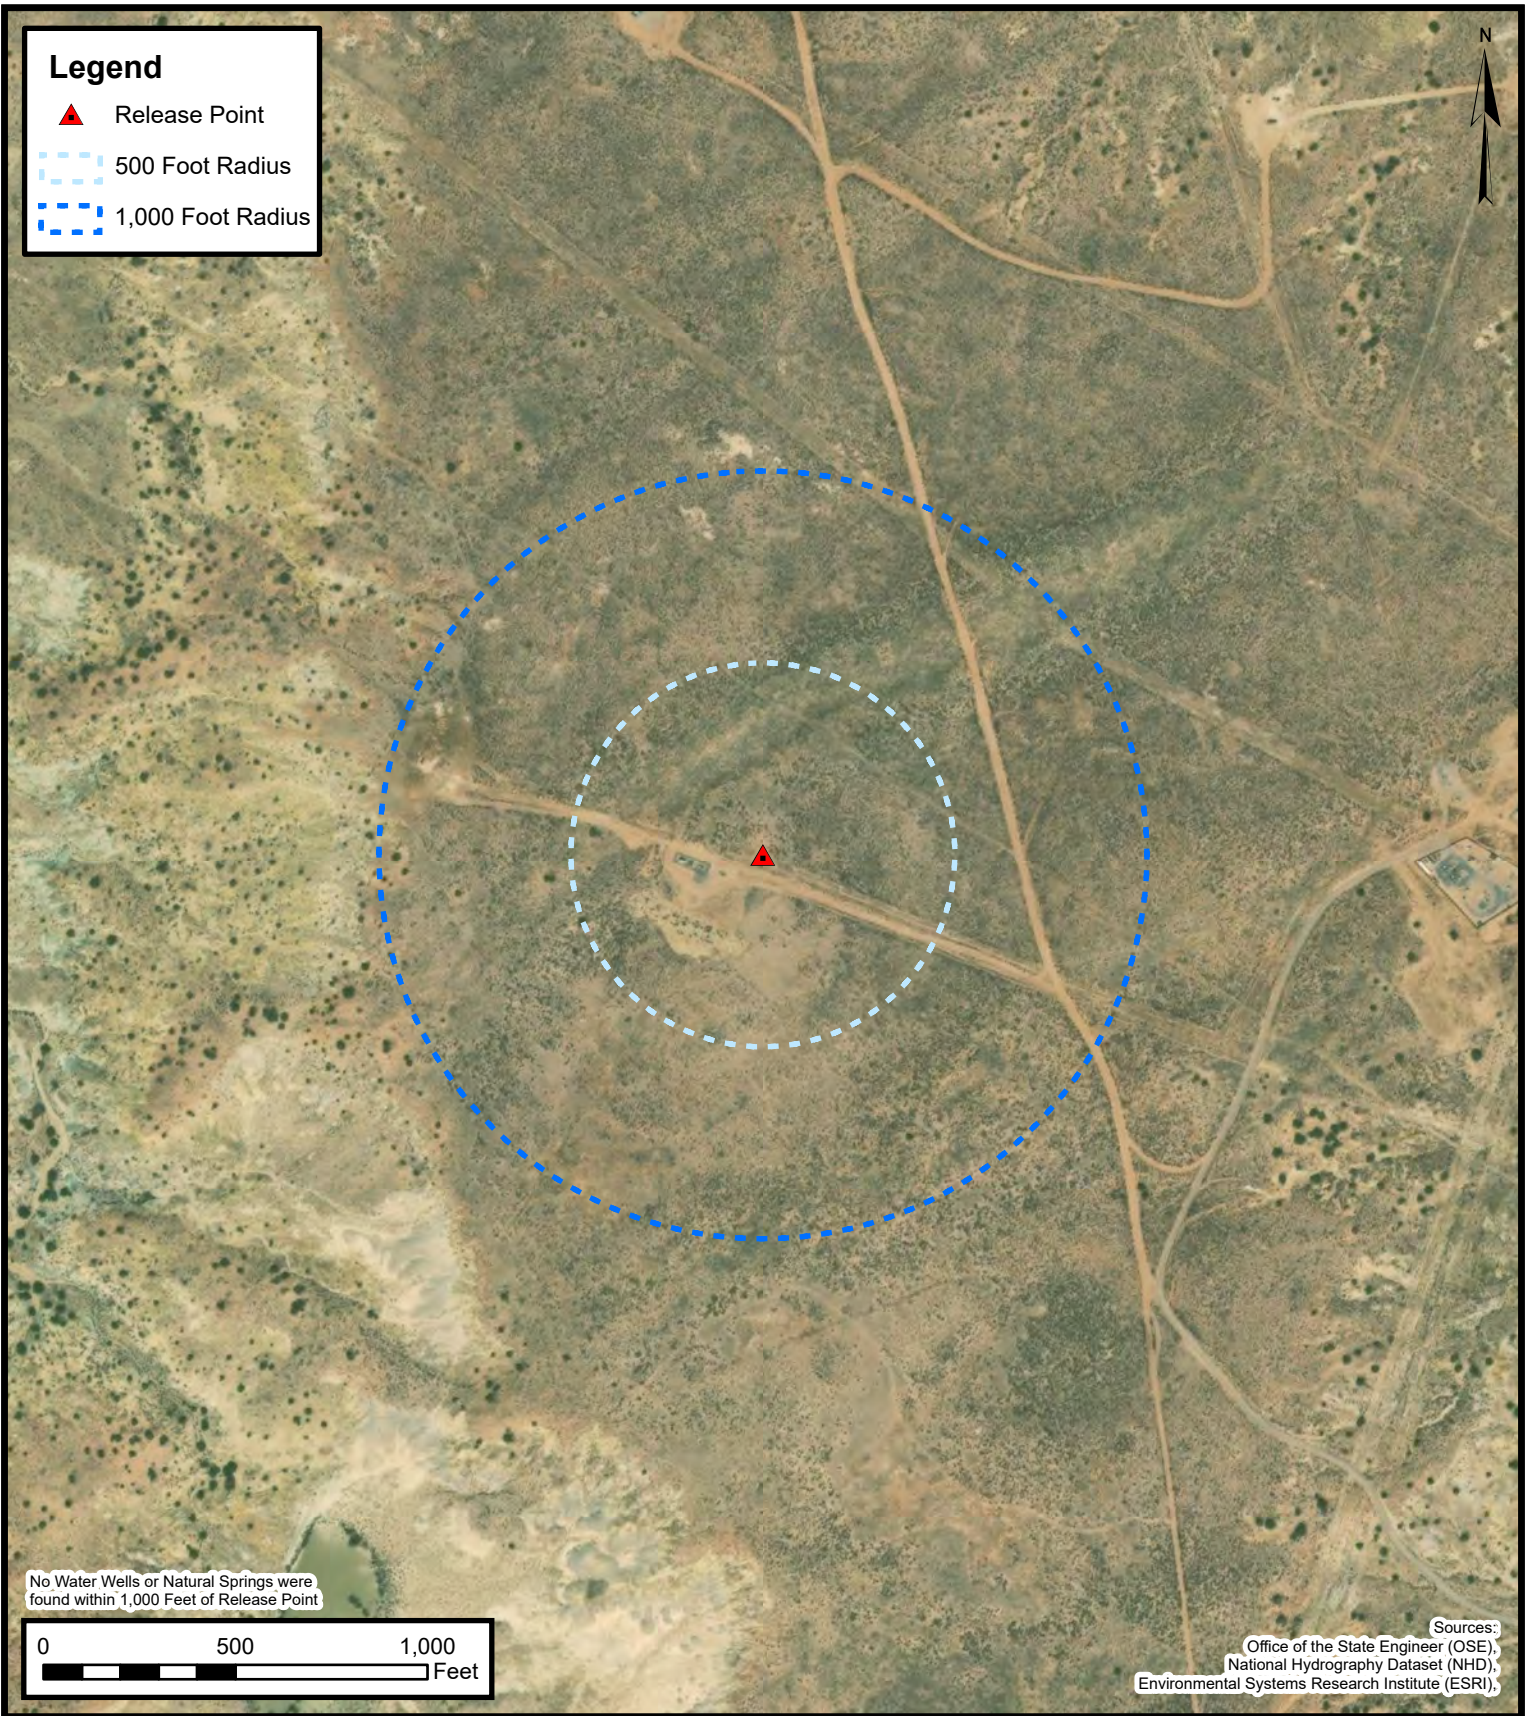
**FIGURE
E**

- No springs, or private domestic freshwater wells used by less than five households for domestic or stock watering purposes were identified within 500 feet of the Site (**Figure E, Appendix B**).

- No freshwater wells or springs were identified within 1,000 feet of the Site (**Figure E, Appendix B**).
- The Site is not located within incorporated municipal boundaries or within a defined municipal fresh water well field covered under a municipal ordinance adopted pursuant to New Mexico Statutes Annotated (NMSA) 1978, Section 3-27-3.

**Water Well and
Natural Spring Location**
Enterprise Field Services, LLC
Gallegos Com #5E (08/16/23)
Project Number: 05A1226258

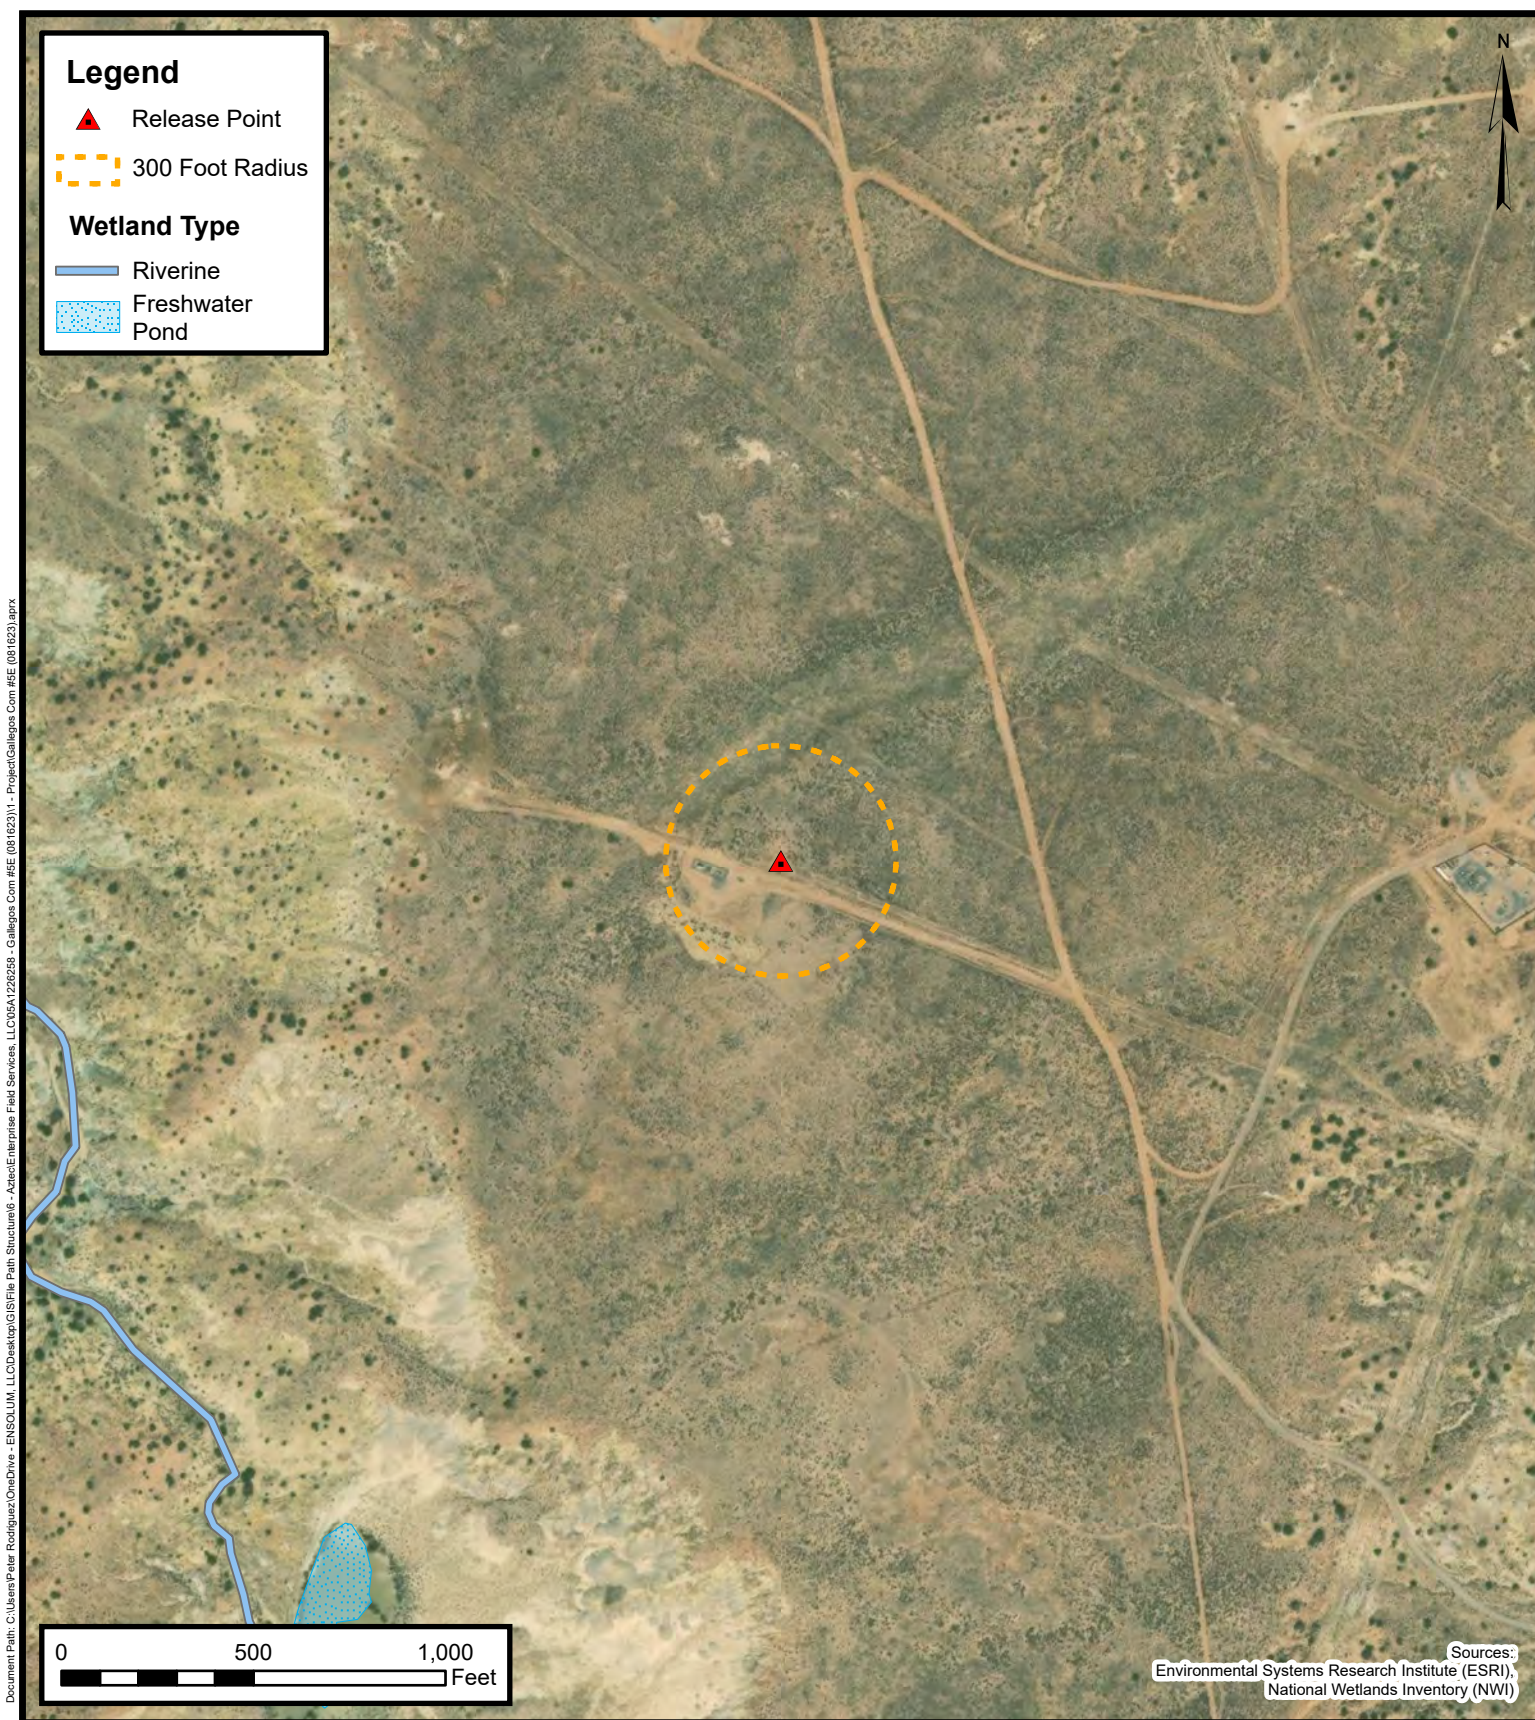
FIGURE
F

- Based on information identified in the U.S. Fish & Wildlife Service National Wetlands Inventory Wetlands Mapper, the Site is not within 300 feet of a wetland (**Figure F, Appendix B**).

Wetlands

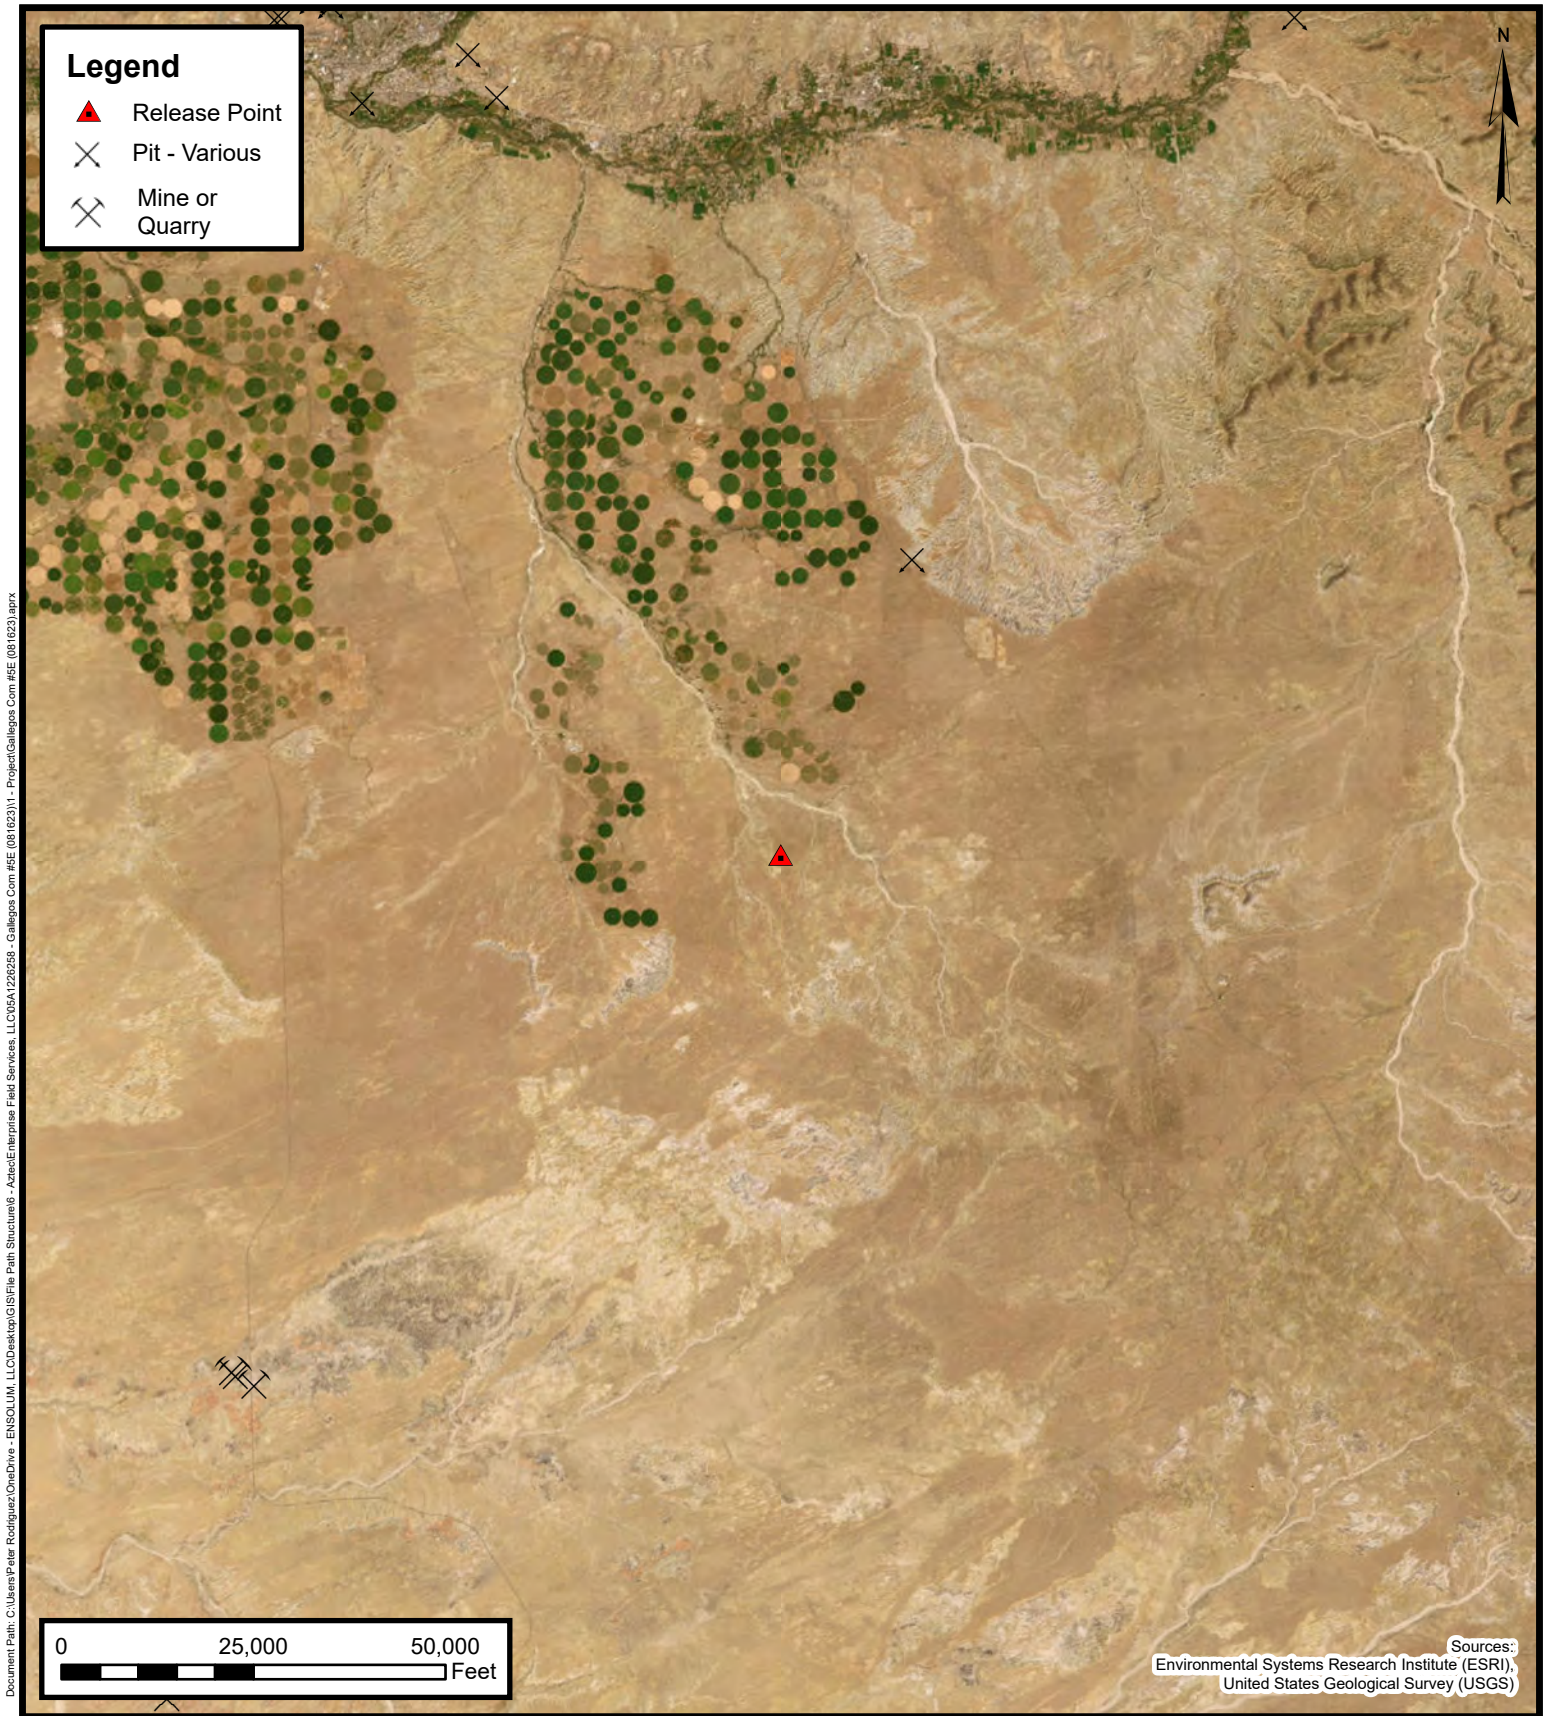
FIGURE
G

- Based on information identified in the NM Mining and Minerals Division's Geographic Information System (GIS) Maps and Mine Data database, the Site is not within an area overlying a subsurface mine (**Figure G, Appendix B**).

Mines, Mills, and Quarries
