CLOSURE REPORT

Gallegos Com #5E (08/16/23)
Unit Letter K, S32 T26N R11W
San Juan County, New Mexico

New Mexico EMNRD OCD Incident ID No. NAPP2322931994

November 9, 2023

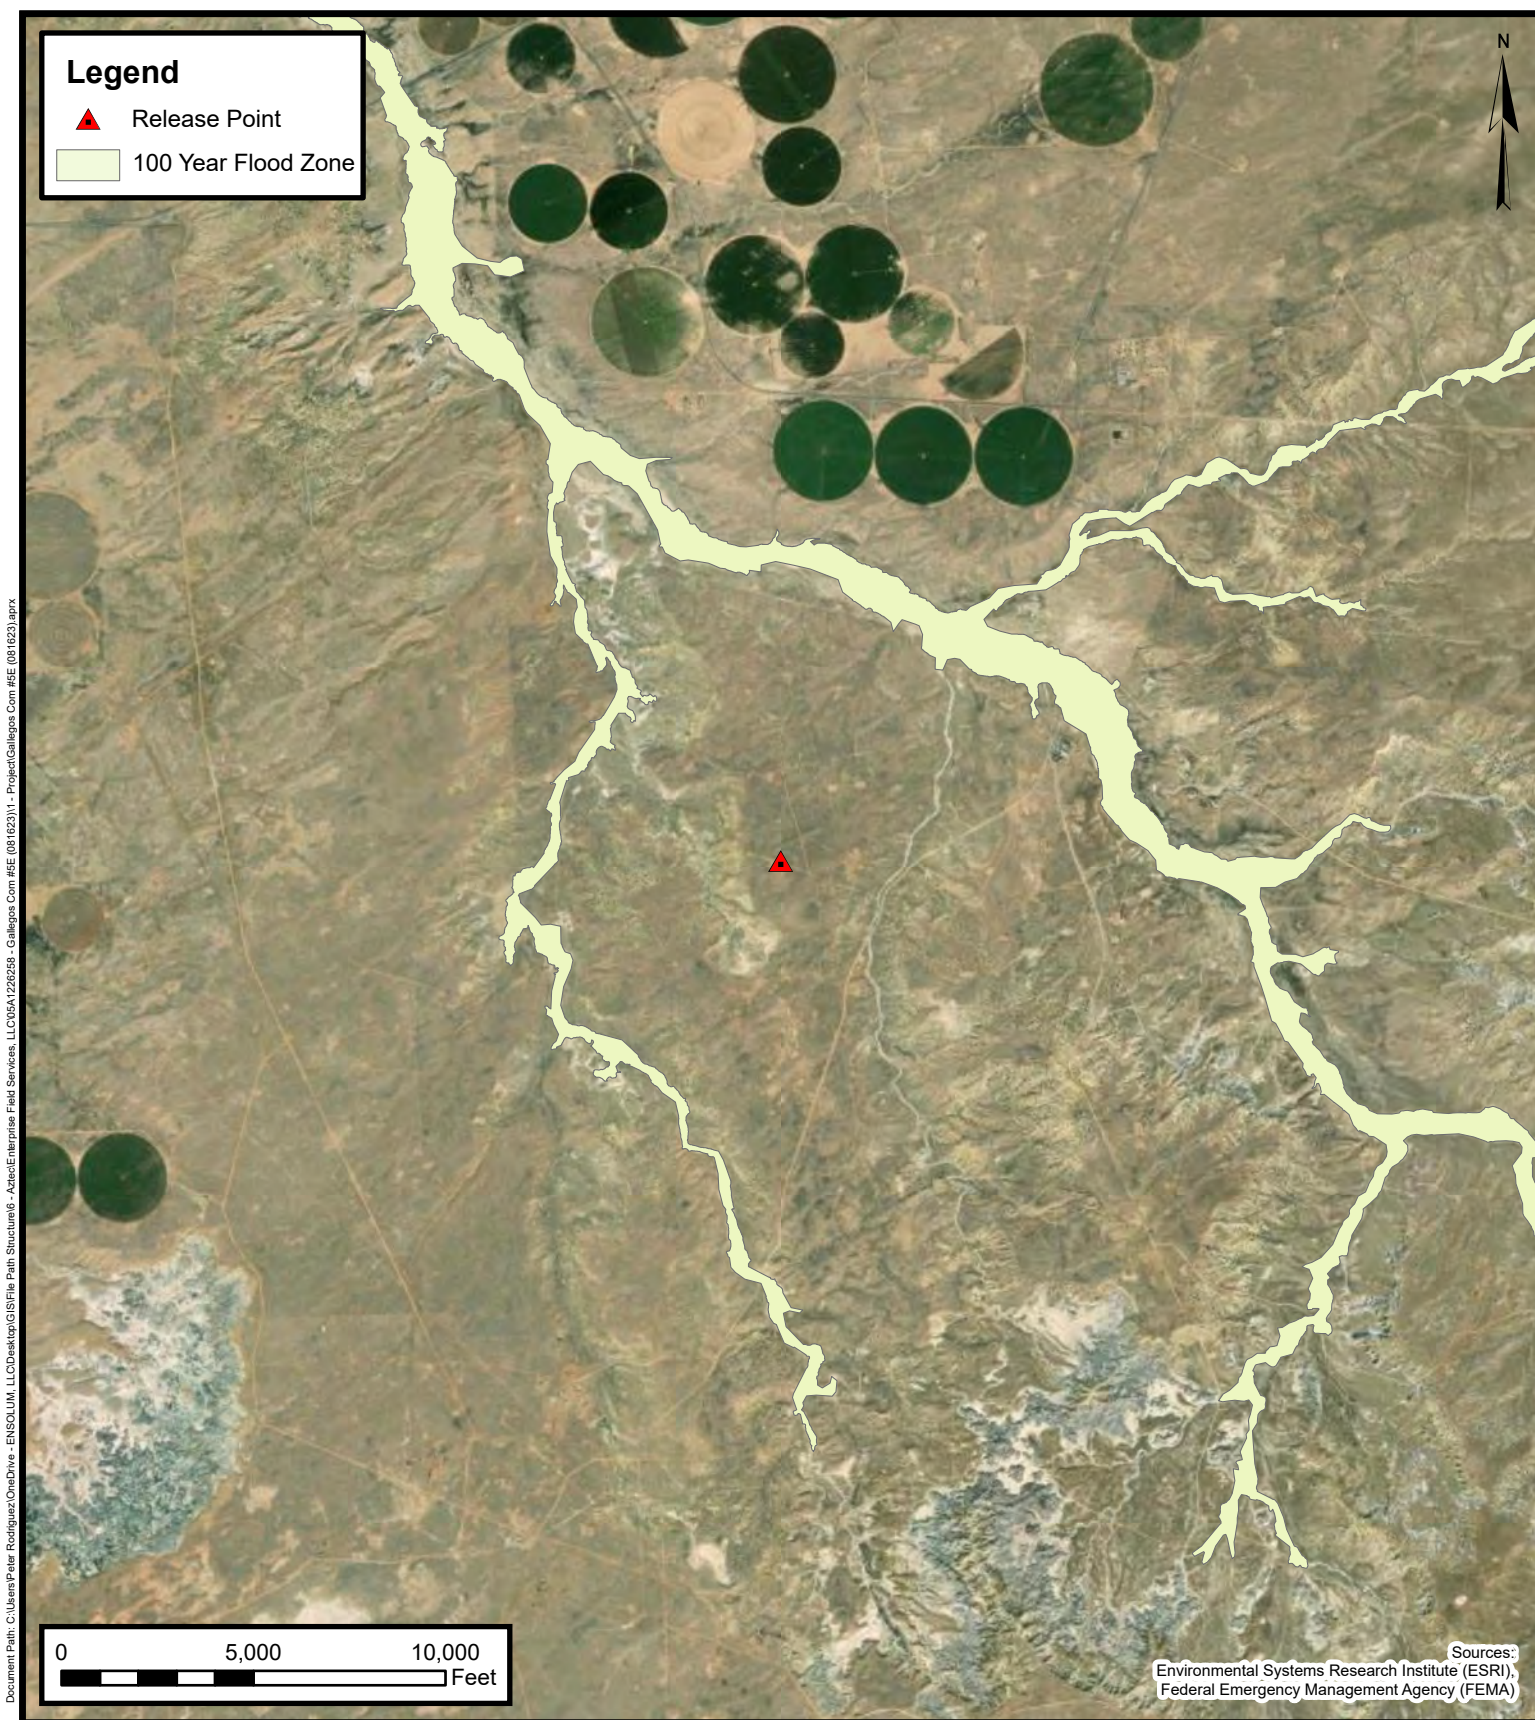
FIGURE
H

- The Site is not located within an unstable area per Paragraph (6) of Subsection U of 19.15.2.7 NMAC.
- Based on information provided by the Federal Emergency Management Agency (FEMA) National Flood Hazard Layer (NFHL) geospatial database, the Site is not within a 100-year floodplain (**Figure H, Appendix B**).

100-Year Flood Plain Map

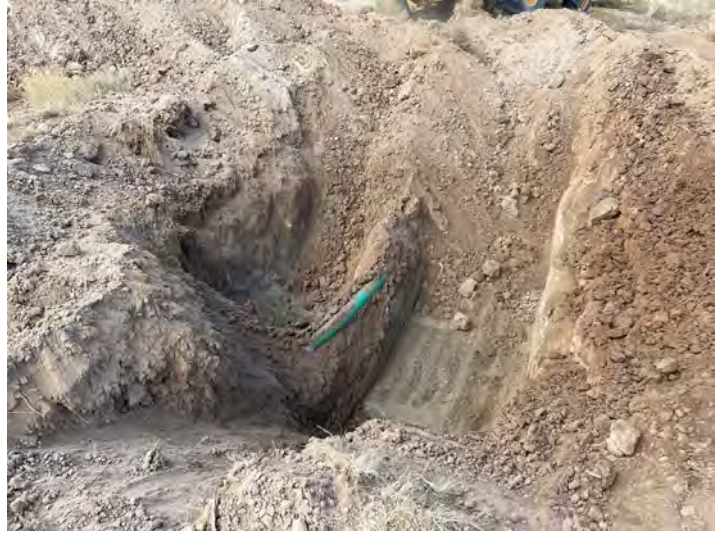
**Photograph 1**

Photograph Description: View of the in-process excavation activities.

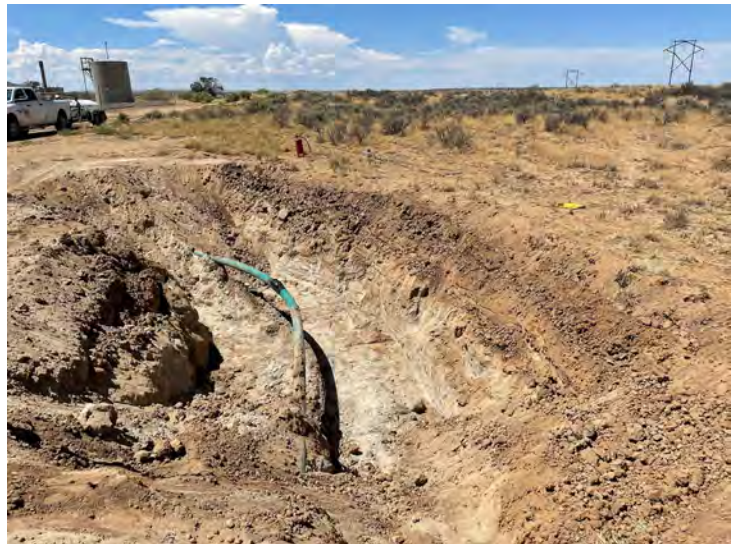
**Photograph 2**

The final excavation measured approximately 32 feet long and 12 feet wide at the maximum extents. The maximum depth of the excavation measured approximately 7 feet bgs. The lithology encountered during the completion of remediation activities consisted primarily of silty sand underlain by weathered sandstone.

Photograph Description: View of the final excavation.

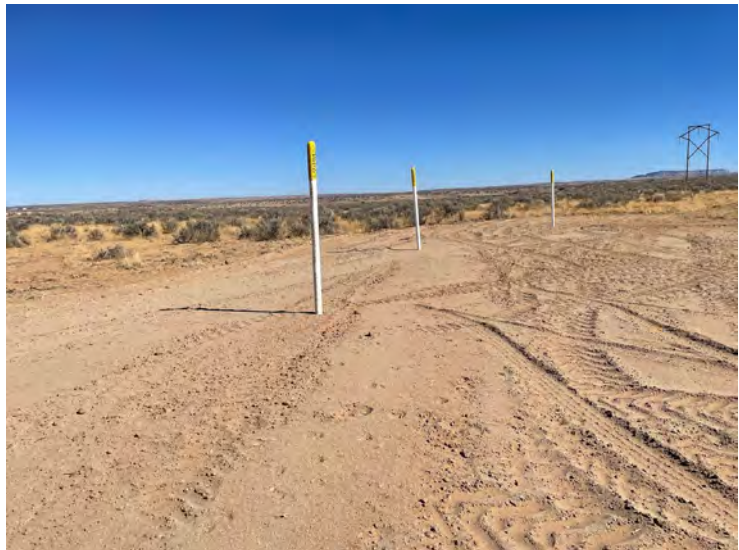
**Photograph 3**

Photograph Description: View of the site after initial restoration.

The excavation was backfilled with imported fill and then contoured to the surrounding topography.
