CLOSURE REPORT

Payne #6 (08/29/23)
Unit Letter E, S14 T25N R8W
San Juan County, New Mexico

New Mexico EMNRD OCD Incident ID No. NAPP2324151130

Ensolum Project No. 05A1226262

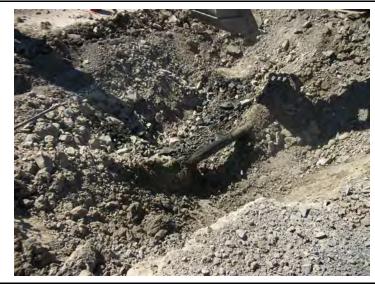
Photograph 1

Photograph Description: View of the inprocess excavation activities.

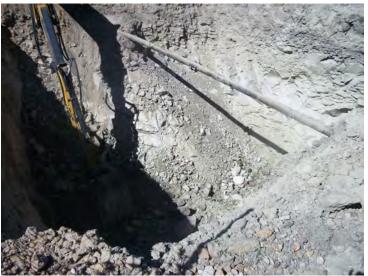
Photograph 2

Photograph Description: View of the inprocess excavation activities.

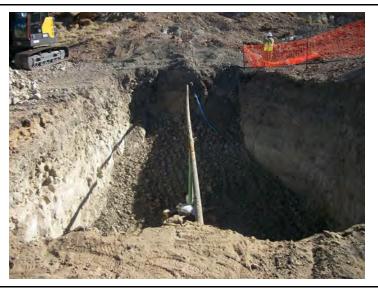
Photograph 3

The final excavation measured approximately 40 feet long and 15 feet wide at the maximum extents. The maximum depth of the excavation measured approximately 12 feet bgs. The lithology encountered during the completion of remediation activities consisted primarily of silty sand underlain by sandstone.

Photograph Description: View of the final excavation.

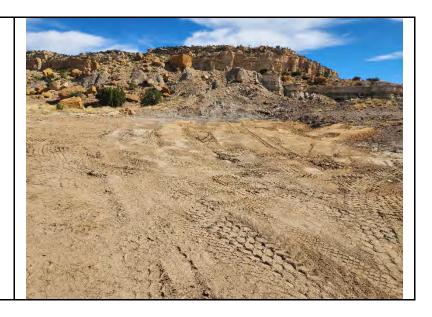
Photograph 4

Photograph Description: View of the site after initial restoration.

The excavation was backfilled with imported fill and then contoured to the surrounding topography.
