Incident ID	nAPP2315058592
District RP	
Facility ID	
Application ID

Site Assessment/Characterization

Based on laboratory analytical results and field activities conducted to date, Etech recommends Mewbourne Oil Company provide copies of this *Remediation Summary & Soil Closure Request* to the appropriate agencies and request closure be granted to the Black Sheep 4/33 Battery release site.

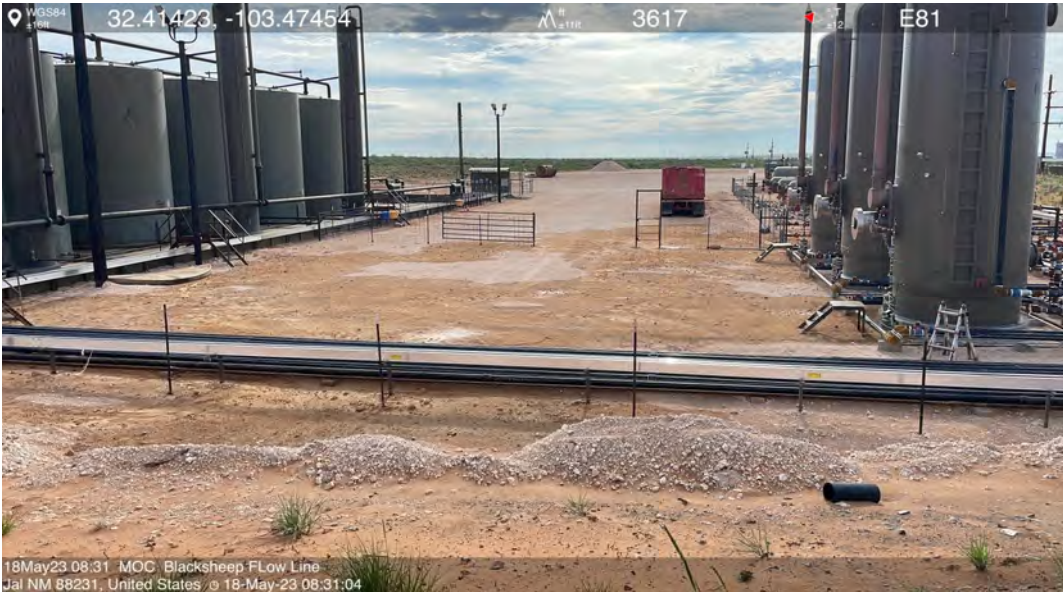
Photo Number: 1

Photo Direction: East	
Photo Description: View of the affected area.

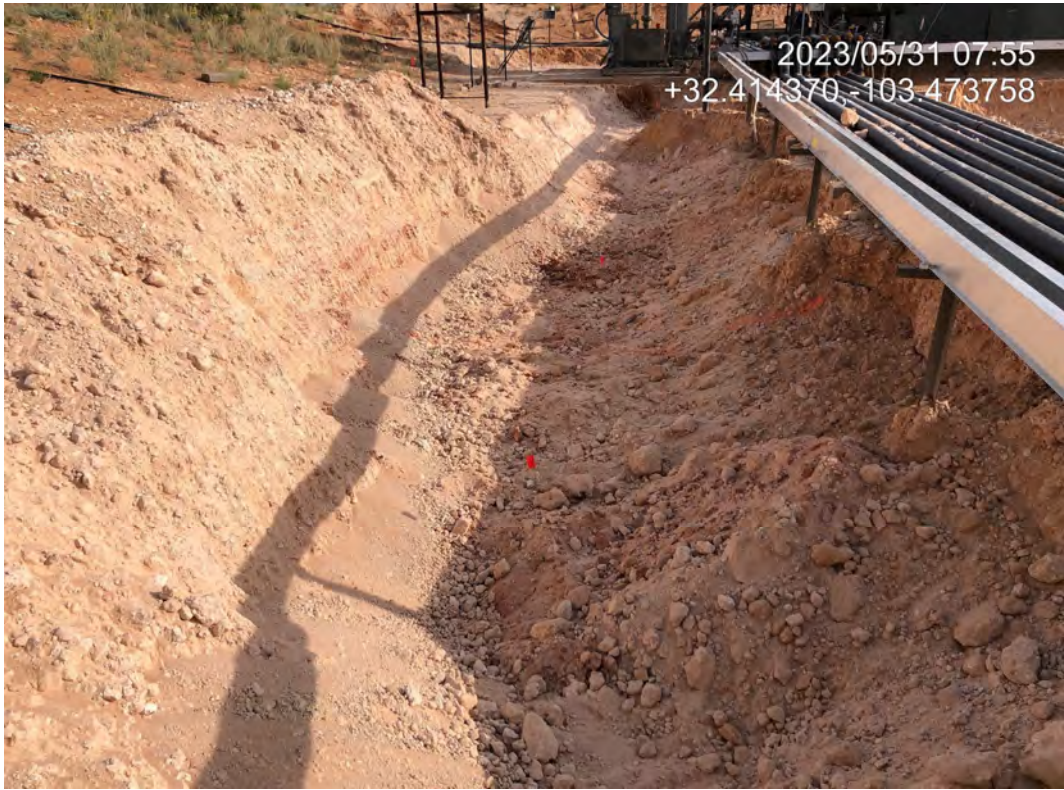
Photo Number: 5

<p>2023/05/31 07:55 +32.414370,-103.473758</p>
Photo Direction: North	
Photo Description: View of the excavated area.

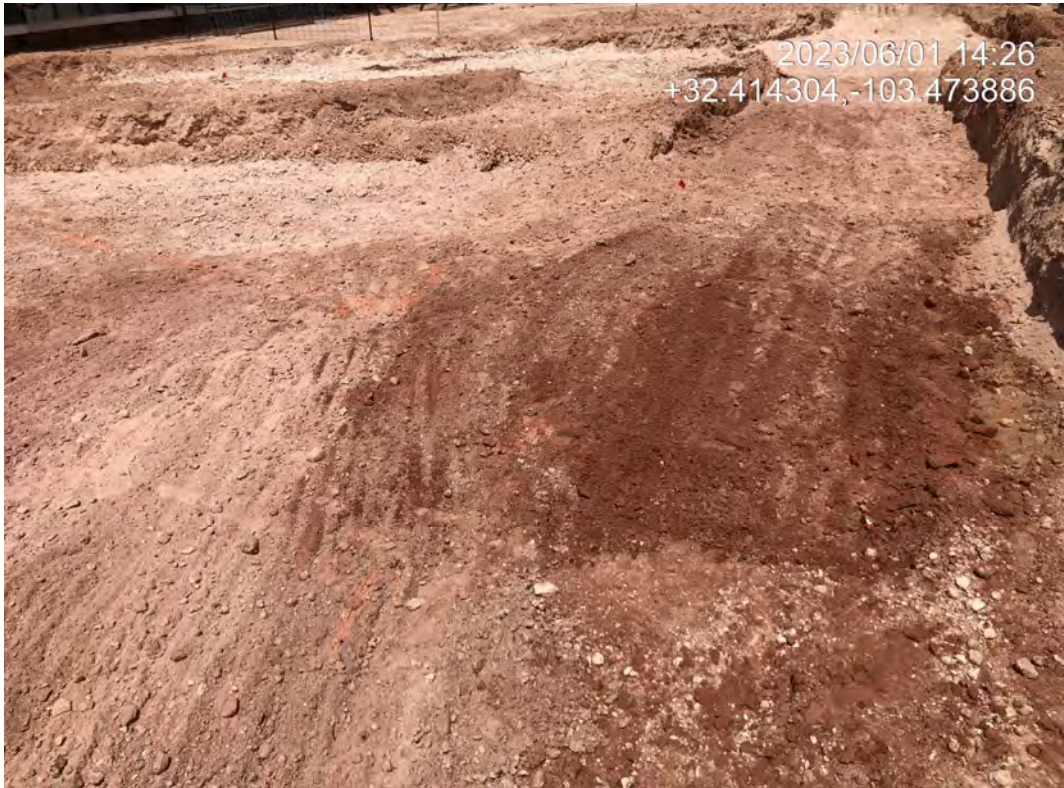
Photo Number: 9

Photo Direction: West-Northwest	
Photo Description: View of the excavated area.

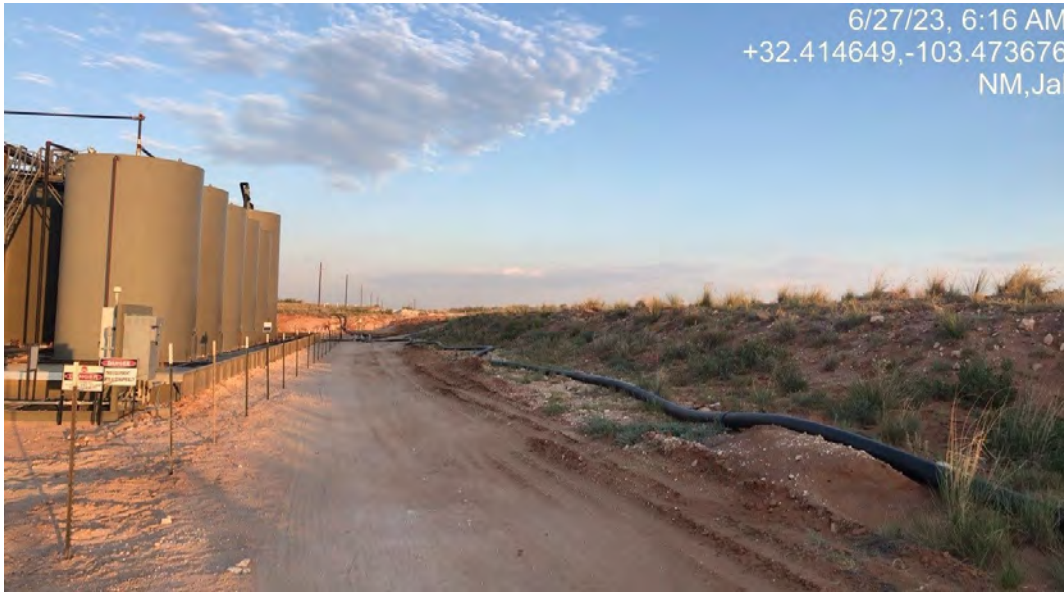
Photo Number: 10

Photo Direction: West	
Photo Description: View of the remediated area after backfill and regrading.

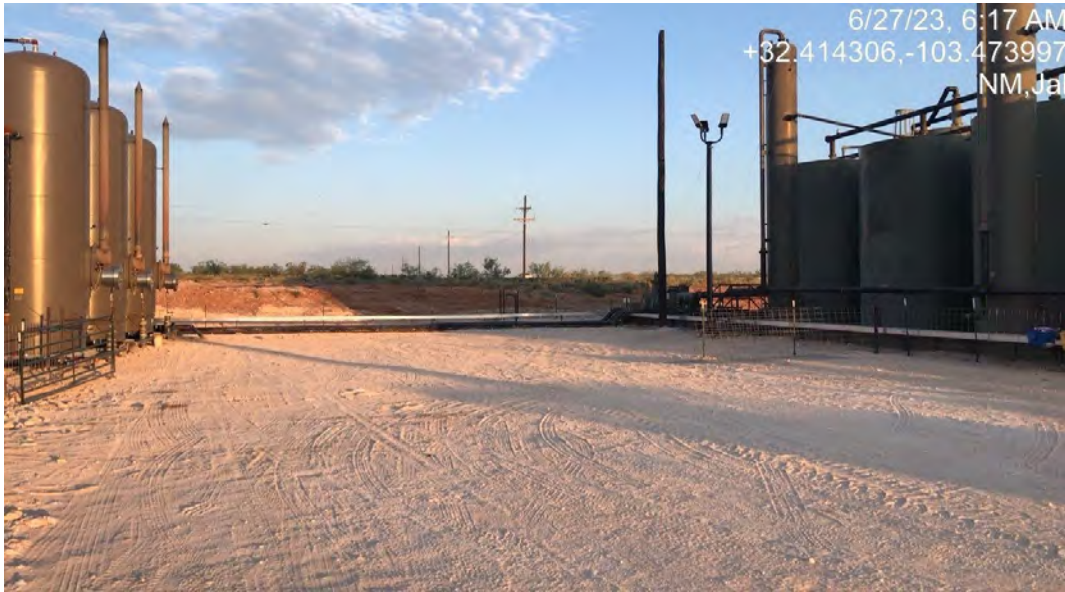
Photo Number: 11

Photo Direction: West	
Photo Description: View of the remediated area after backfill and regrading.

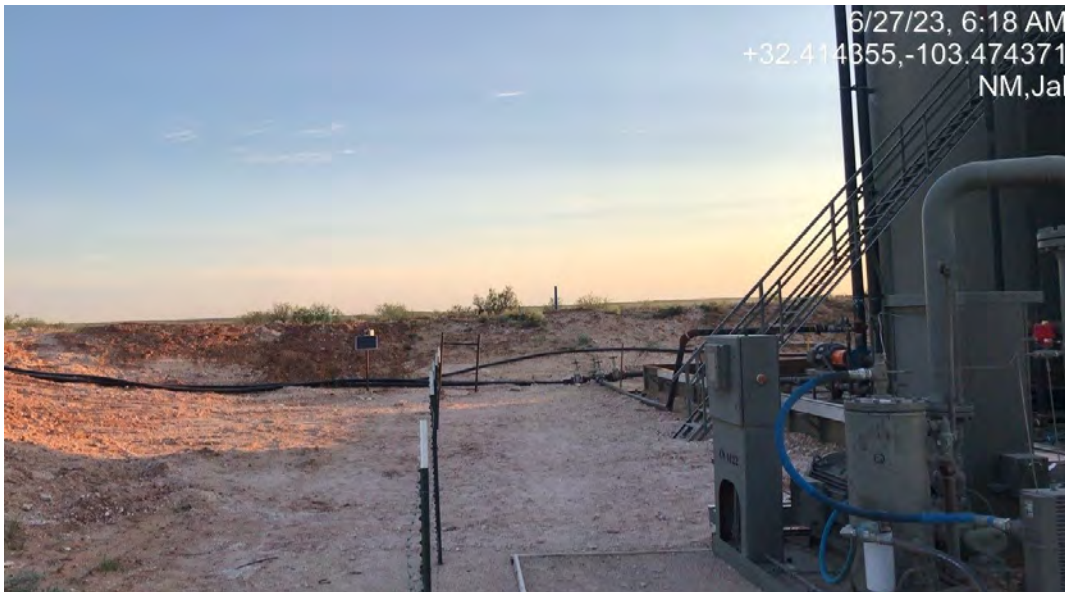
Photo Number: 13

<p>6/27/23, 6:18 AM +32.414355,-103.474371 NM, Jal</p>
Photo Direction: North	
Photo Description: View of the remediated area after backfill and regrading.
