I Release Notification

Site Name: Holloway Federal #1E	Site Type: Well Site
Date Release Discovered: 6/21/2023	API# (if applicable) 30-04525827

Historical release discovered during the permanent removal of a below-grade tank (BGT). Soil sample result for TPH of 231 mg/kg exceeded BGT Closure Plan criteria.

RE: Holloway Fed 1E

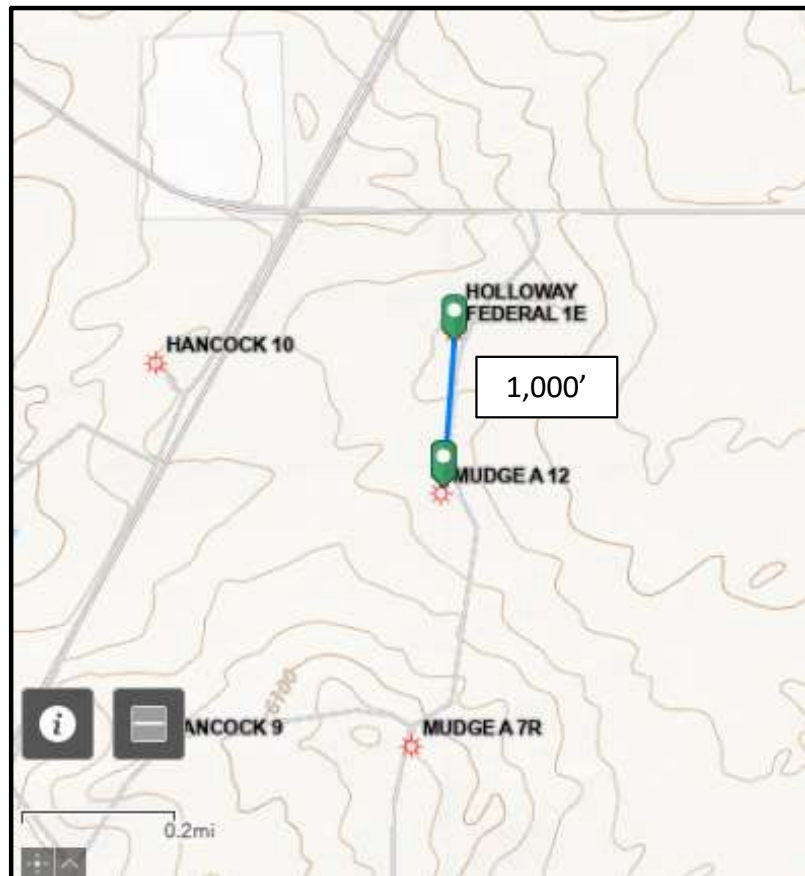
Depth to groundwater determination:

Siting criteria for the Mudge A 6 #12, which is located approximately 1000' south of the Holloway Federal #1E.

Depth to groundwater at the Mudge A 6 #12 is >100'

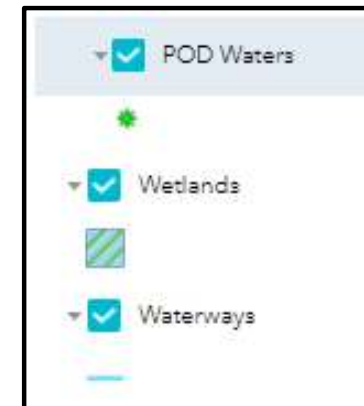
NMAC 19.15.29 Siting Criteria for Closure Standards

BGT is not shown to be within:

- 300 ft of any continuously flowing watercourse or any other significant water course.
- 200 feet of any lakebed, sinkhole or playa lake
- 300 feet of any occupied permanent residence
- 500 feet of a spring or private, domestic fresh water well.
- 1000 feet of any fresh water well
- 300 feet of a wetland
- Incorporated municipal boundaries
- Overlying a subsurface mine
- An unstable area
- A 100-year floodplain
