Remediation Summary & Soil Closure Request

H.L. Brown Operating, LLC Federal G #001

Roosevelt County, New Mexico
Unit Letter "D", Section 3, Township 8 South, Range 37 East
Latitude 33.6546570 North, Longitude 103.146285 West
NMOCD Reference No. nAPP2227233275

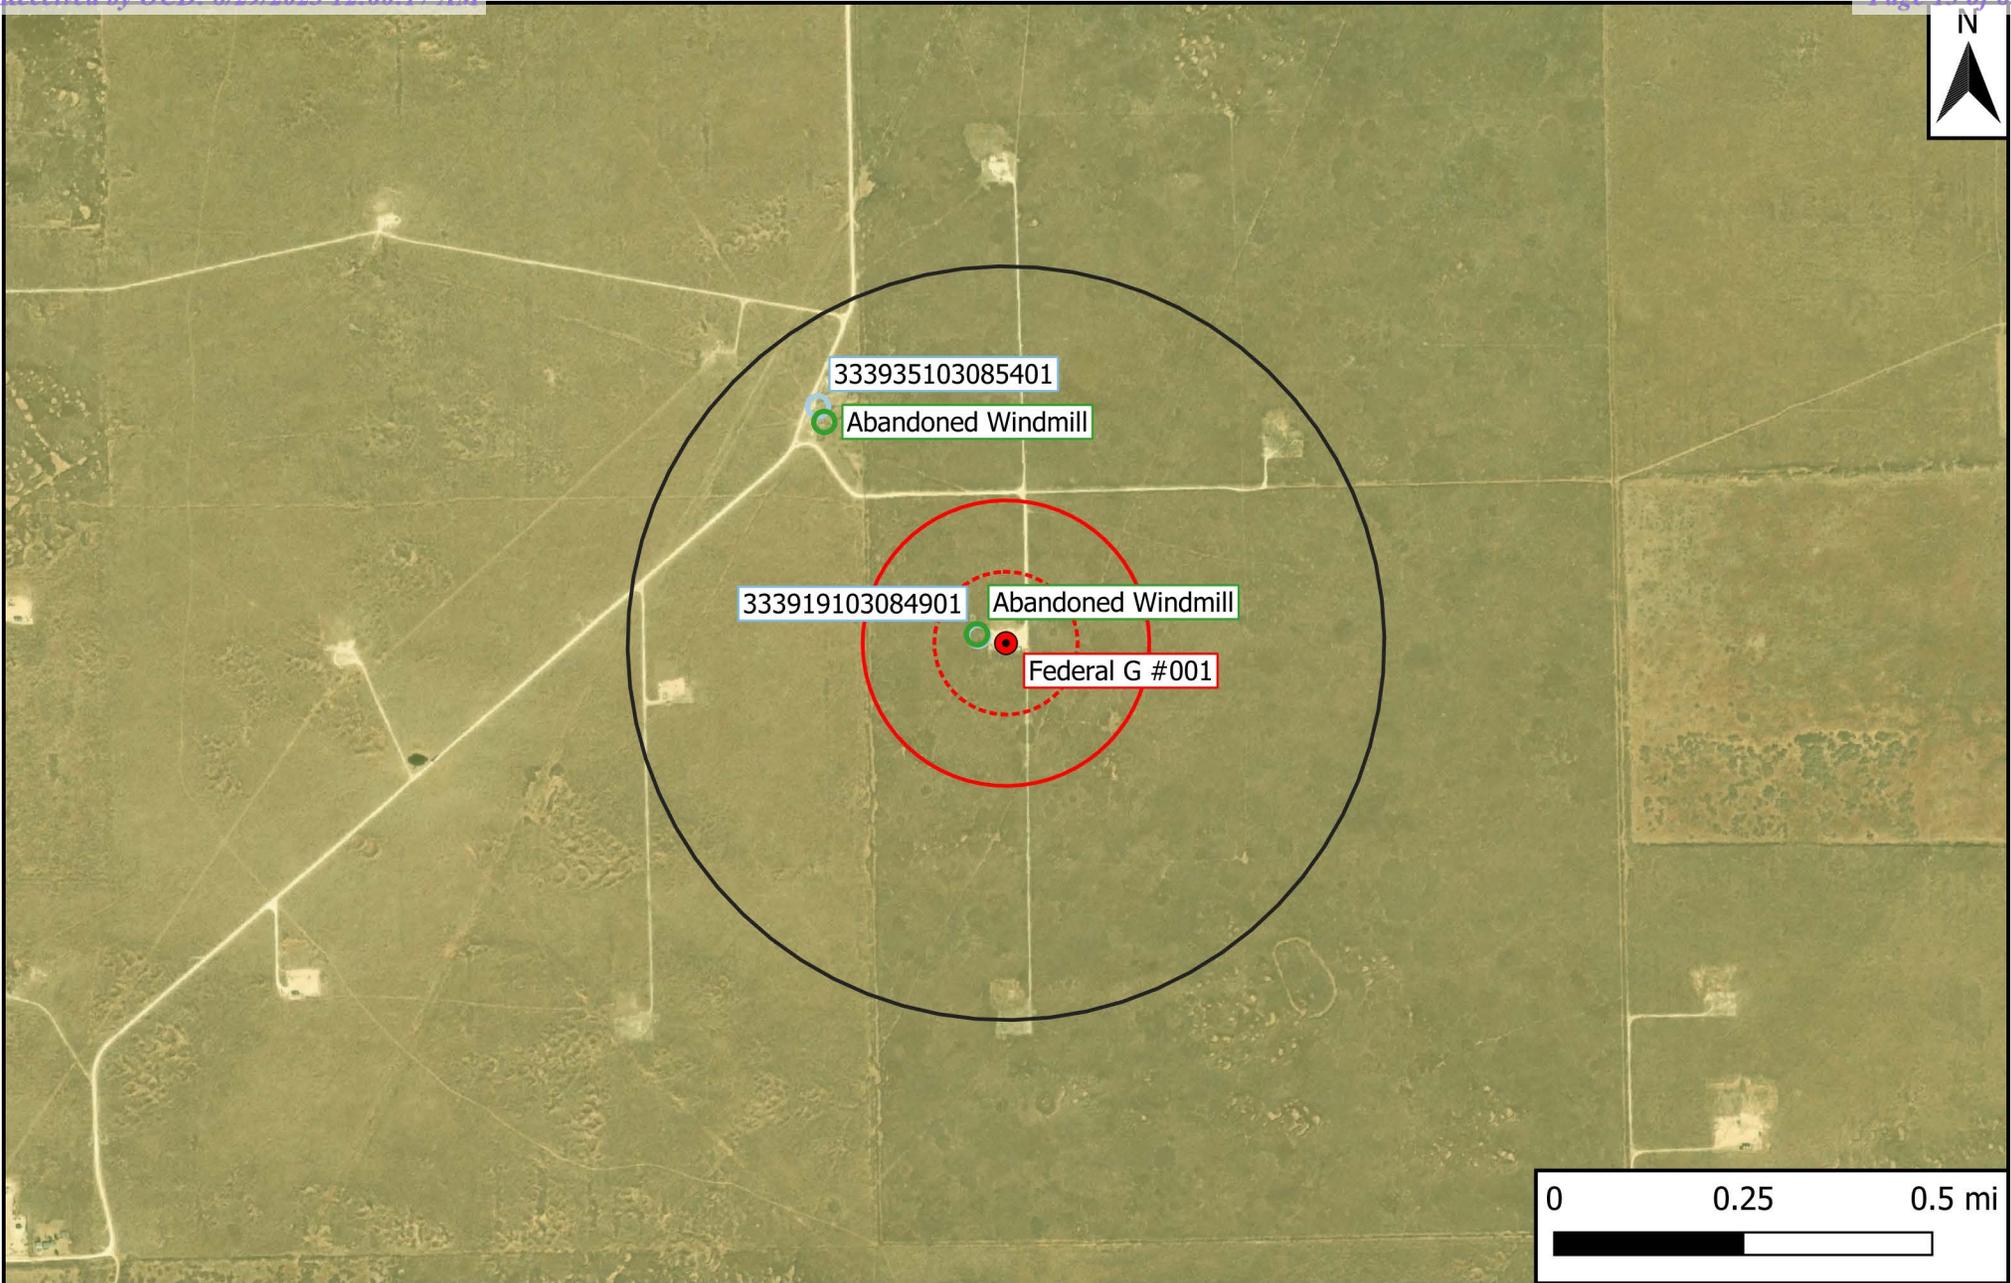
Figure 2

Site Characterization Map

Legend		
Site Location	1% Annual Flood Chance	500-Ft Radius
Well - NMOSE	Emergent/Forested Wetlands	1,000-Ft Radius
Well - USGS	Freshwater Pond/Lake	0.5-Mi Radius
Well - Exploratory/Monitor	Karst Potential (Low/Med./High)	Municipal Boundary
Potash Mine Workings	Riverine

NMOCD Siting Criteria data was gathered from available resources including Bureau of Land Management (BLM) and Fish & Wildlife Services (FWS) shapefiles, topographic maps, NMOSE and USGS databases, and aerial imagery. The results are depicted in Figures 1, 2, 4, and 5.

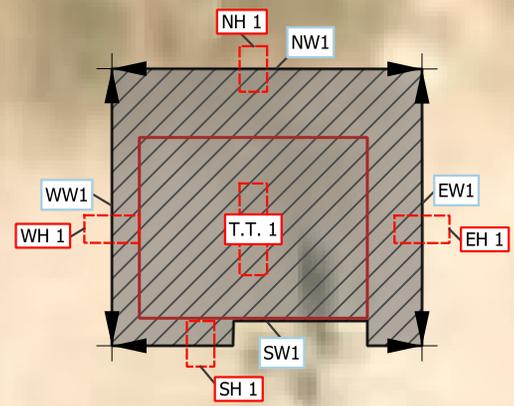
Figure 3

Site & Sample Location Map

Legend	
	Excavation Extent
	Historical Reserve Pit
	Liner (≈6' bgs)
	Pipeline
	Composite Wall Sample
	Test Pit (≈18' bgs)
	Test Trench

On June 19, 2023, Etech resumed remediation activities at the release site. In accordance with the NMOCD-approved Variance Request, the uppermost six (6) feet of the test pit sidewalls were advanced horizontally to the areas characterized by test trenches NH 1, EH 1, SH 1, and WH 1. Excavated soil was stockpiled on-site, pending transfer to an NMOCD-permitted surface waste facility for disposal.

Upon receipt of laboratory analytical results from the confirmation soil samples, the test pit was backfilled with locally sourced, non-impacted material to approximately six (6) feet bgs. A 20-mil, string-reinforced liner was installed on the floor of the excavated area atop impacted soil affected above the NMOCD Closure Criteria. Approximately six (6) inches of pad material was installed both above and below the liner in an effort to maintain its integrity during backfilling activities. The liner was sloped to facilitate shedding of moisture outside both the footprint of the excavated area and the maximum horizontal extent of impacted soil. This engineered control is designed to inhibit the vertical migration of chloride contamination remaining in-situ.

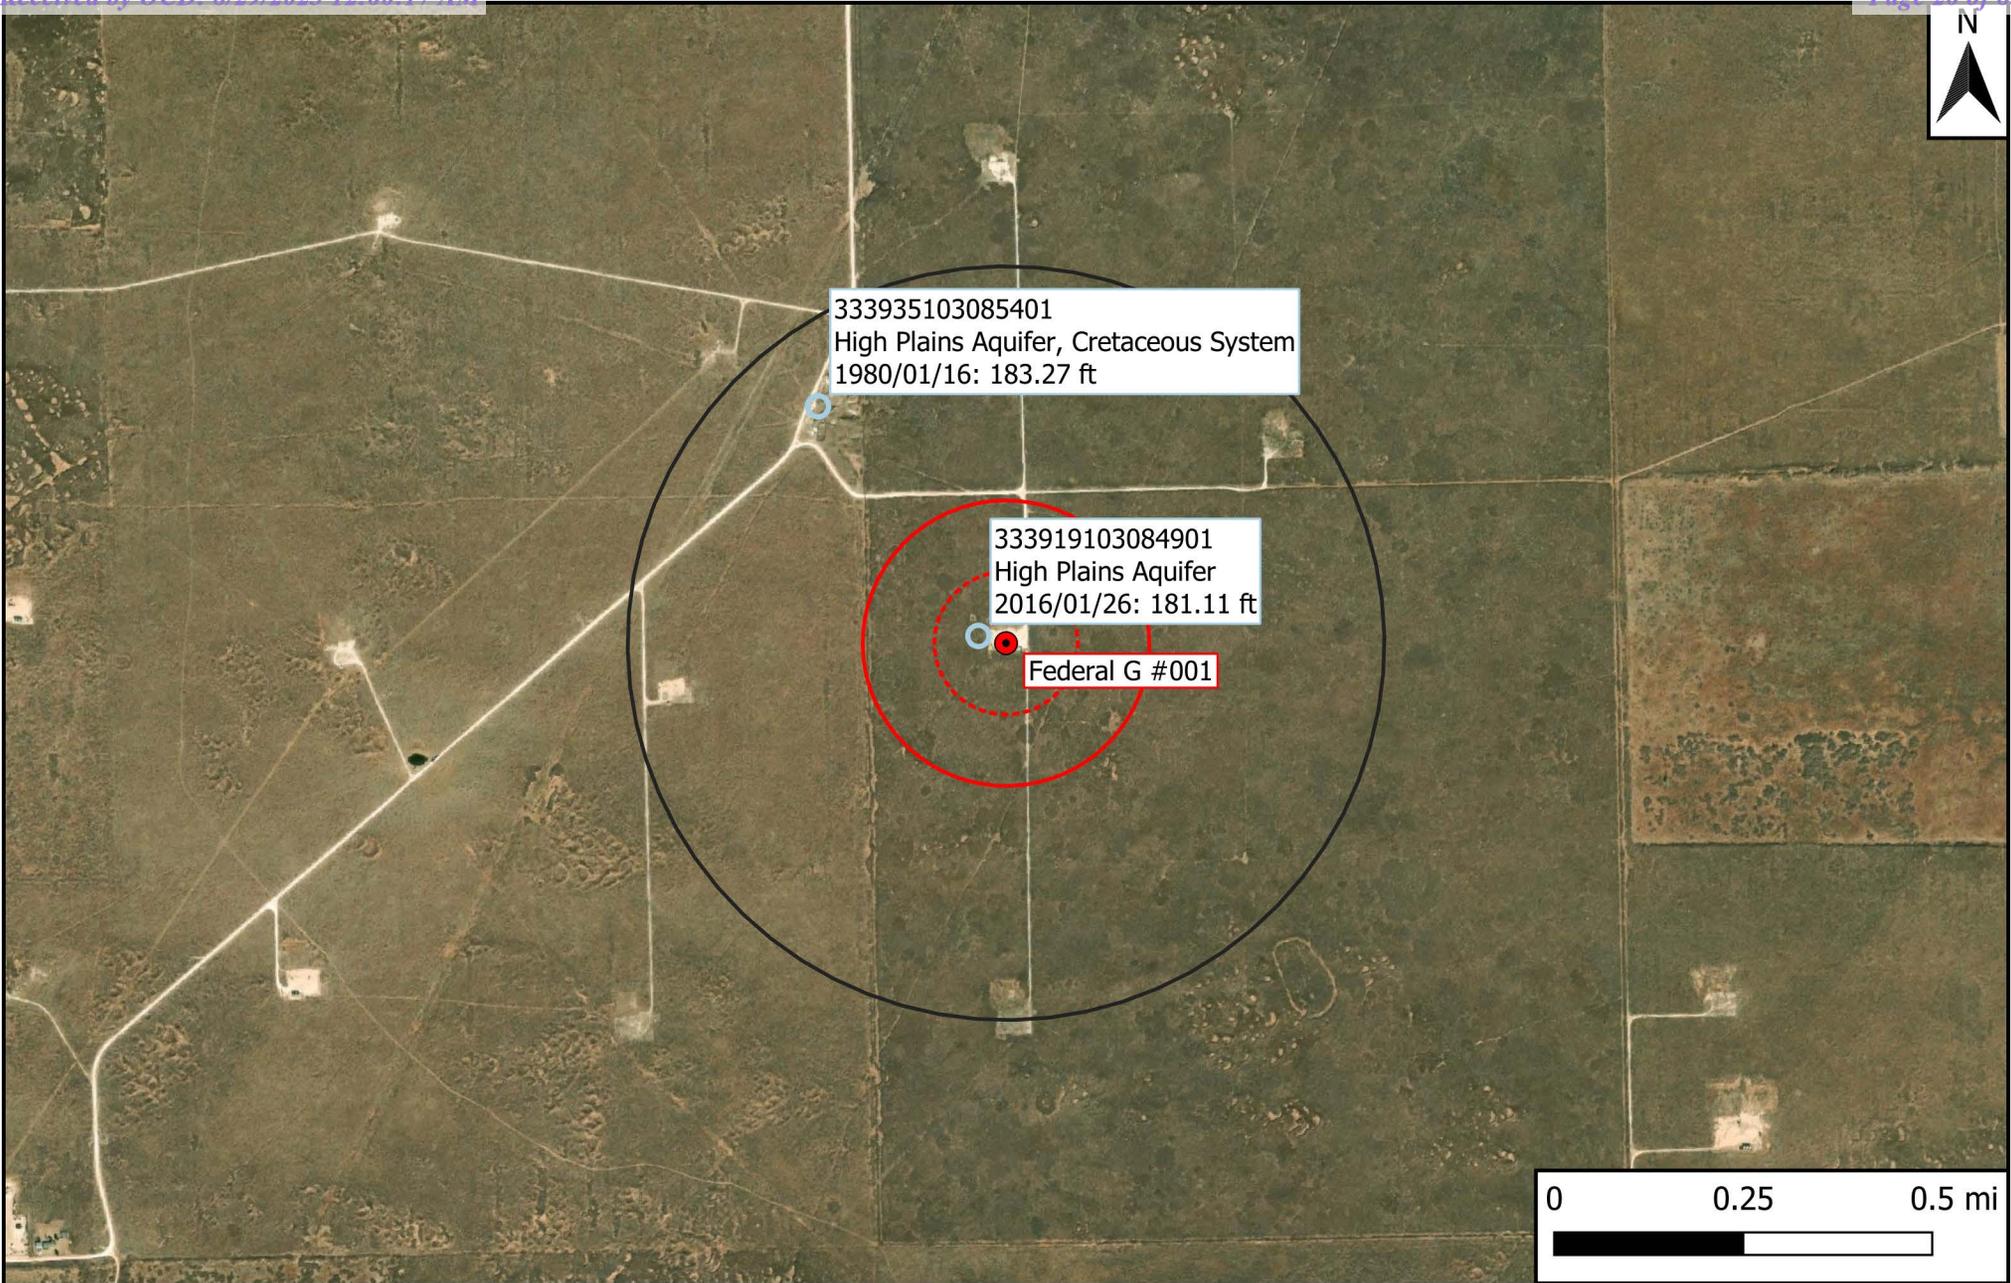
Figure 4
 USGS Well Proximity Map
 H.L. Brown Operating, LLC
 Federal G #001
 GPS: 33.654657, -103.146285
 Roosevelt County

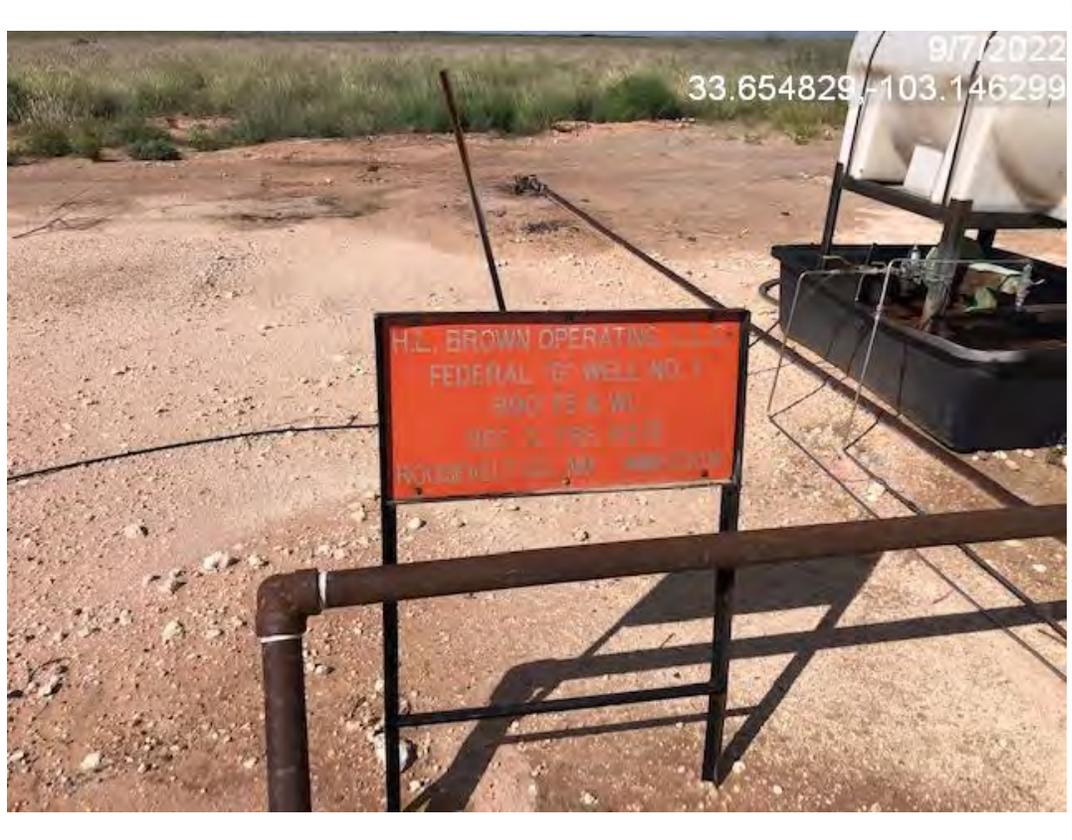
Photo Number: 1

<p>9/7/2022 33.654829,-103.146299</p>
Photo Direction: North-Northeast	
Photo Description: View of the affected area.

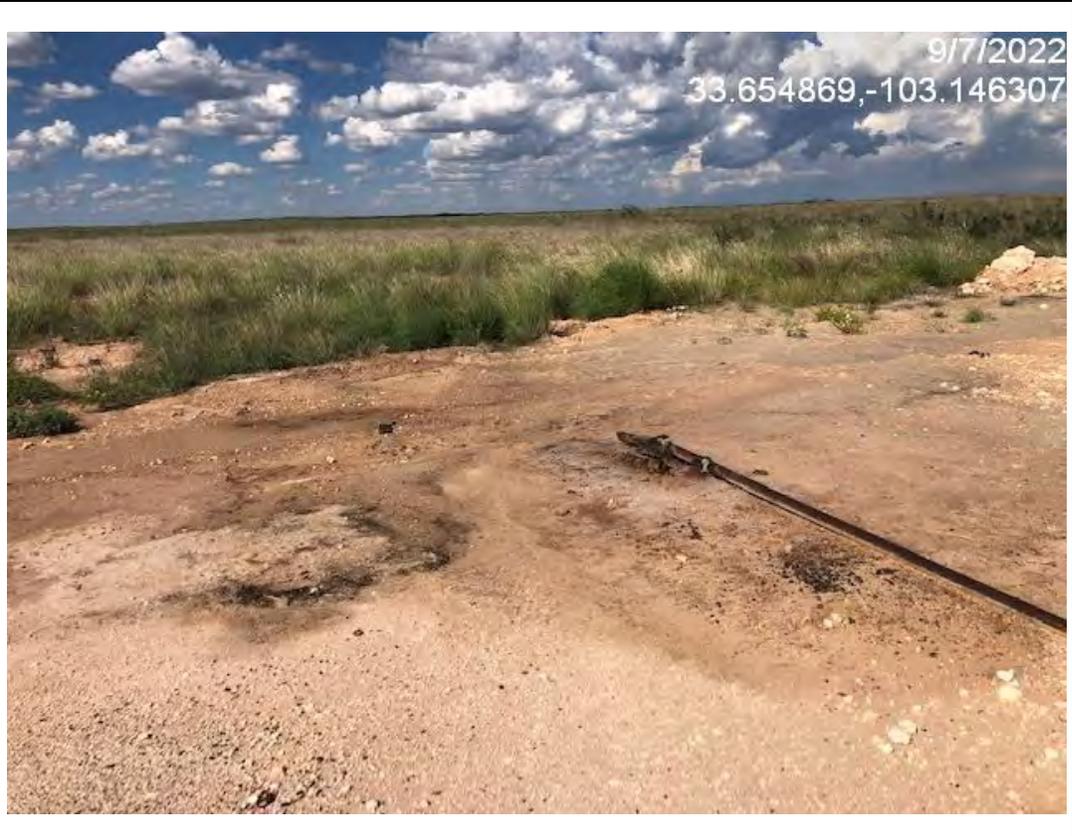
Photo Number: 2

<p>9/7/2022 33.654869,-103.146307</p>
Photo Direction: Northeast	
Photo Description: View of the affected area.

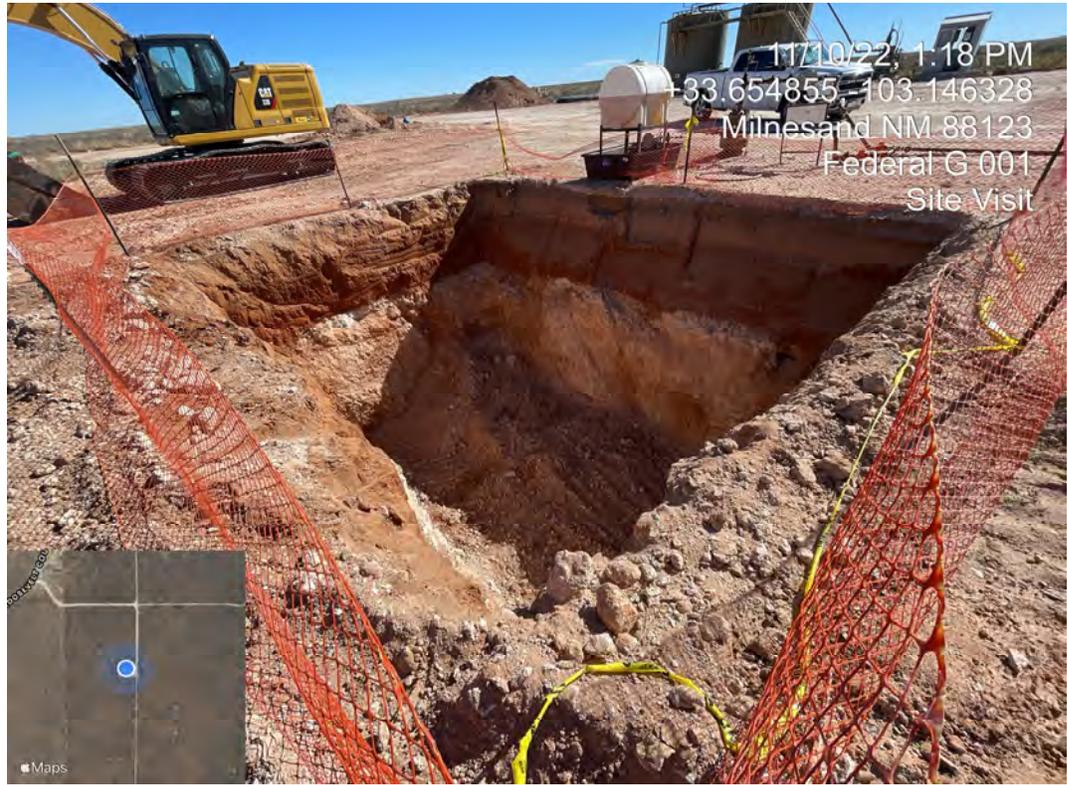
Photo Number: 3

Photo Direction: Southwest	
Photo Description: View of the excavated area & test pit/trench.

On October 26, 2022, remediation activities commenced at the release site. In accordance with NMOCD regulatory guidelines, impacted soil affected above the NMOCD Closure Criteria and/or NMOCD Reclamation Standards was excavated and stockpiled on-site, pending transfer to an NMOCD-permitted surface waste facility for disposal. Olfactory/visual senses and/or a Hach Quantab[®] chloride test kit were utilized to field-screen the extent of impacted soil and to guide the excavation. The sidewalls of the excavation were advanced until field tests and field observations suggested BTEX, TPH, and chloride concentrations were below the applicable NMOCD Closure Criteria and/or NMOCD Reclamation Standards. The excavation was initially advanced vertically to approximately four (4) feet below ground surface (bgs).

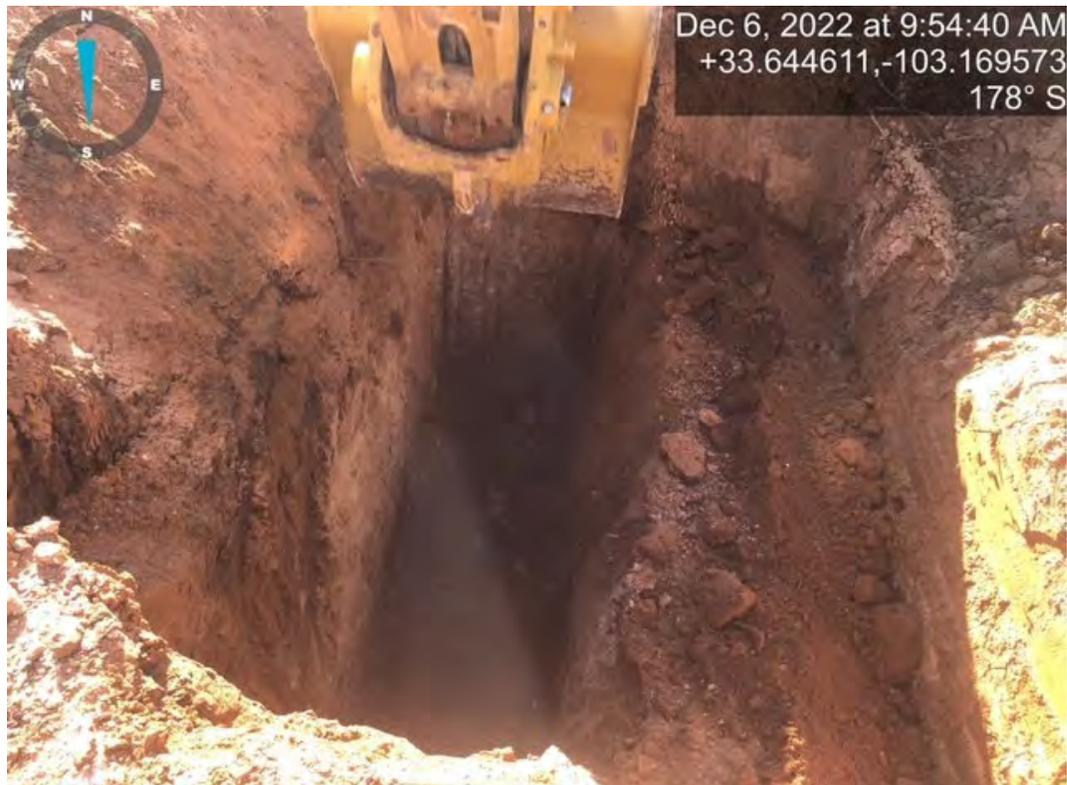
Photo Number: 4

Photo Direction: South	
Photo Description: View of the advancement of test trench T.T. 1.

On November 8, 2022, Etech advanced a test trench (T.T. 1) in the floor of the excavated area in an effort to determine the vertical extent of impacted soil. During the advancement of the test trench, soil samples were collected and field-screened for concentrations of chloride utilizing a chloride test kit and/or the presence of Volatile Organic Compounds (VOCs) utilizing olfactory/visual senses. Based on field observations and field test data, five (5) delineation soil samples (T.T. 1 @ 4', T.T. 1 @ 6', T.T. 1 @ 8', T.T. 1 @ 10', and T.T. 1 @ 12') were submitted to a certified, commercial laboratory (henceforth, "the laboratory") for analysis of BTEX, TPH, and chloride. Laboratory analytical results indicated BTEX and TPH concentrations were below the applicable NMOCD Closure Criteria, NMOCD Reclamation Standards, and laboratory method detection limit (MDL) in each of the submitted soil samples. Chloride concentrations exceeded the NMOCD Closure Criterion in each of the submitted soil samples and ranged from 2,800 mg/kg in soil sample T.T. 1 @ 6' to 11,900 mg/kg in soil sample T.T. 1 @ 10'.

On November 28, 2022, test trench T.T. 1 was re-entered and advanced to a total depth of 32 feet bgs in an effort to further investigate the vertical extent of impacted soil. To prevent sloughing and collapse of the open hole, the sidewalls of the trench were advanced horizontally in each cardinal direction, creating a "test pit" measuring approximately 25 feet in length, 25 feet in width, and 18 feet in depth. During the advancement of the test pit/trench, soil samples were collected and field-screened for concentrations of chloride utilizing a chloride test kit and/or the presence of VOCs utilizing olfactory/visual senses. Based on field observations and field test data, four (4) delineation soil samples (T.T. 1 @ 20', T.T. 1 @ 24', T.T. 1 @ 28', and T.T. 1 @ 32') were submitted to the laboratory for analysis of chloride. Laboratory analytical results indicated chloride concentrations exceeded the NMOCD Closure Criterion in each of the submitted soil samples and ranged from 4,040 mg/kg in soil sample T.T. 1 @ 32' to 9,330 mg/kg in soil sample T.T. 1 @ 24'.

On November 30, 2022, test pit/trench T.T. 1 was re-entered and advanced to a total depth of 40 feet bgs in an effort to further investigate the vertical extent of impacted soil. During the advancement of the test pit, soil samples were collected and field-screened for concentrations of chloride utilizing a chloride test kit and/or the presence of VOCs utilizing olfactory/visual senses. Based on field observations and field test data, one (1) delineation soil sample (T.T. 1 @ 40') was submitted to the laboratory for analysis of chloride. Laboratory analytical results indicated the chloride concentration was 48.0 mg/kg and below the NMOCD Closure Criterion. Based on these laboratory analytical results, the vertical extent of impacted soil was adequately defined.

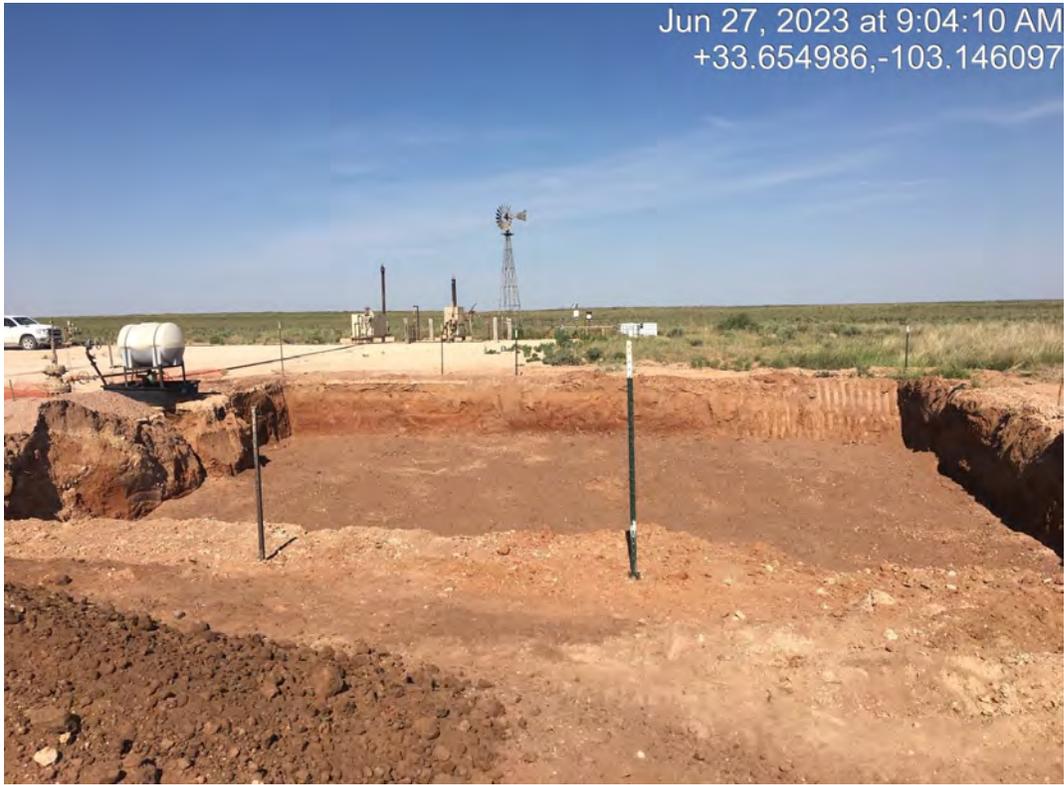
Photo Number: 5

<p>Jun 27, 2023 at 9:04:10 AM +33.654986,-103.146097</p>
Photo Direction: West	
Photo Description: View of the excavated area.

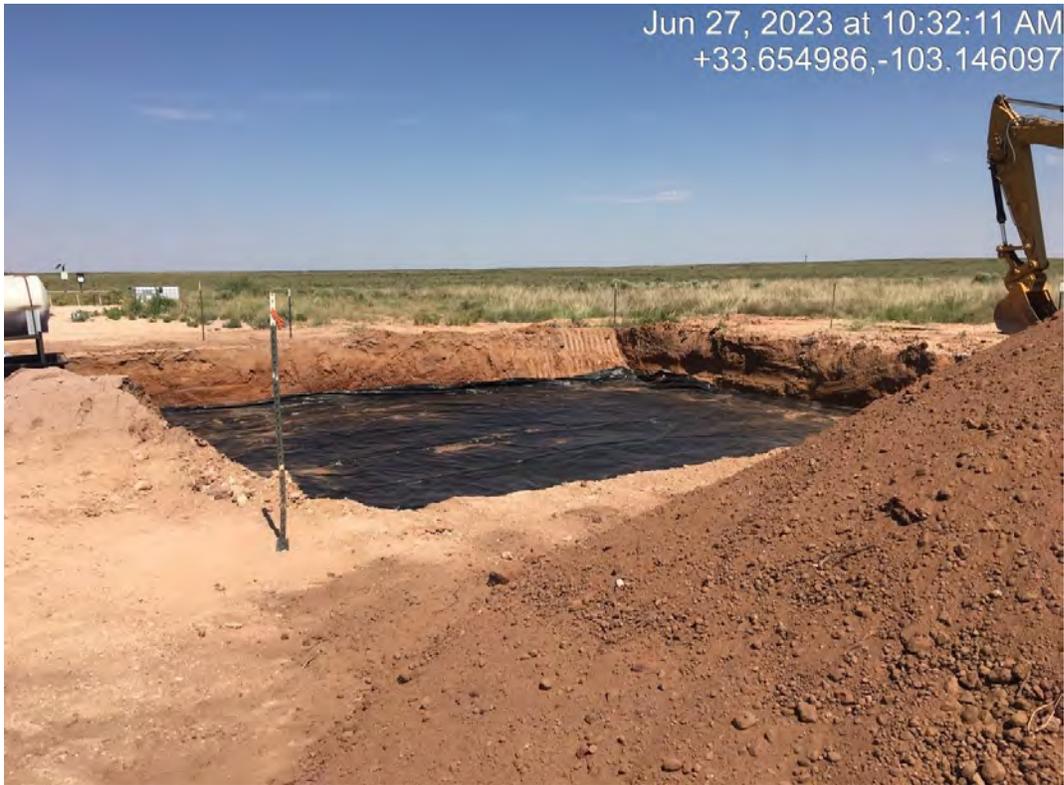
Photo Number: 6

<p>Jun 27, 2023 at 10:32:11 AM +33.654986,-103.146097</p>
Photo Direction: Northwest	
Photo Description: View of the installed liner.

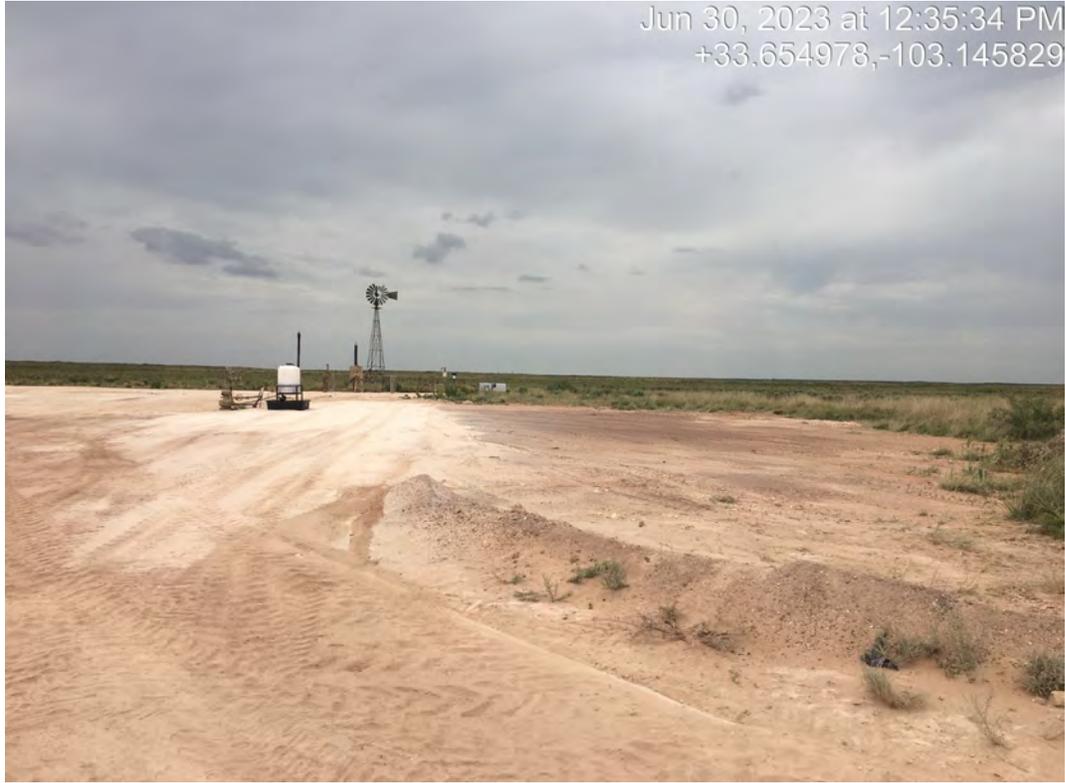
Photo Number: 7

<p data-bbox="1045 214 1474 289">Jun 30, 2023 at 12:35:34 PM +33.654978,-103.145829</p>
Photo Direction: West	
Photo Description: View of the remediated area after backfill and regrading.
