Release Notification

Site Name: Hallertau 4 Federal 8H	Site Type: Battery
Date Release Discovered: 8/20/2023	API# (if applicable)

Liner Integrity Certification

CIMAREX ENERGY
HALLERTAU 4 FEDERAL 8H CTB
LEA, NM

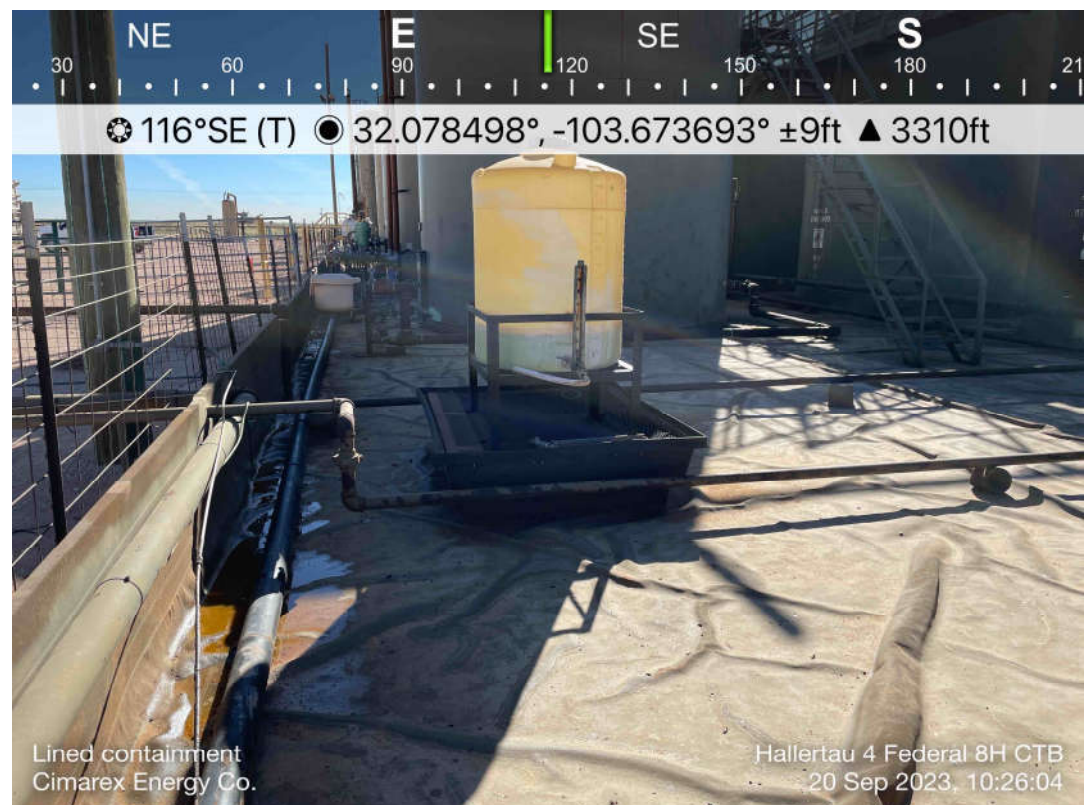
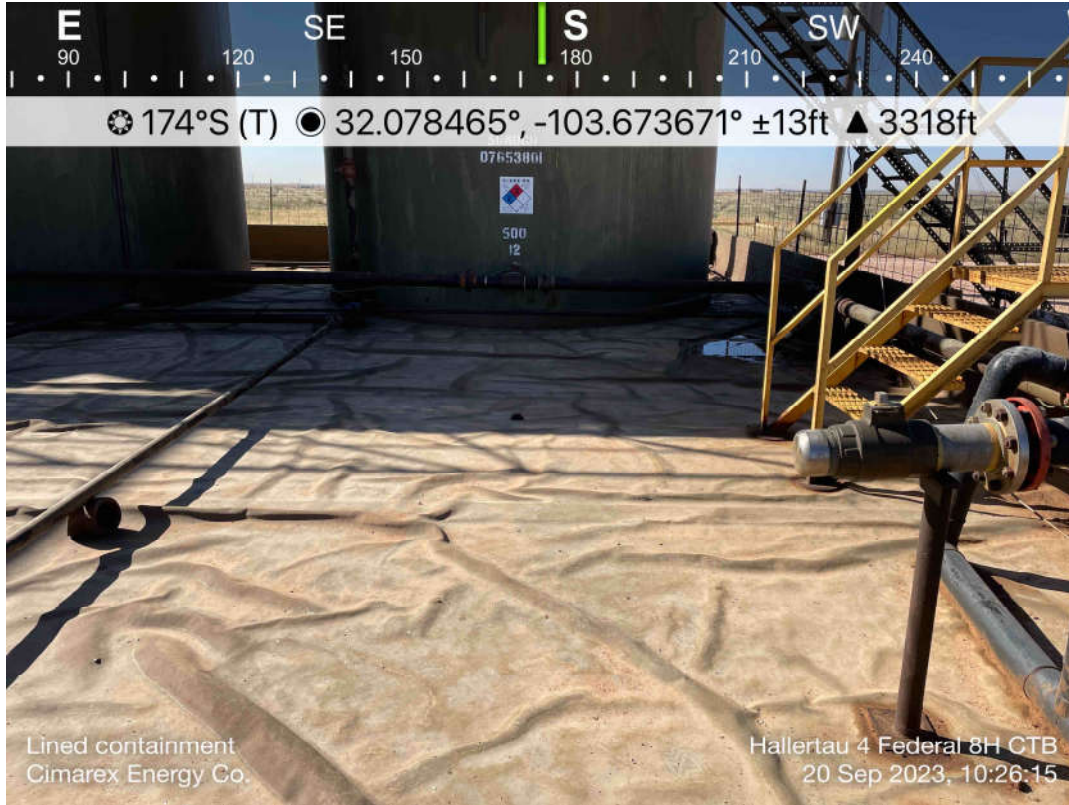
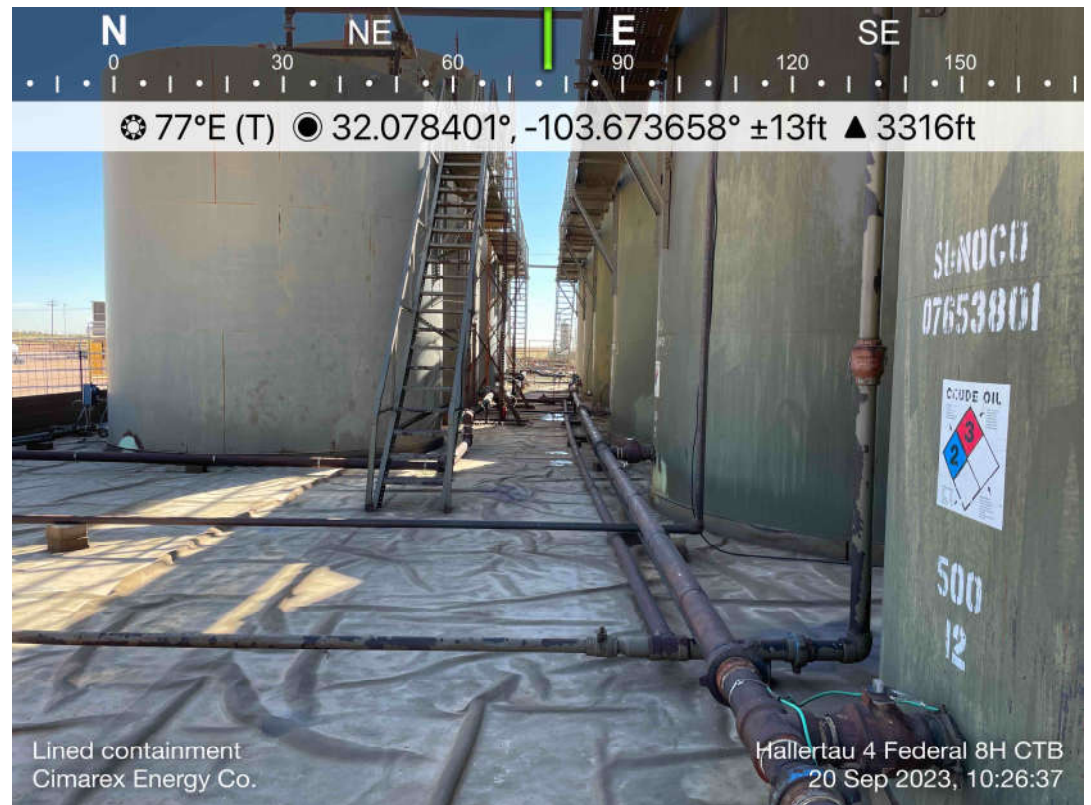
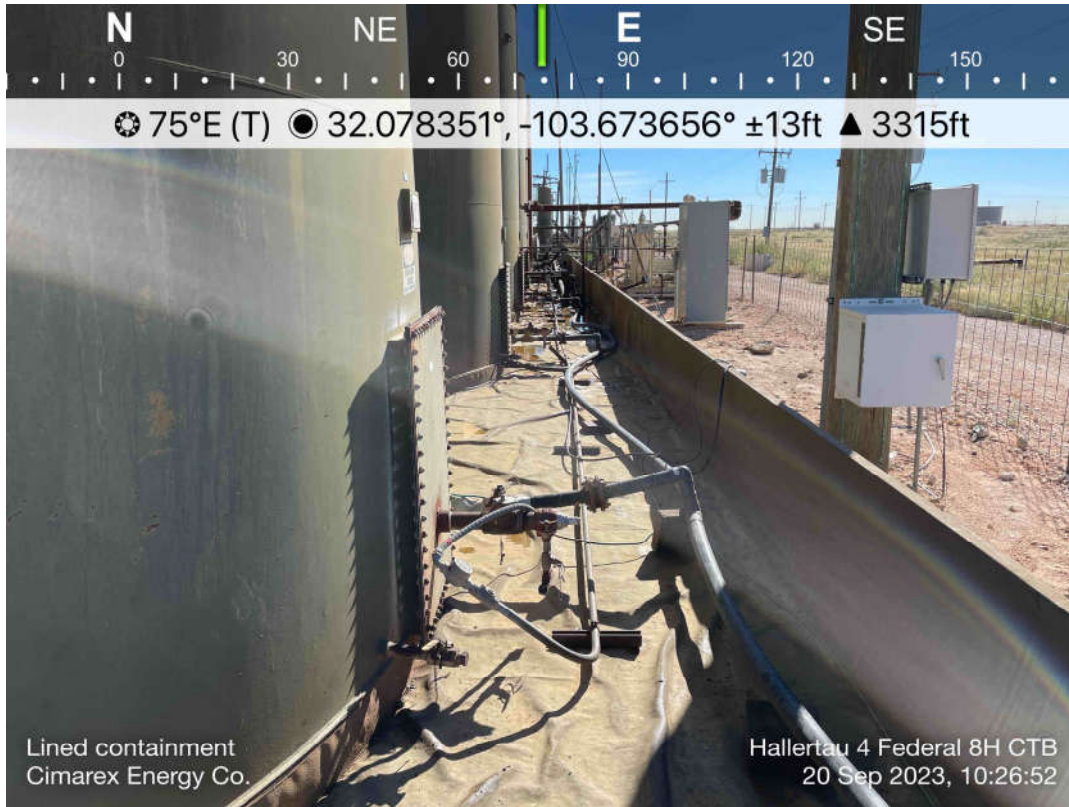
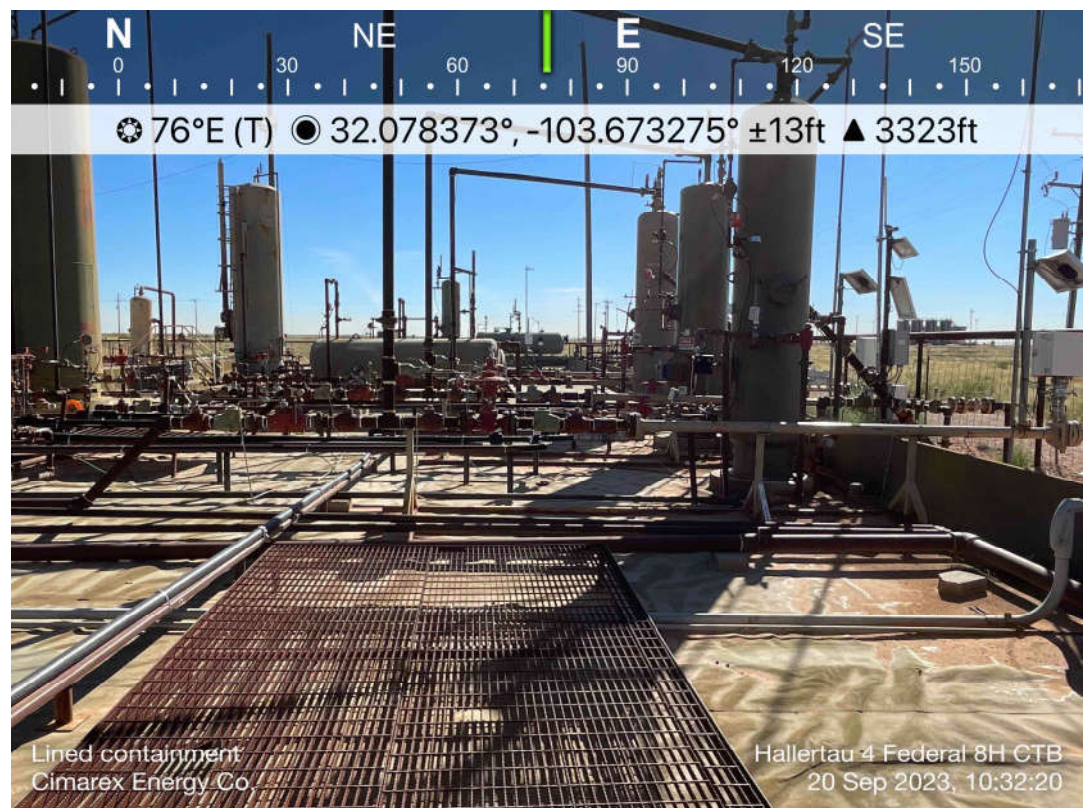
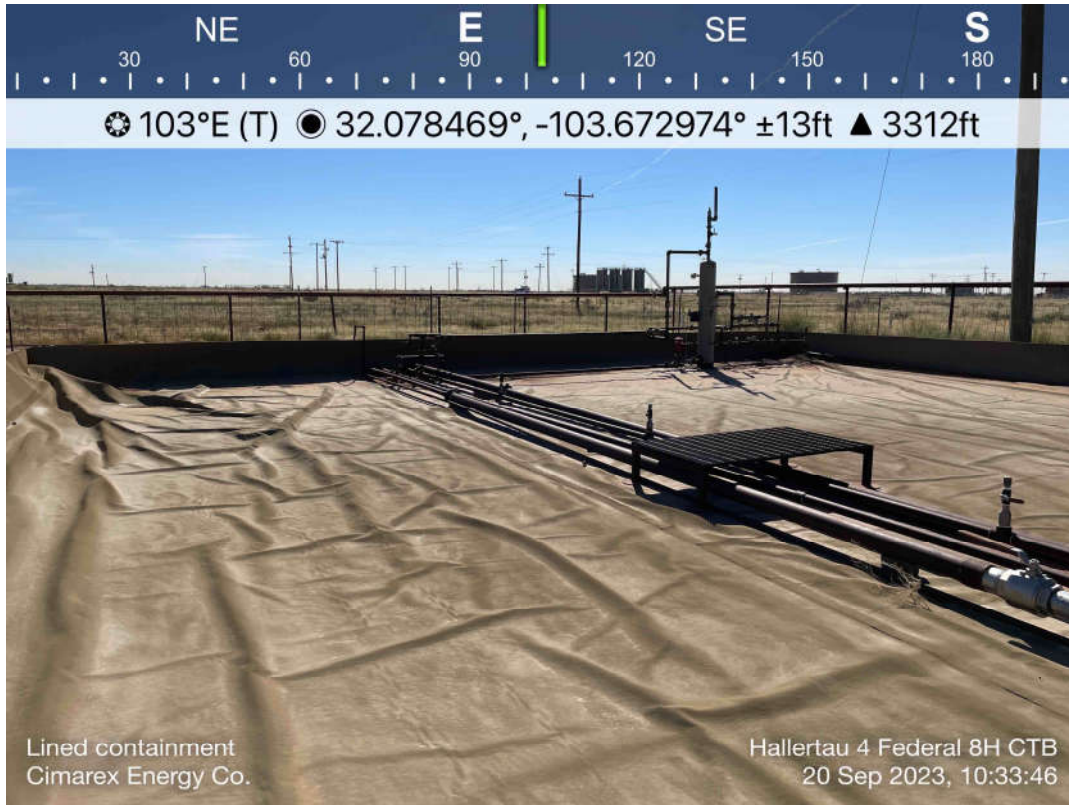
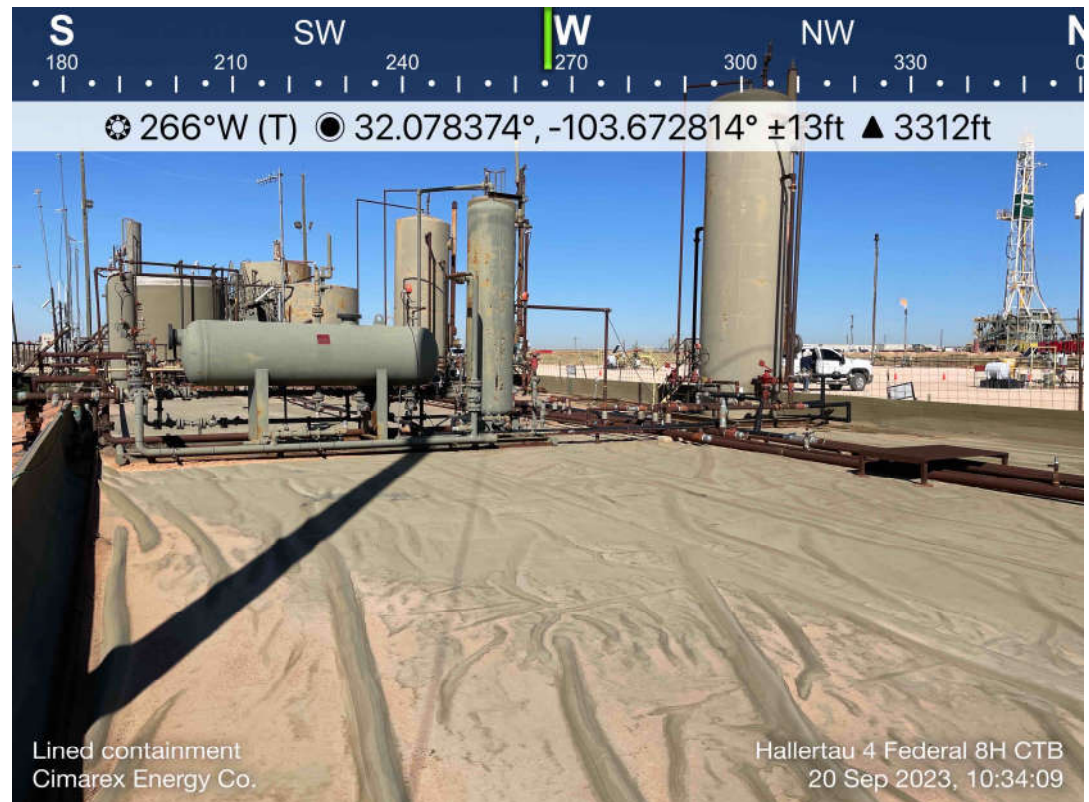
The following serves to verify that the affected liner has been inspected and found to be in serviceable condition in accordance with 19.15.29.11 A.(5)(a)(i-ii) of the New Mexico Administrative Code.

- ☒ Responsible Party has visually inspected the liner.
- ☒ Liner remains intact and was able to contain the leak in question.
- ☒ At least two business days' notice was given to the appropriate division district office before conducting the liner inspection.
- ☒ Photographs illustrating liner integrity are included.
