**RE: Closure Report
ConocoPhillips
ConocoPhillips (Heritage COG Operating LLC)
Cuatro Hijos Fee #004H Flowline Release
Unit Letter A, Section 02, Township 19 South, Range 34 East
Lea County, New Mexico
Incident ID: nAPP2312933596**

Closure Report
September 18, 2023

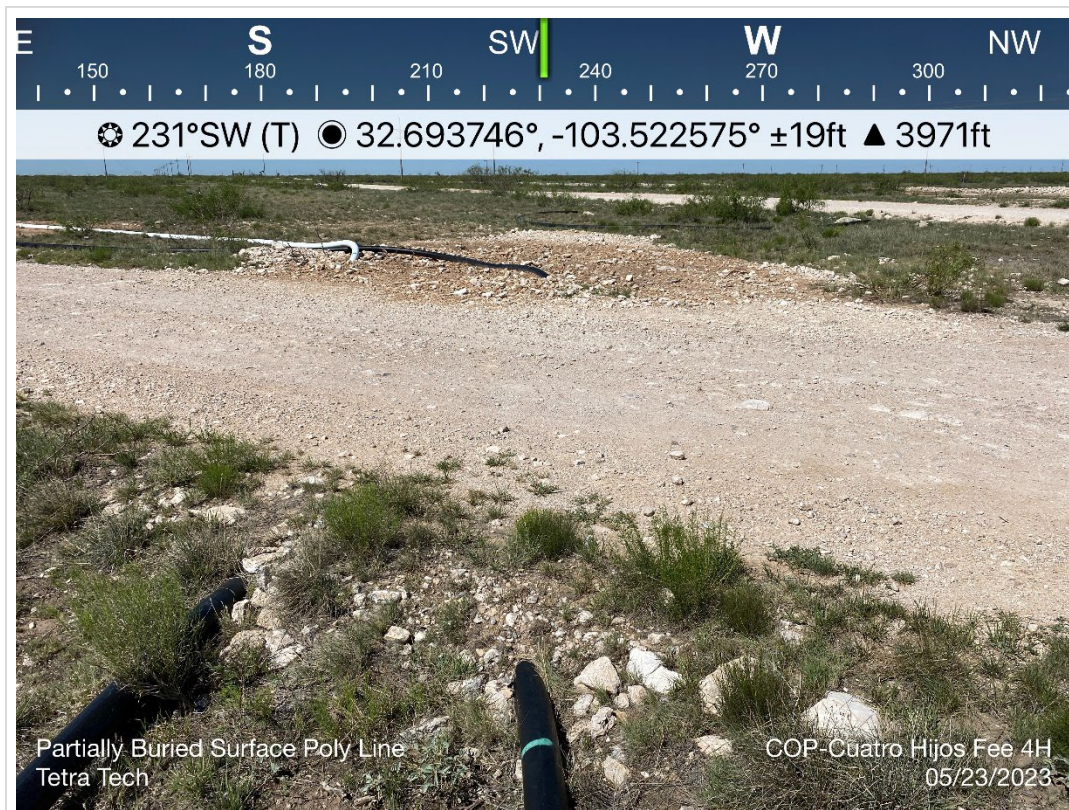
TETRA TECH, INC. PROJECT NO. 212C-MD-03154	DESCRIPTION	View southwest. View of release area from across lease road.	1
	SITE NAME	Cuatro Hijos Fee 4H PW Flowline Release	5/23/2023

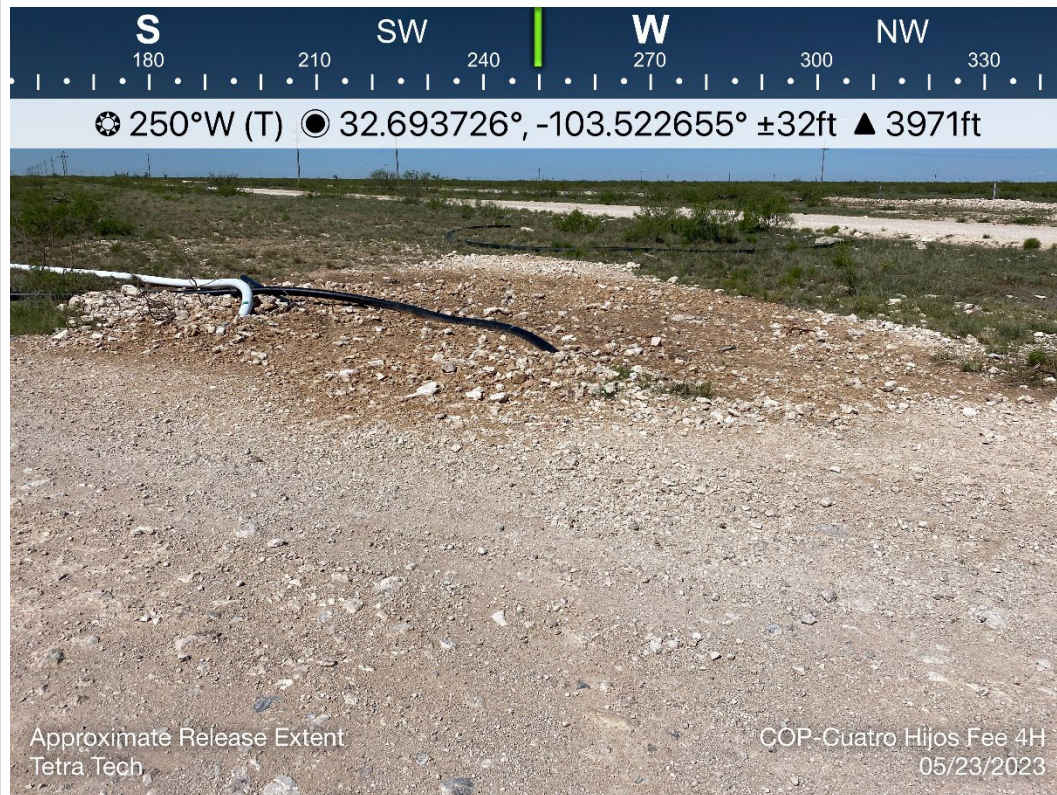
TETRA TECH, INC. PROJECT NO. 212C-MD-03154	DESCRIPTION	View southwest west. View of release area. Subsurface/surface poly lines present.	2
	SITE NAME	Cuatro Hijos Fee 4H PW Flowline Release	5/23/2023

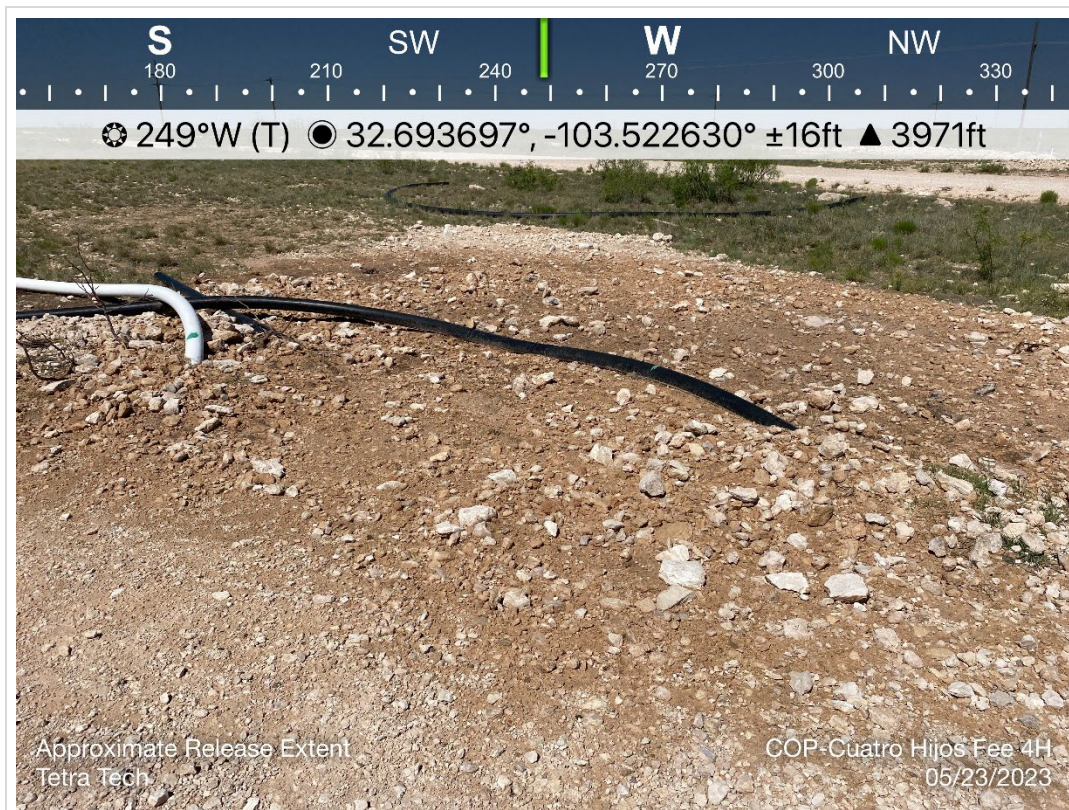
TETRA TECH, INC. PROJECT NO. 212C-MD-03154	DESCRIPTION	View southwest. View of release area. Subsurface/surface poly lines present.	3
	SITE NAME	Cuatro Hijos Fee 4H PW Flowline Release	5/23/2023

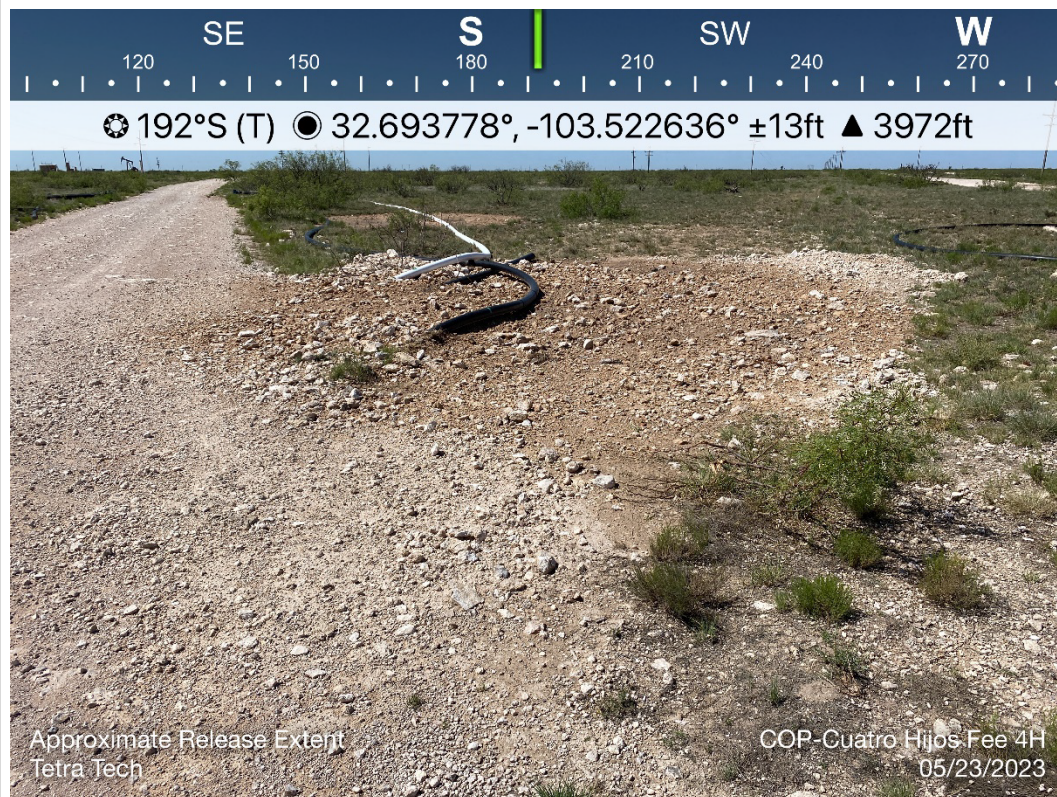
TETRA TECH, INC. PROJECT NO. 212C-MD-03154	DESCRIPTION	View south. View of release area. Subsurface/surface poly lines present.	4
	SITE NAME	Cuatro Hijos Fee 4H PW Flowline Release	5/23/2023

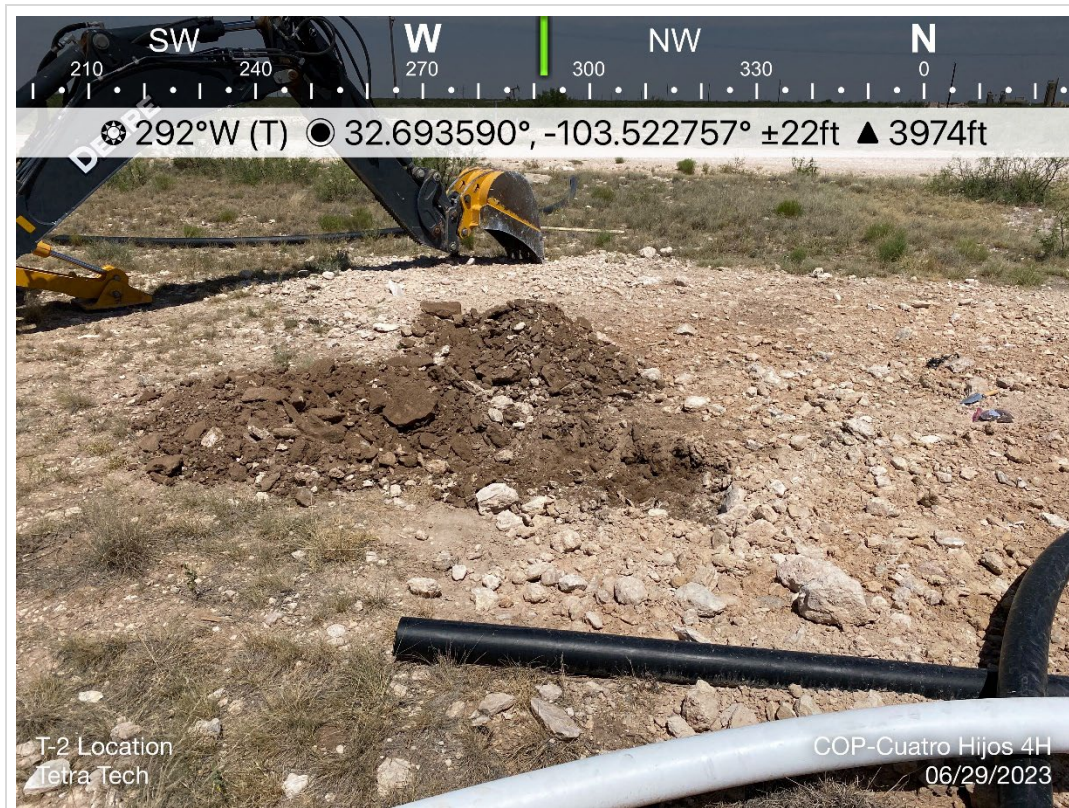
TETRA TECH, INC. PROJECT NO. 212C-MD-03154	DESCRIPTION	View west. View of release area and assessment activities. Surface polylines present.	5
	SITE NAME	Cuatro Hijos Fee 4H PW Flowline Release	6/29/2023

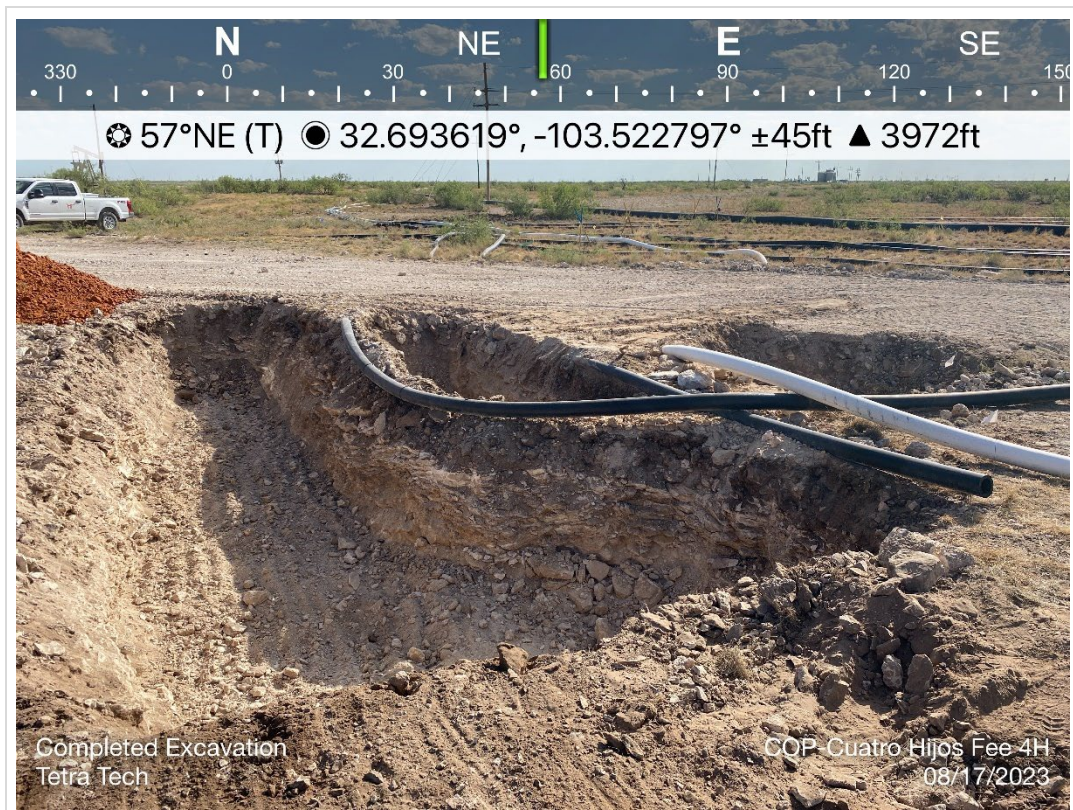
TETRA TECH, INC. PROJECT NO. 212C-MD-03154	DESCRIPTION	View east north-east. View of completed excavation. Surface polylines present.	7
	SITE NAME	Cuatro Hijos Fee 4H PW Flowline Release	8/17/2023

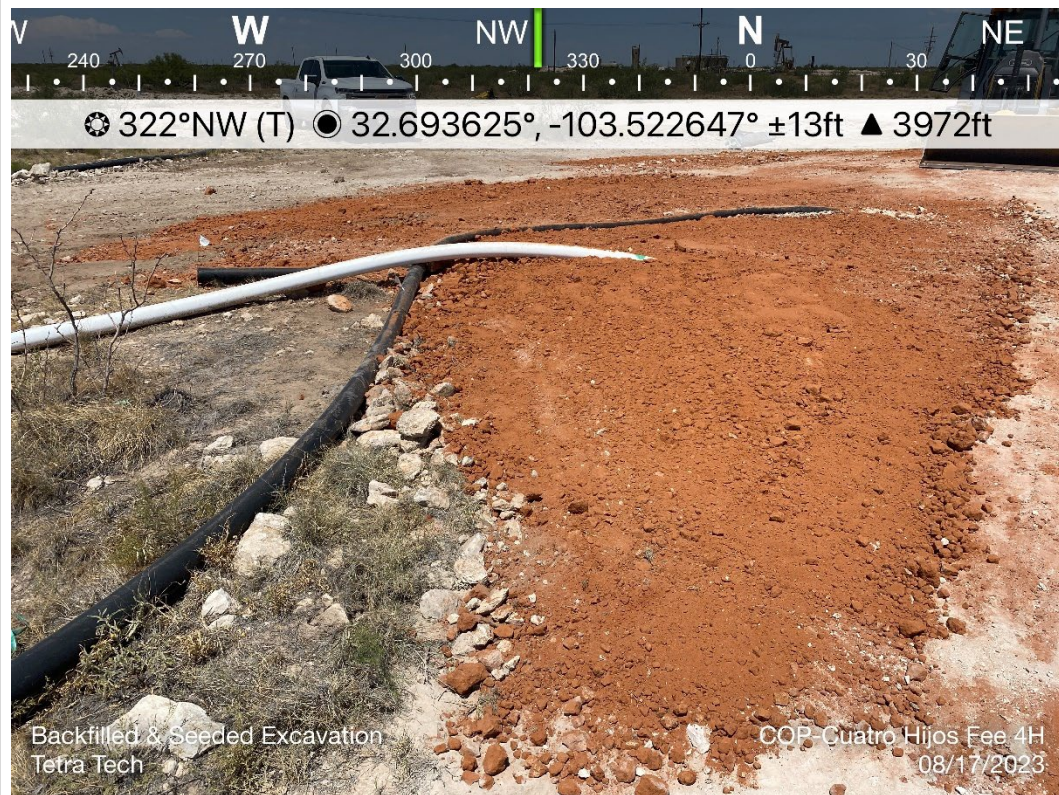
TETRA TECH, INC. PROJECT NO. 212C-MD-03154	DESCRIPTION	View north-northwest. View of backfilled and seeded excavation. Surface polylines present.	10
	SITE NAME	Cuatro Hijos Fee 4H PW Flowline Release	8/17/2023
