Re: Site Assessment, Remediation, and Deferral Request
Skelly #942 Battery
API No. 30-015-34645
GPS: Latitude 32.8240166 Longitude -103.8560791
UL "B", Sec. 22, T17S, R31E
Eddy County, NM
NMOCD Ref. No. NRM2003849084

Paragon Environmental, LLC (Paragon) has been contracted by Spur Energy Partners (Spur) to perform a spill assessment and conduct remediation activities for the release site known as the Skelly #942 Battery (Skelly). Details of the release are summarized below:

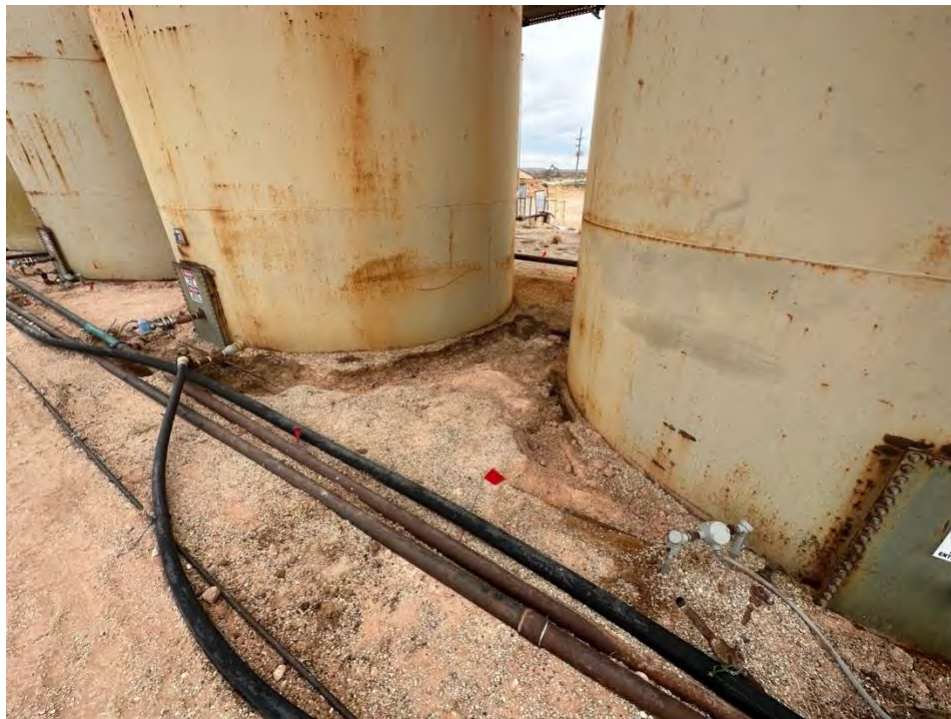
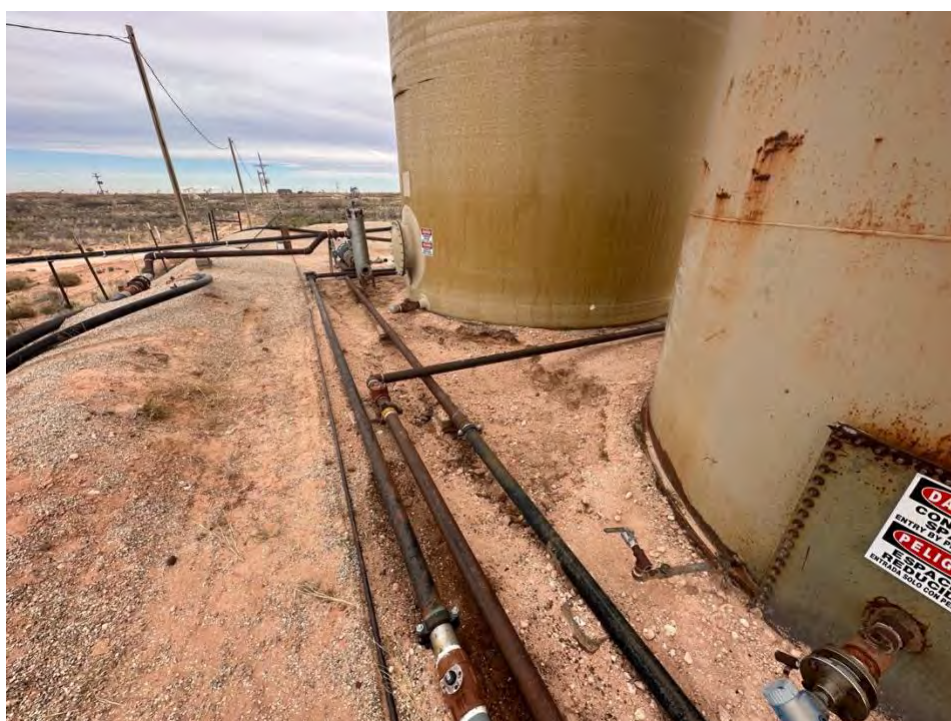
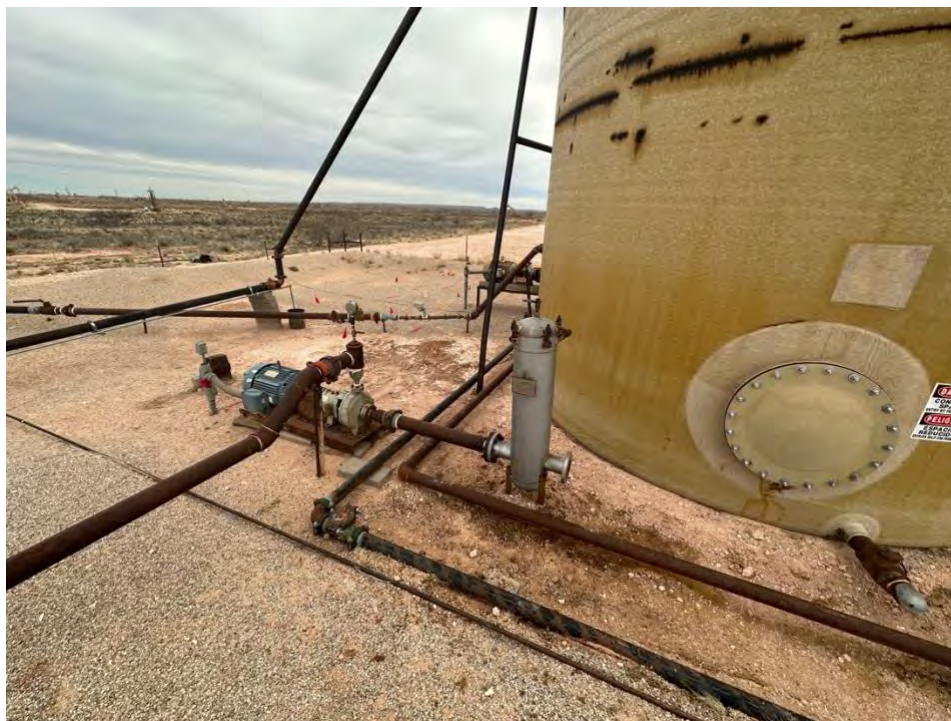
**Photographic Documentation
During**

We excavated the stained soil from inside the containment utilizing a crew and hand tools. The depth of excavation ranged from 6-8 inches BGS. The spill was right against the tanks, and because of safety issues and risks of damaging any infrastructure, it was decided not to excavate any deeper than this and request a deferral.

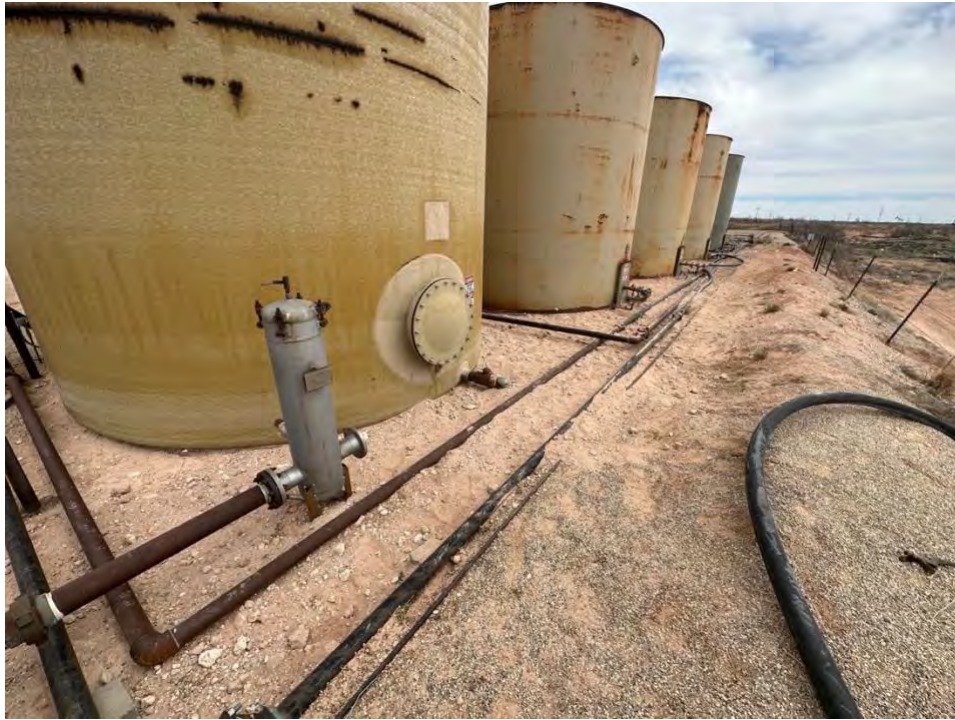
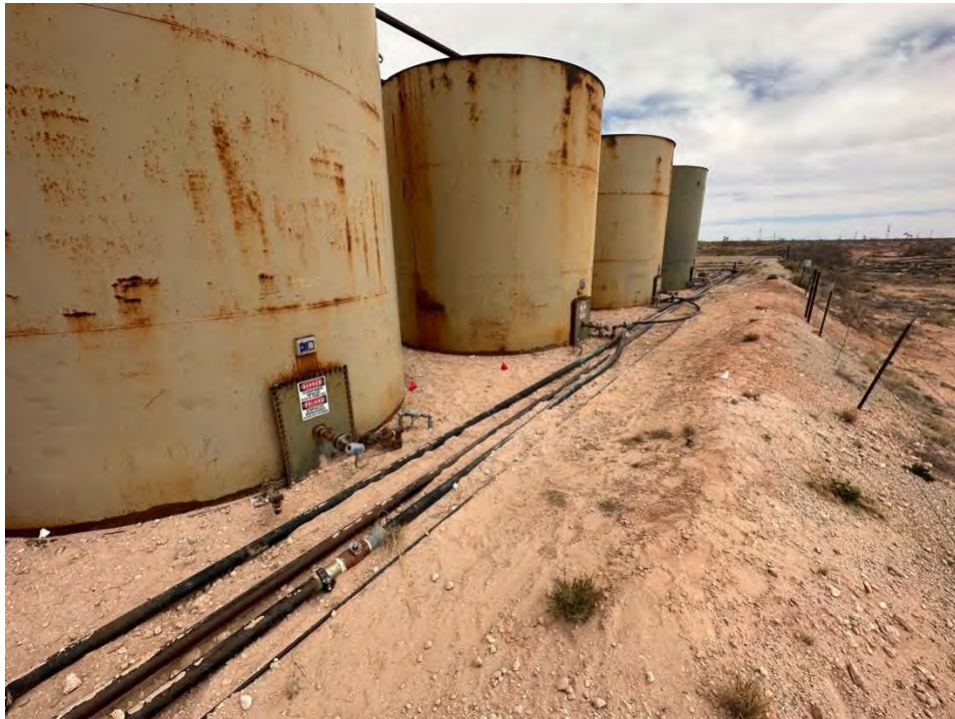
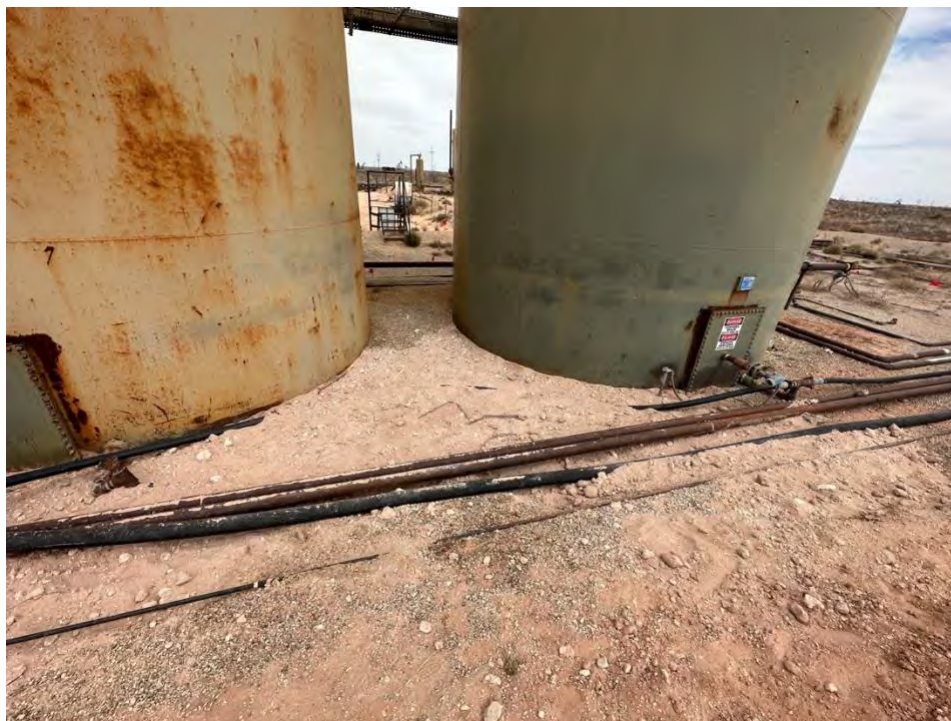
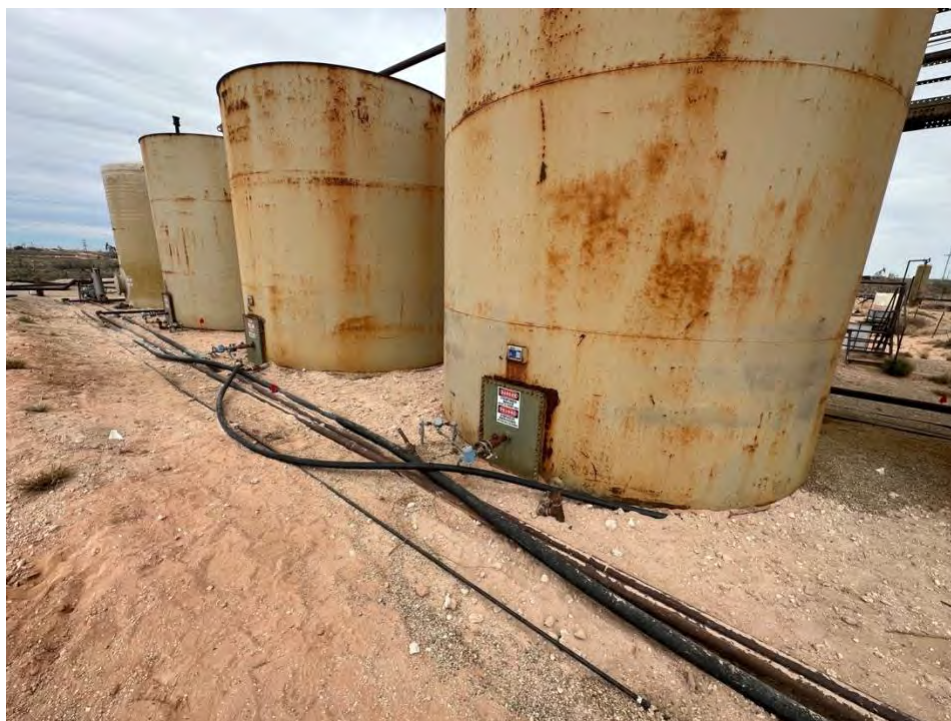
Completed

These laboratory analytical results completed the delineation of this incident in accordance with deferral instructions for NMOCD Closure Criteria. The excavated soils were loaded into trucks and transported to Lea Land, an NMOCD-approved waste disposal facility. The excavated areas were backfilled with "like" material obtained from Lea Land. The affected area was then contoured and hand tool compacted to match the surrounding grade.
