Release Notification

## CLOSURE REPORT

**J.E. Decker #2 (07/20/23)**  
Unit Letter K, S12 T32N R12W  
San Juan County, New Mexico

**New Mexico EMNRD OCD Incident ID No. NAPP2320228954**

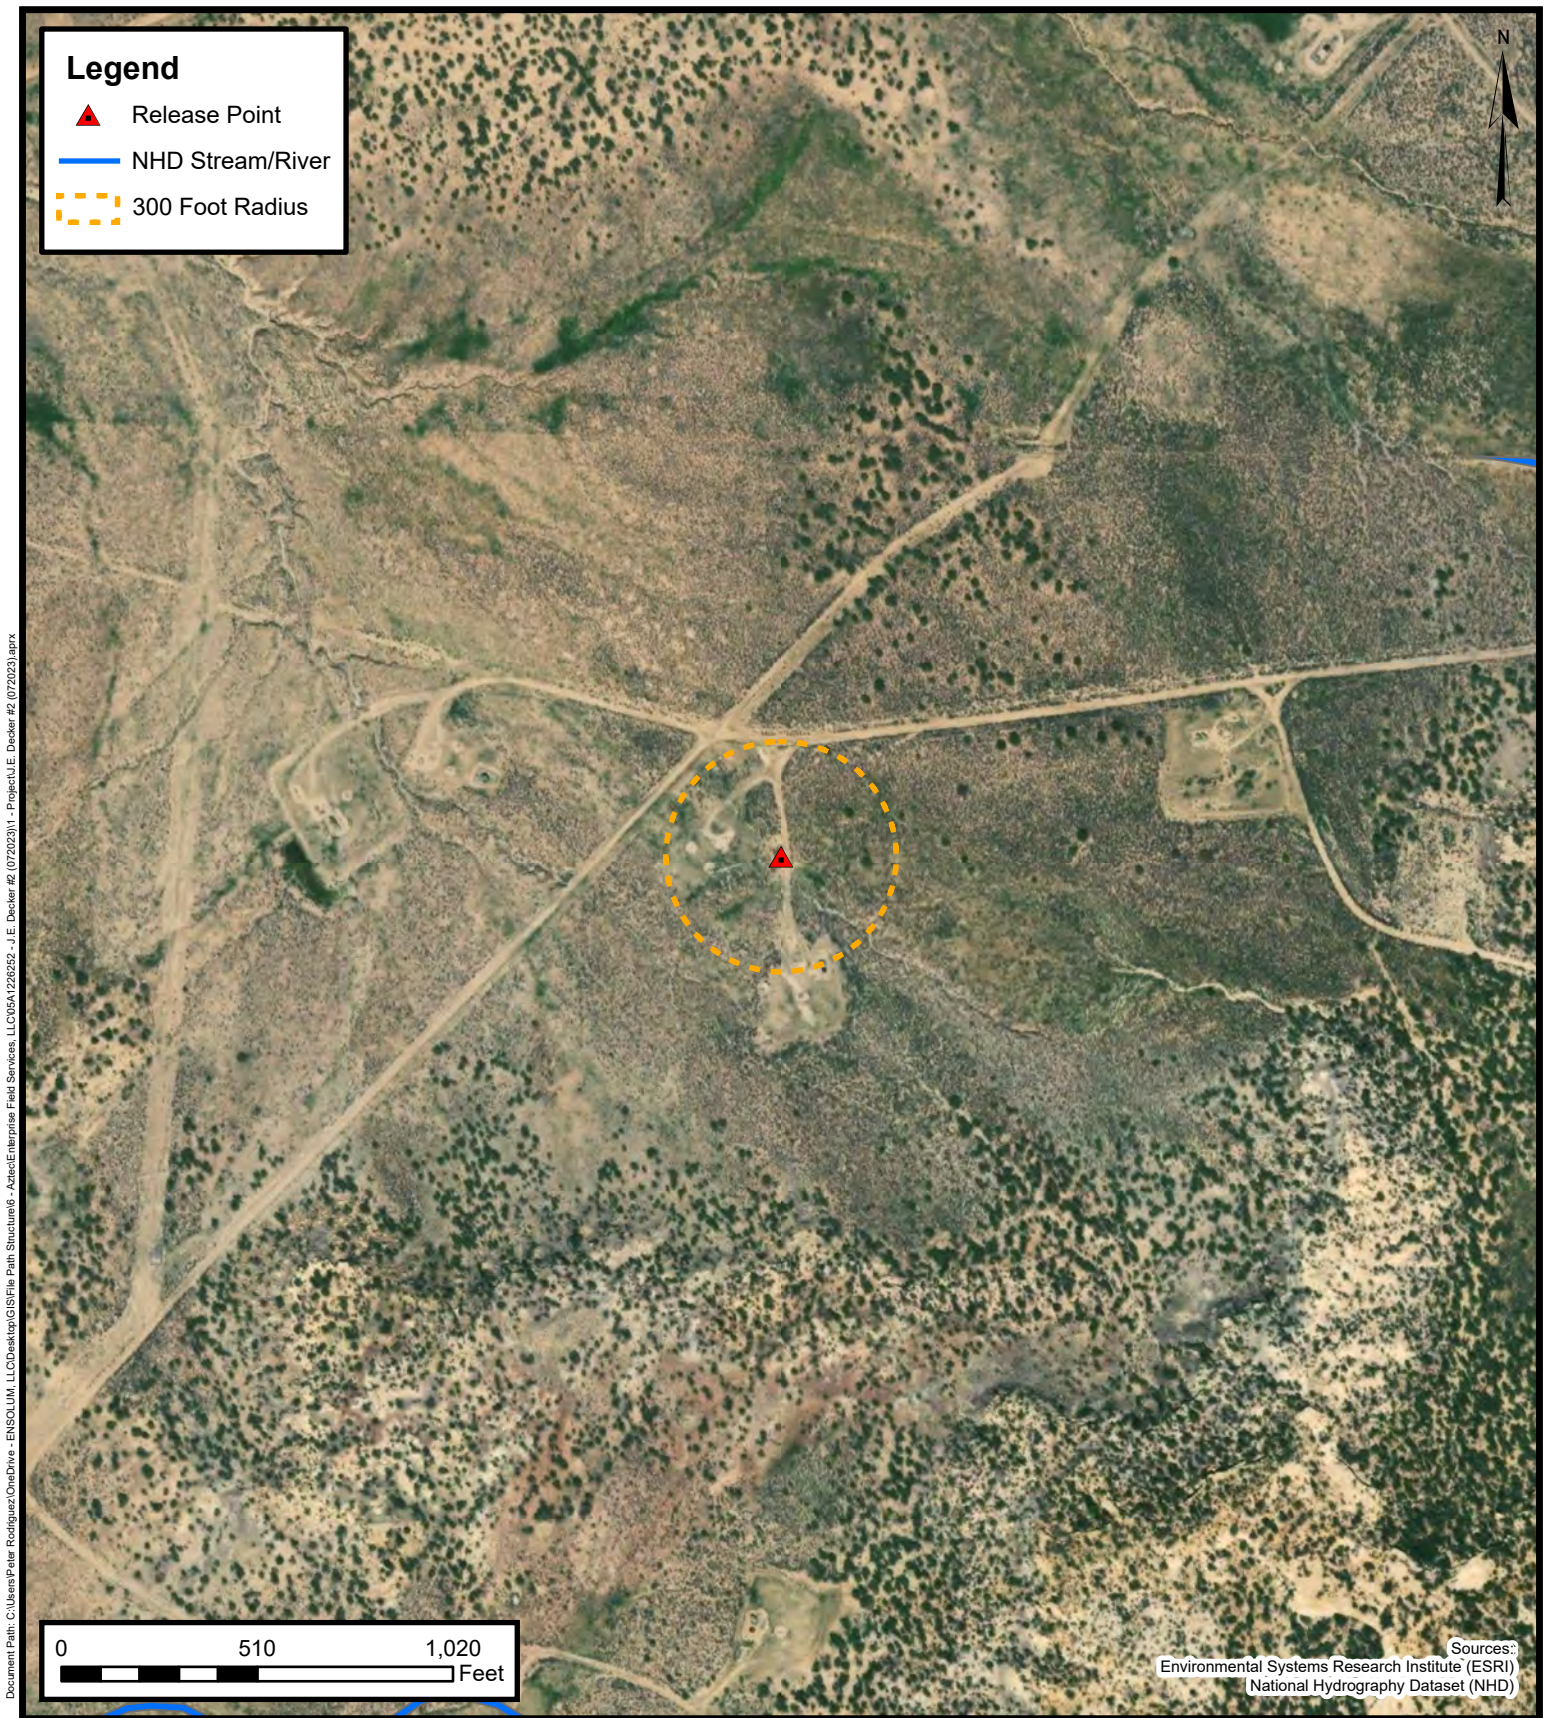
C

### 300 Foot Radius Watercourse and Drainage Identification

- The Site is located within 300 feet of a NM EMNRD OCD-defined continuously flowing watercourse or significant watercourse (**Figure C, Appendix B**). A stock pond is located within 300 feet of the Site, and the NM EMNRD OCD has previously indicated that was equivalent to a significant watercourse.

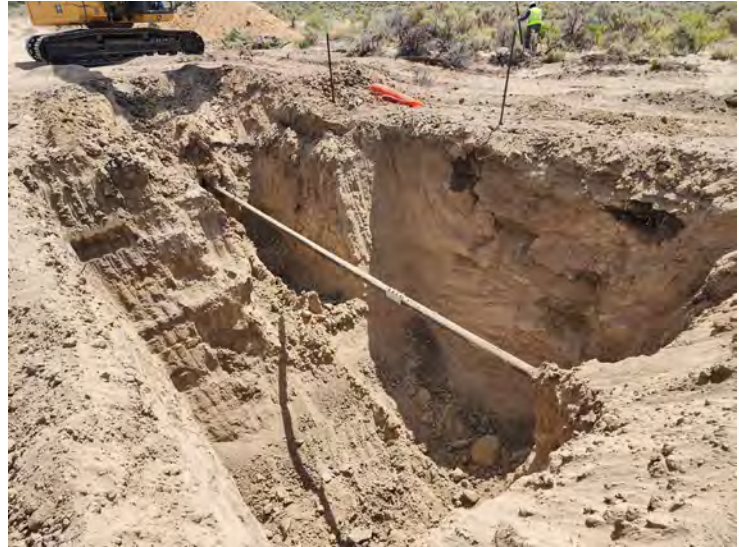
**Photograph 1**

Photograph Description: View of the in-process excavation activities.

The final excavation measured approximately 22.5 feet long and 13 feet wide at the maximum extents. The maximum depth of the excavation measured approximately 15 feet bgs. The lithology encountered during the completion of remediation activities consisted primarily of sandy silt.

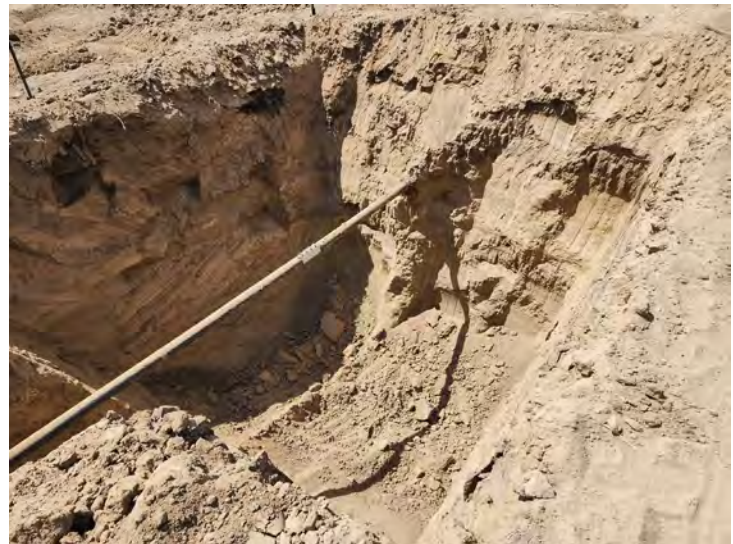
**Photograph 2**

Photograph Description: View of the excavation.

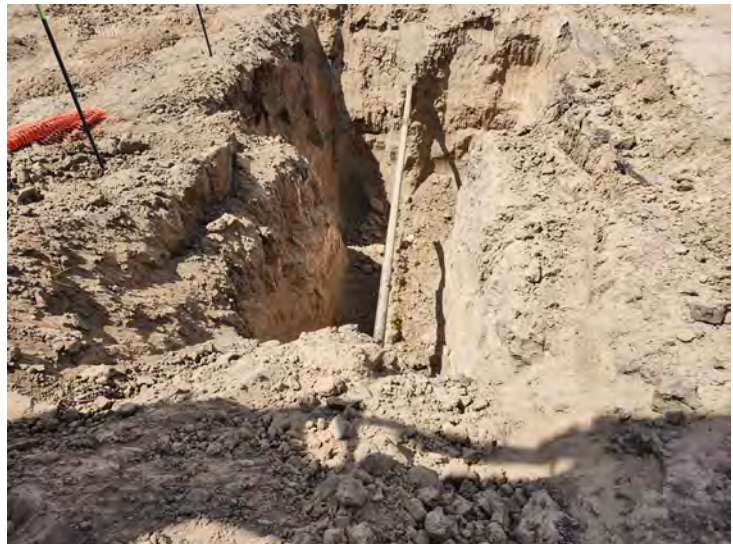
**Photograph 3**

Photograph Description: View of the excavation.

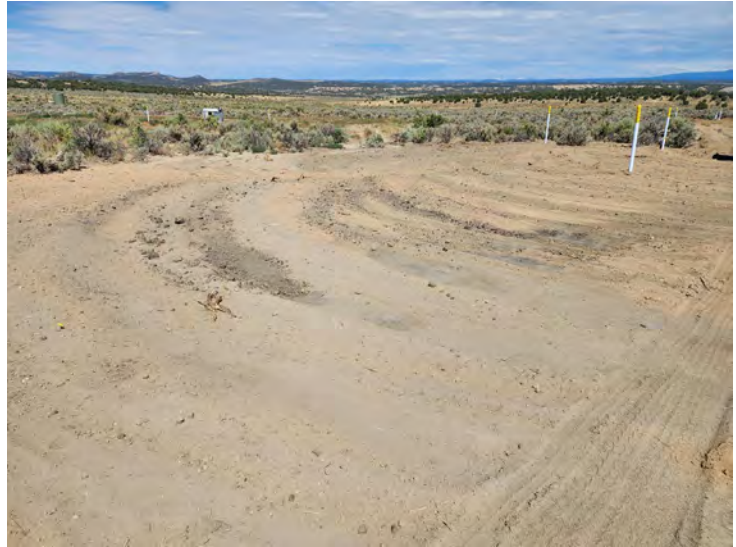
**Photograph 4**

Photograph Description: View of the site after initial restoration.

The excavation was backfilled with imported fill and then contoured to the surrounding topography.

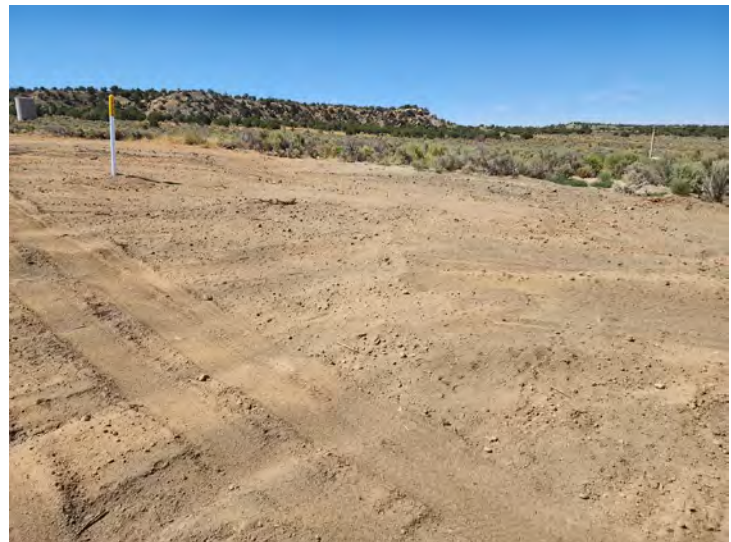
**Photograph 5**

Photograph Description: View of the site after initial restoration.
