Re: **REVISED**

> C-141 Closure Addendum ConocoPhillips (Heritage COG Operating, LLC) Condor State #001H Release Unit Letter D, Section 20, Township 18 South, Range 35 East Lea County, New Mexico Incident ID# nJXK1519633884

2023 VISUAL SITE INSPECTION

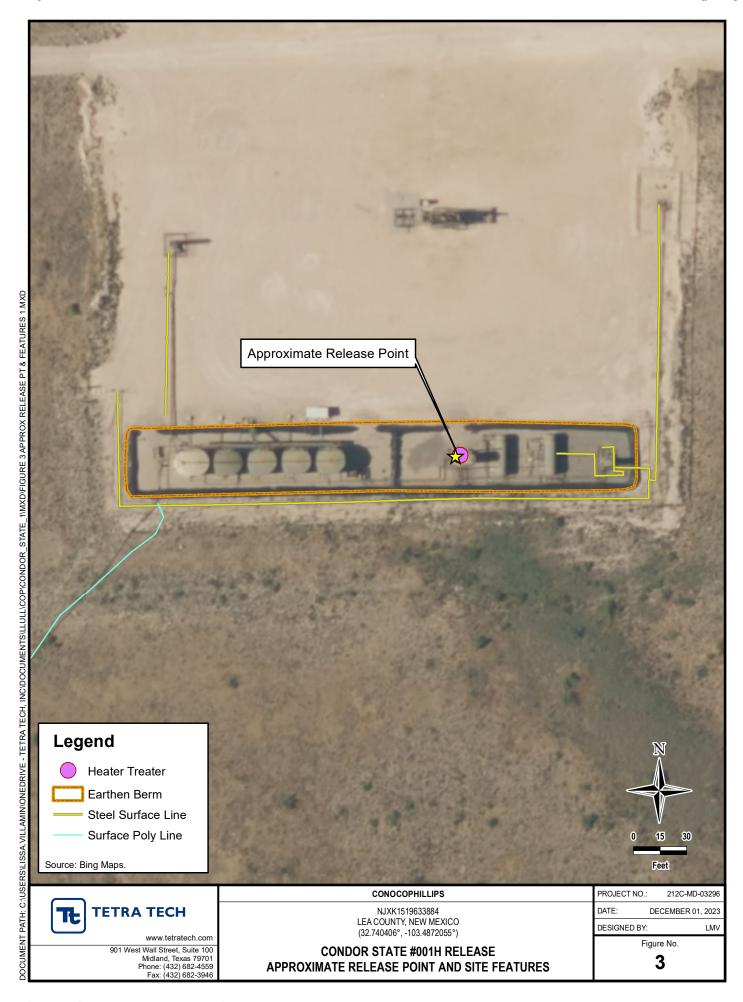
Figure 3 – Approximate Release Point and Site Features

Tetra Tech personnel were able to identify the heater treater as presented in Figure 3. The secondary containment is made up of earthen berms approximately 2 feet tall with an intact polyethylene liner. The readily observable exposed areas of the liner were visually inspected. The liner was intact and appeared to have had the ability to contain the leak in question. As mentioned, the release was reported as having been contained within a lined bermed area, and, as documented in the C-141, initial response efforts were successful in recovering 14 bbls of released fluids (approximate 80% recovery). The liner extended up and over the 2-foot-tall earthen berm and was anchored on the exterior side. Photographic documentation is presented in Attachment C.

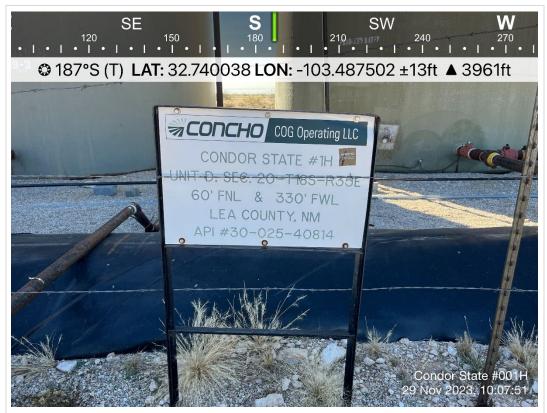
TETRA TECH, INC. PROJECT NO. 212C-MD-03296	DESCRIPTION	View south of site signage. Condor State #1H.	1
	SITE NAME	CONDOR STATE #001H Release	11/29/2023

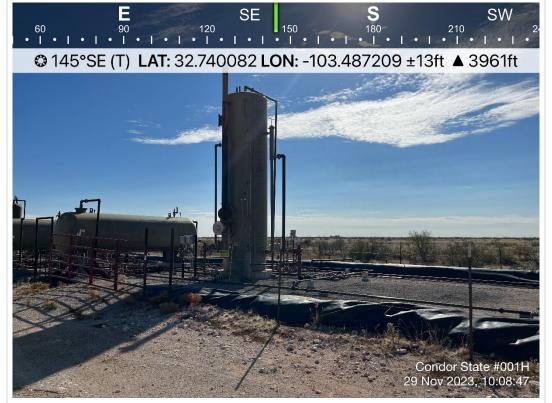
TETRA TECH, INC. PROJECT NO. 212C-MD-03296	DESCRIPTION	View southeast of approximate release area inside lined berm. Heater treater and surface pipelines.	2
	SITE NAME	CONDOR STATE #001H Release	11/29/2023

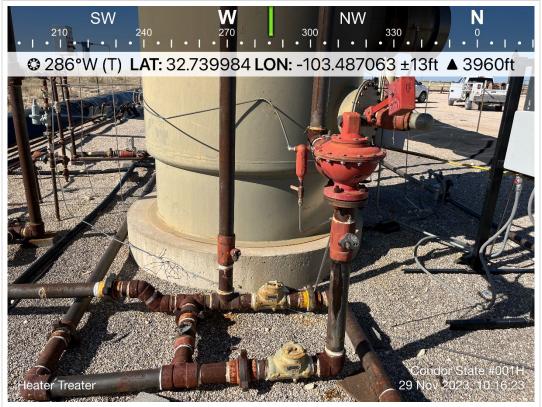
TETRA TECH, INC. PROJECT NO. 212C-MD-03296	DESCRIPTION	View west-northwest of approximate release area near heater treater. Mass of surface pipelines.	3
	SITE NAME	CONDOR STATE #001H Release	11/29/2023

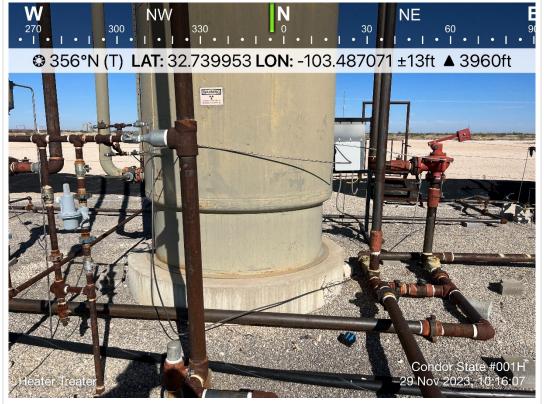
TETRA TECH, INC. PROJECT NO. 212C-MD-03296	DESCRIPTION	View north of approximate release area near heater treater. Mass of surface pipelines.	4
	SITE NAME	CONDOR STATE #001H Release	11/29/2023

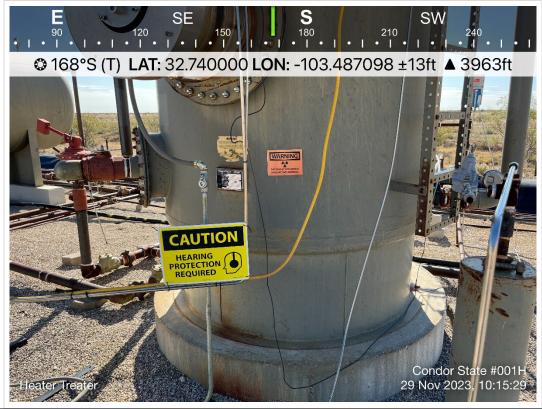
TETRA TECH, INC. PROJECT NO. 212C-MD-03296	DESCRIPTION	View south approximate release area near heater treater. Mass of surface pipelines.	5
	SITE NAME	CONDOR STATE #001H Release	11/29/2023

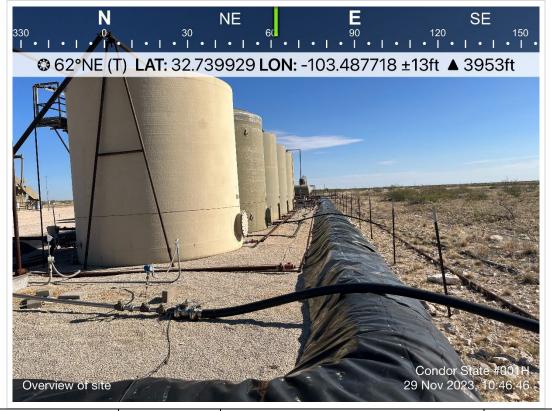
TETRA TECH, INC. PROJECT NO. 212C-MD-03296	DESCRIPTION	View east-northeast of lined tank battery west of approximate release area.	6
	SITE NAME	CONDOR STATE #001H Release	11/29/2023

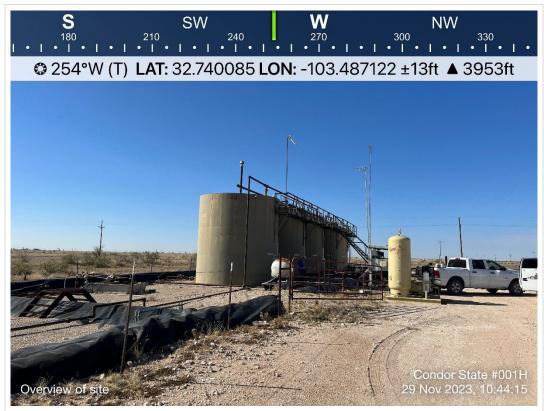
TETRA TECH, INC. PROJECT NO. 212C-MD-03296	DESCRIPTION	View west-southwest of lined tank battery west of approximate release area.	7
	SITE NAME	CONDOR STATE #001H Release	11/29/2023

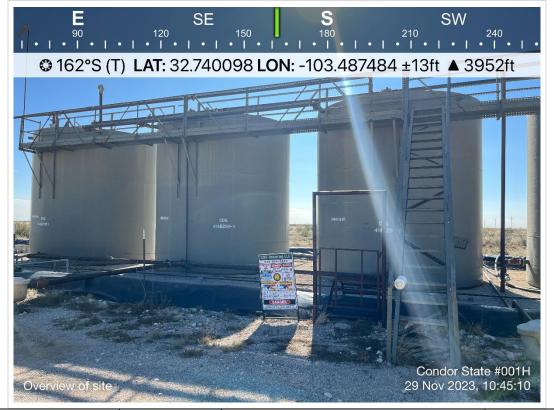
TETRA TECH, INC. PROJECT NO. 212C-MD-03296	DESCRIPTION	View south-southeast of lined tank battery west of approximate release area.	8
	SITE NAME	CONDOR STATE #001H Release	11/29/2023

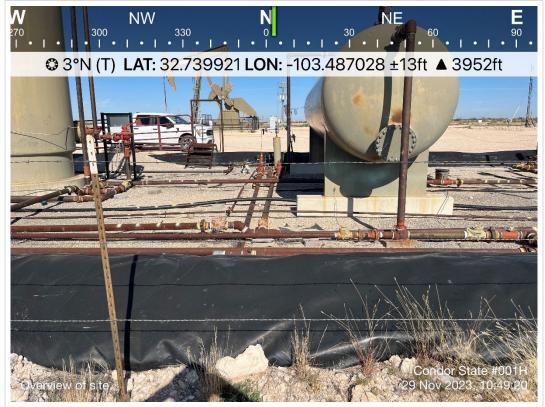
TETRA TECH, INC. PROJECT NO. 212C-MD-03296	DESCRIPTION	View north of approximate release area inside lined berm near heater treater. Mass of surface pipelines.	9
	SITE NAME	CONDOR STATE #001H Release	11/29/2023

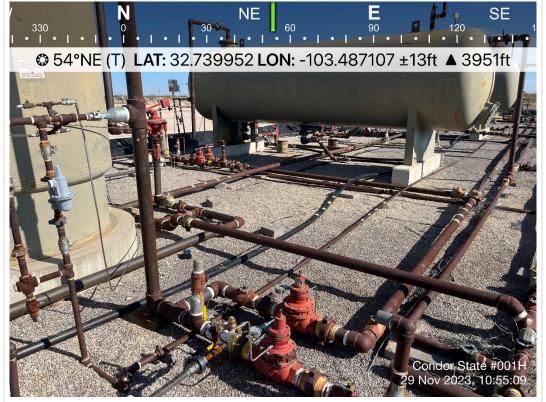
TETRA TECH, INC. PROJECT NO.	DESCRIPTION	View northeast of approximate release area inside lined berm near heater treater. Mass of surface pipelines.	10
212C-MD-03296	SITE NAME	CONDOR STATE #001H Release	11/29/2023

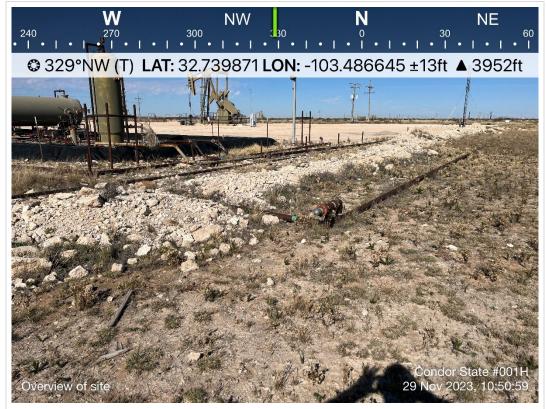
TETRA TECH, INC. PROJECT NO.	DESCRIPTION	View north-northwest of approximate release area. Heater treater and surface pipelines.	11
212C-MD-03296	SITE NAME	CONDOR STATE #001H Release	11/29/2023

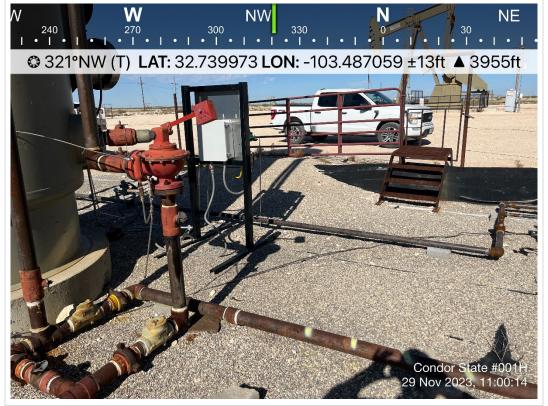
TETRA TECH, INC. PROJECT NO.	DESCRIPTION	View northwest of approximate release area. Heater treater and surface pipelines.	12
212C-MD-03296	SITE NAME	CONDOR STATE #001H Release	11/29/2023
