Closure Report

Riverbend Federal Com 12-13 Battery
Eddy County, New Mexico
Facility ID # fAPP2123545971
Incident # NAPP2313976458

June 27, 2023

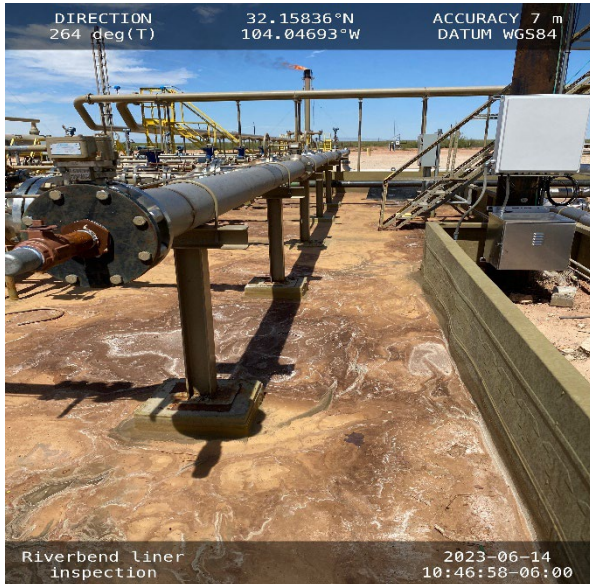
**Photograph No.1 Description:**

Centrifugal Pump Containment, Liner Inspection.

- ☒ Responsible Party has visually inspected the liner.
- ☒ Liner remains intact and was able to contain the leak in question.
- ☒ At least two business days' notice was given to the appropriate division district office before conducting the liner inspection.
- ☒ Photographs illustrating liner integrity are included.

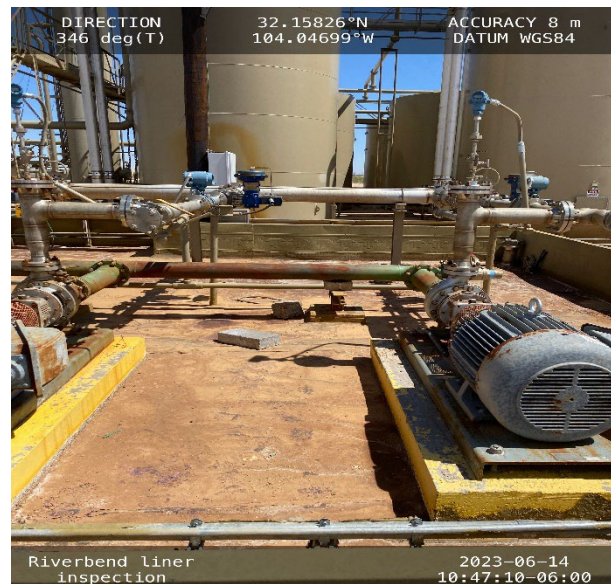
**Photograph No.2 Description:**

Centrifugal Pump Containment, Liner Inspection.

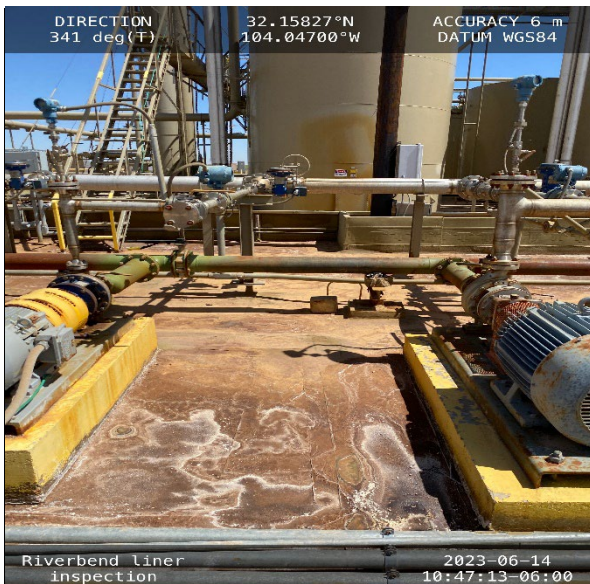
**Photograph No.3 Description:**

Centrifugal Pump Containment, Liner Inspection.

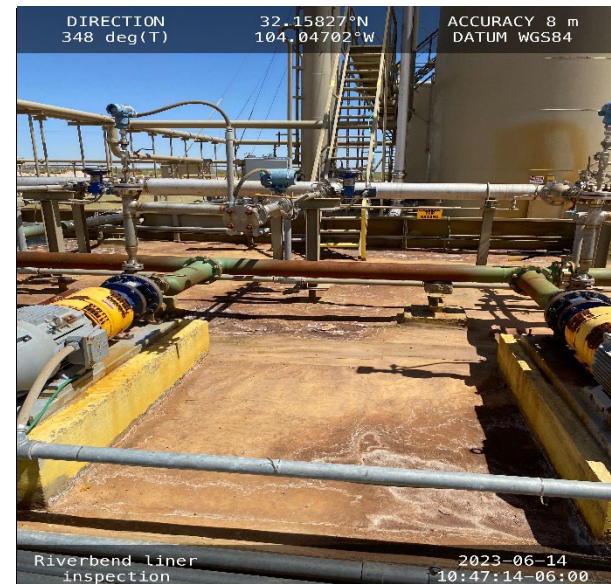
**Photograph No.4 Description:**

Centrifugal Pump Containment, Liner Inspection.

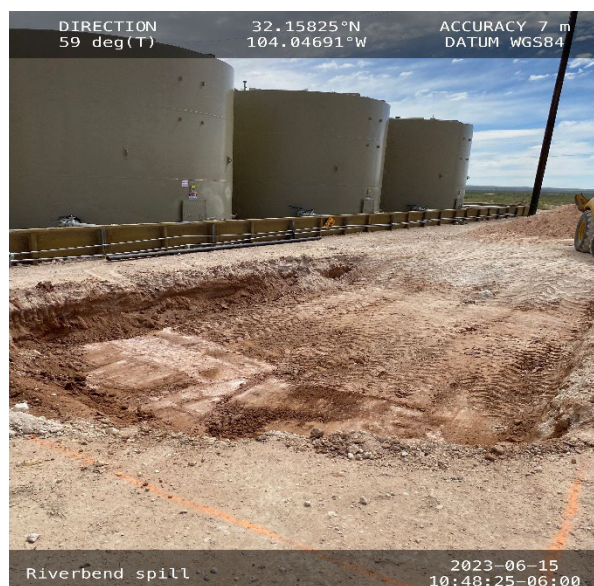
Photograph No.6 Description:

Excavation of Over Spray Area.

- The impacted areas on location were excavated to depths of two (2) feet bgs. Talon field titrated soil samples for total chlorides to guide the vertical and horizontal extents of the excavation process.
- Pursuant to NMOCD guidance, confirmation soil samples were collected at 200 square foot intervals and analyzed for TPH, BTEX and Total Chlorides to ensure all other areas had reached NMOCD closure criteria.
- The excavated areas on the well pad were backfilled with new caliche, machine compacted, and contoured to match the surrounding location.
- Approximately 60 cubic yards of excavated material was transported to Lea Land Disposal, a NMOCD approved solid waste disposal facility.
- Photographic documentation is provided in [Appendix IV](#).
- Copies of the Final C-141s are presented in [Appendix III](#).

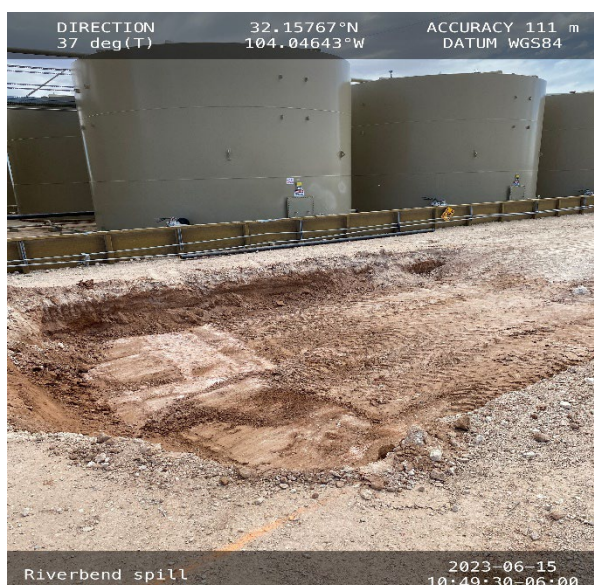
Photograph No.8 Description:

Excavation of Over Spray Area.
