**Re: Site Assessment, Remediation, and Closure Report
Fir Federal Battery
API No. 30-015-32069
GPS: Latitude 32.8027039, Longitude -104.2376099
UL "L", Sec. 25, T17S, R27E
Eddy County, NM
NMOCD Ref. No. NRM2004952392**

Paragon Environmental, LLC (Paragon) has been contracted by Spur Energy Partners (Spur) to perform a spill assessment and remediation activities for the Release Site known as the Fir Federal Battery (Fir Fed). Details of the release are summarized below:

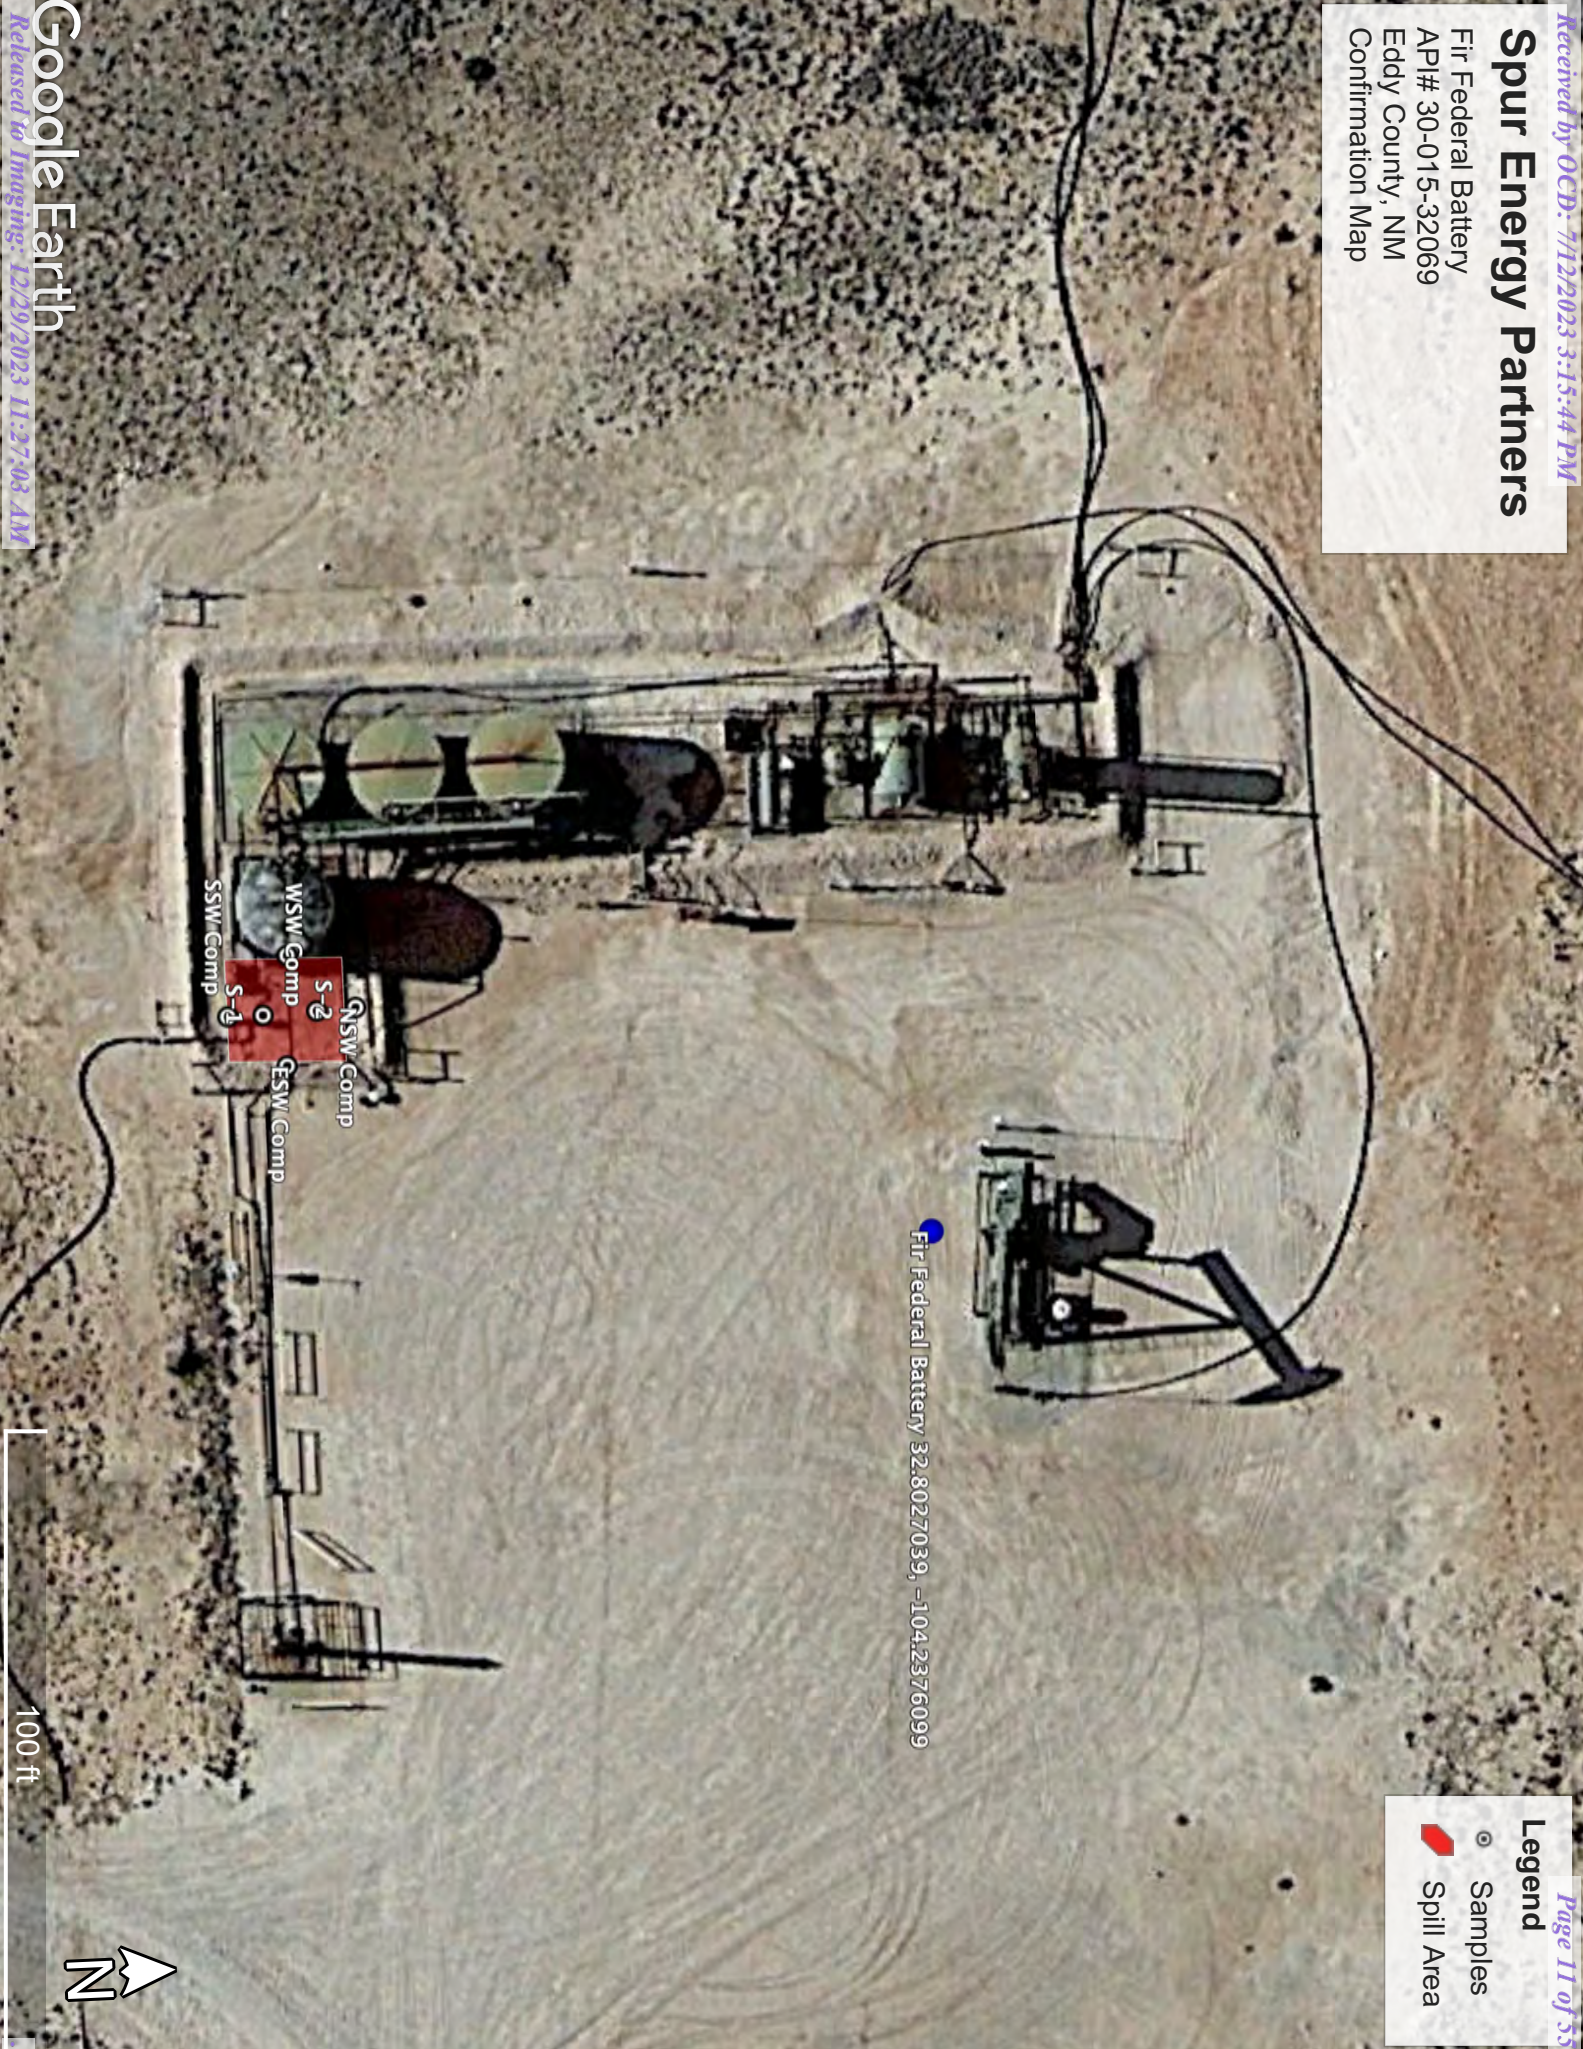
Fir Federal Battery
API# 30-015-32069
Eddy County, NM
Confirmation Map

On May 26, 2023, Paragon returned with personnel and equipment. We utilized the backhoe to further the vertical and horizontal excavation to 4-feet BGS in the area of S-2 and extended the horizontal areas of ESW and SSW an additional 1-foot. We then sampled again. Those results are as follows:

5-26-23 Confirmation Sample Results

With below closure level bottom and sidewall sample results, we backfilled the area, utilizing hand tools and equipment, we compacted and contoured the area to match the location.

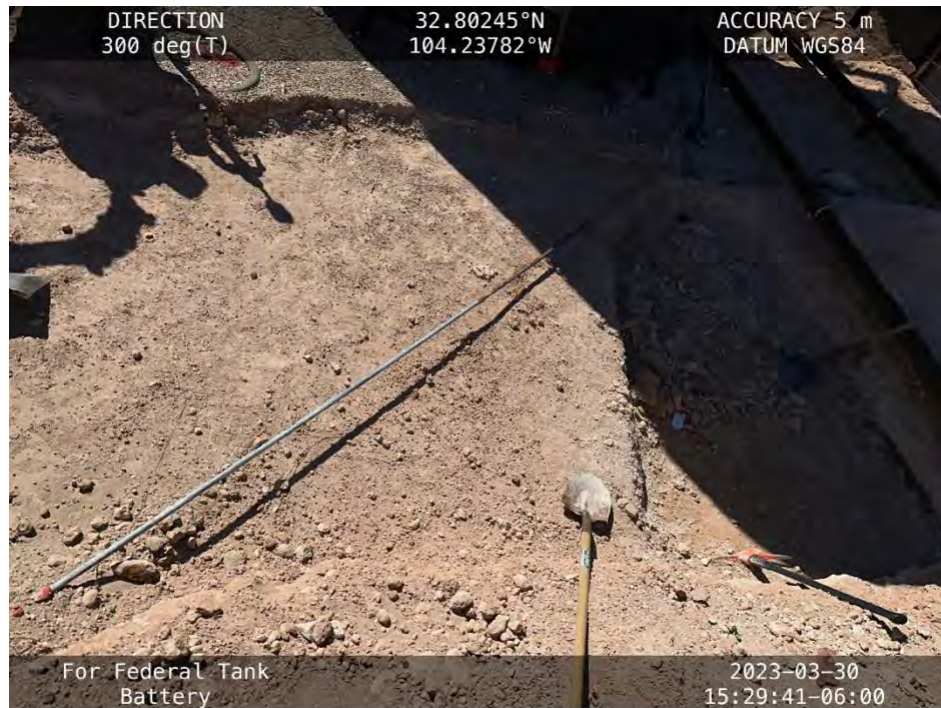
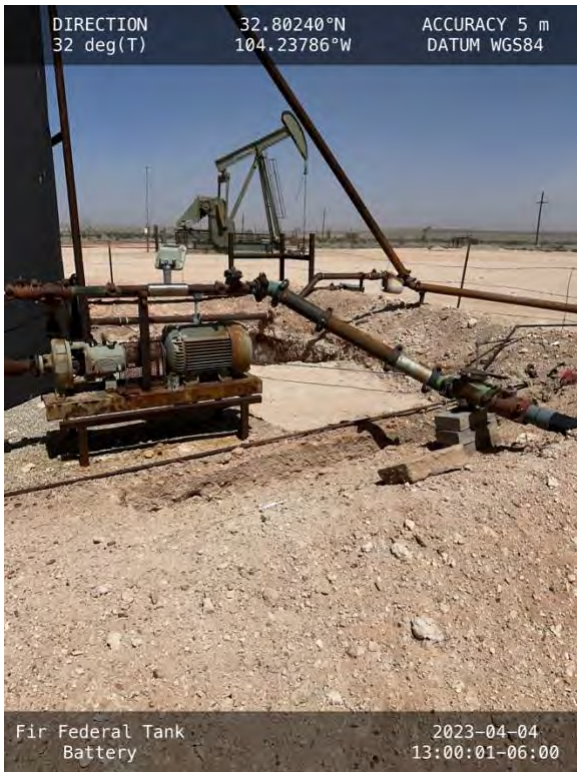
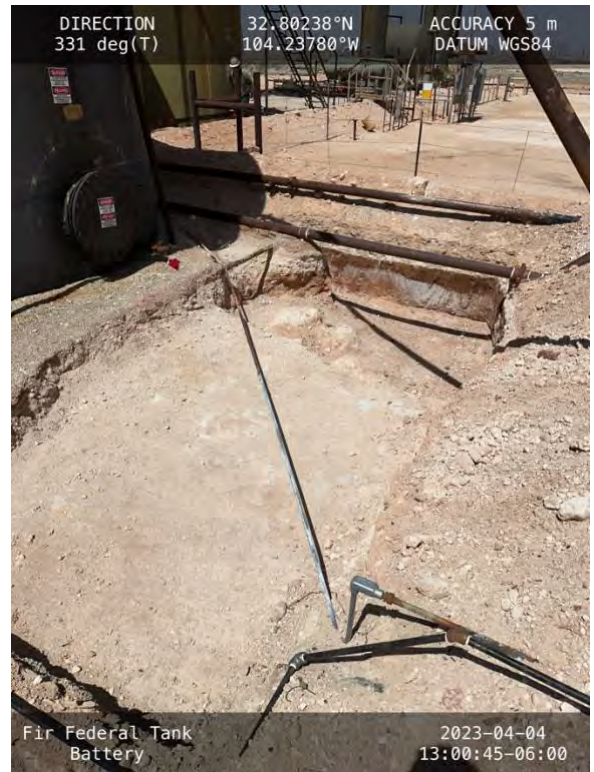
Excavation

- Utilizing hand equipment, we excavated the impacted soils that were above the NMOCD Closure Criteria in the areas categorized by soil sample S-2 to a depth of 1 foot BGS.
- In the area of S-1, we excavated to a depth of 3 feet BGS, where we met refusal with our hand tools.
- An email was sent on 3-31-23 notifying the NMOCD that we would be obtaining confirmation soil samples on 4-5-23. The labeling got flipped and was submitted backward, meaning S-1 now became S-2 and vice versa. The results of this sampling event are in the following data table.
