BD P-4 EOL Corrective Action Plan

**UL "P", Sec. 4, T22S, R37E
32.416894°, -103.161316°
Lea County, New Mexico
nAPP2110241347**

Re: Corrective Action Plan (CAP) and Variance Request
BD P-4 EOL – BD SWD System
UL “P”, Section 4, Township 22 South, Range 37 East
Lea County, New Mexico
Rice Operating Company Project No. 1R426-06
Tasman Project No. 2251

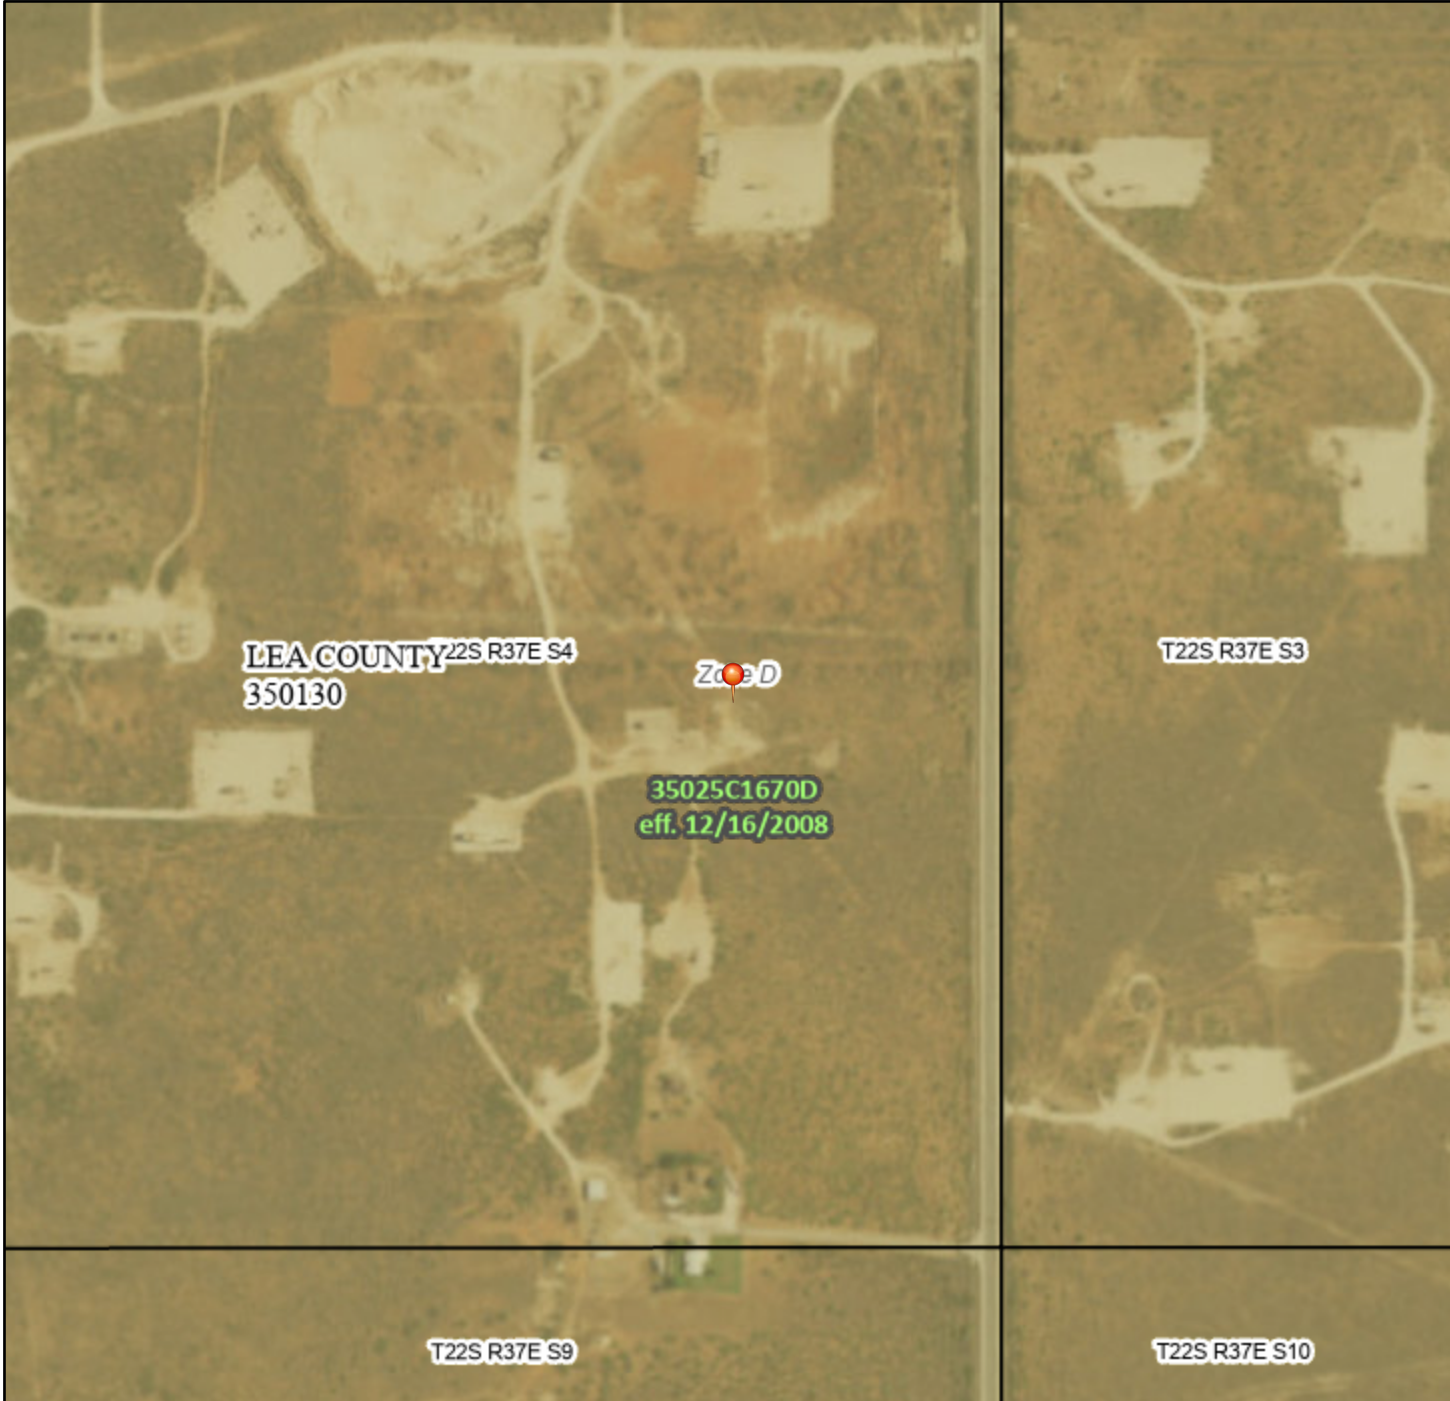
Figure
3

National Flood Hazard Layer FIRMMette

Review of flood map data published by the Federal Emergency Management Agency (FEMA) indicates the site is not located within a 100-year floodplain. A copy of the FEMA FIRMette Map can be found attached as Figure 4.

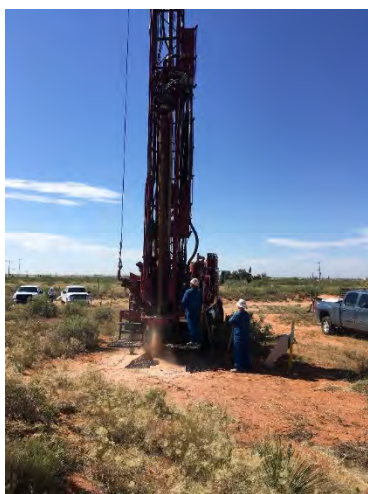
Drilling SB-1, facing south 8/27/2018

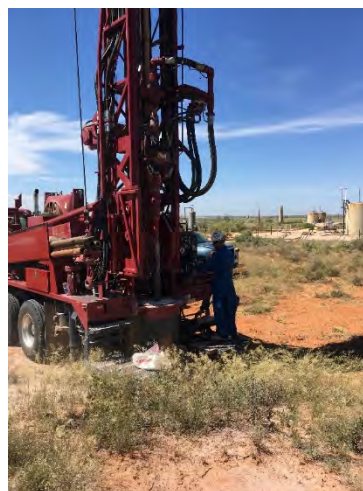
Drilling SB-2, facing southwest 8/27/2018

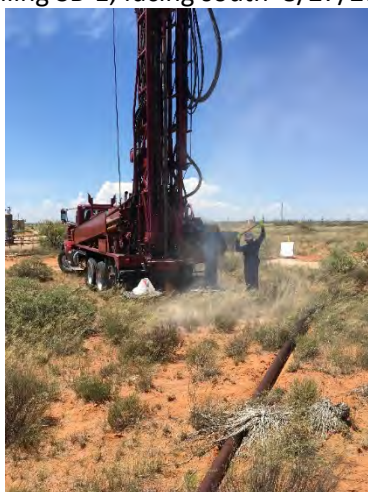
Drilling SB-3, facing west 8/27/2018

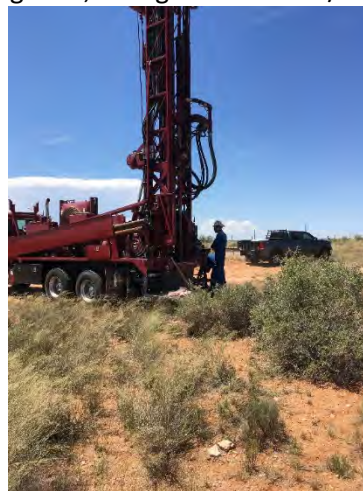
Drilling SB-4, facing west 8/27/2018

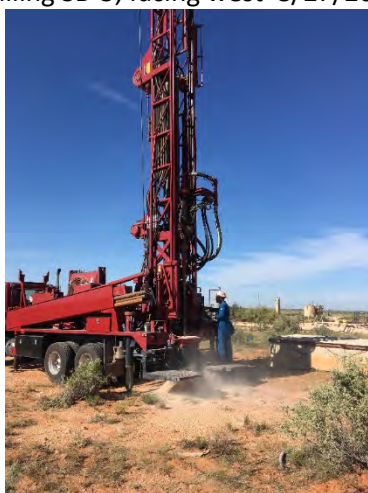
Drilling SB-5 8/28/2018
