**RE: Liner Inspection and Closure Report
Seawolf 12 CTB 1
API No. N/A
GPS : Latitude 32.0535538 Longitude -103.5278845
UL N, Section 12, Township 26S, Range 33E
NMOCD Reference No. NAPP2324225435**

Devon Energy Production Company (Devon) has contracted Pima Environmental Services, LLC (Pima) to perform a liner inspection and prepare this closure report for a crude oil and produced water release that happened at the Seawolf 12 CTB 1 (Seawolf). An initial C-141 was submitted on August 30, 2023, and can be found in Appendix B. This incident was assigned Incident ID NAPP2324225435, by the New Mexico Oil Conservation Division (NMOCD).

**SITE PHOTOGRAPHS
DEVON ENERGY
SEAWOLF 12 CTB 1**

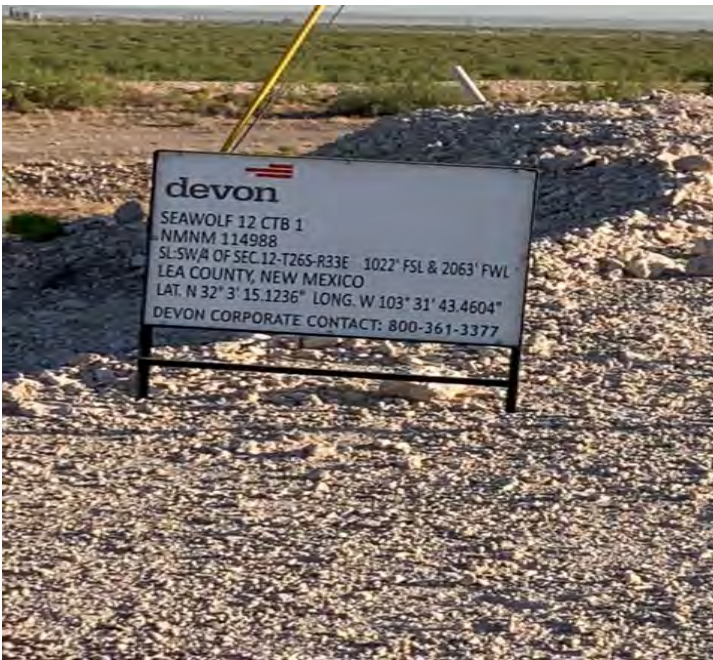
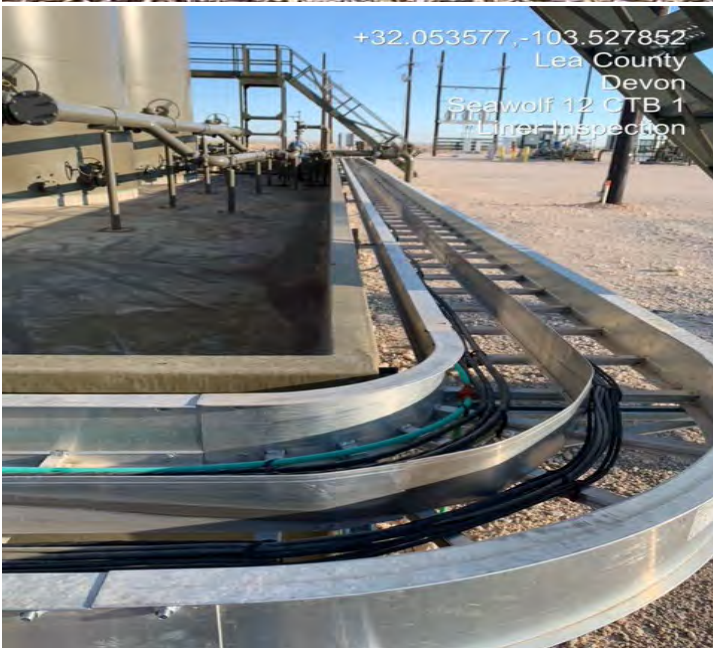
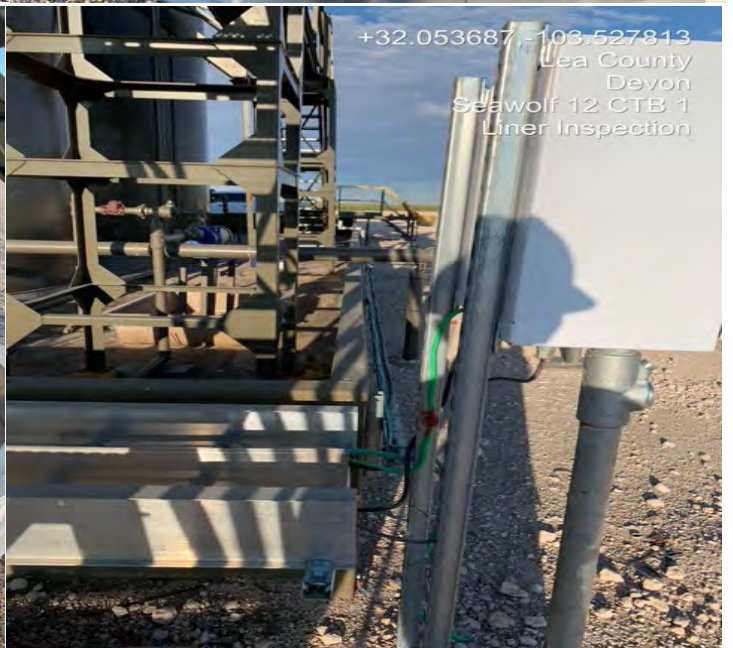
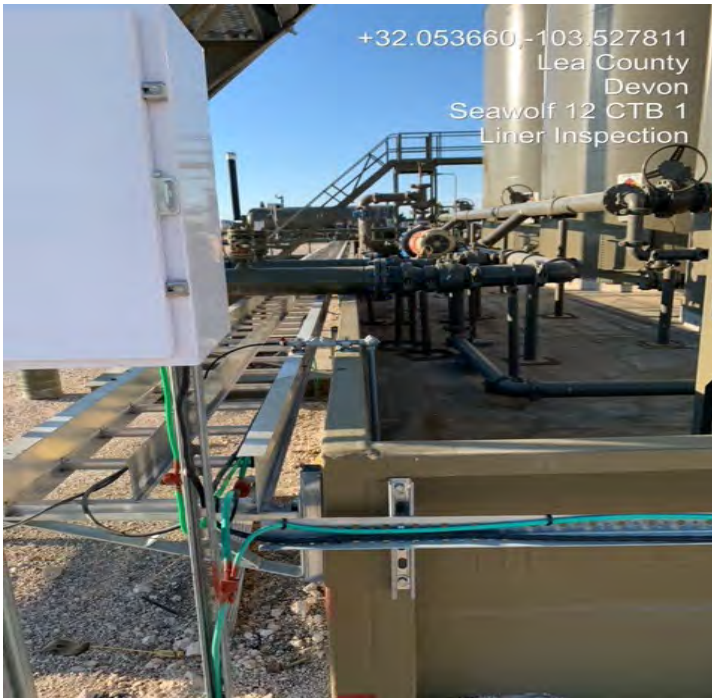
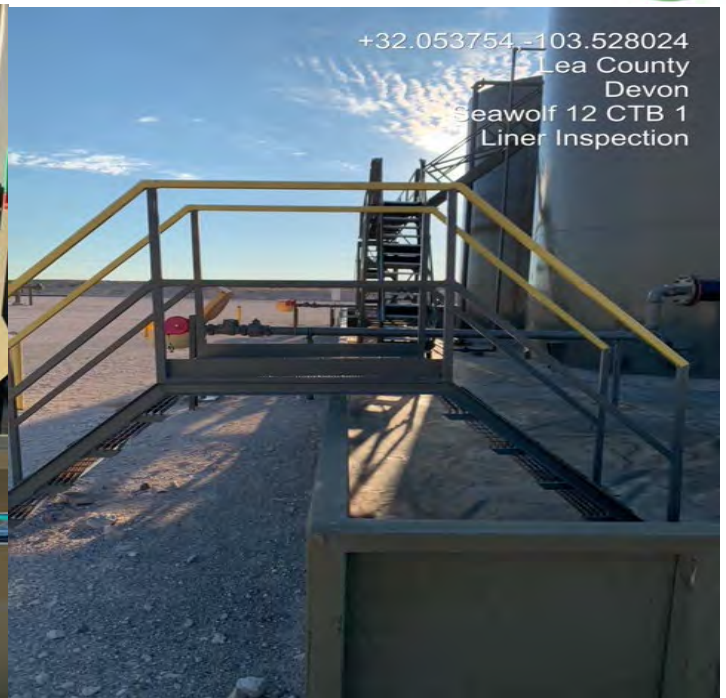
LINER INSPECTION

On October 4, 2023, after sending the 48-hour notification email, Pima Environmental conducted a liner inspection at this location. We concluded that this liner and containment maintained its integrity and was able to retain the fluids. The liner inspection form and photographic documentation can be found in Appendix C.

Visualization	Yes	No	Comments
Is there a tear in the liner?		X	
Are there holes in the liner?		X	
Is the liner retaining any fluids?		X	
Does the liner have integrity to contain a leak?	X

After careful review, Pima requests that this incident, NAPP2324225435, be closed. Devon has complied with the applicable closure requirements.
