Closure Report
Crow Flats 16 State Com #002
Incident ID: NMLB1030934407
Eddy County, New Mexico
Unit M Sec 16 T16S R28E
32.9171333°, -104.1882935°

Point of Release:
Leak developed in an unattended circulating pump
Release Date: 10/12/10
Volume Released: 17 Barrels of Crude Oil
Volume Recovered: 0 Barrels of Crude Oil

Re: Closure Report
Crow Flats 16 State Com #002
Incident ID: NMLB1030934407
Cimarex Energy Co. of Colorado
Site Location: Unit M, S16, T16S, R28E
(Lat 32.9171333°, Long -104.1882935°)
Eddy County, New Mexico

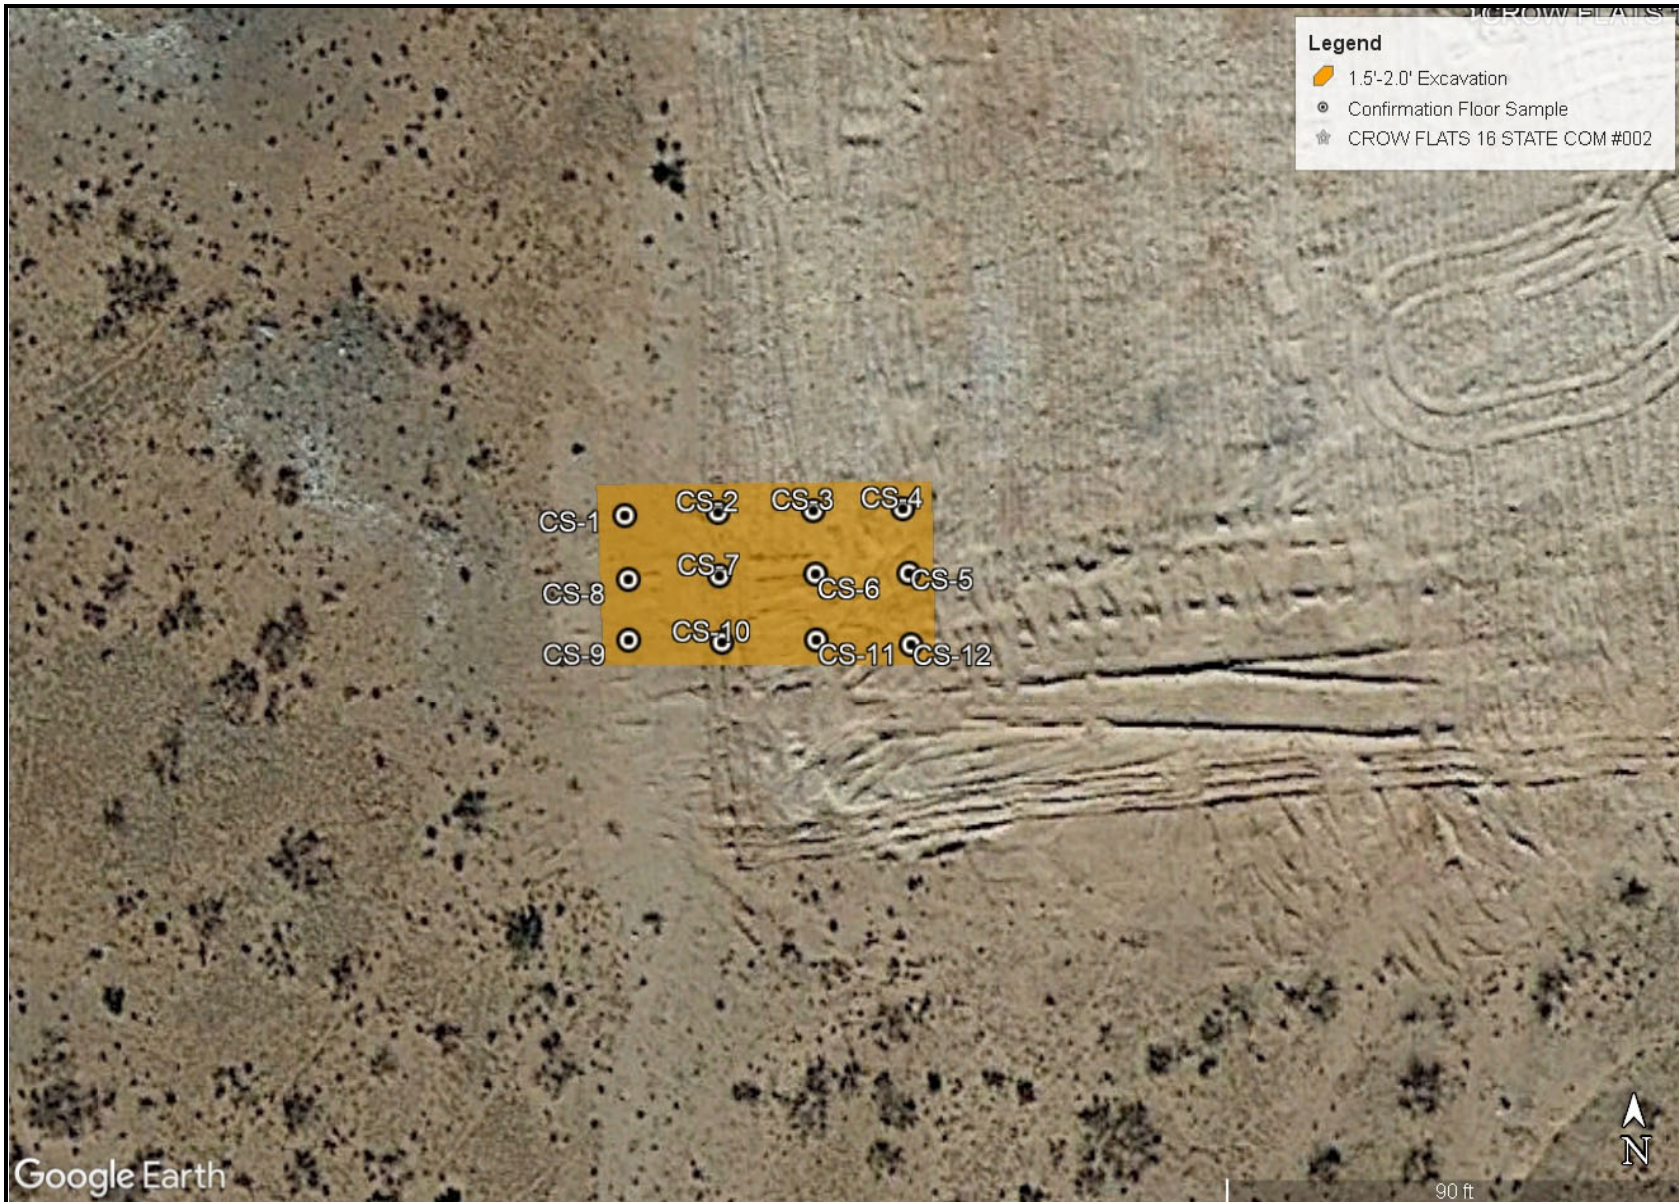
FIGURE 4A

INITIAL EXCAVATION DEPTH MAP
CIMAREX ENERGY CO. OF COLORADO
CROW FLATS 16 STATE COM #002
EDDY COUNTY, NEW MEXICO
32.9171333°, -104.1882935°

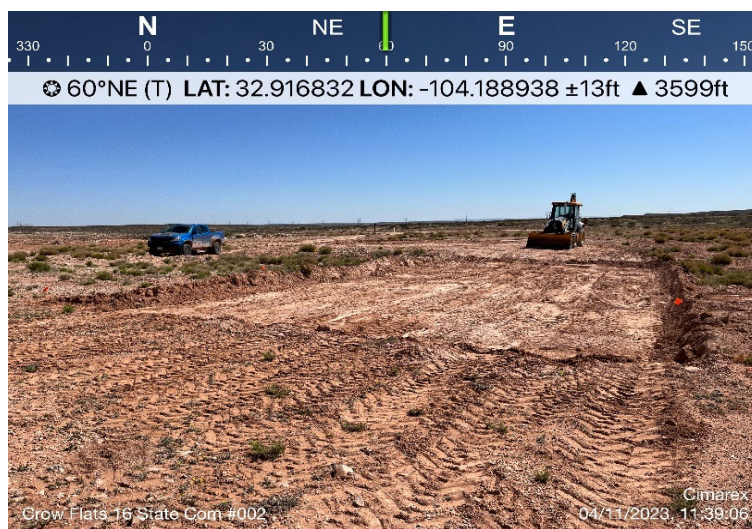
PHOTOGRAPHIC LOG**Cimarex Energy Co. of Colorado****Photograph No. 1****Facility:** Crow Flats 16 State Com #002**County:** Eddy County, New Mexico**Description:**

View Northeast, area of CS-1 through CS-12.

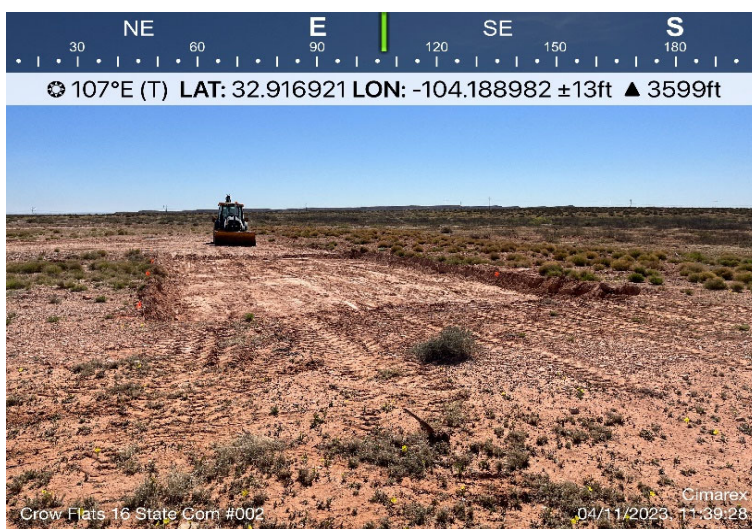
**Photograph No. 2****Facility:** Crow Flats 16 State Com #002**County:** Eddy County, New Mexico**Description:**

View East, area of CS-1 through CS-12.

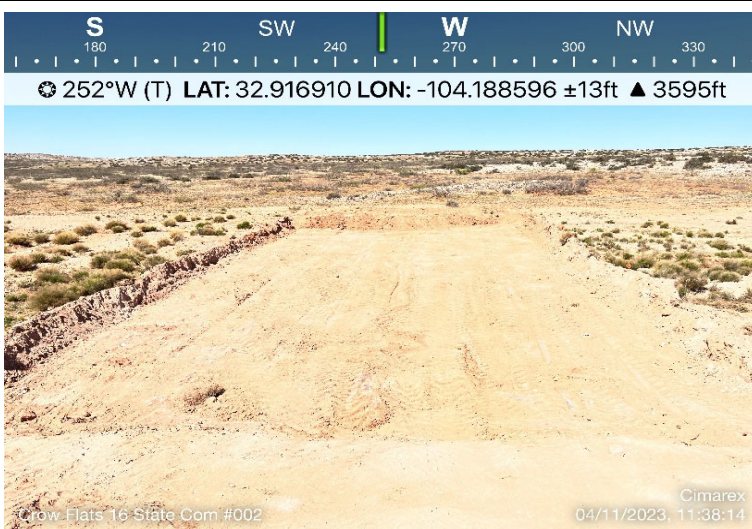
**Photograph No. 3****Facility:** Crow Flats 16 State Com #002**County:** Eddy County, New Mexico**Description:**

View West, area of CS-1 through CS-12.

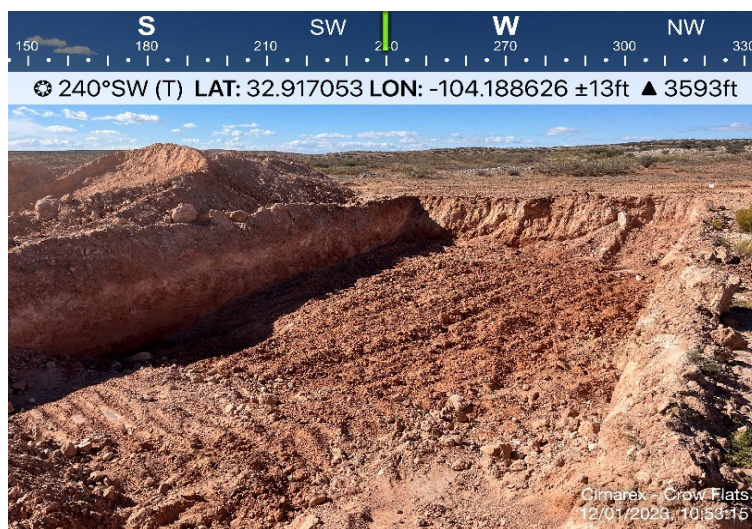
PHOTOGRAPHIC LOG**Cimarex Energy Co. of Colorado****Photograph No. 4****Facility:** Crow Flats 16 State Com #002**County:** Eddy County, New Mexico**Description:**

View Southwest, area of CS-13 through CS-19 and stockpiled clean backfill material.

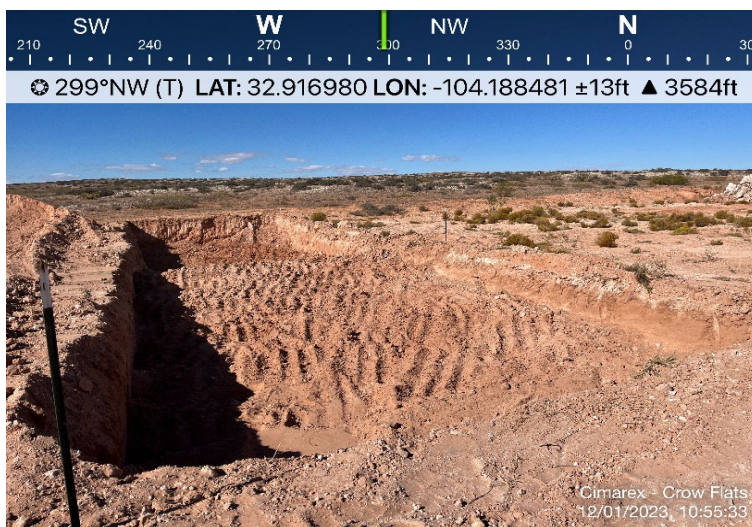
**Photograph No. 5****Facility:** Crow Flats 16 State Com #002**County:** Eddy County, New Mexico**Description:**

View Northwest, area of CS-20 through CS-25 and stockpiled clean backfill material.

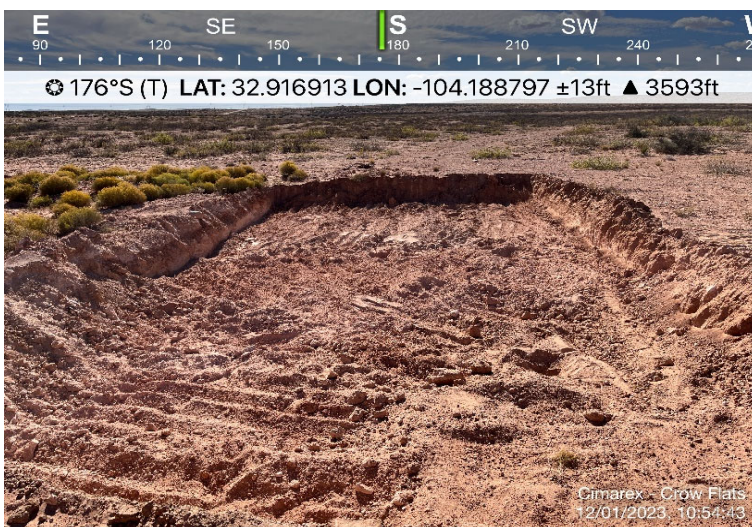
**Photograph No. 6****Facility:** Crow Flats 16 State Com #002**County:** Eddy County, New Mexico**Description:**

View South, area of CS-26 through CS-32.
