Liner Inspection and Closure Request

BTA Oil Producers, LLC

Mesa Bronco

NMOCD Incident # nAPP2328424619

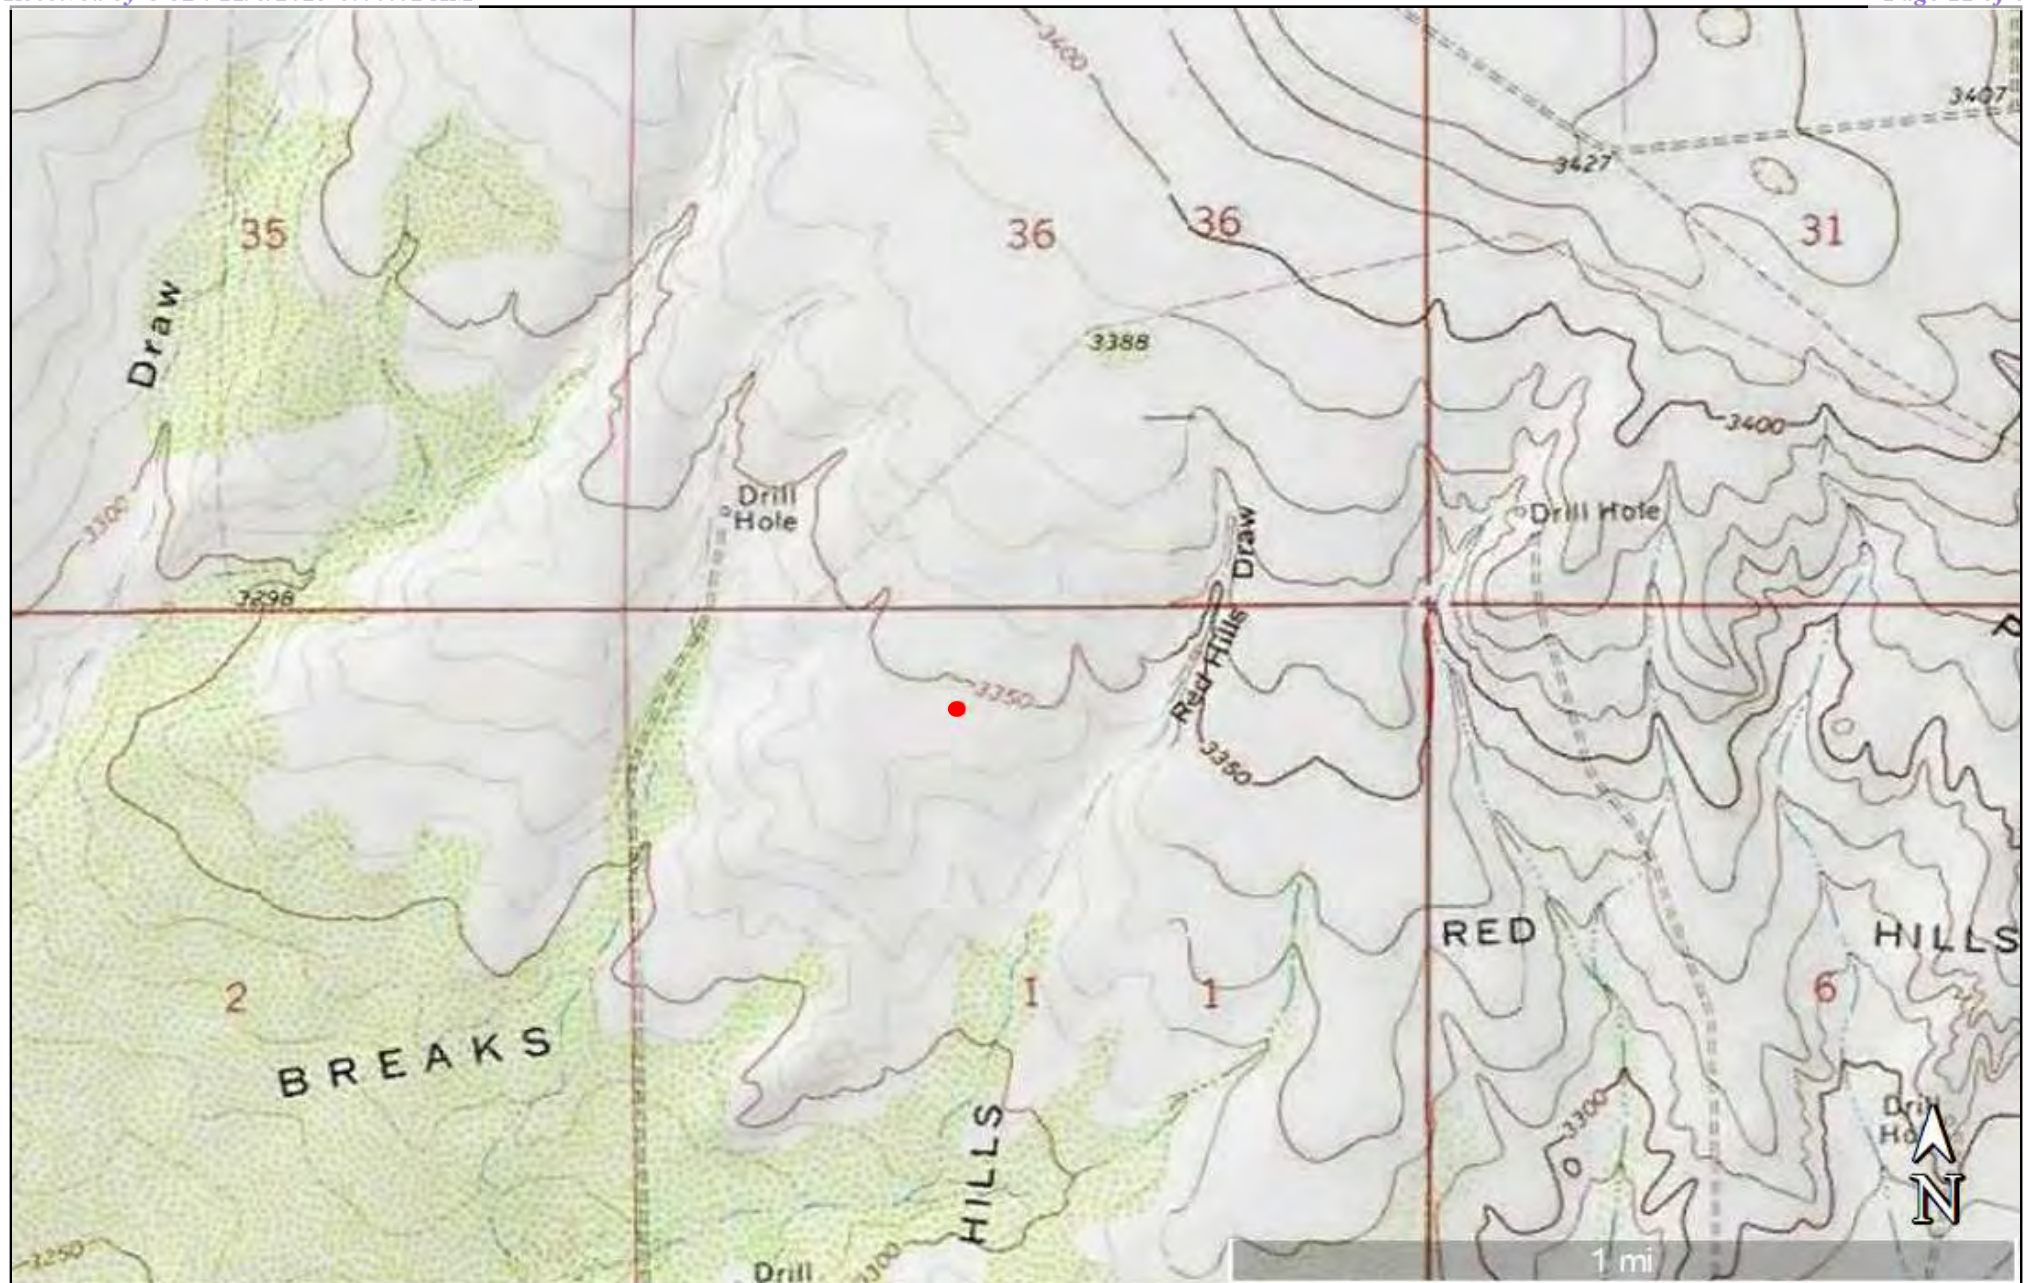
**Figure 1**

Topographic Map
BTA Oil Producers, LLC
Mesa Bronco
GPS: 32.077917, -103.629977
Lea County

The site is located in Unit Letter C (NE/NW), Section 1, Township 26 South, Range 32 East, approximately twenty-six miles south west of Jal, in Lea County, New Mexico. The site is located on Bureau of Land Management land. Topographic Map, OSE POD Locations Map, and USGS Well Locations Map are included as Figure 1, Figure 2, and Figure 3, respectively.

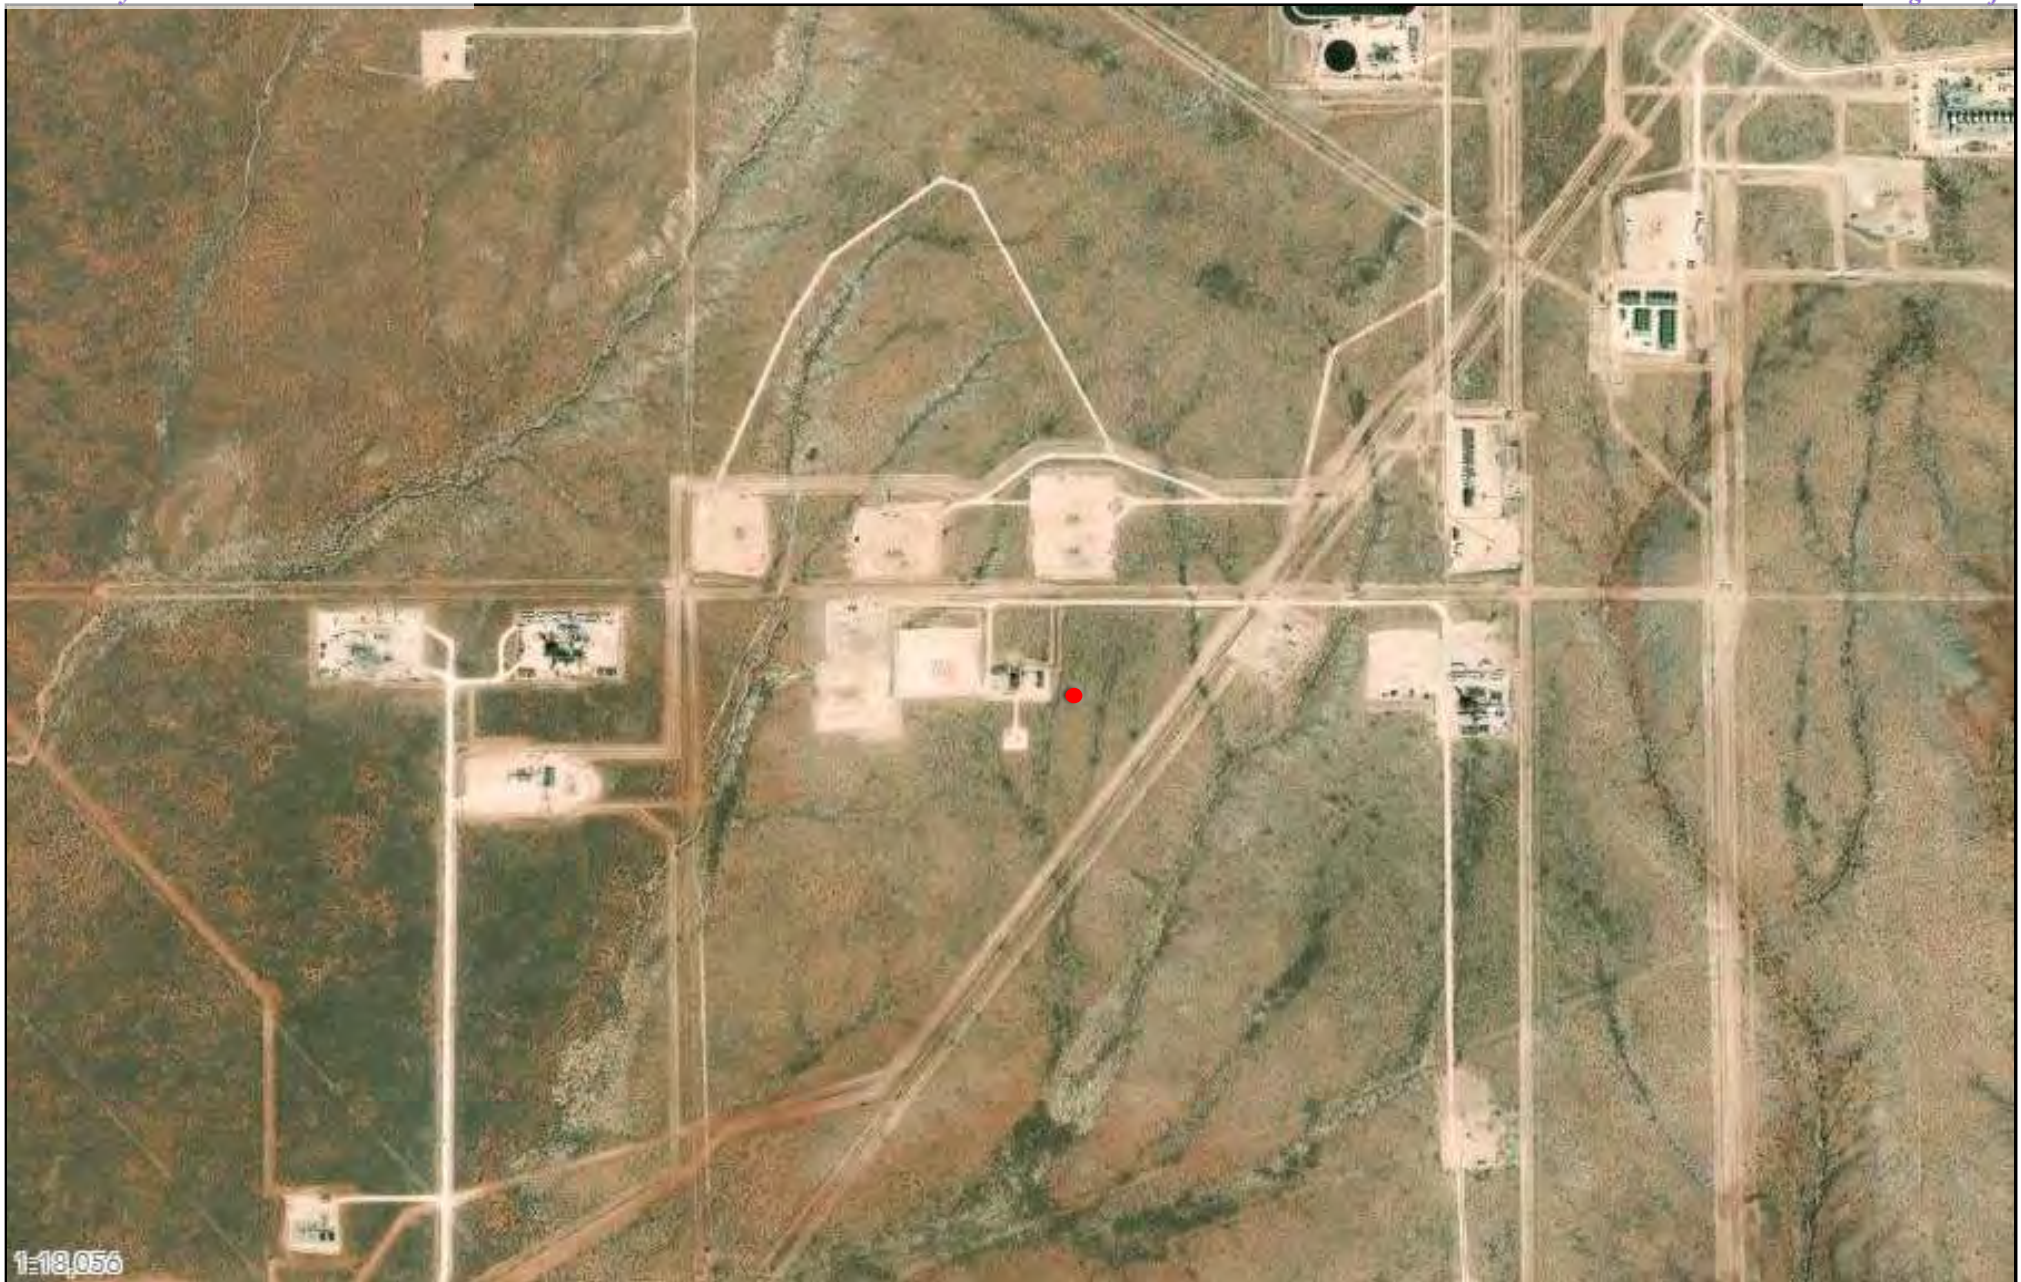
**Figure 2**

OSE POD Locations Map
BTA Oil Producers, LLC
Mesa Bronco
GPS: 32.077917, -103.629977
Lea County

A search of the New Mexico Office of the State Engineer (NMOSE) and United States Geological Survey (USGS) groundwater databases was completed in an effort to determine the horizontal distance to known water sources within a half mile radius of the Release Site. Approximate depth to groundwater was determined using maintained and published water well data. Karst mapping indicates the site is located in a Karst designated area. Karst and Wetland Maps are provided as Attachment I. Depth to groundwater information is provided as Attachment IV and the results are depicted on Figures 2 & 3.

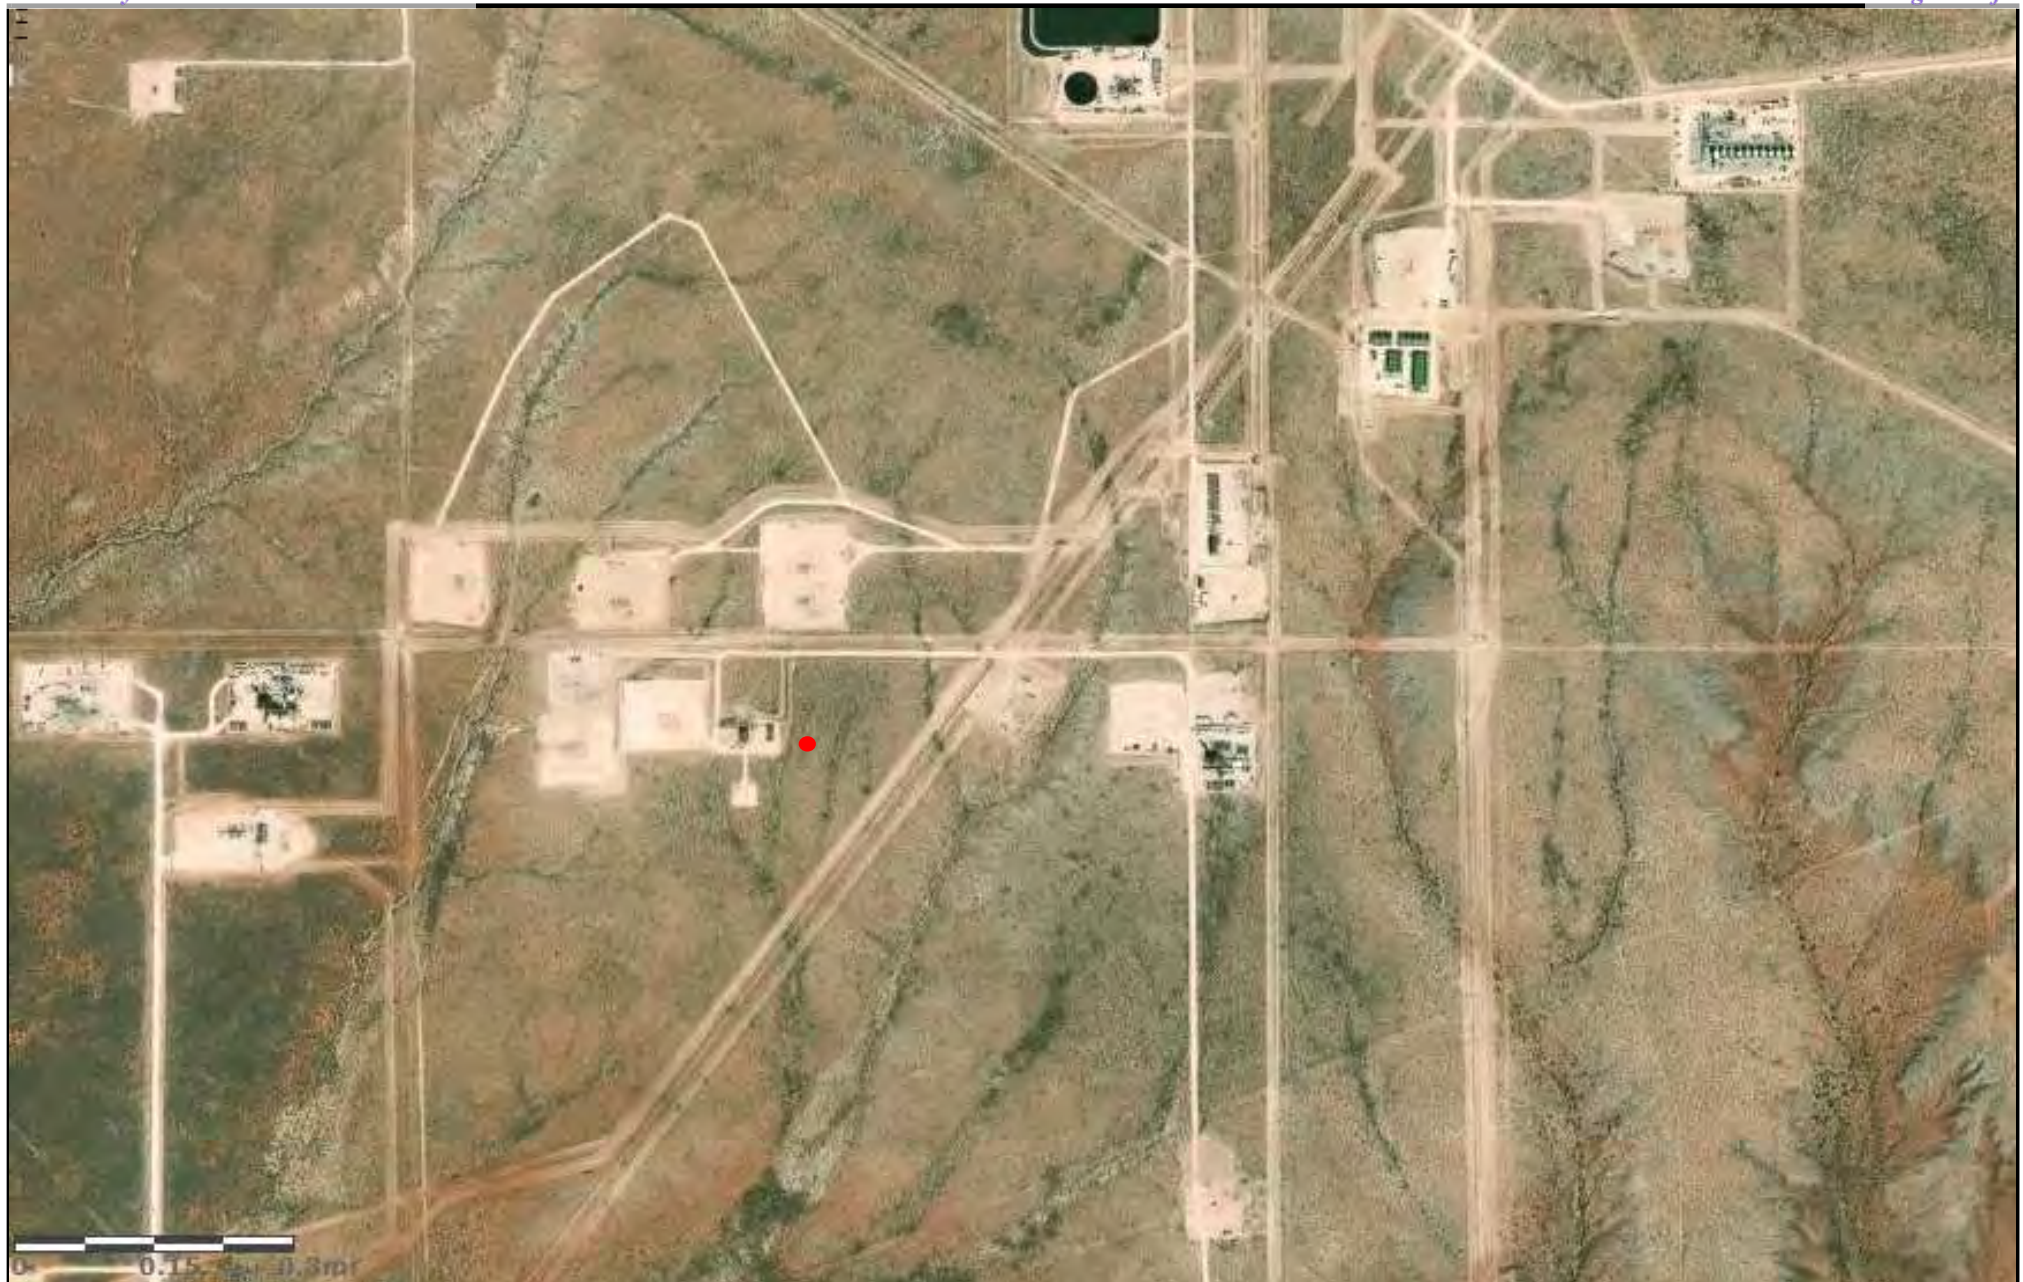
**Figure 3**

USGS Well Locations Map
BTA Oil Producers, LLC
Mesa Bronco
GPS: 32.077917, -103.629977
Lea County

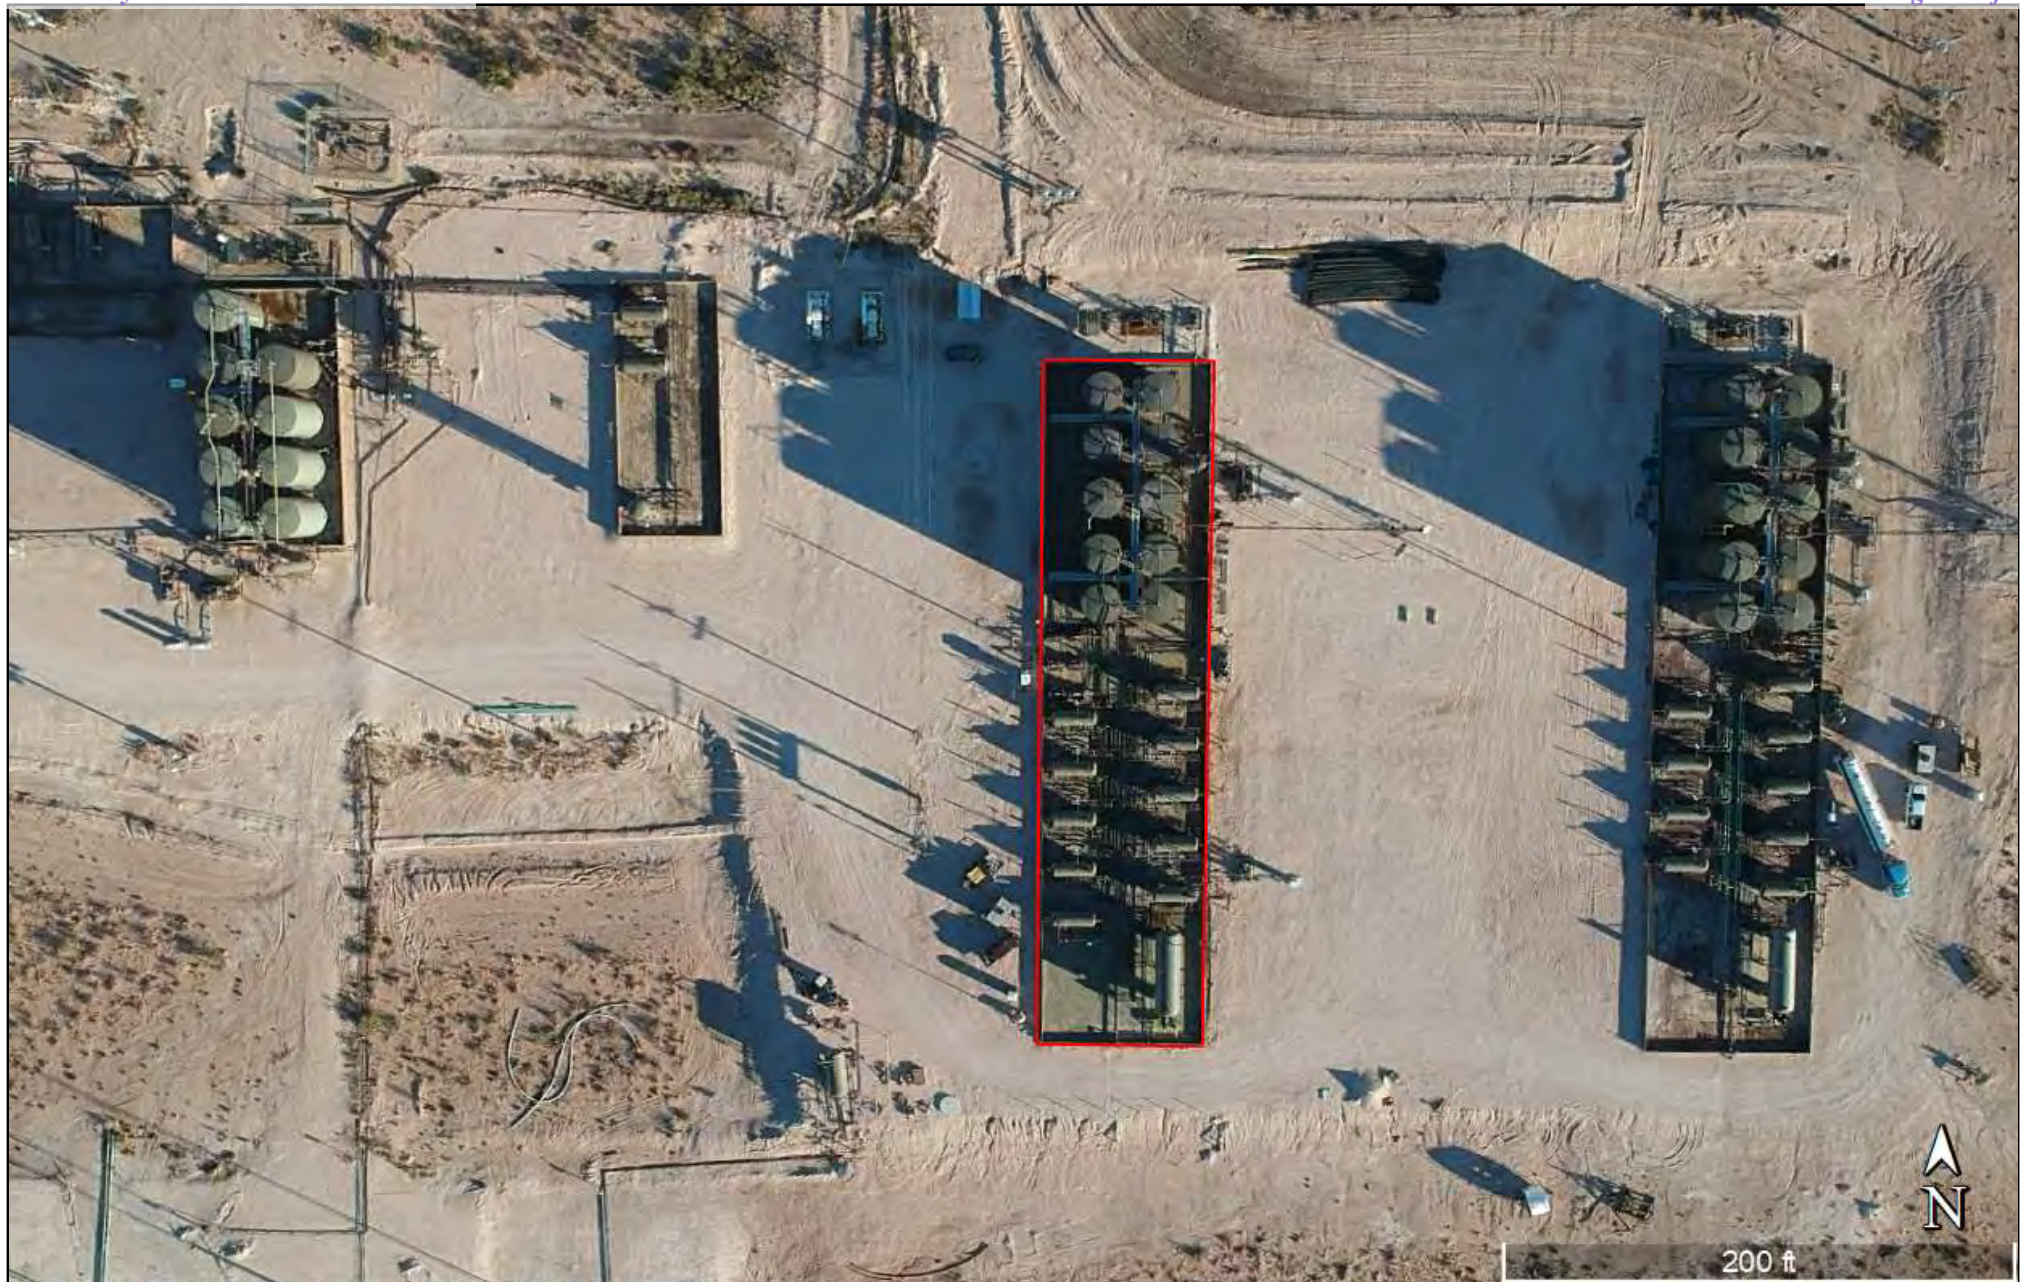
**Figure 4**

Liner Inspection Map
BTA Oil Producers, LLC
Mesa Bronco
GPS: 32.077917, -103.629977
Lea County

Release Within Lined Containment Area
