Site Assessment/Characterization

State of New Mexico
Oil Conservation Division

**SITE LOCATION MAP
CLOSURE REPORT
DEVON ENERGY PRODUCTION COMPANY
LONGVIEW FEDERAL 12 #013H
EDDY COUNTY, NEW MEXICO**

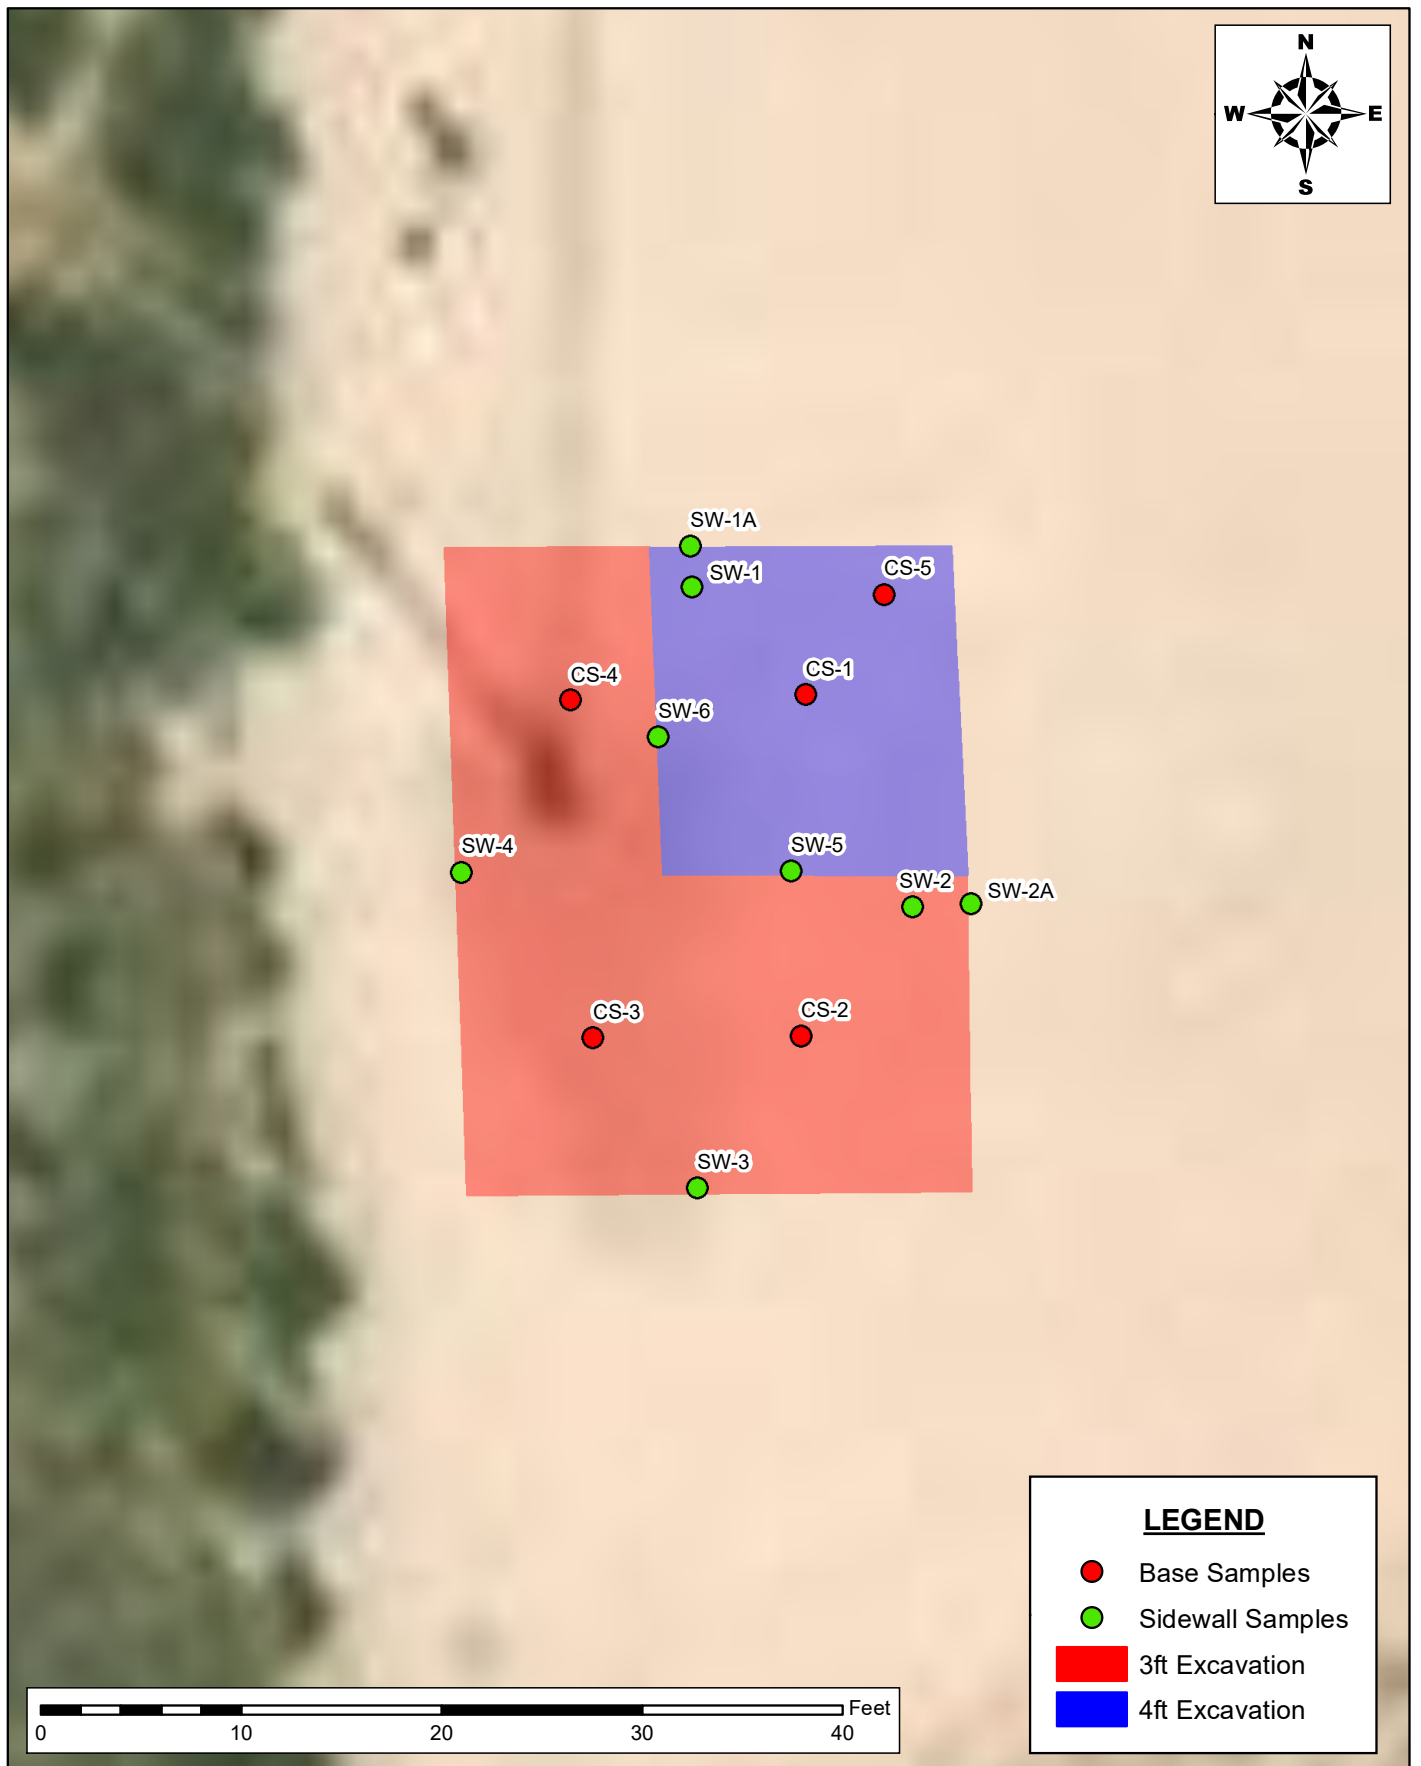
**CONFIRMATION SAMPLE MAP
CLOSURE REPORT
DEVON ENERGY PRODUCTION COMPANY
LONGVIEW FEDERAL 12 #013H
EDDY COUNTY, NEW MEXICO**

After further excavation, two (2) additional confirmation base samples (i.e., SW-1 and SW-5) and four (4) confirmation sidewall samples (i.e., SW-1A, SW-2A, SW-5 and SW-6) were collected on June 27th, 2023, to ensure impacted soils were successfully removed. Analytical results indicated that impacted soils had been removed and the Site required no further excavation. A photographic log documenting site conditions during confirmation sampling activities is attached.

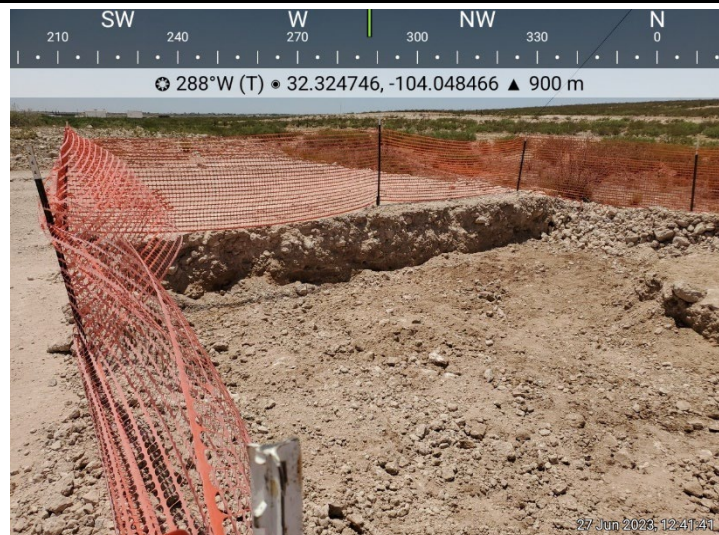
**Photograph No. 3**

Description:
View of Excavation.
