## Liner Inspection and Closure Request

**BTA Oil Producers, LLC  
Rojo B Tank Battery  
Lea County, New Mexico  
Unit Letter "C", Section 22, Township 25 South, Range 33 East  
Latitude 32.122733 North, Longitude 103.561319 West  
NMOCD Incident # nAPP2327526699**

**October 2023**

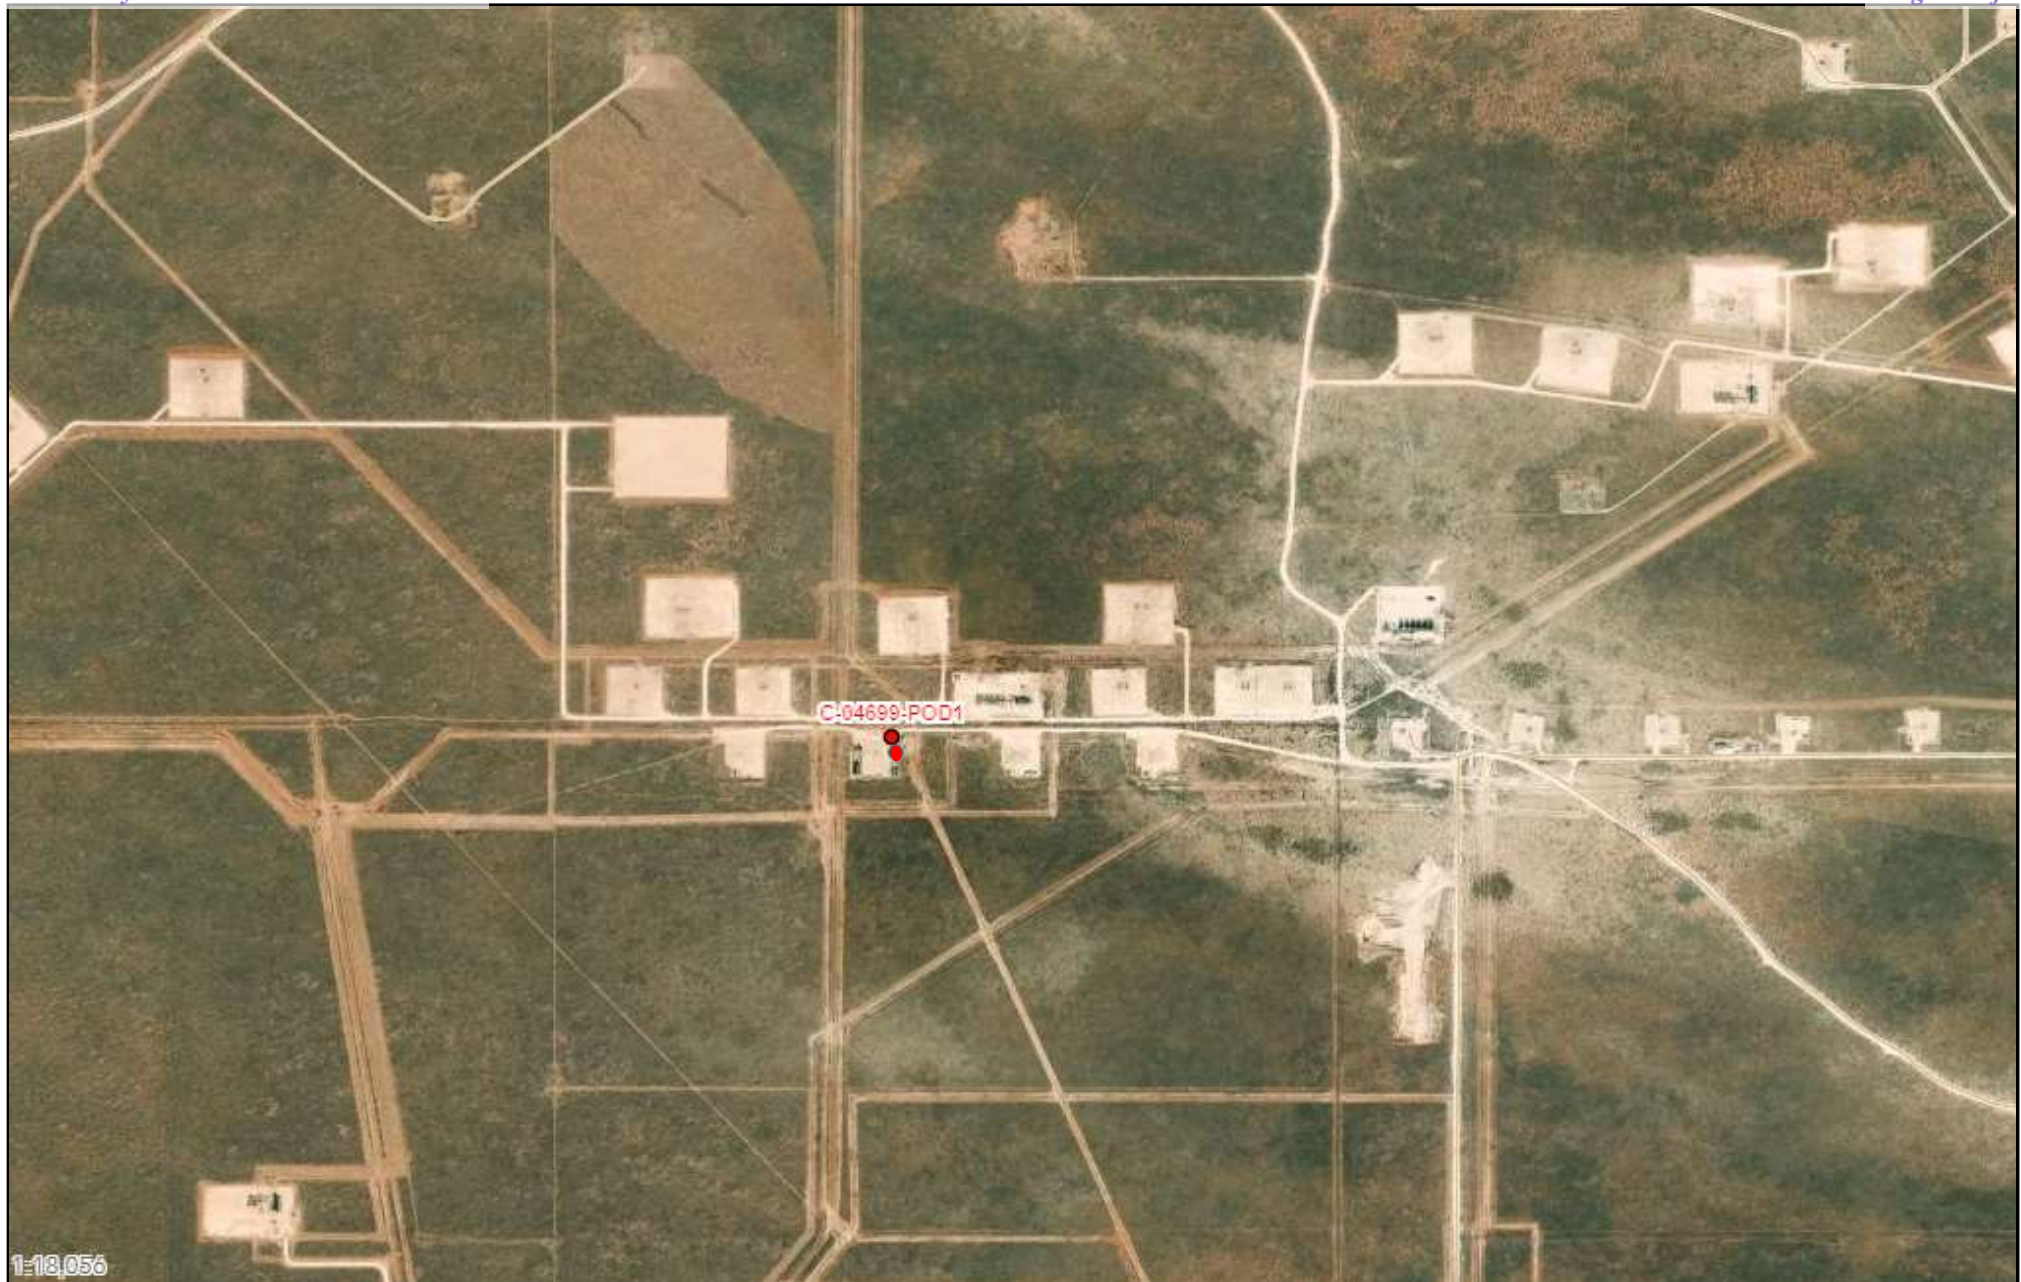
**Figure 2**

A search of the New Mexico Office of the State Engineer (NMOSE) and United States Geological Survey (USGS) groundwater databases was completed in an effort to determine the horizontal distance to known water sources within a half mile radius of the Release Site. Approximate depth to groundwater was determined using maintained and published water well data. Karst mapping indicates the site is located in a Karst designated area. Karst and Wetland Maps are provided as Attachment I. Depth to groundwater information is provided as Attachment IV and the results are depicted on Figures 2 & 3.

OSE POD Locations Map  
BTA Oil Producers, LLC  
Rojo B Tank Battery  
GPS: 32.122733, -103.561319  
Lea County

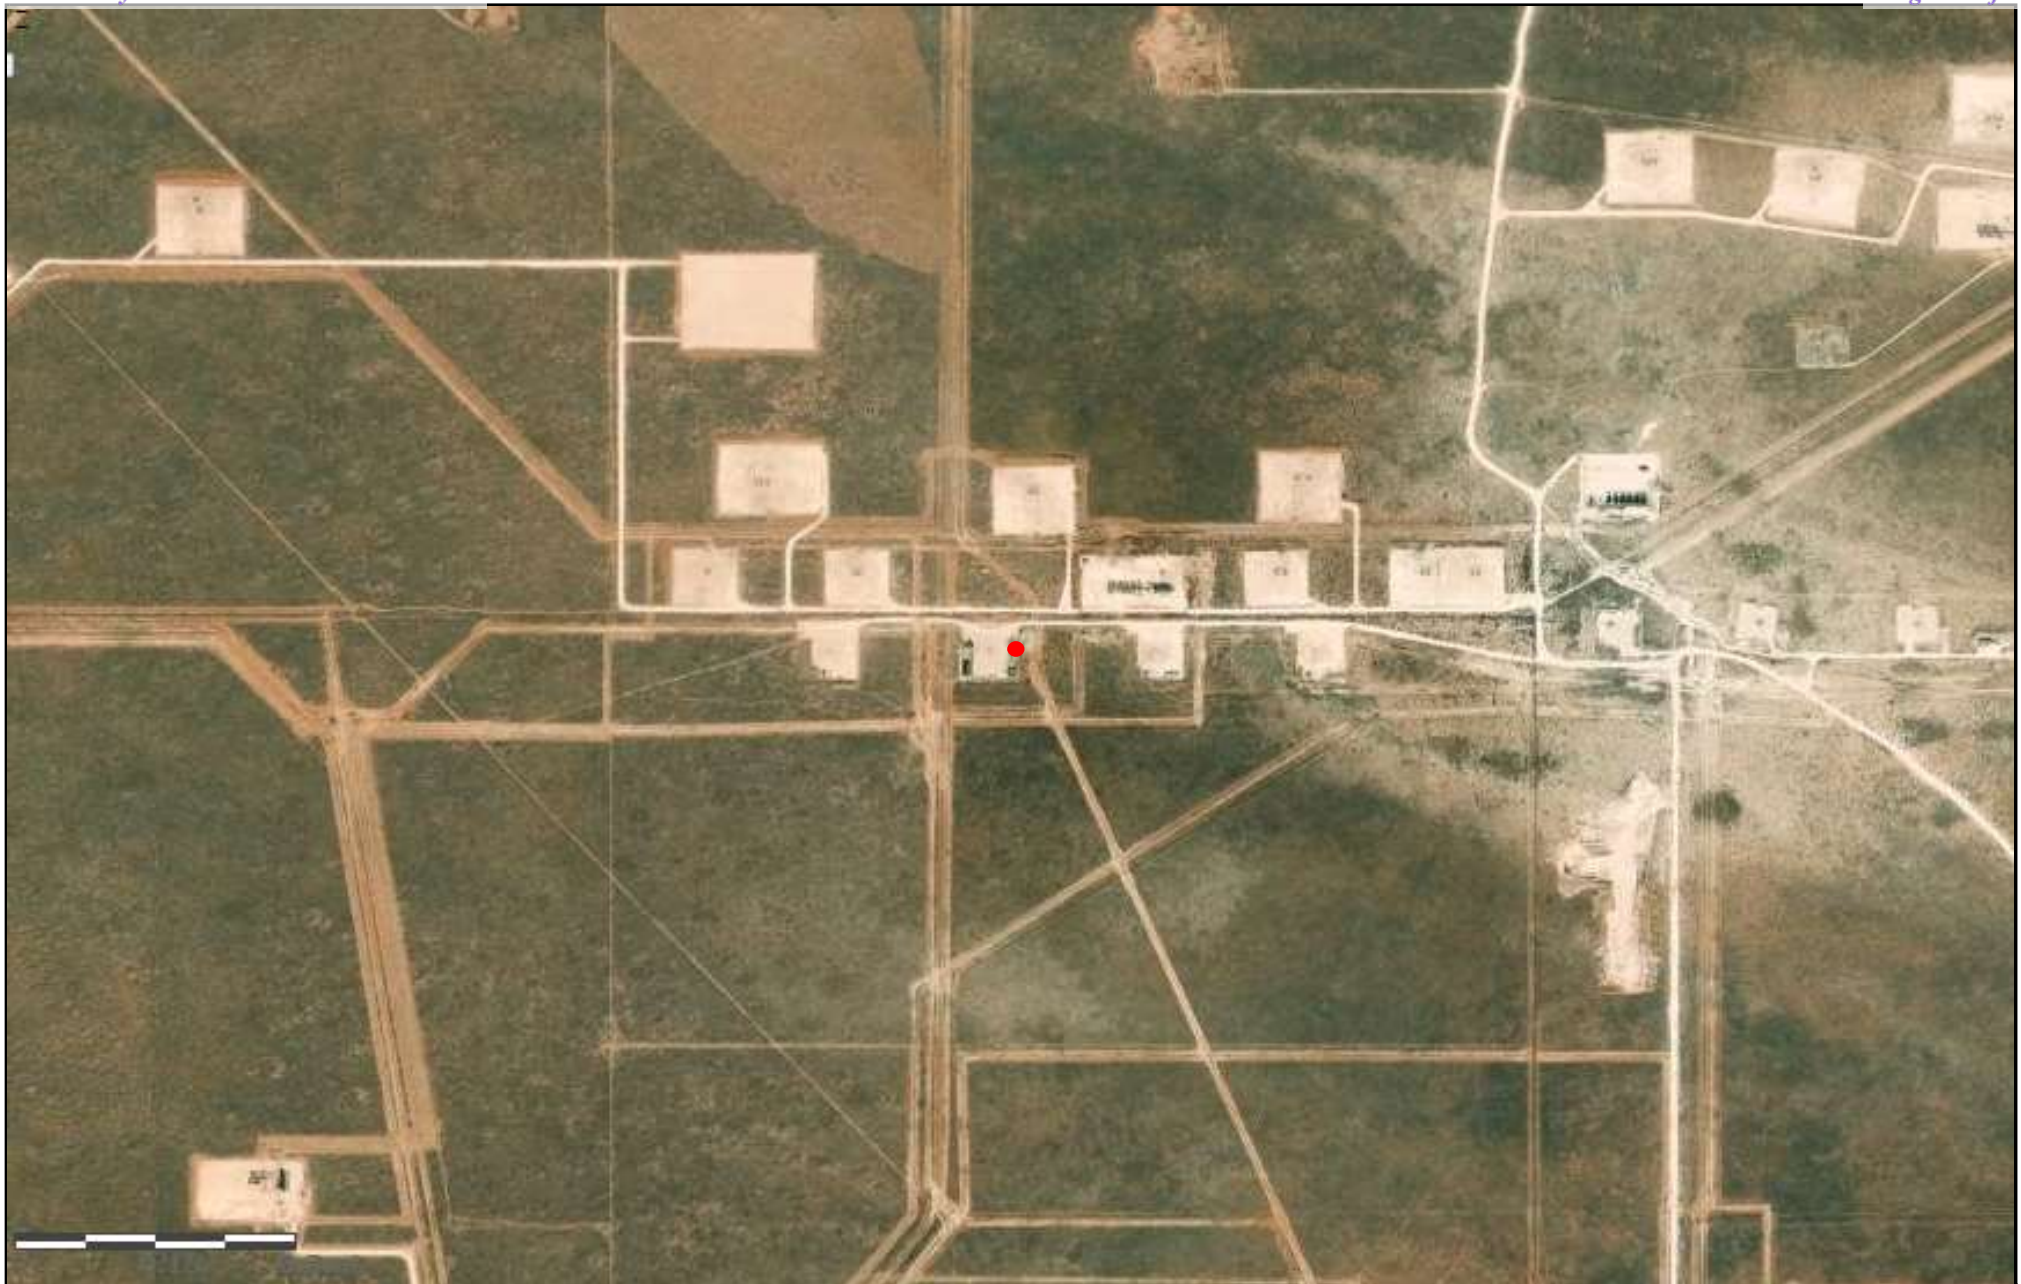
**Figure 3**

USGS Well Locations Map  
BTA Oil Producers, LLC  
Rojo B Tank Battery  
GPS: 32.122733, -103.561319  
Lea County

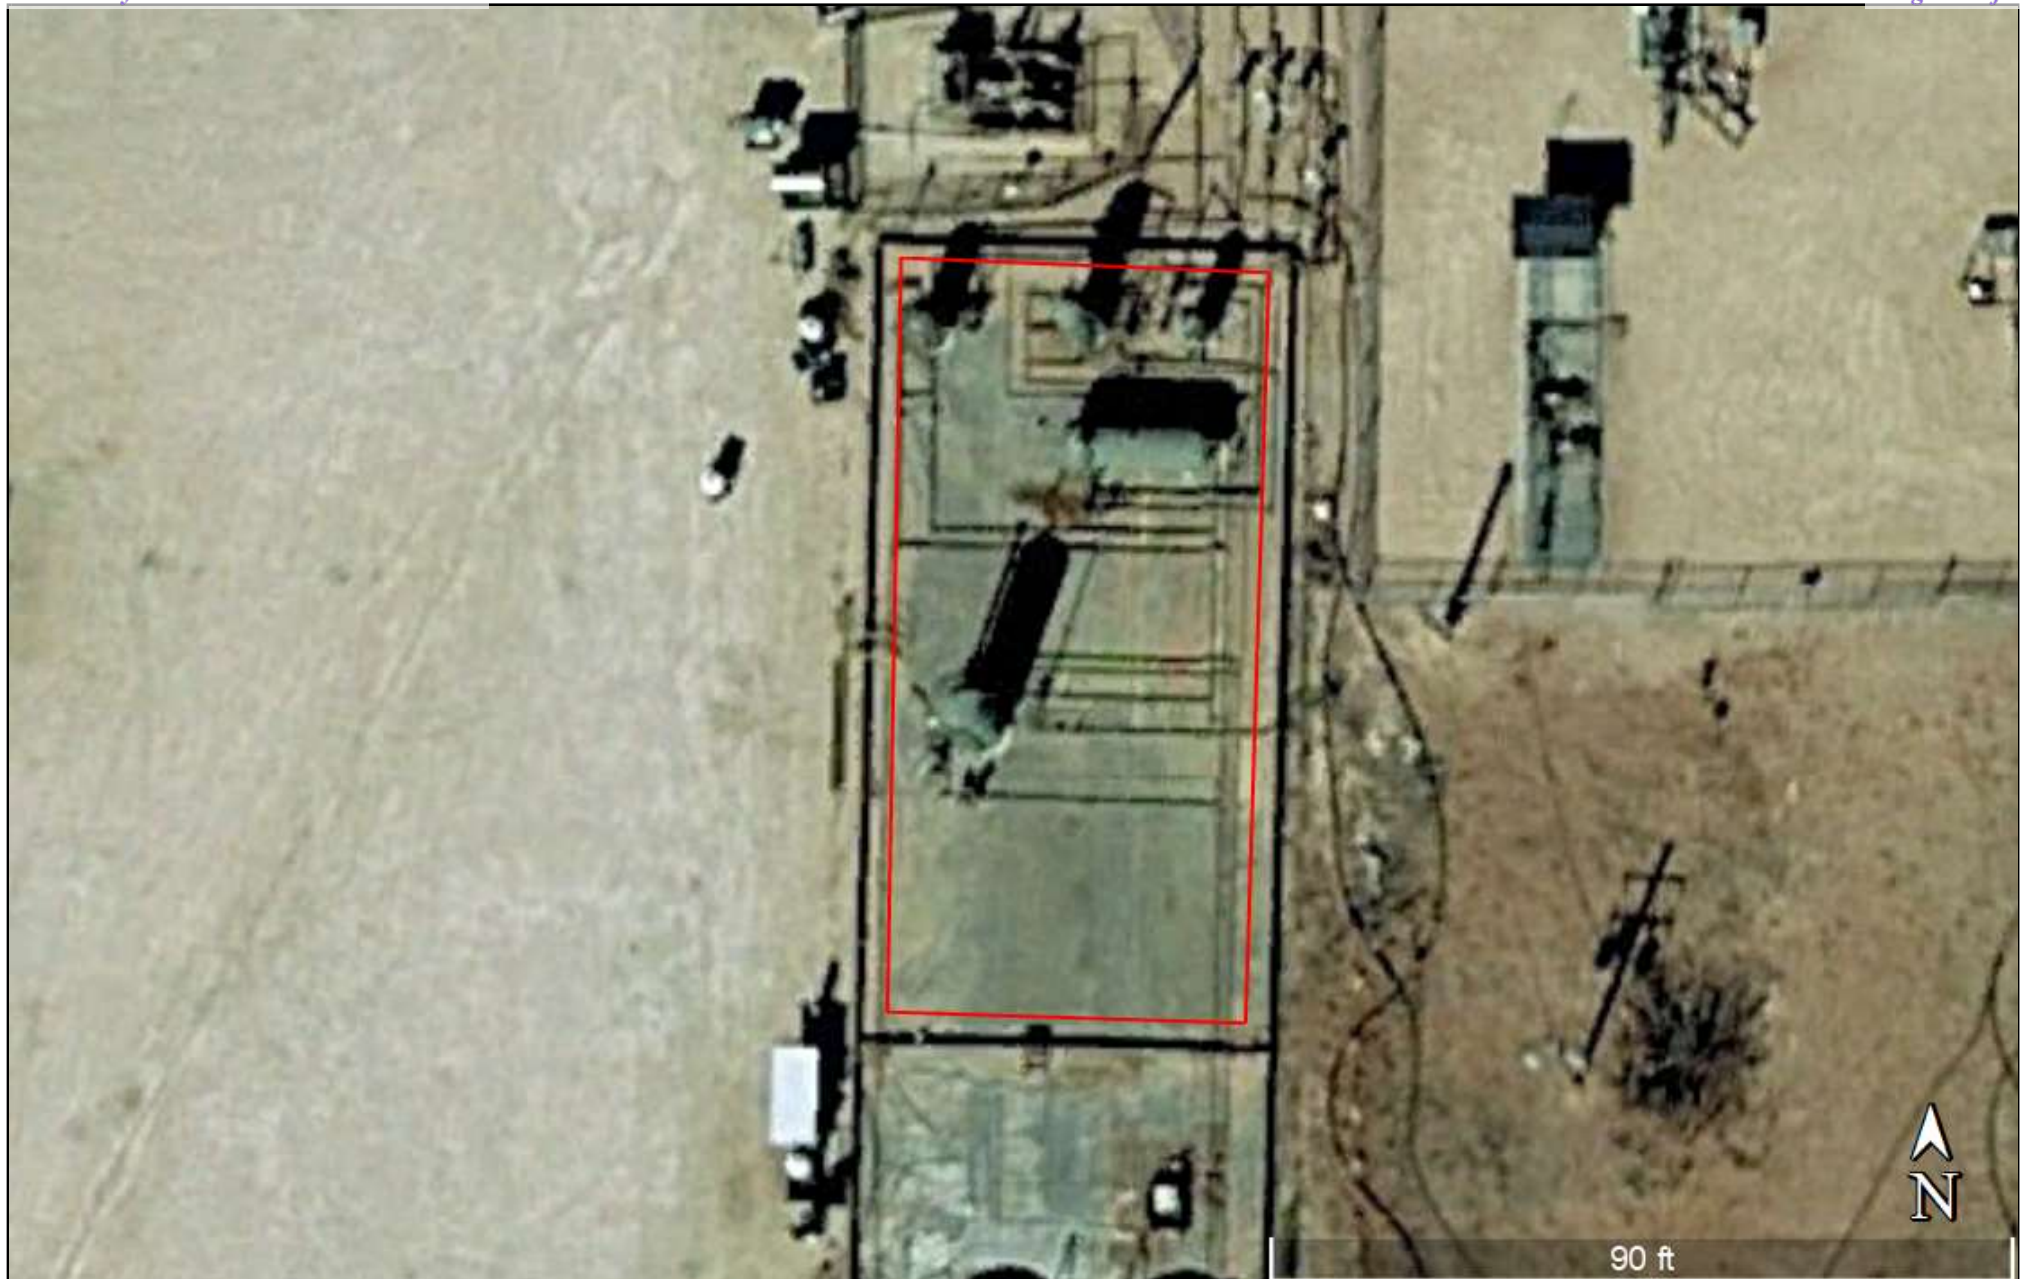
**Figure 4**

Liner Inspection Map  
BTA Oil Producers, LLC  
Rojo B Tank Battery  
GPS: 32.122733, -103.561319  
Lea County

Release area within lined containment

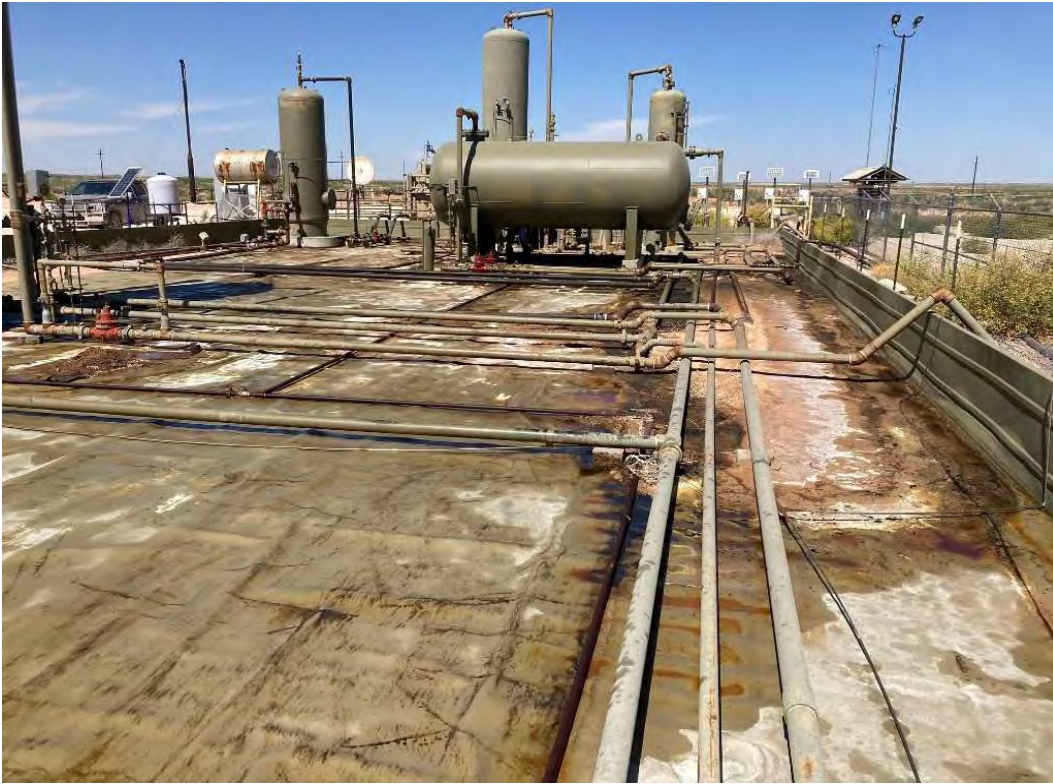
<b>Photo:</b>	<b>1</b>	<b>Description:</b> Release area - September 2023
---------------	----------	---

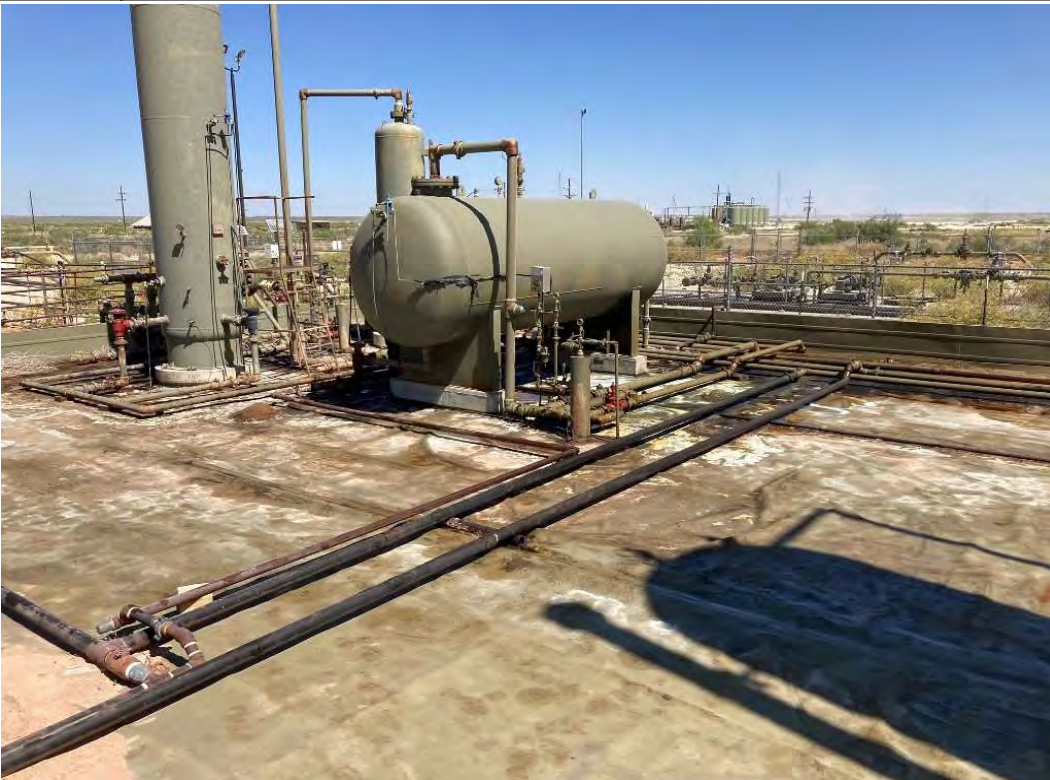
<b>Photo:</b>	<b>2</b>	<b>Description:</b> Release area - September 2023
---------------	----------	---

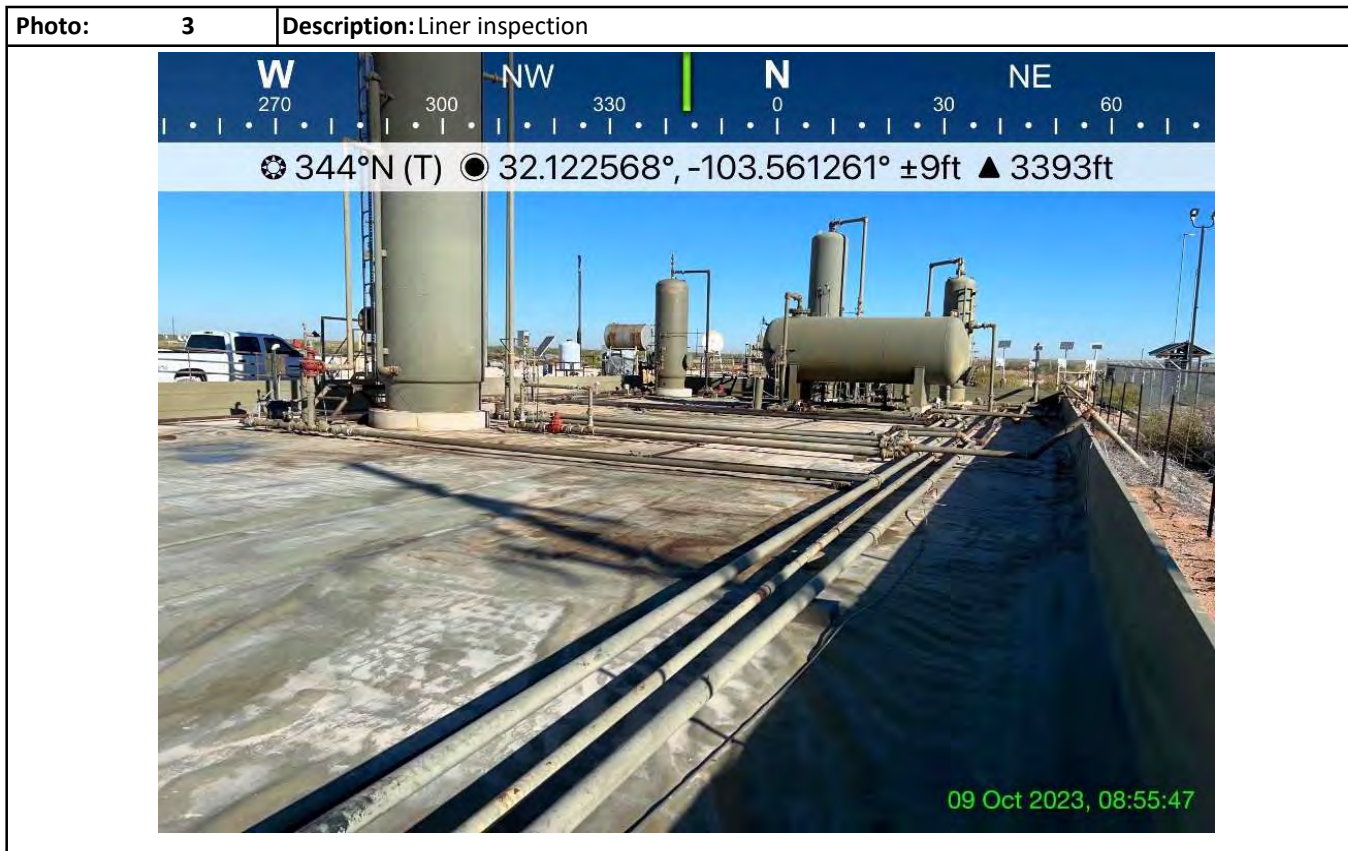
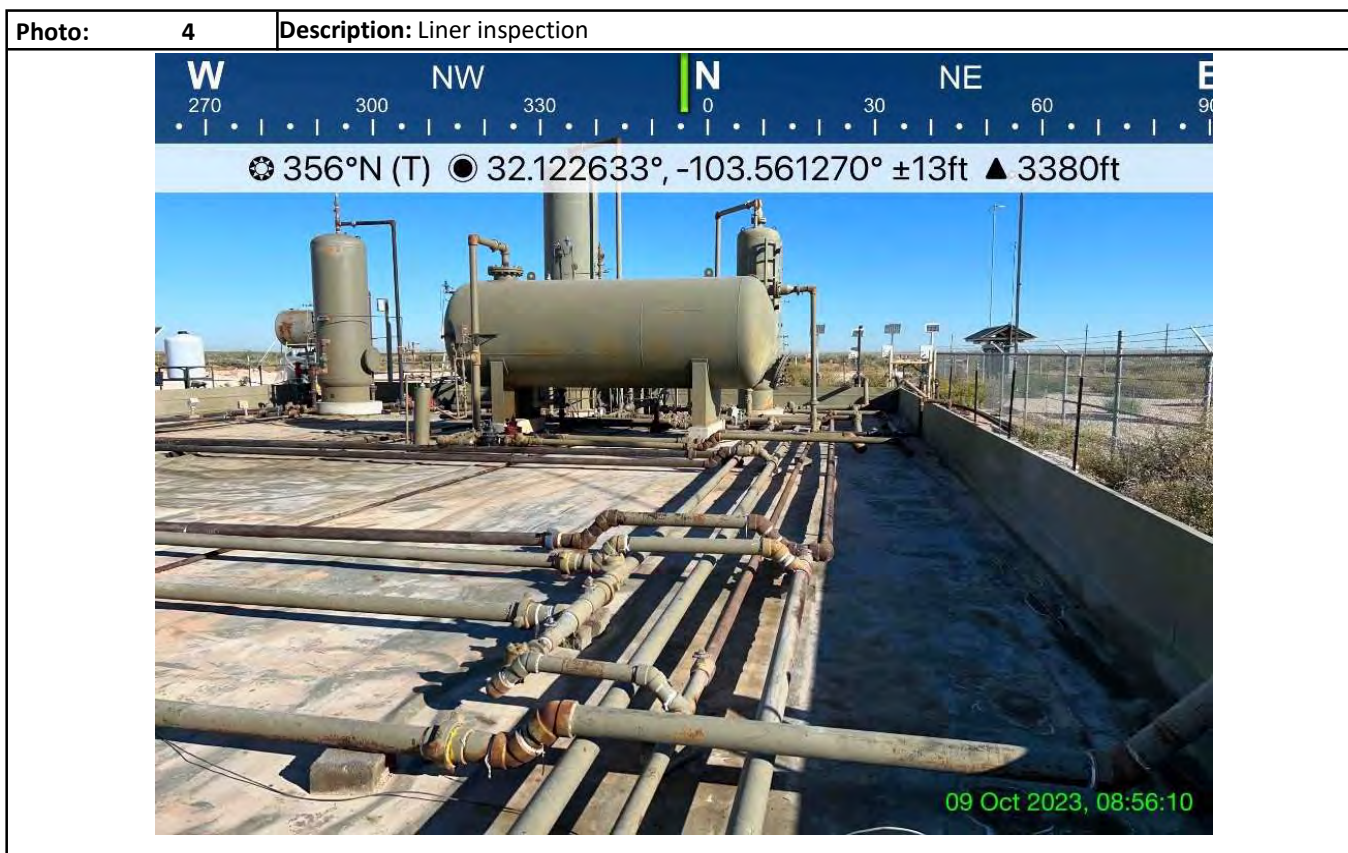
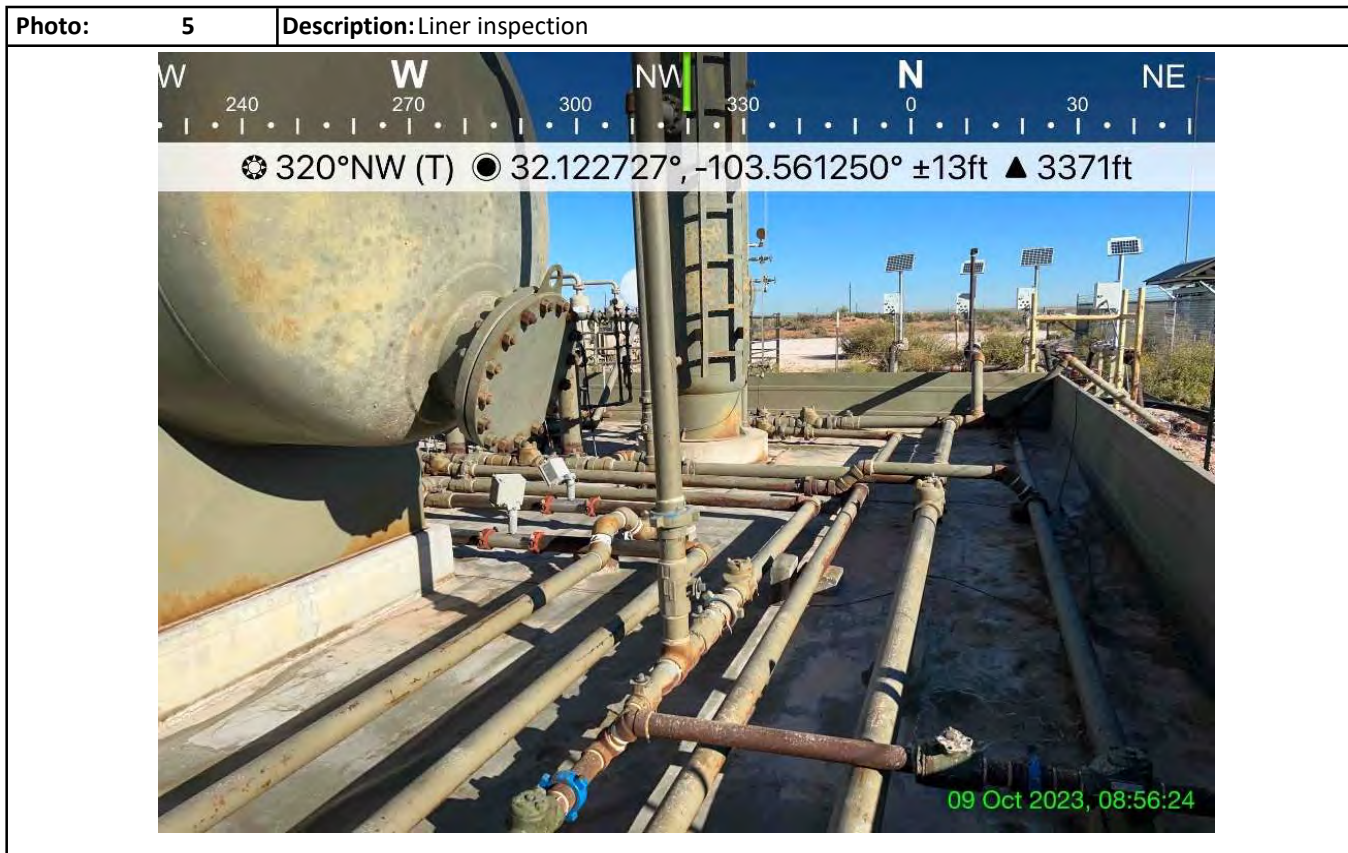
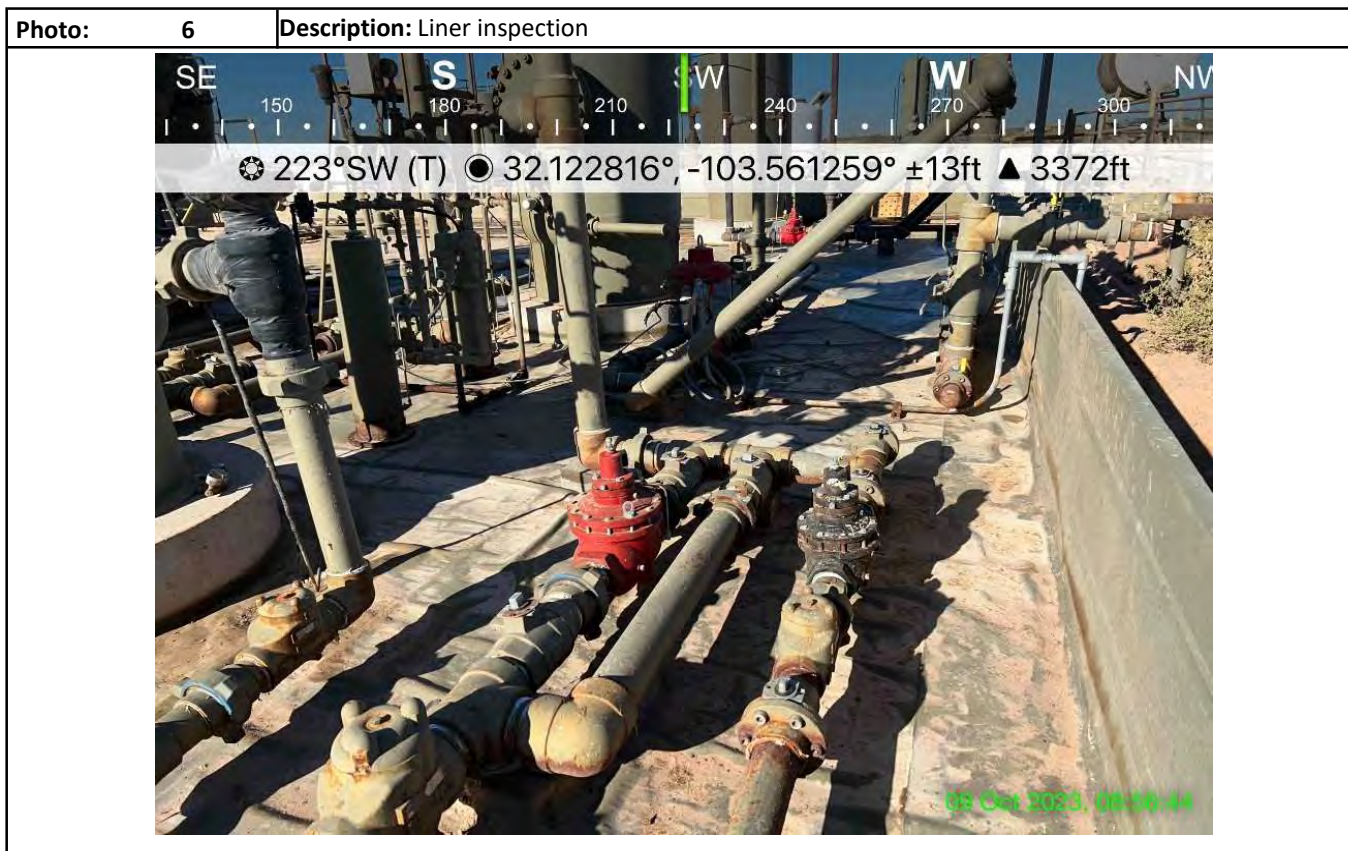
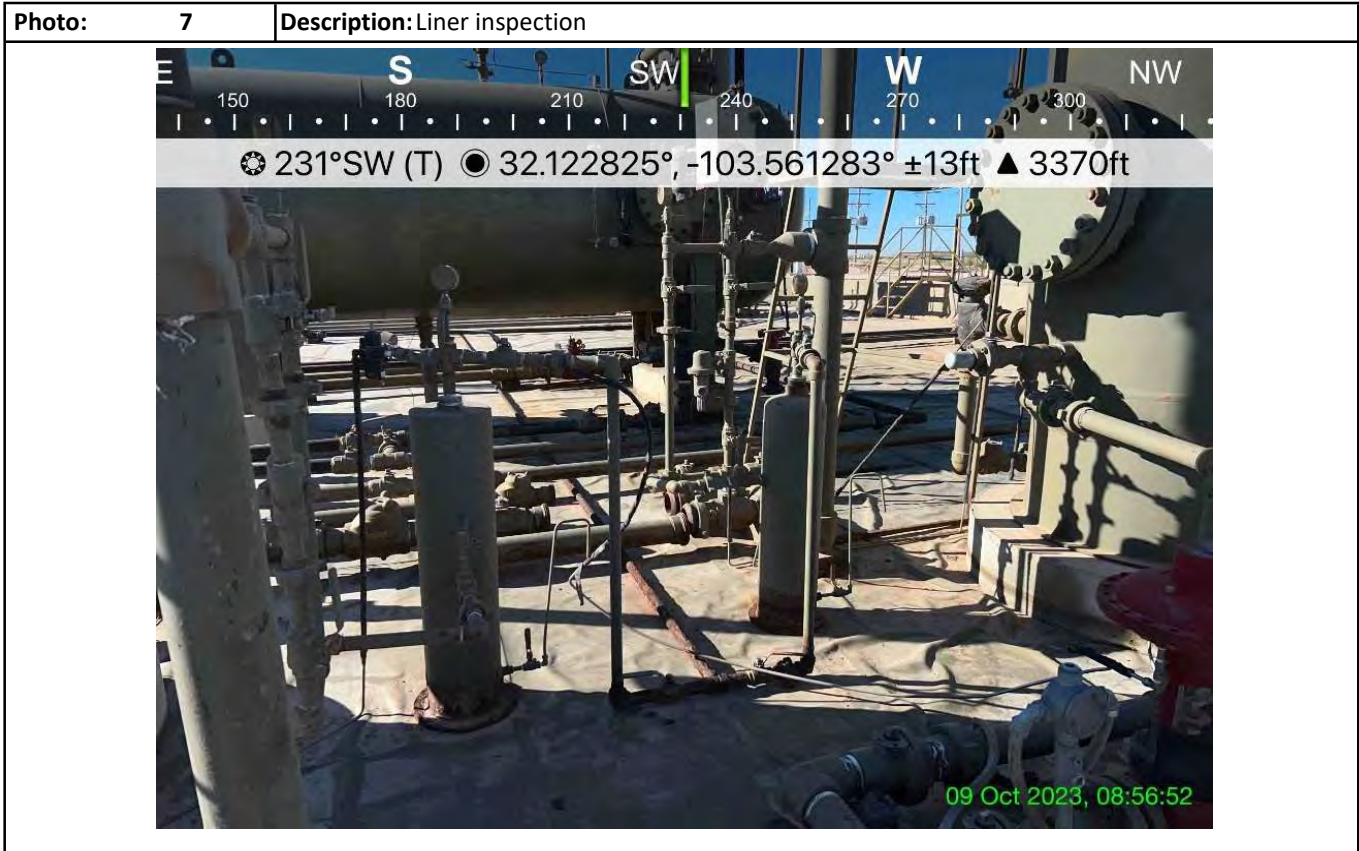
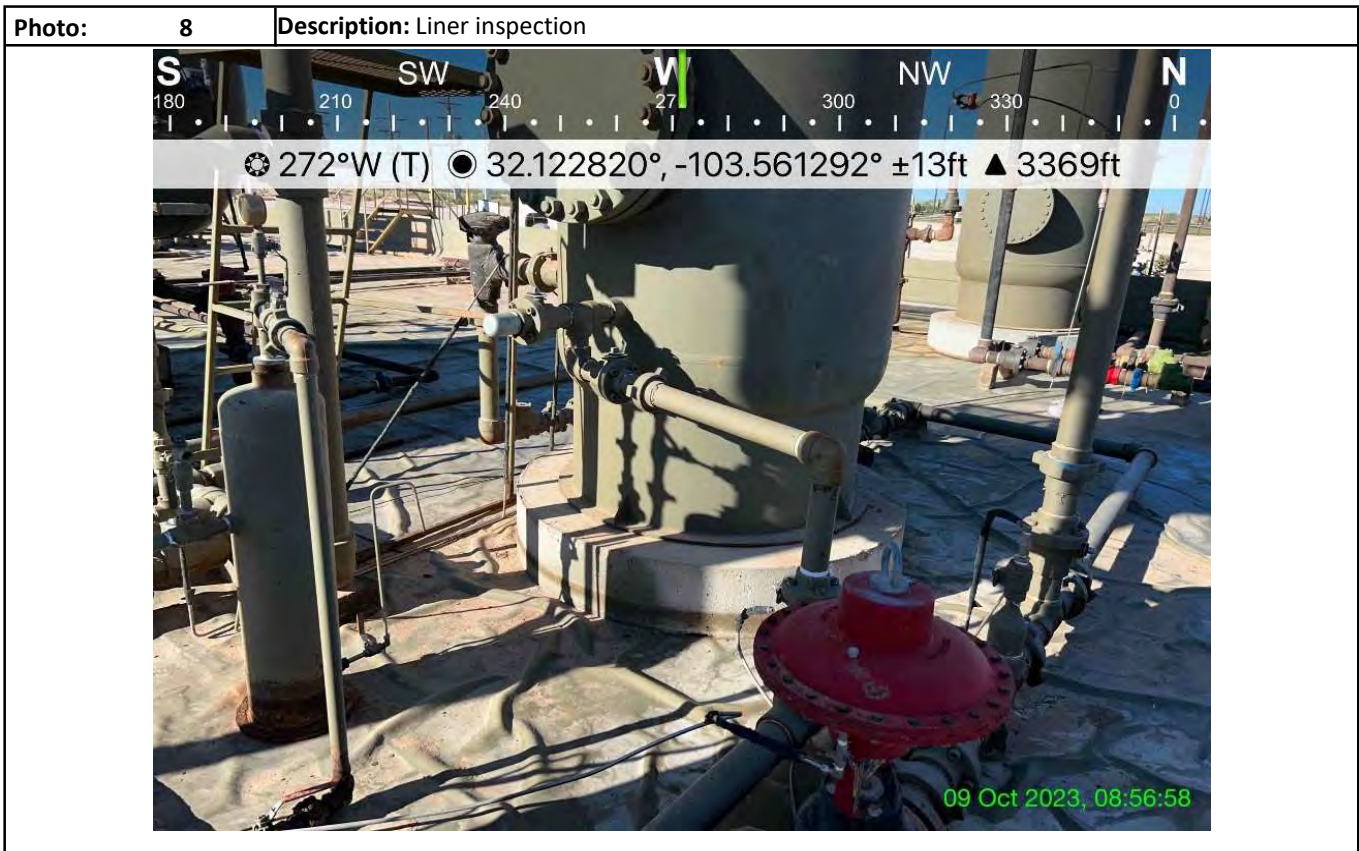
On October 9, 2023, Hungry Horse personnel arrived on location to inspect the liner. The liner and metal containment were thoroughly inspected form edge to edge, as well as around the tanks and process equipment installed on the liner itself. The liner was found to be in place, intact, with no visible, breaks, or tears. There was no evidence of the release escaping the metal containment area. A completed Liner Inspection Form is attached as Attachment V and Photographs are provided as Attachment III.

Based upon the reported volume recovered from the release and a thorough liner inspection with photographs demonstrating an intact, untorn, unbroken liner with no evidence of release escaping containment, BTA Oil Producers LLC respectfully requests closure of the Rojo B Tank Battery location, incident nAPP2327526699.
