Site Assessment/Characterization

State of New Mexico
Oil Conservation Division

Based on laboratory analytical results and field activities conducted to date, Etech recommends Mewbourne Oil Company provide copies of this *Remediation Summary & Soil Closure Request* to the appropriate agencies and request closure be granted to the ARWMS Deer Booster 82623 release site.

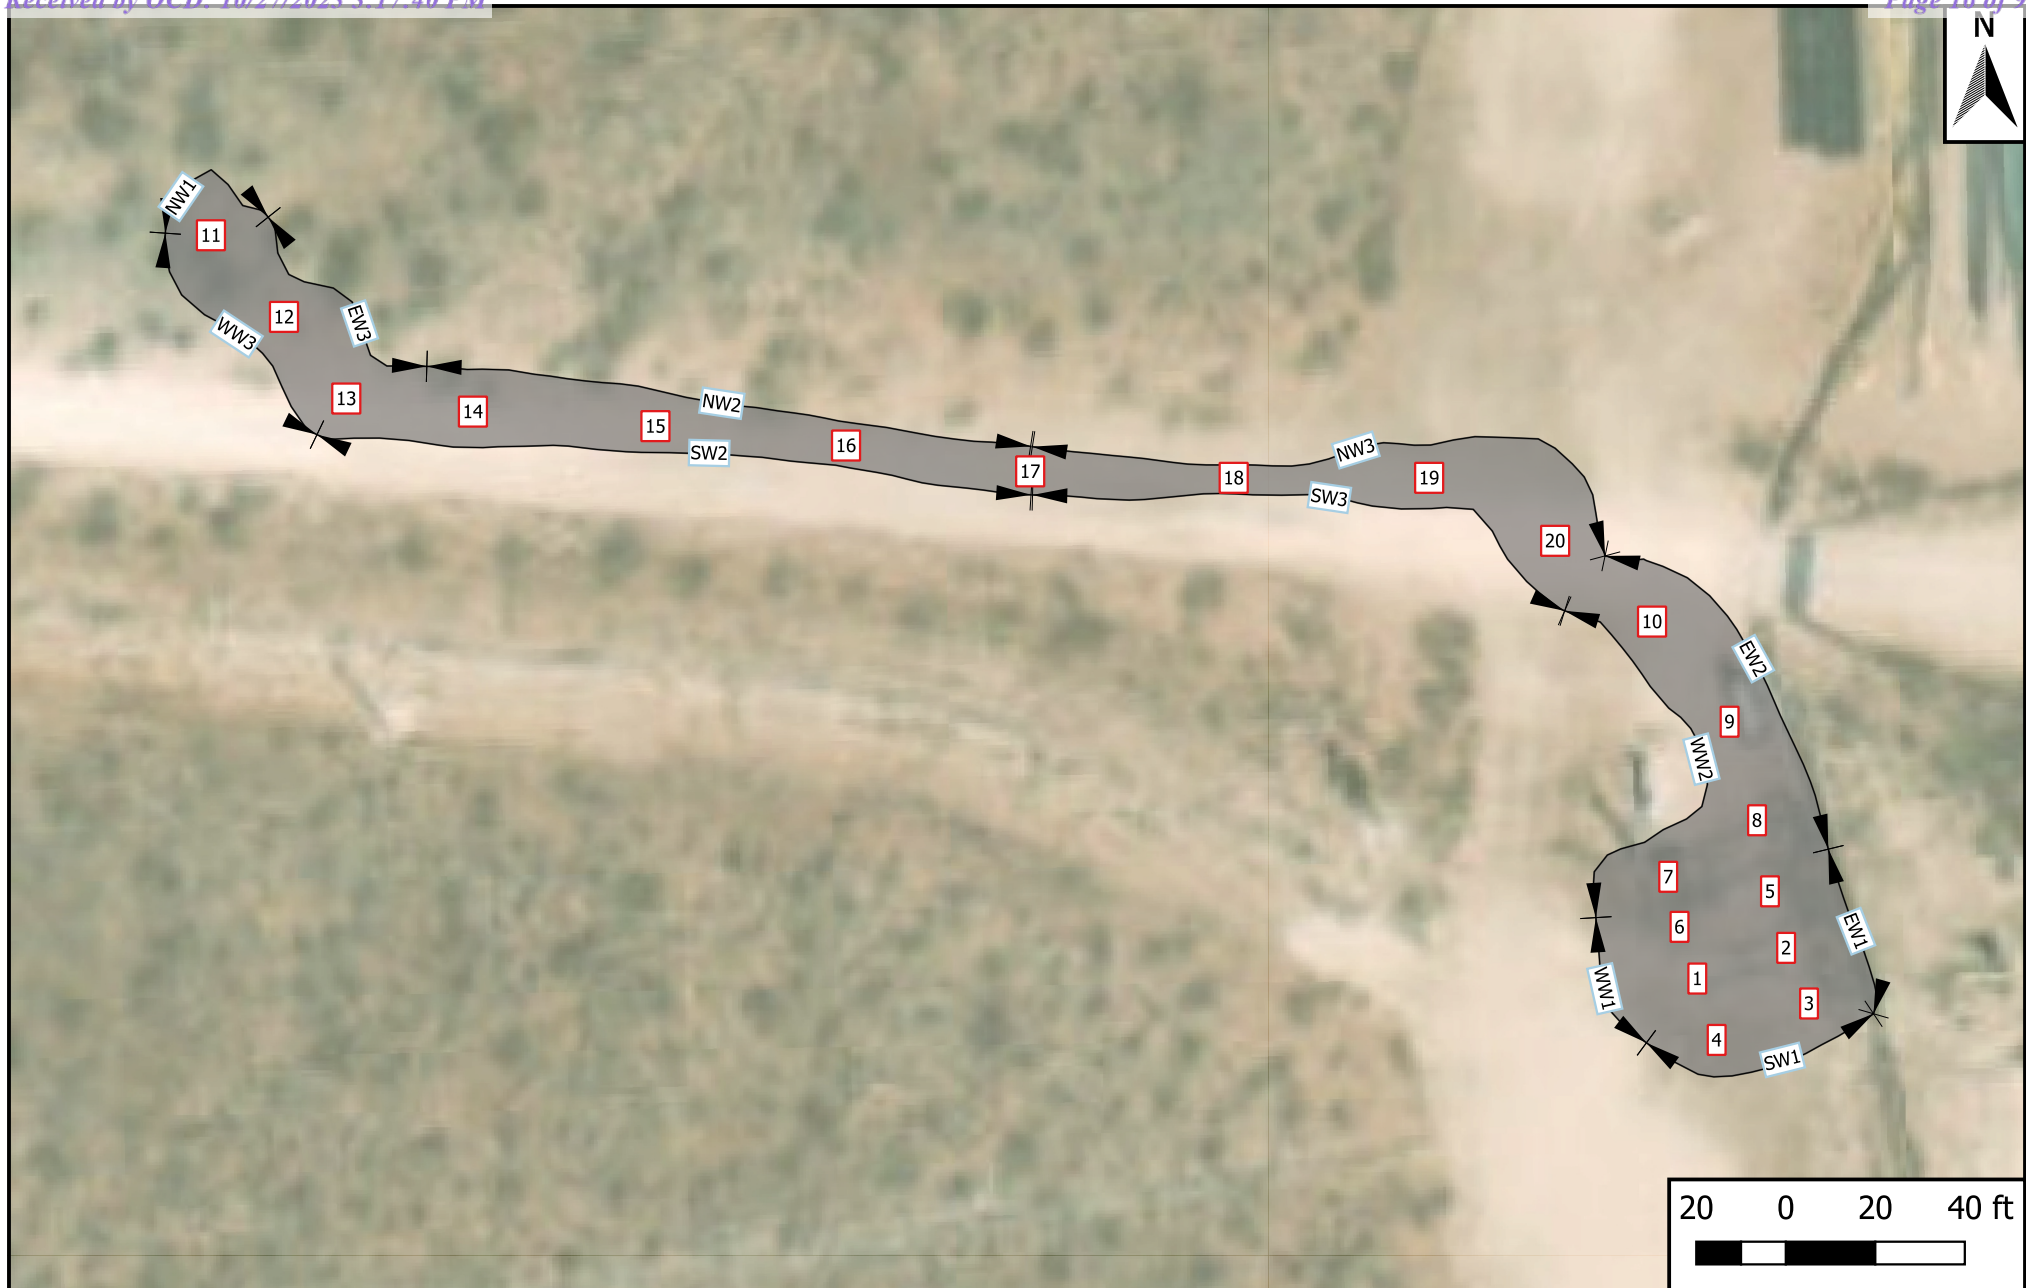
Figure 3

Site & Sample Location Map

- Excavation Extent
- Composite Floor Sample
- Composite Wall Sample

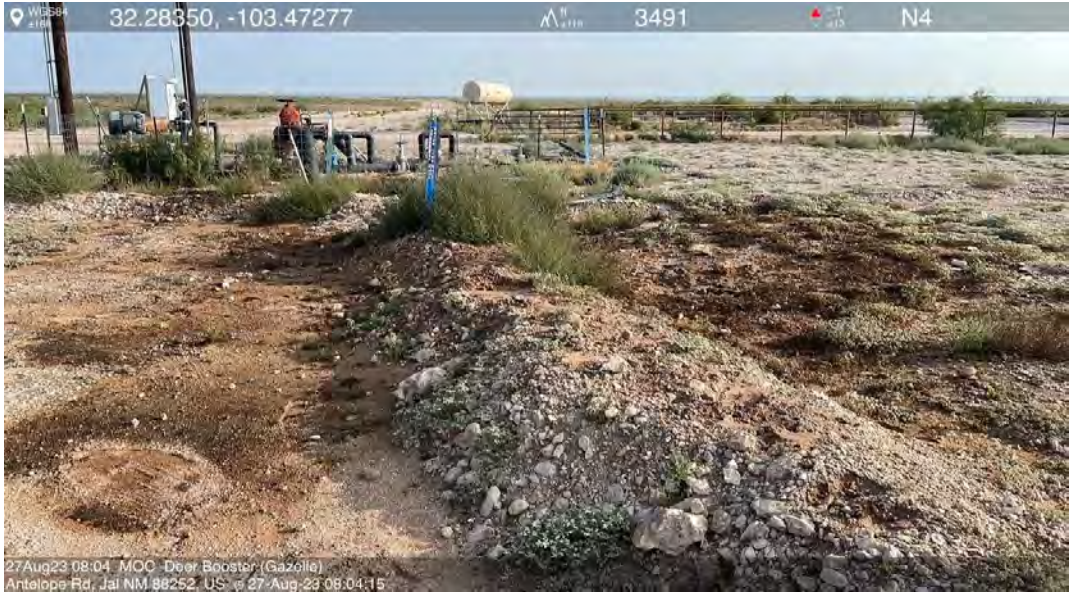
Photo Number: 1

<p>27Aug23 08:04 MOC - Deer Booster (Gazelle) Antelope Rd, Jai NM 88252, US 27-Aug-23 08:04:15</p>
Photo Direction: North	
Photo Description: View of the affected area.

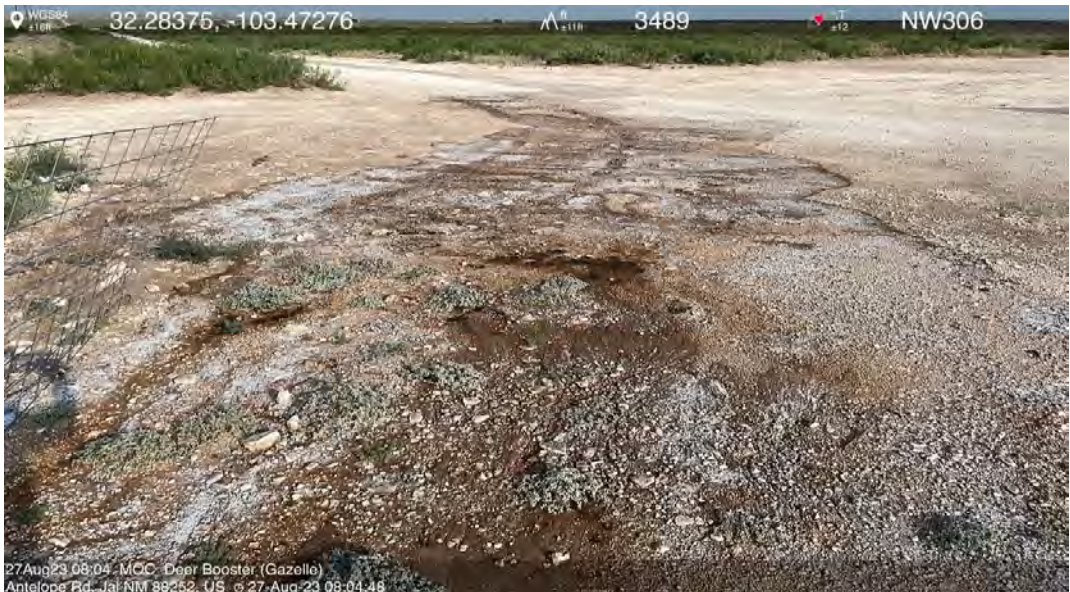
Photo Number: 2

<p>27Aug23 08:04 MOC - Deer Booster (Gazelle) Antelope Rd, Jai NM 88252, US 27-Aug-23 08:04:48</p>
Photo Direction: Northwest	
Photo Description: View of the affected area.

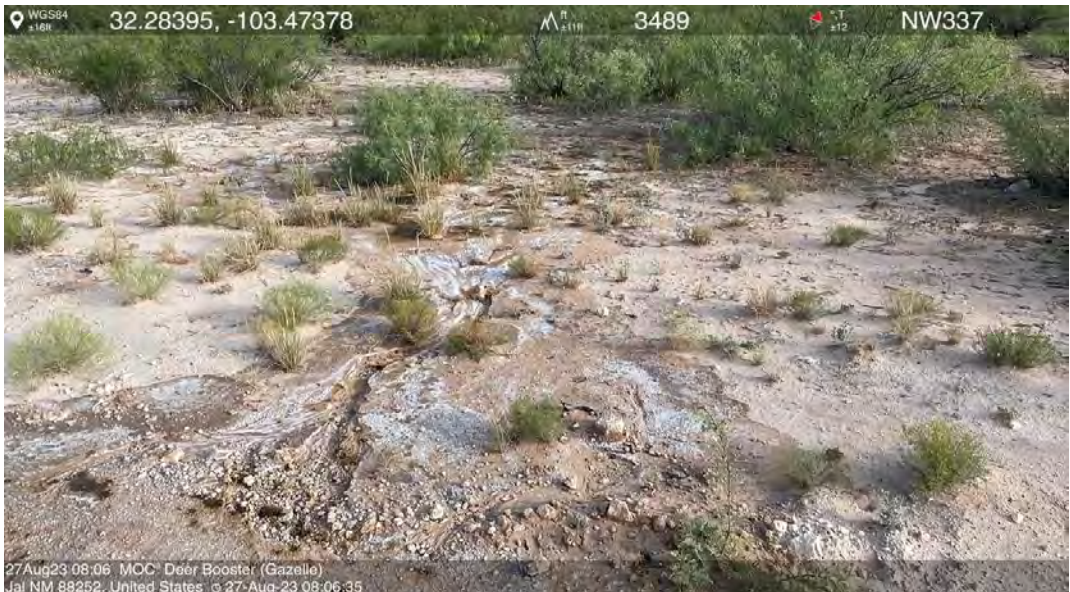
Photo Number: 6

Photo Direction: North-Northwest	
Photo Description: View of the affected area.

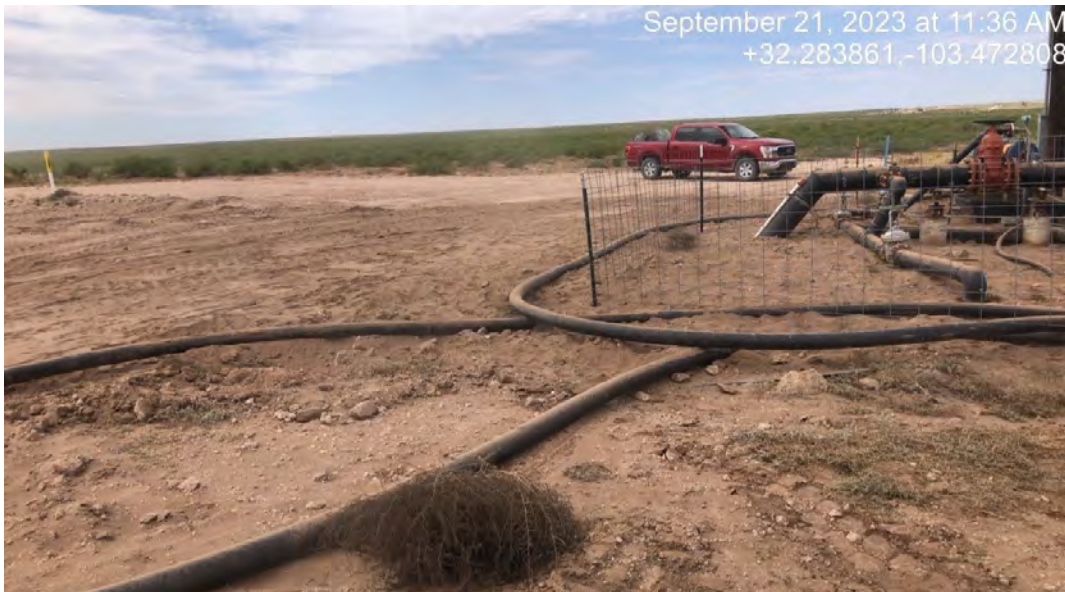
Photo Number: 13

<p>September 21, 2023 at 11:36 AM +32.283861,-103.472808</p>
Photo Direction: South-Southeast	
Photo Description: View of the remediated area after backfill and regrading.

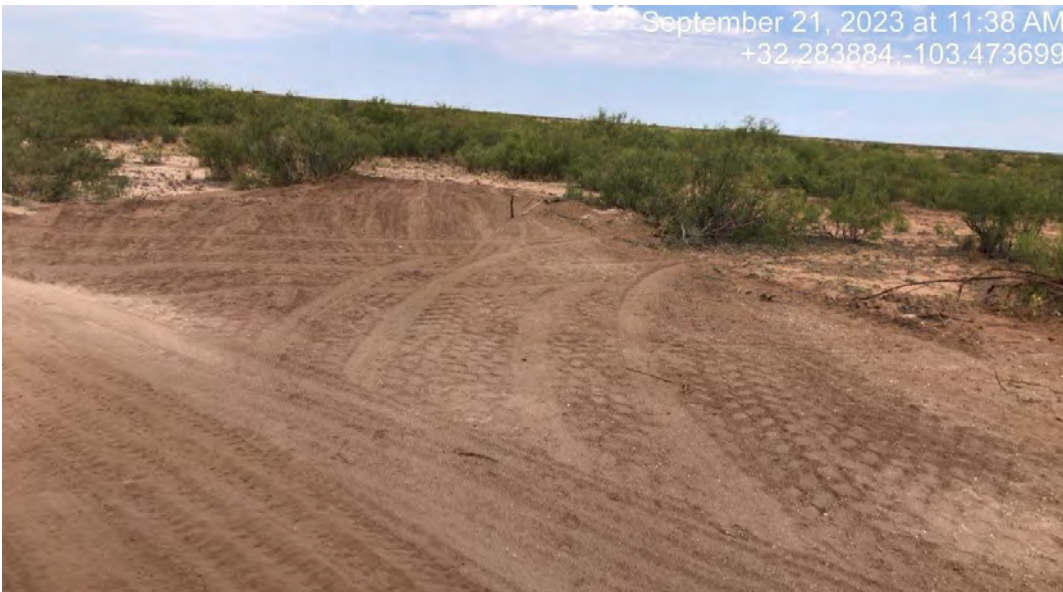
Photo Number: 16

Photo Direction: Northwest	
Photo Description: View of the remediated area after backfill and regrading.
