**Re: Closure Request
Chiso 14 State 8711 Flowline
Incident Number NRM2034960665
Lea County, New Mexico**

BTA Oil Producers, LLC
Closure Request
Chiso 14 State 8711 Flowline

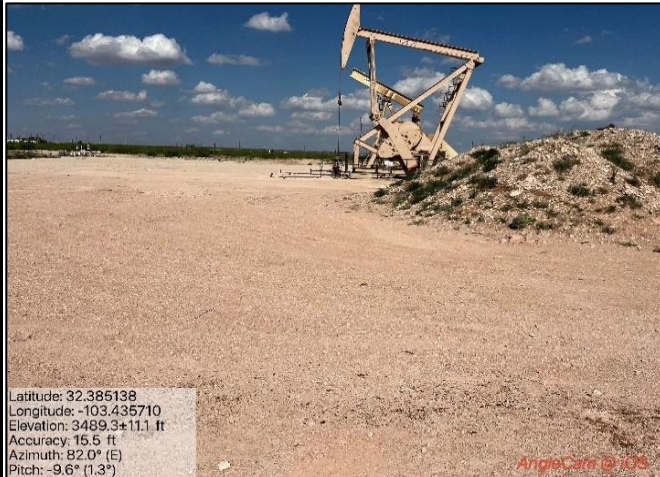
Photograph: 1 Date: 5/24/2023
Description: Initial assessment activities
View: East

On May 24 and May 30, 2023, Ensolum personnel visited the Site to evaluate the release extent based on information provided on the Form C-141 and visual observations. Six assessment soil samples (SS01 through SS06) were collected within and around the release extent at a depth of approximately 0.25 feet bgs to assess for the presence or absence of impacted soil resulting from the release. The soil samples were field screened for volatile organic compounds (VOCs) utilizing a calibrated photoionization detector (PID) and chloride using Hach® chloride QuanTab® test strips. The soil sample locations were mapped utilizing a handheld Global Positioning System (GPS) unit and are depicted on Figure 2. Photographic documentation was completed during the Site visit and a photographic log is included as Appendix B.

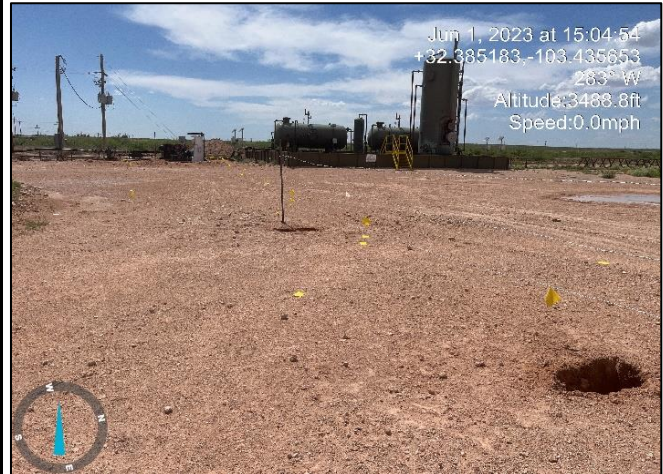
Photograph: 2 Date: 6/1/2023
Description: Delineation activities
View: West

On June 1, 2023, Ensolum personnel returned to the Site to complete vertical delineation activities to determine the depth of impacts identified during the initial Site assessment. Potholes were advanced via hydro-vacuum at the location of assessment samples SS01 and SS02. The potholes were advanced to a depth of 4 feet bgs. Soil from the boreholes was field screened for VOCs and chloride. Field screening

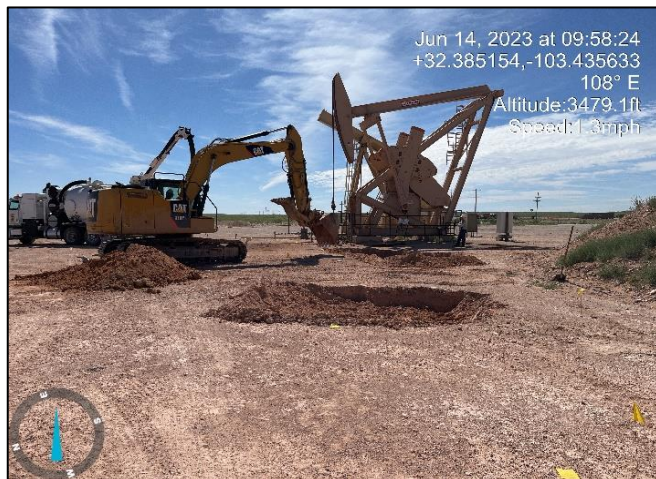
Photograph: 3 Date: 6/14/2023
Description: Excavation activities
View: Southeast

On June 14, 2023, Ensolum personnel were at the Site to oversee excavation activities based on laboratory analytical results for soil sample SS01. Excavation activities were performed utilizing a hydrovac and back-hoe. To direct excavation activities, soil was screened for VOCs and chloride. The excavation was completed to a depth of 4.5 feet bgs. Photographic documentation of the excavation activities is included in Appendix B.

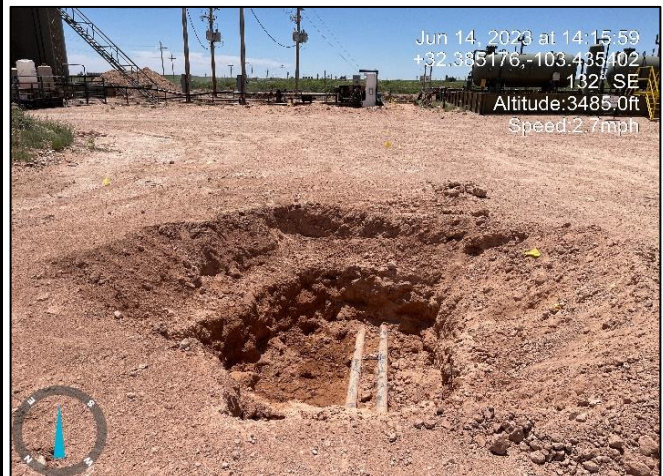
Photograph: 4 Date: 6/14/2023
Description: Excavation activities
View: Southeast
