**Re: Closure Request
Ogden 20509 32-29 Fed Com #5 & #6 Battery
Incident Number NRM2013250898
Eddy County, New Mexico**

Ensolum, LLC (Ensolum), on behalf of BTA Oil Producers, LLC (BTA), has prepared this *Closure Request* to document assessment and soil sampling activities performed at the Ogden 20509 32-29 Fed Com #5 & #6 Battery (Site). The purpose of the Site assessment and soil sampling activities was to assess the integrity of the lined containment and assess for the presence or absence of impacts to soil outside of the containment following a release of produced water within a lined containment at the Site. Based on field observations, field screening activities, and soil sample laboratory analytical results, BTA is submitting this *Closure Request*, describing Site assessment and delineation activities that have occurred and requesting no further action and closure for Incident Number NRM2013250898.

BTA Oil Producers, LLC
Closure Request
Ogden 20509 32-29 Fed Com #5 & #6 Battery

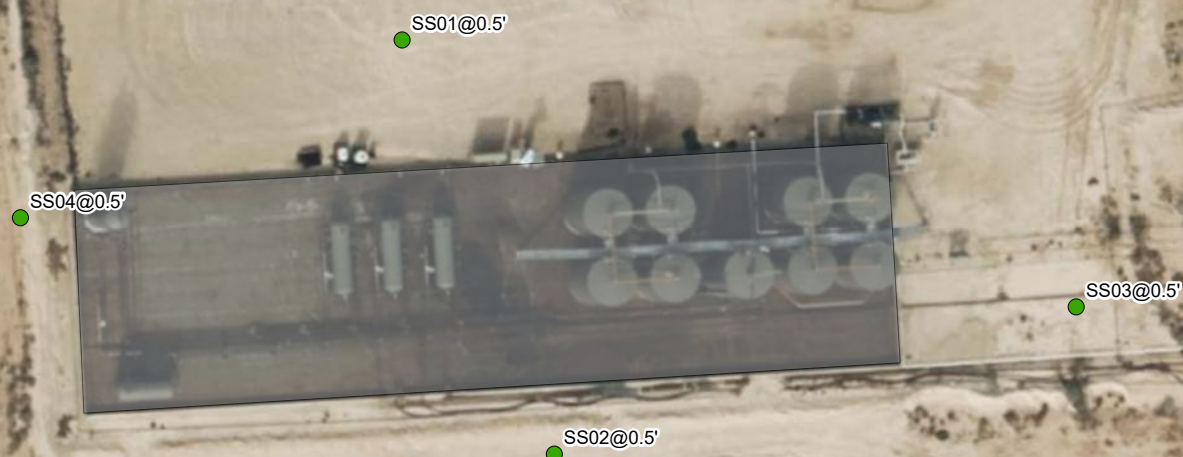
FIGURE
2

In addition to evaluating the integrity of the lined containment, which was determined to not be compromised, four discrete delineation soil samples, SS01 through SS04, were collected at a depth of 0.5 feet bgs to confirm the lateral release extent did not extend outside/breach the containment. Delineation soil samples were field screened for volatile organic compounds (VOCs) utilizing a calibrated photoionization detector (PID) and chloride using Hach® chloride QuanTab® test strips. The delineation soil sample locations are depicted on Figure 2. Photographic documentation was conducted at the Site. A photographic log is included in Appendix B.

- Delineation Soil Sample in Compliance with Closure Criteria
- Lined Containment Area

Delineation Soil Sample Locations

Laboratory analytical results for delineation soil samples SS01 through SS04 indicated all COC concentrations were compliant with most stringent Table I Closure Criteria and successfully defined the lateral extent of the release and confirmed produced water did not breach the walls of the lined containment. Laboratory analytical results are summarized in Table 1 and the complete laboratory analytical reports are included as Appendix C.

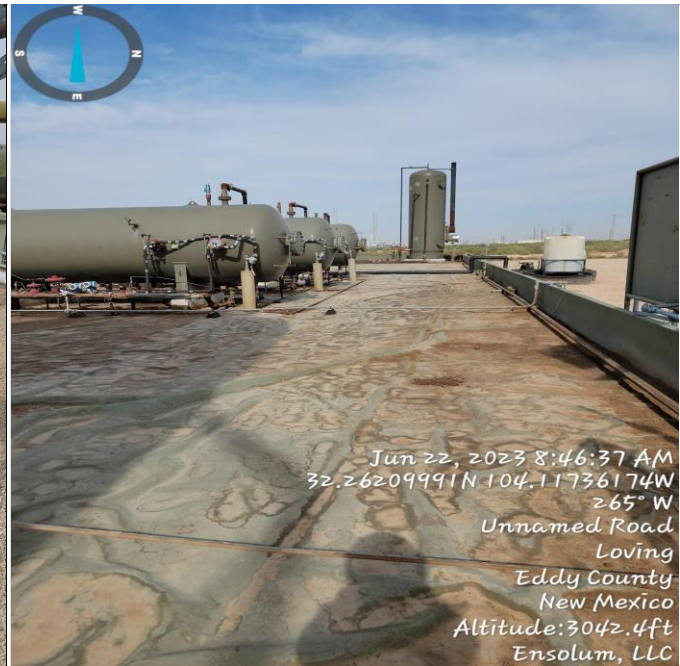
Photograph 2

Description: View of lined containment deemed to be in good condition facing west

A 48-hour advance notice of the liner inspection was provided via email on June 19, 2023, to the NMOCD. A liner integrity inspection was conducted by Ensolum personnel on June 22, 2023. Upon inspection, no rips, tears, holes, or damage was observed. The liner was determined to be sufficient and all released fluids have been removed.
