Incident ID	nAPP2305942242
District RP	
Facility ID	
Application ID

## Site Assessment/Characterization

Based on laboratory analytical results and field activities conducted to date, Etech recommends Mewbourne Oil Company provide copies of this *Remediation Summary & Soil Closure Request* to the appropriate agencies and request closure be granted to the Malaga 30 Battery release site.

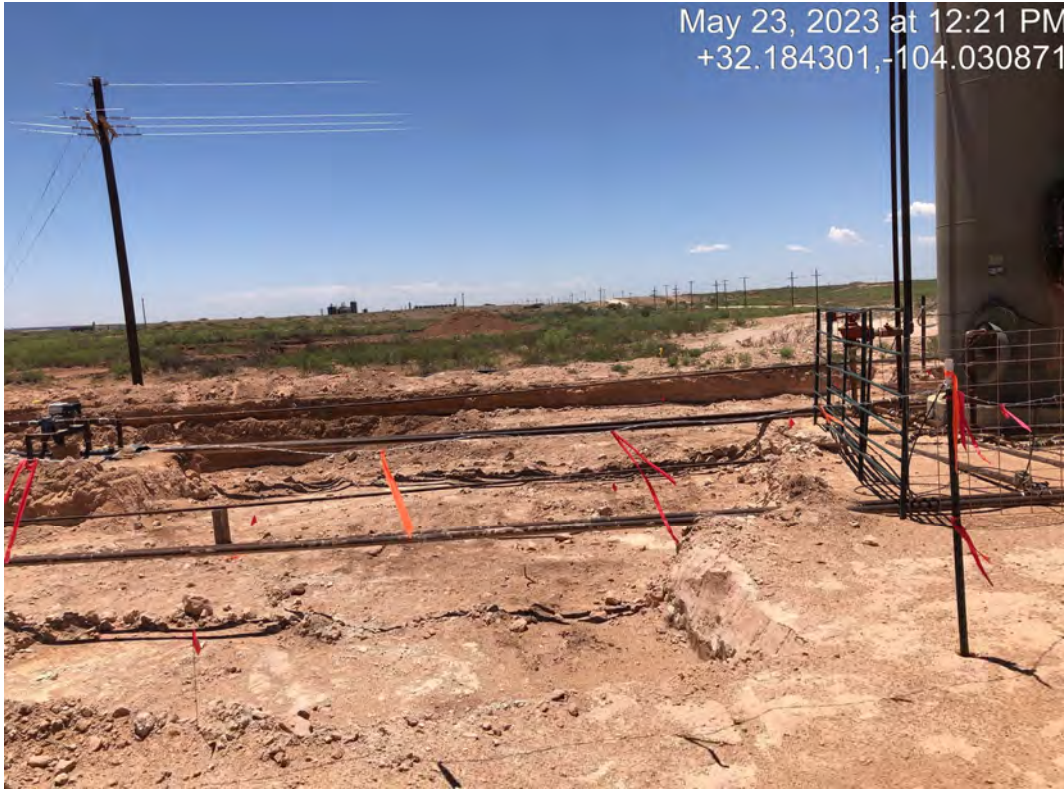
<b>Photo Number:</b> 8

<b>Photo Direction:</b> South	
<b>Photo Description:</b>  View of the excavated area.

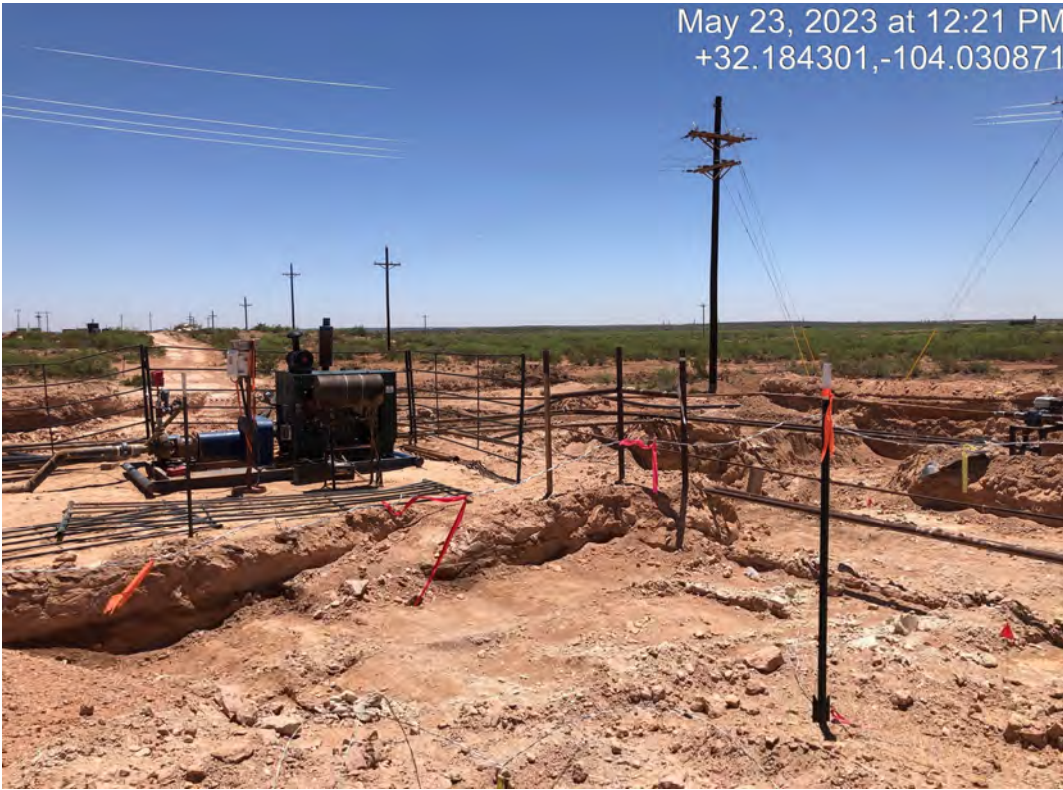
<b>Photo Number:</b> 9	<div>May 23, 2023 at 12:21 PM +32.184301,-104.030871</div>

A photograph showing a large, rectangular excavation pit in a dry, sandy area. In the background, a generator and other equipment are visible. Power lines and poles are in the distance under a clear blue sky. The ground is reddish-brown soil.
<b>Photo Direction:</b> Southeast	
<b>Photo Description:</b>  View of the excavated area.

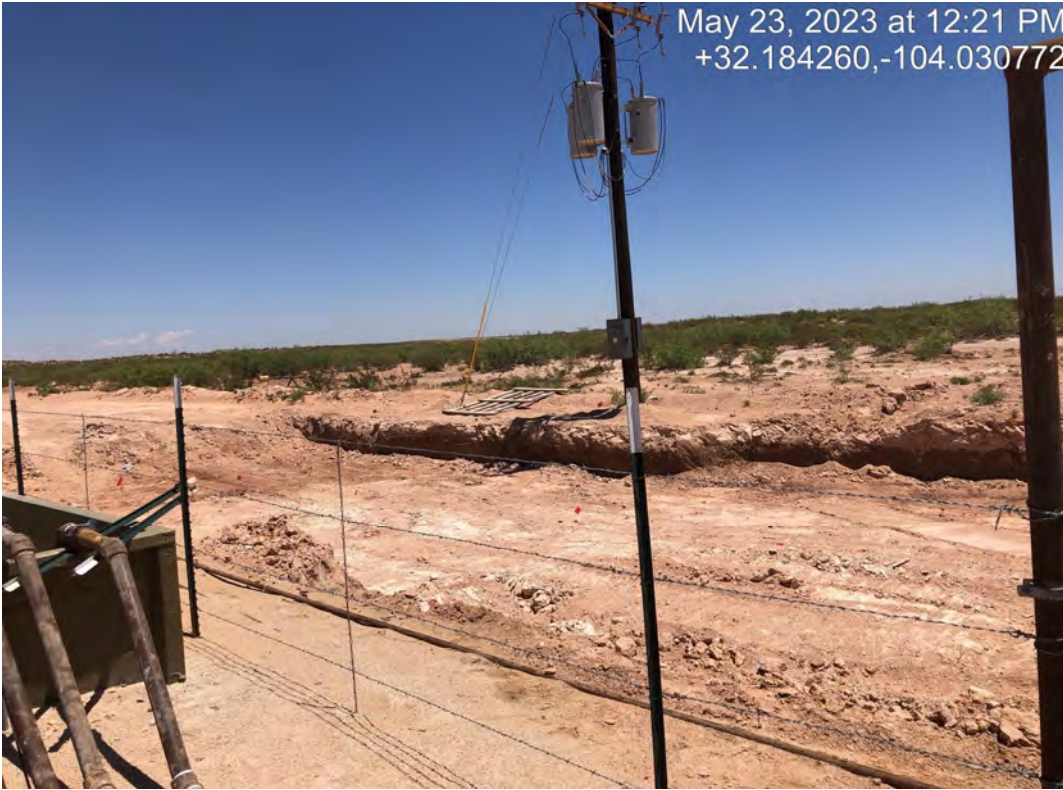
<b>Photo Number:</b> 10	<div>May 23, 2023 at 12:21 PM +32.184260,-104.030772</div>

A photograph showing a large, rectangular excavation pit in a dry, sandy area. In the background, a generator and other equipment are visible. Power lines and poles are in the distance under a clear blue sky. The ground is reddish-brown soil.
<b>Photo Direction:</b> Northeast	
<b>Photo Description:</b>  View of the excavated area.

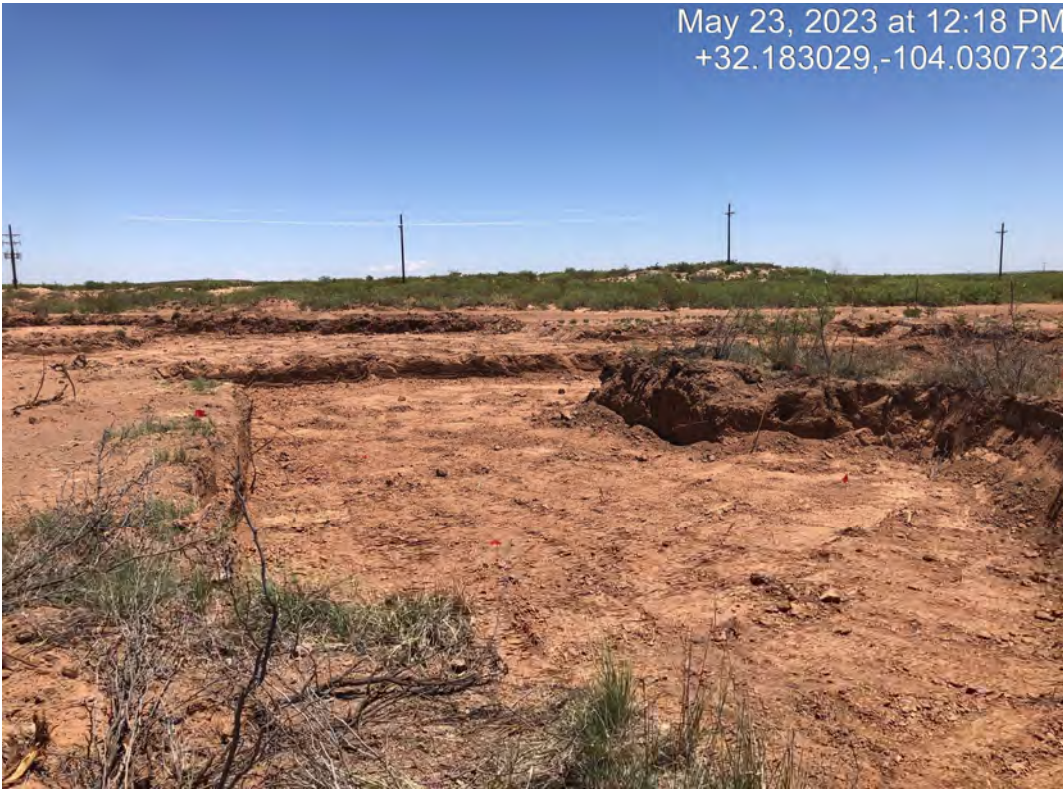
<b>Photo Number:</b> 11	<div>May 23, 2023 at 12:18 PM +32.183029,-104.030732</div>

<b>Photo Direction:</b> Southeast	
<b>Photo Description:</b>  View of the excavated area.

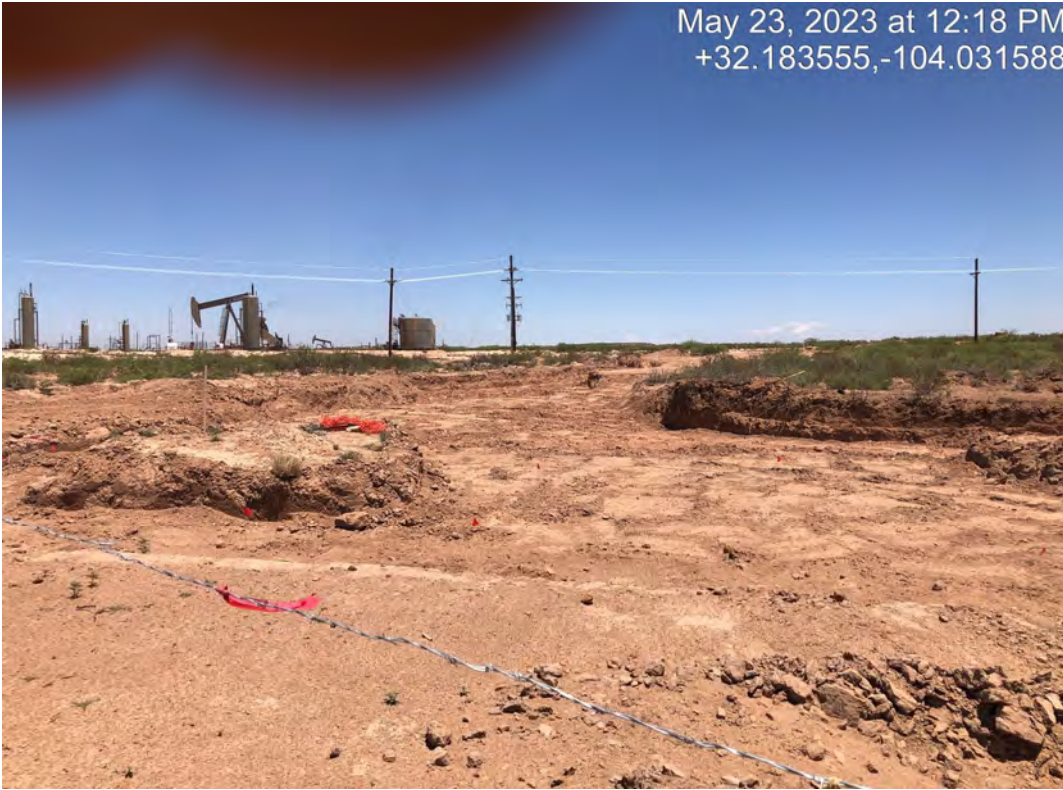
<b>Photo Number:</b> 12	<div>May 23, 2023 at 12:18 PM +32.183555,-104.031588</div>

<b>Photo Direction:</b> North	
<b>Photo Description:</b>  View of the excavated area.

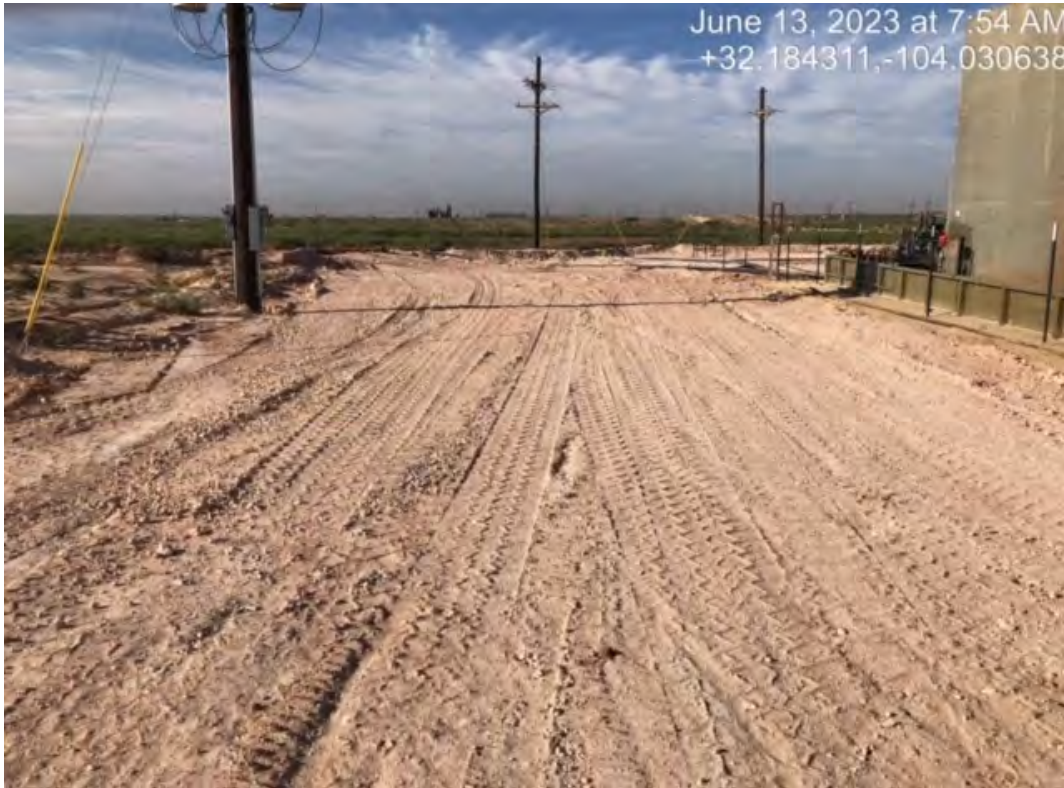
<b>Photo Number:</b> 13

<b>Photo Direction:</b> South	
<b>Photo Description:</b>  View of the remediated area after backfill and regrading.

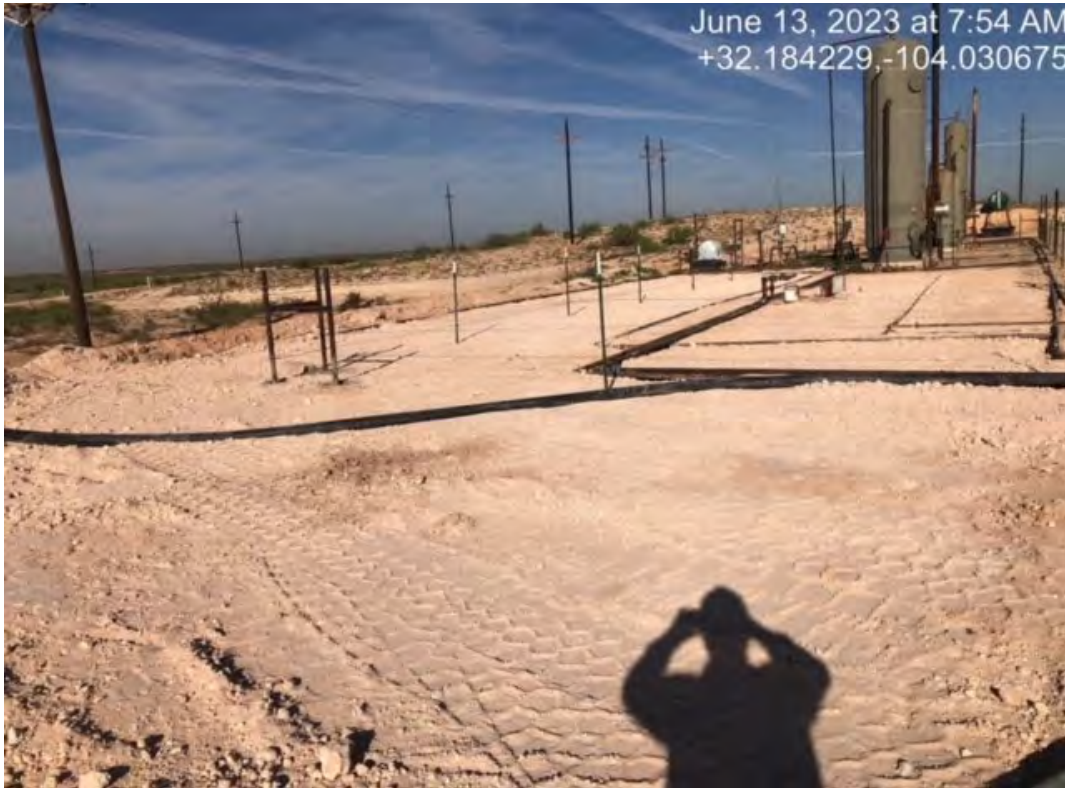
<b>Photo Number:</b> 15

<p>June 13, 2023 at 7:54 AM +32.184229,-104.030675</p>
<b>Photo Direction:</b> Southwest	
<b>Photo Description:</b>  View of the remediated area after backfill and regrading.

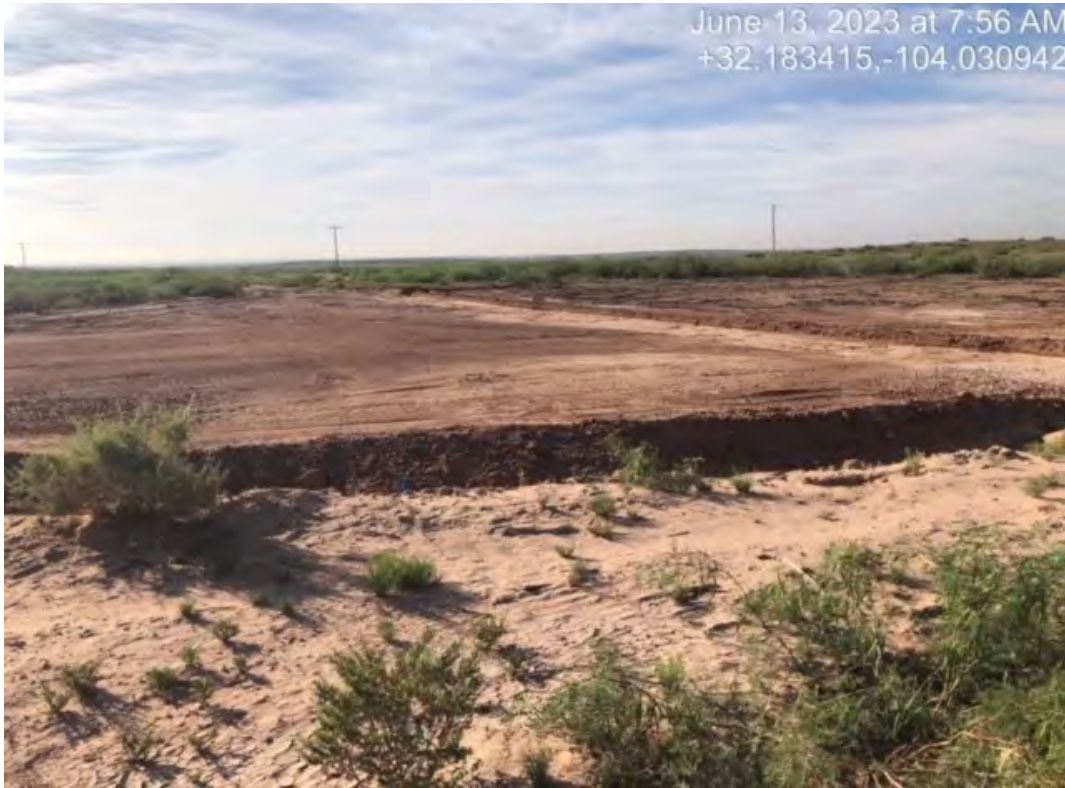
<b>Photo Number:</b> 17

<b>Photo Direction:</b> Southeast	
<b>Photo Description:</b>  View of the remediated area after backfill and regrading.
