Environmental Site Remediation Work Plan

Incident ID:	nAPP2315236756
RP Reference:	N/A
Site Location:	Margarita Pony Riser
Project #:	23E-04266
Phone #:	575.200.7551
Phone #:	575.988.1472

Characterization Schematic Margarita Pony Riser

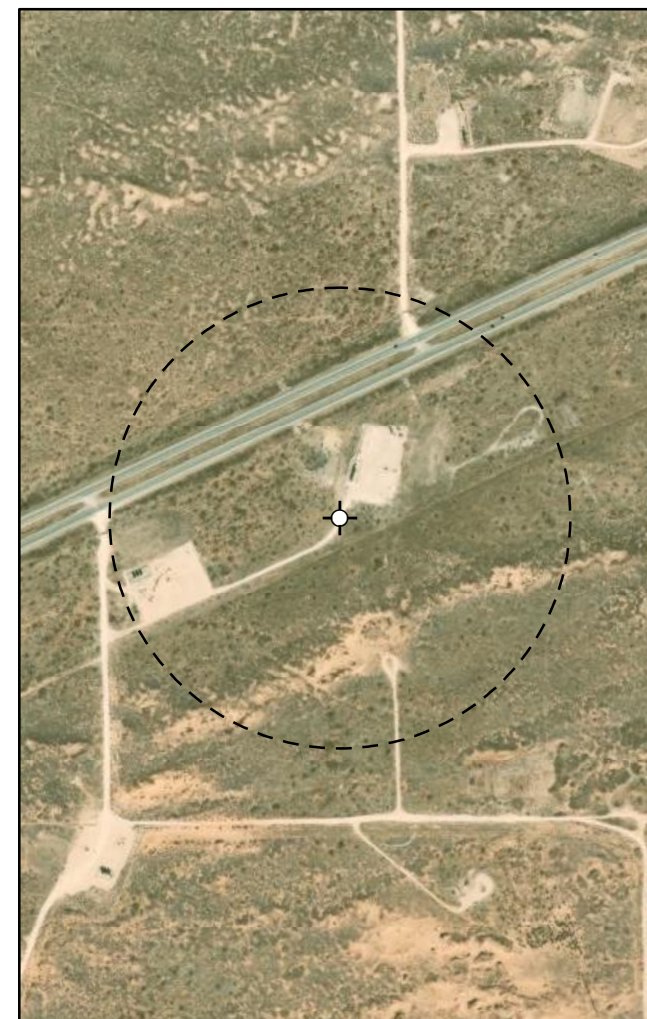
**Karst Potential**

- Critical
 - High
 - Medium
 - Low
- +
 Site Location

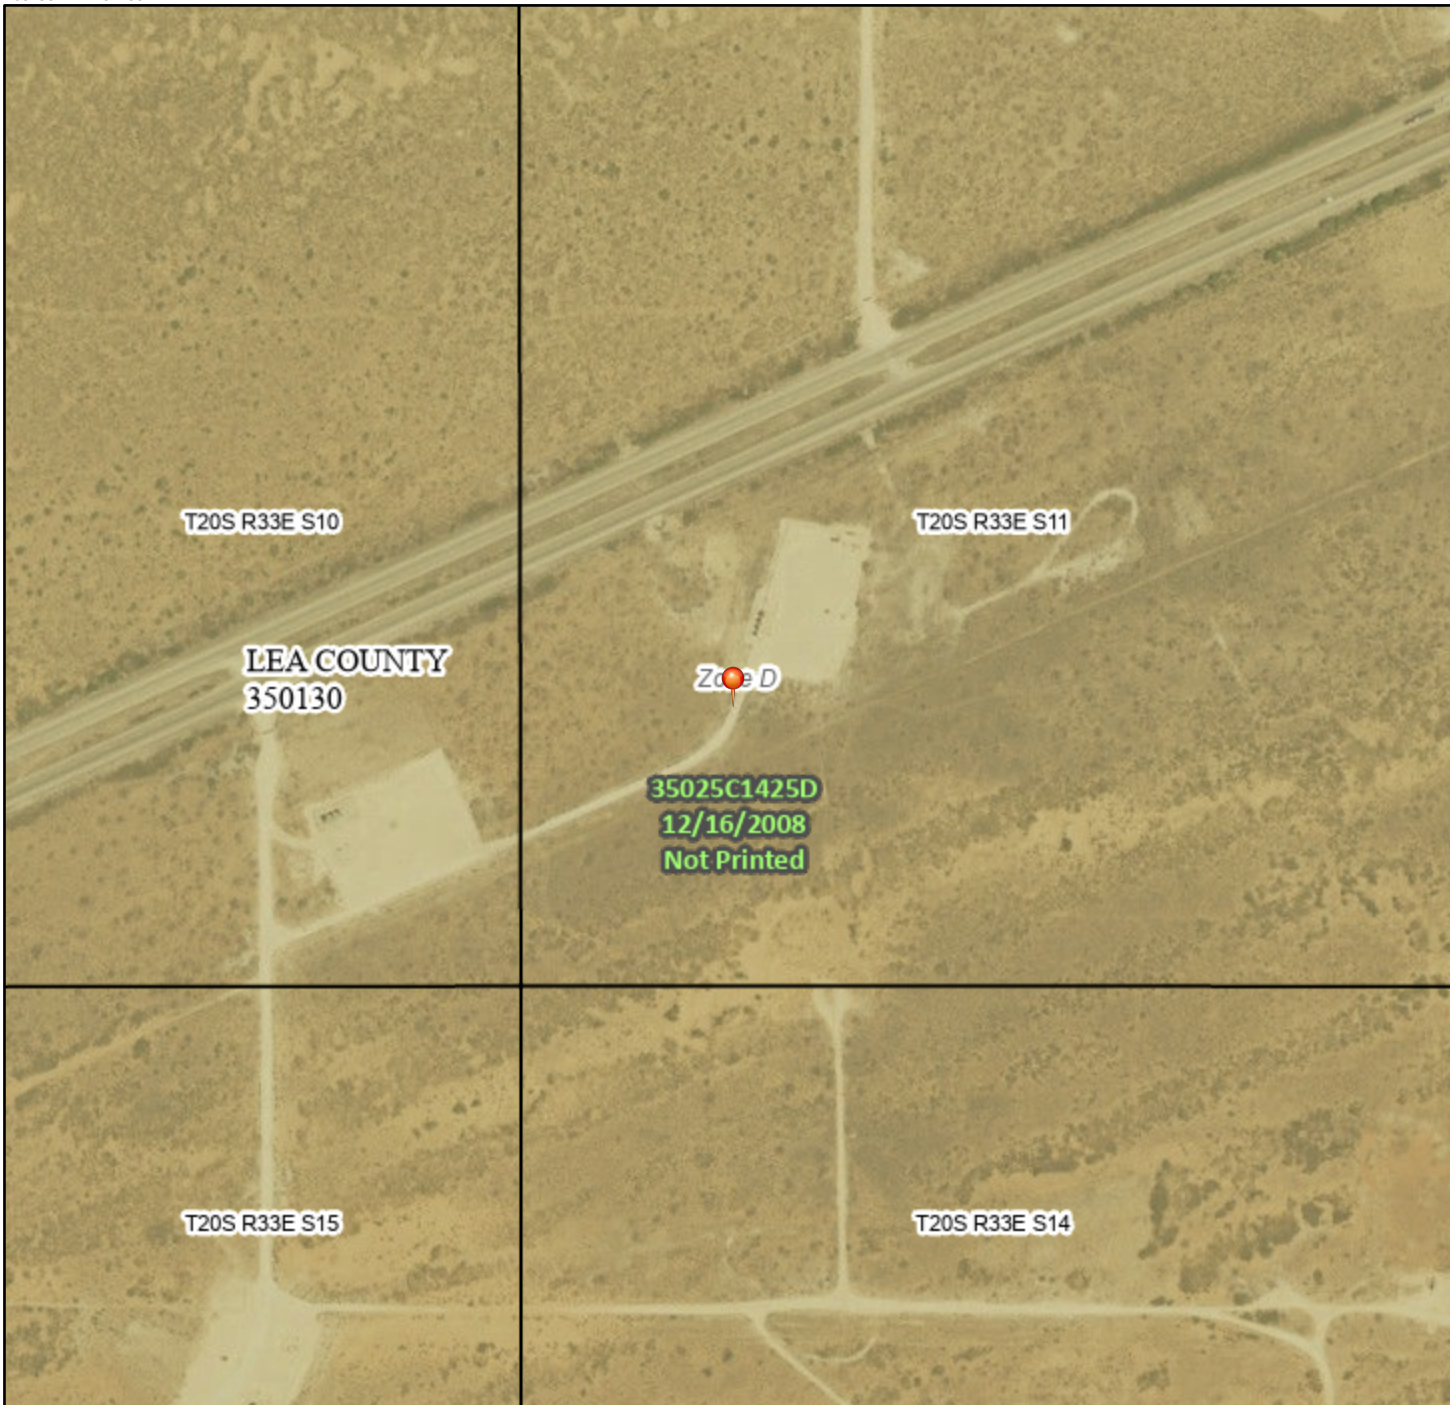
National Flood Hazard Layer FIRMMette

The flood hazard information is derived directly from the authoritative NFHL web services provided by FEMA. This map was exported on 7/24/2023 at 5:38 PM and does not reflect changes or amendments subsequent to this date and time. The NFHL and effective information may change or become superseded by new data over time.
