## Remediation Summary & Soil Closure Request

### Mewbourne Oil Company McKamey Federal #001Y

Lea County, New Mexico  
Unit Letter "L", Section 25, Township 19 South, Range 32 East  
Latitude 32.63078° North, Longitude 103.72612° West  
NMOCD Reference No. nAPP2316627313

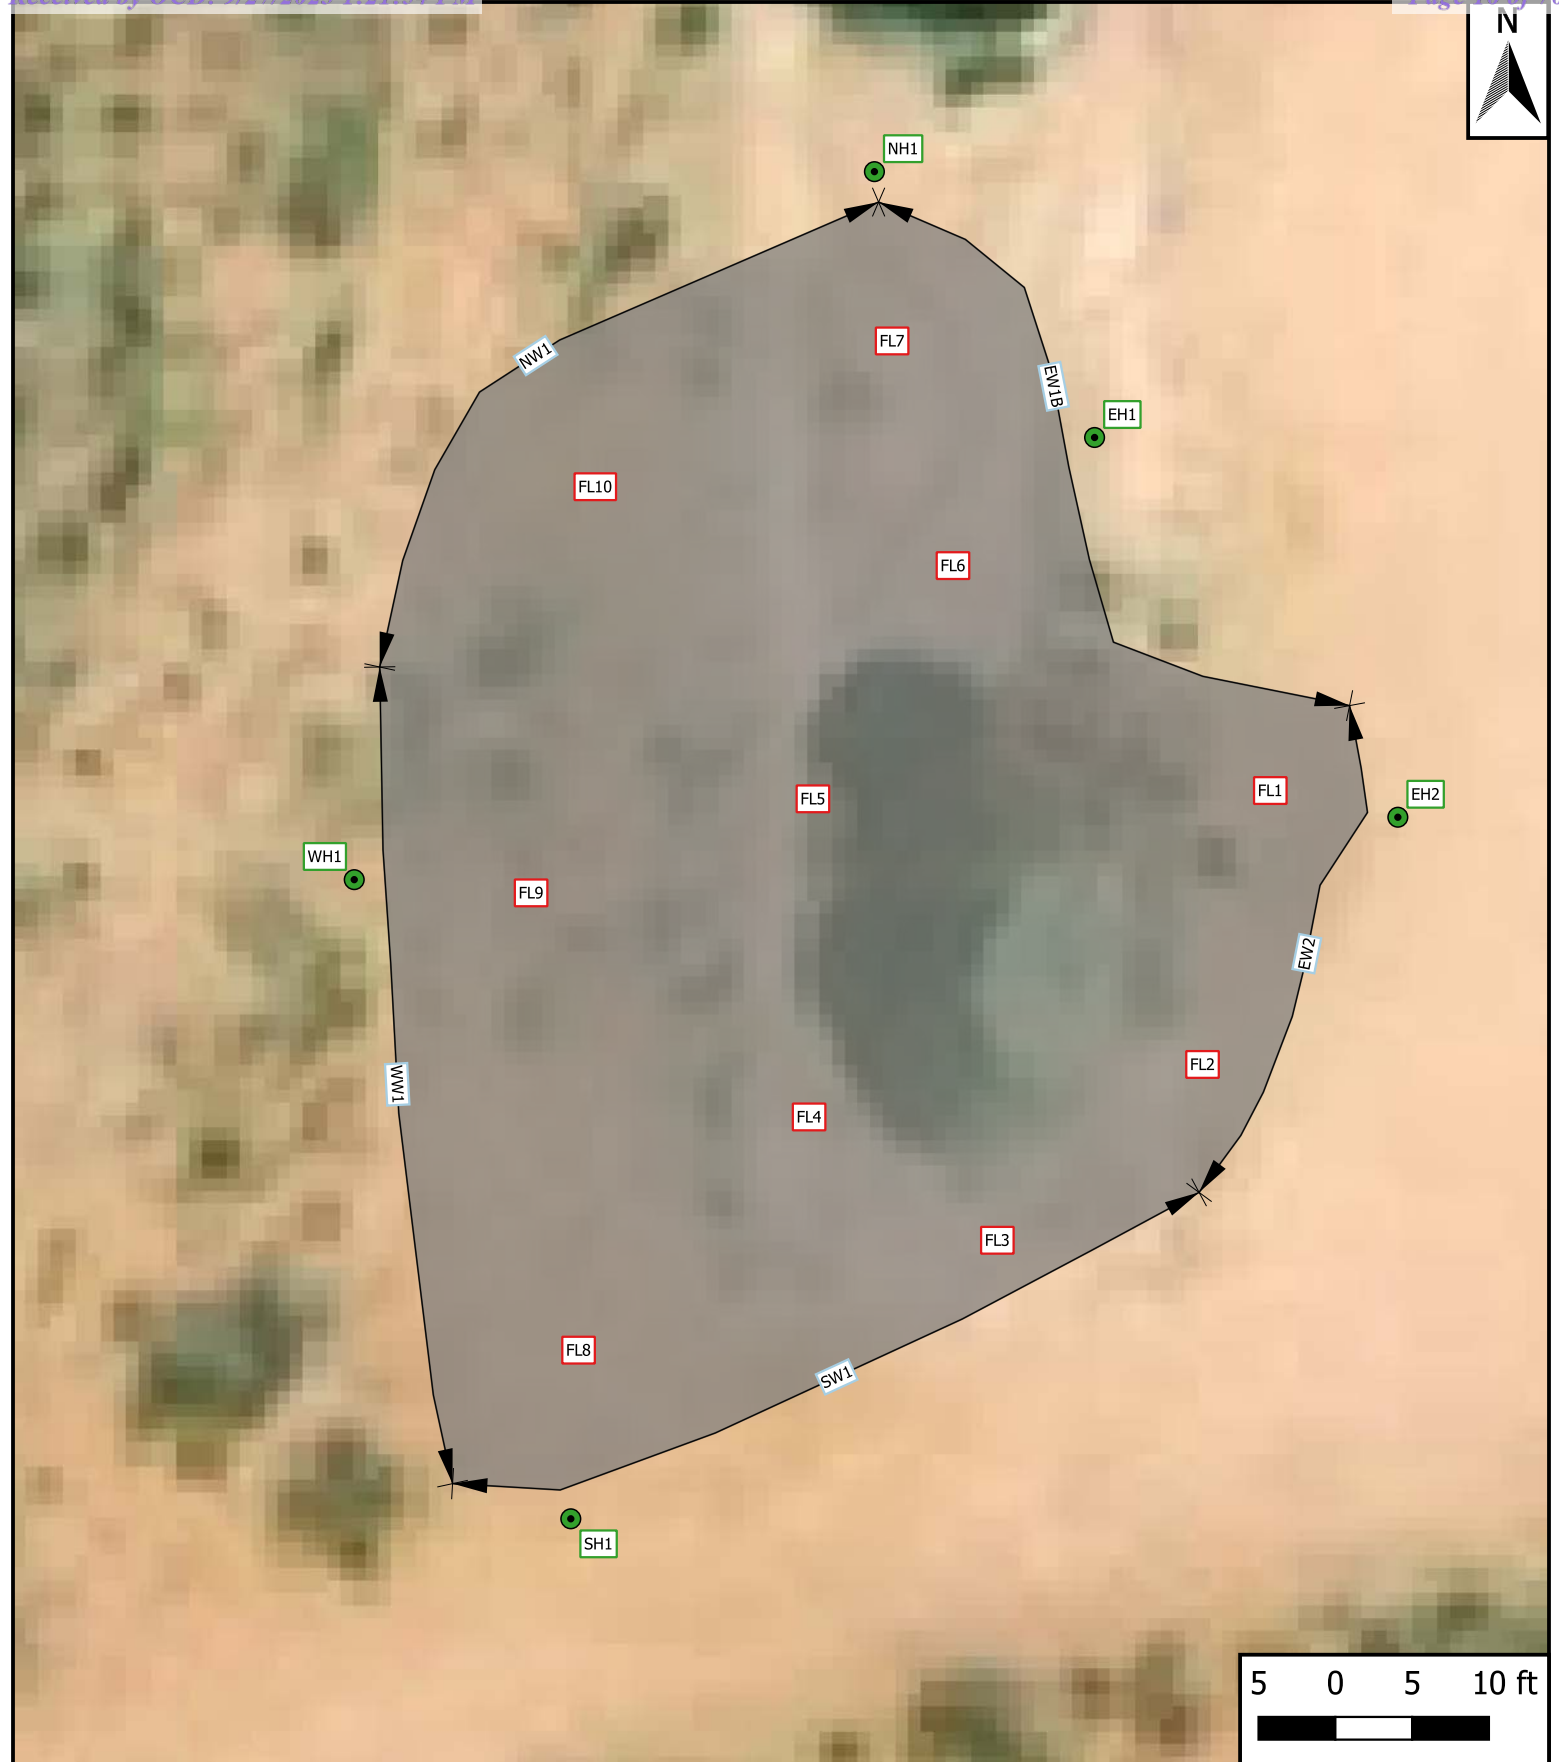
## **Figure 3**

### **Site & Sample Location Map**

- Excavation Extent
- Composite Floor Sample
- Composite Wall Sample
- Delineation Sample Location

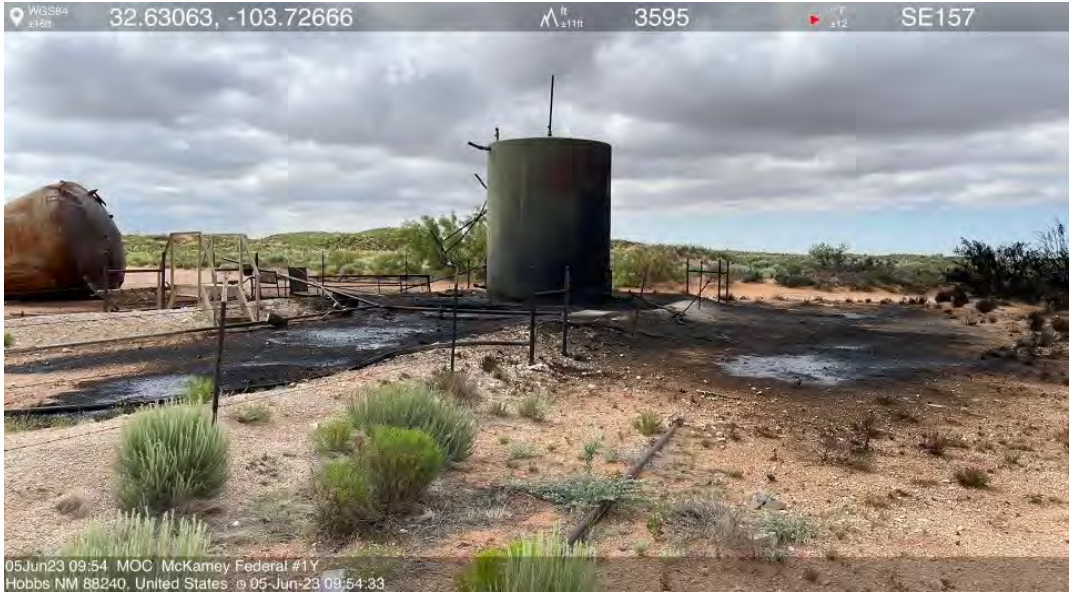
<b>Photo Number:</b> 1

<p>05Jun23 09:54 MOC McKamey Federal #1Y Hobbs NM 88240, United States © 05-Jun-23 09:54:33</p>
<b>Photo Direction:</b> South-Southeast	
<b>Photo Description:</b>  View of the affected area.

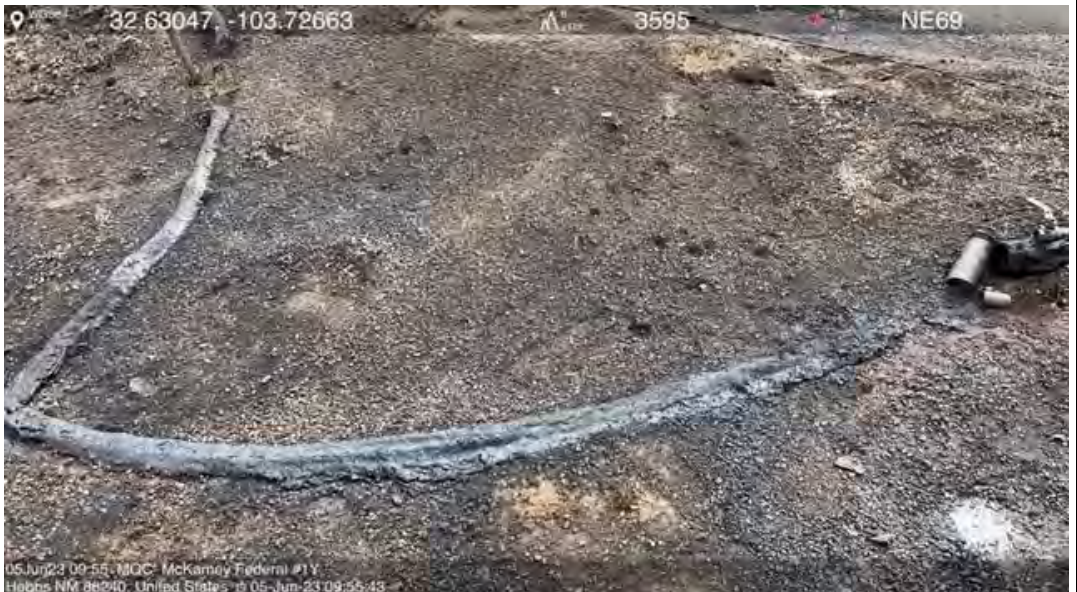
<b>Photo Number:</b> 4

<b>Photo Direction:</b> East-Northeast	
<b>Photo Description:</b>  View of the affected area.

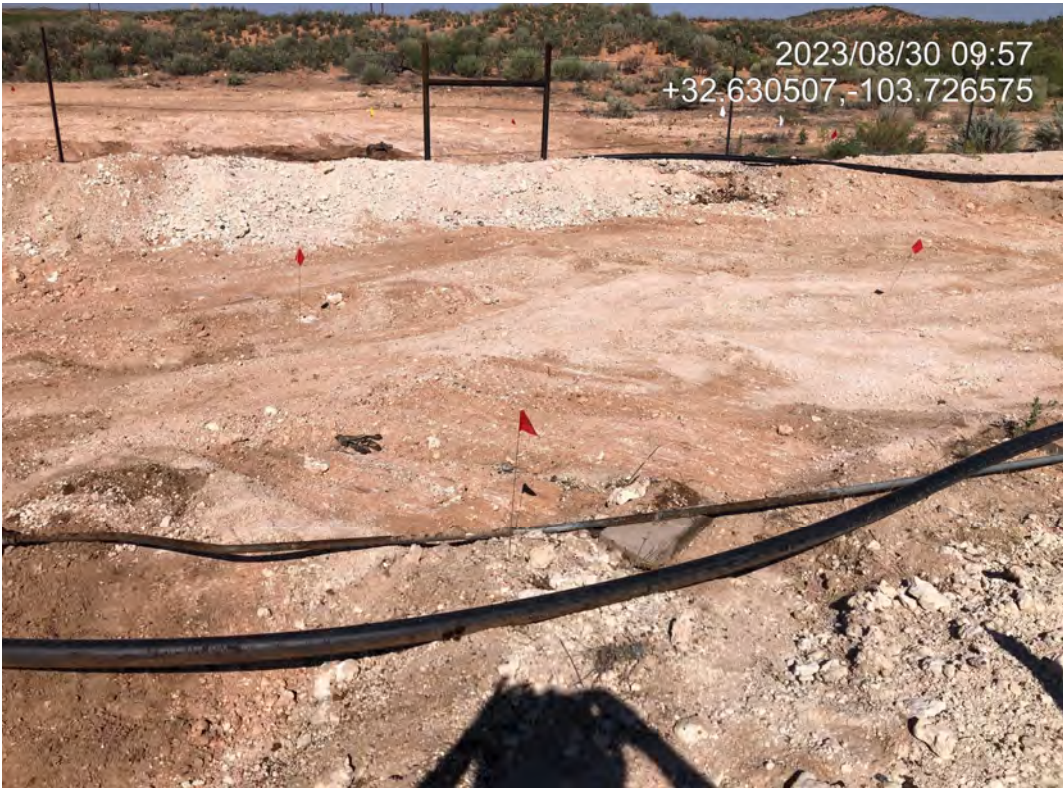
<b>Photo Number:</b> 5

<b>Photo Direction:</b> Northwest	
<b>Photo Description:</b>  View of the excavated area.

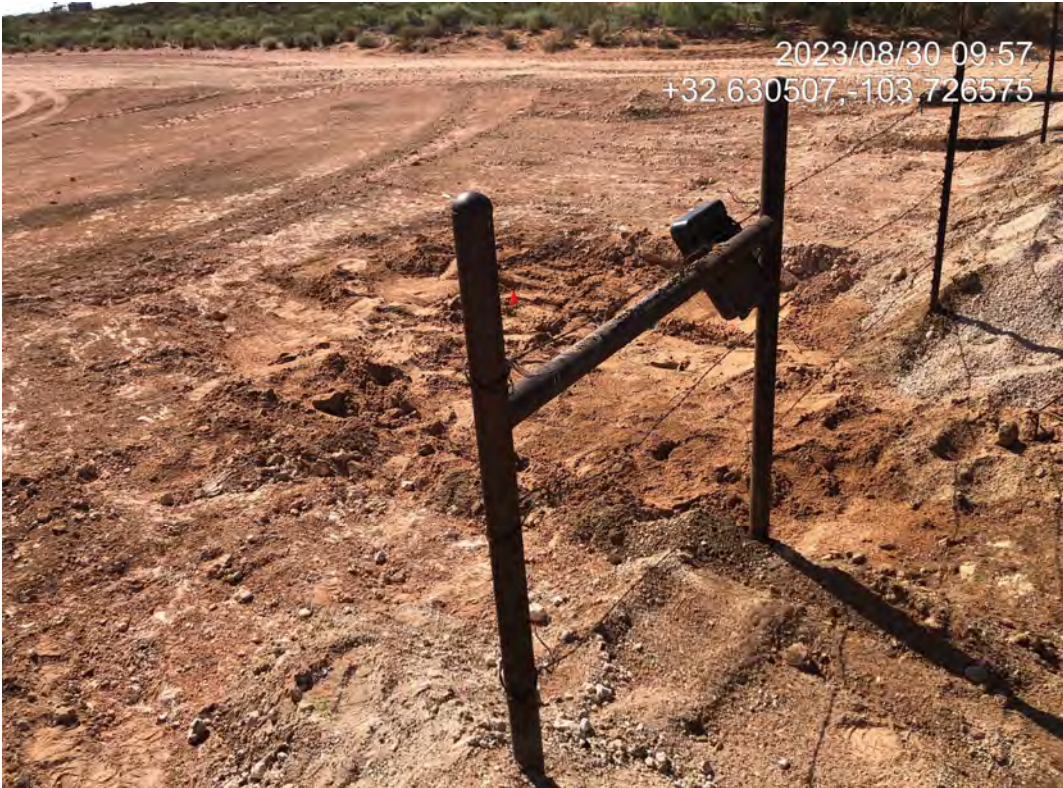
<b>Photo Number:</b> 6

<b>Photo Direction:</b> South-Southeast	
<b>Photo Description:</b>  View of the excavated area.

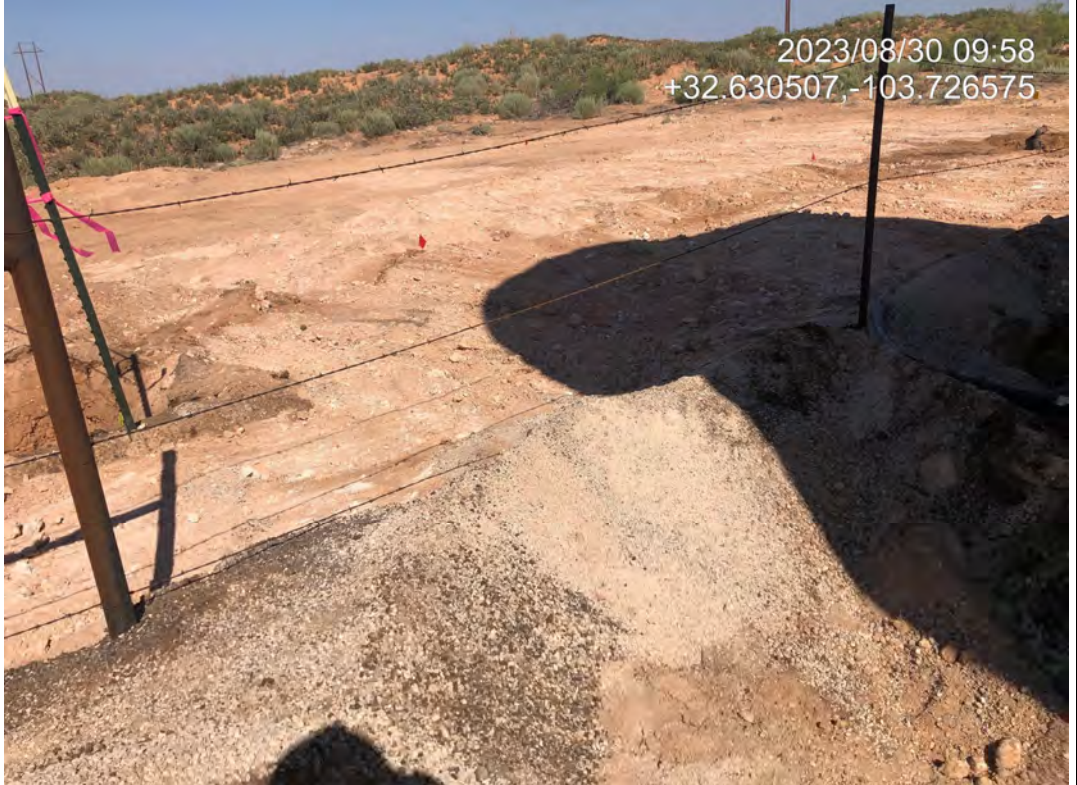
<b>Photo Number:</b> 8

<p>2023/08/30 09:58 +32.630507, -103.726575</p>
<b>Photo Direction:</b> Northwest	
<b>Photo Description:</b>  View of the excavated area.

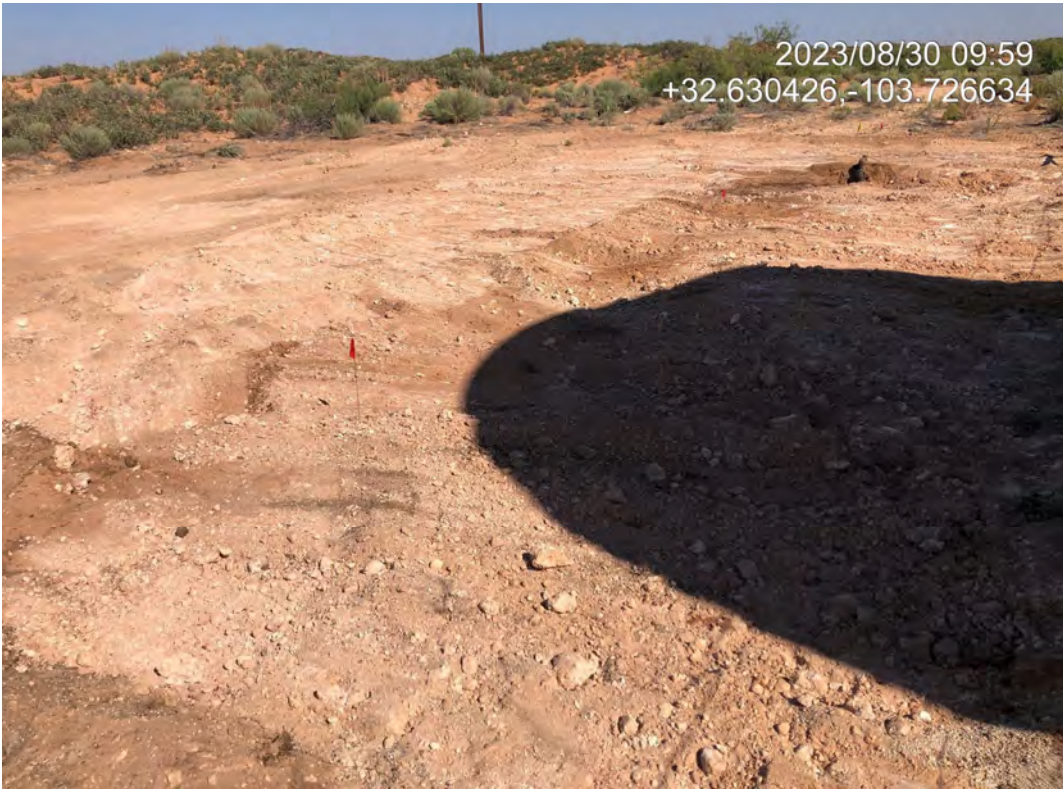
<b>Photo Number:</b> 9

<p>2023/08/30 09:59 +32.630426,-103.726634</p>
<b>Photo Direction:</b> North-Northwest	
<b>Photo Description:</b>  View of the excavated area.

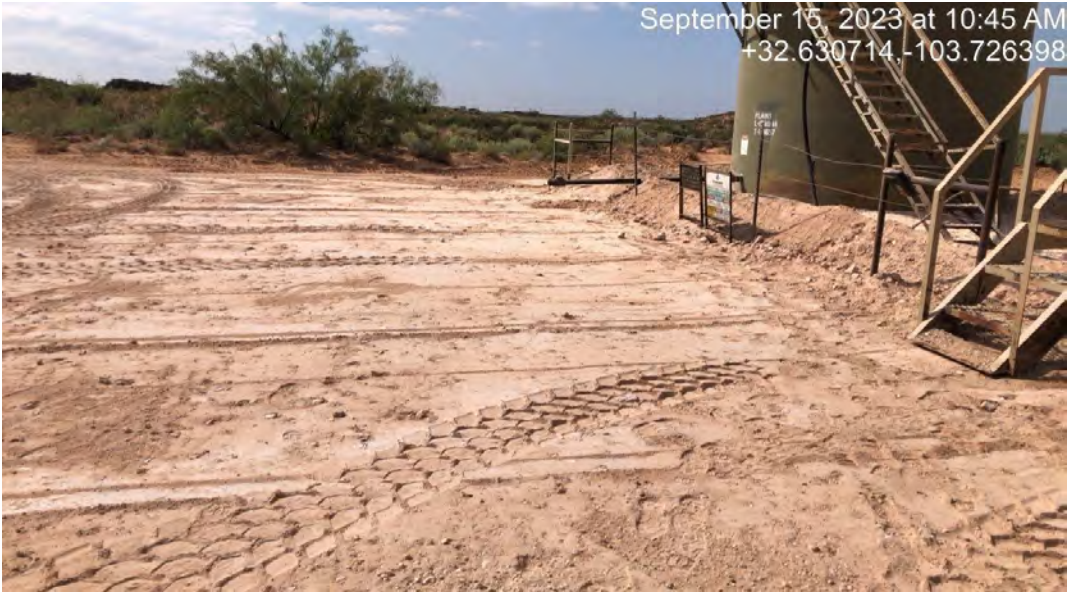
<b>Photo Number:</b> 11

<b>Photo Direction:</b> South-Southwest	
<b>Photo Description:</b>  View of the remediated area after backfill and regrading.

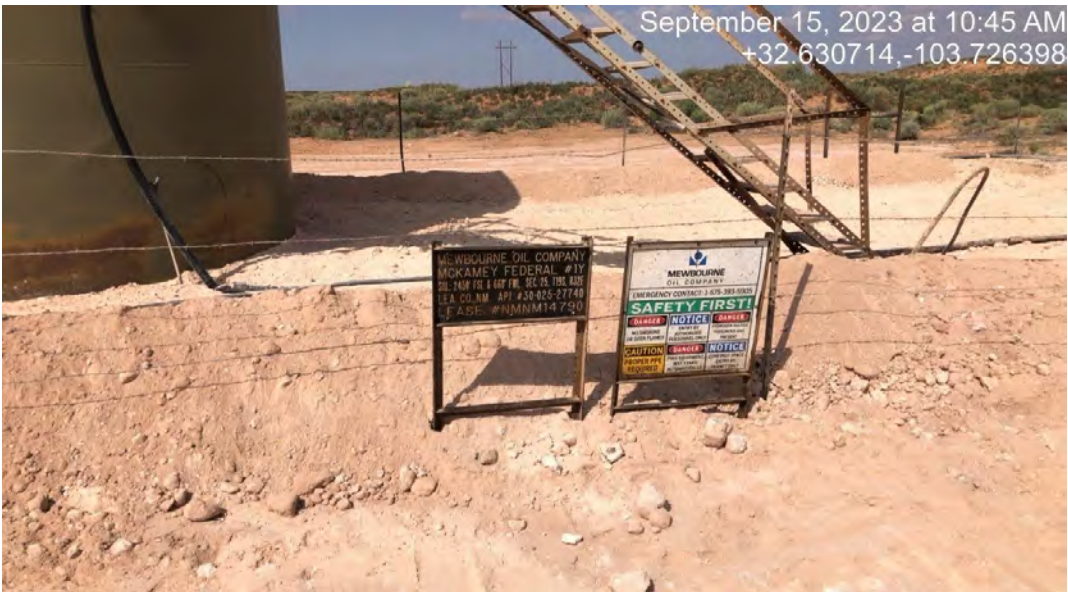
<b>Photo Number:</b> 12

<b>Photo Direction:</b> West	
<b>Photo Description:</b>  View of the remediated area after backfill and regrading.

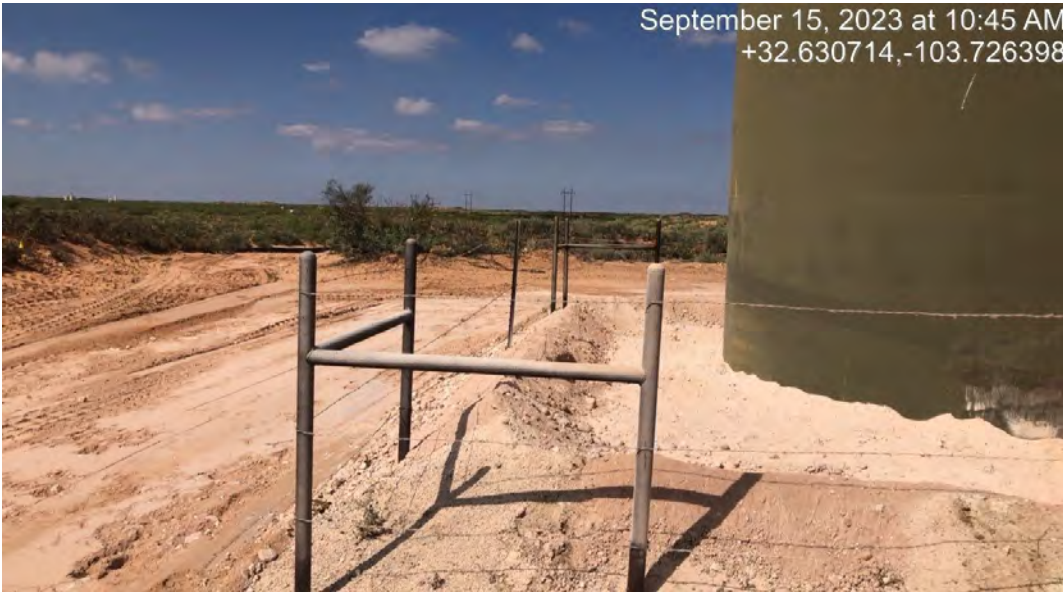
<b>Photo Number:</b> 13

<b>Photo Direction:</b> West	
<b>Photo Description:</b>  View of the remediated area after backfill and regrading.
