RE: Liner Inspection and Closure Report
Huber Federal 10H
API No. 30-015-44848
GPS: Latitude 32.61103 Longitude -104.47287
UL- N, Section 34, Township 19S, Range 25E
NMOCD Reference No. NAPP2303130162

Spur Energy Partners (Spur) has contracted Pima Environmental Services, LLC (Pima) to perform a liner inspection and prepare this closure report for the release of produced water that happened on the Huber Federal 10H (Huber). An initial C-141 was submitted on January 31, 2023, and can be found in Appendix B. This incident was assigned Incident ID. NAPP2303130162, by the New Mexico Oil Conservation Division (NMOCD).

Liner Inspection FormCompany Name: Spur EnergySite: Huber Federal 10. 11. 12 Tank BatteryLat/Long: 32.61103, -104.47287NMOCD Incident ID
& Incident Date: NAPP2303130162 1/29/20232-Day Notification
Sent: via Email by Sebastian Orozco 11/14/2023Inspection Date: 11/17/2023

SITE PHOTOGRAPHS
SPUR ENERGY PARTNERS
Huber 10.11.12 Federal
Battery

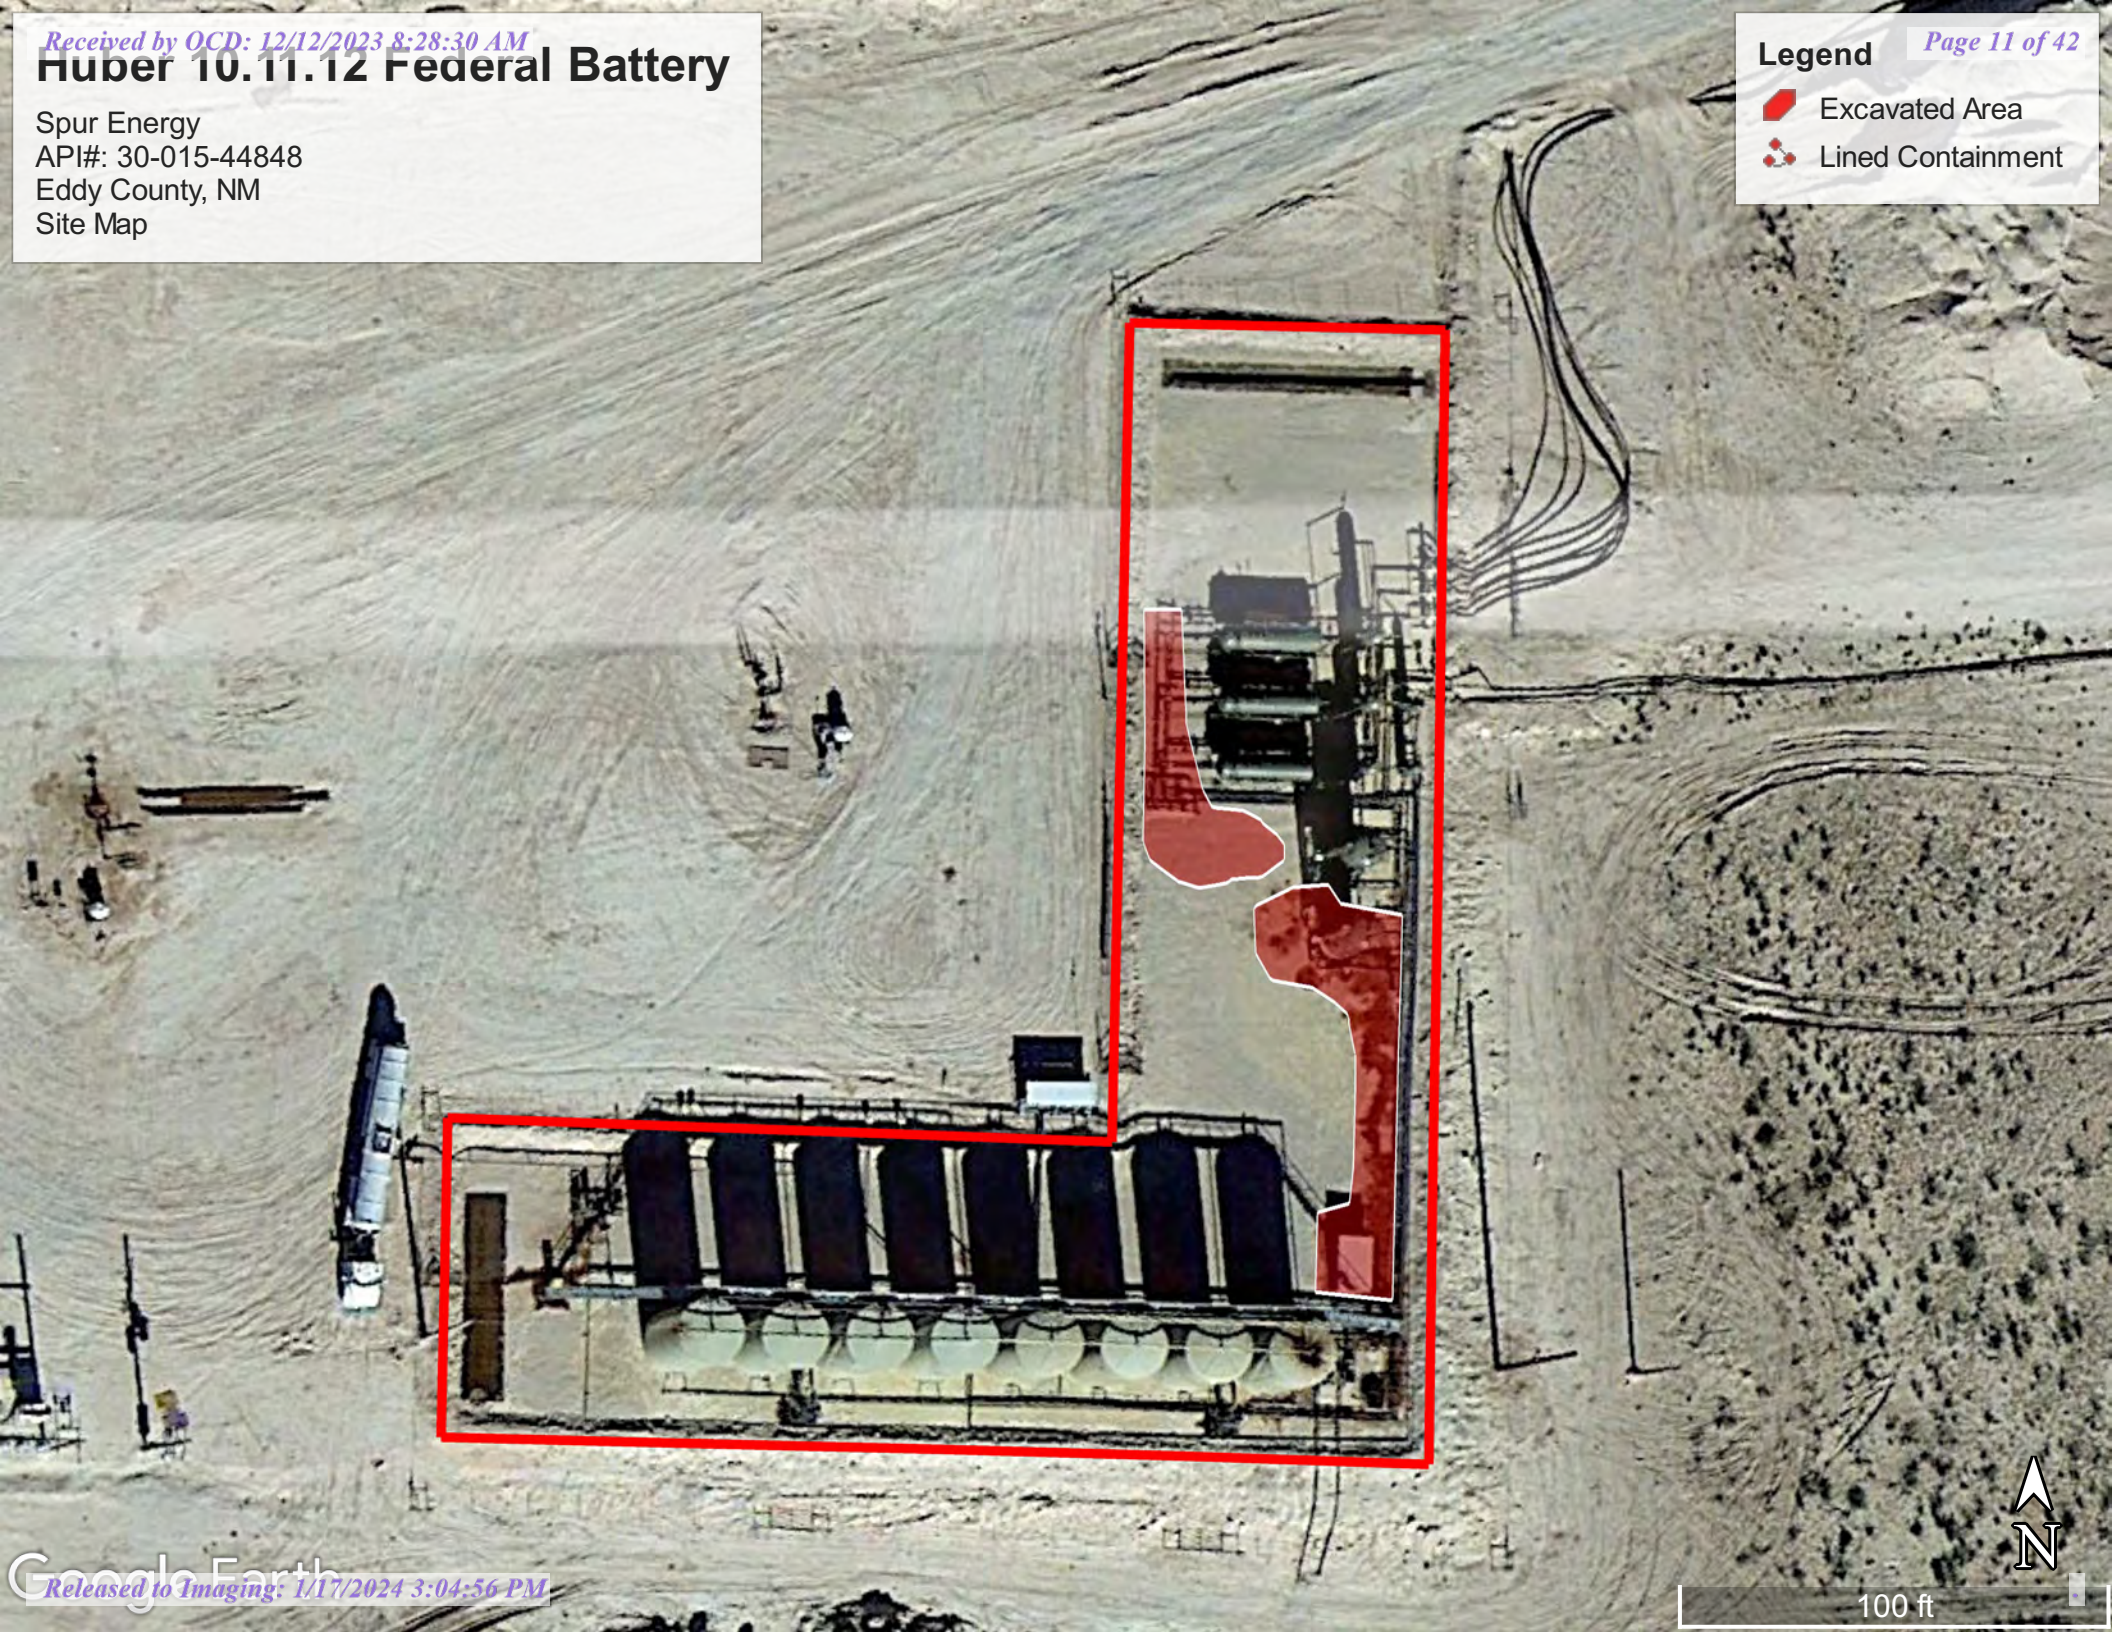
Spur Energy
API#: 30-015-44848
Eddy County, NM
Site Map

Between November 6 and November 10, 2023, a hand shoveling team was deployed to clear out all the contaminated material from within the lined containment area. Around 15 cubic yards of contaminated material were excavated and properly disposed of at a landfill approved by the New Mexico Oil Conservation Division (NMOCD). A site map can be found in Figure 4.

Excavated Area
-

Lined Containment

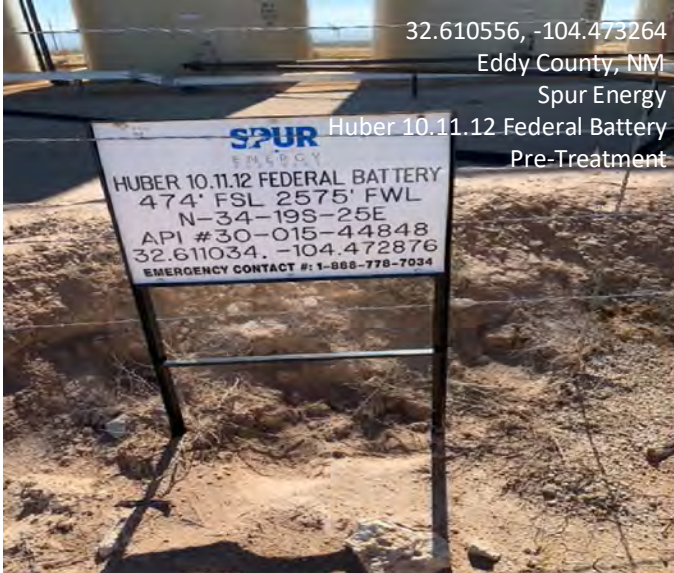
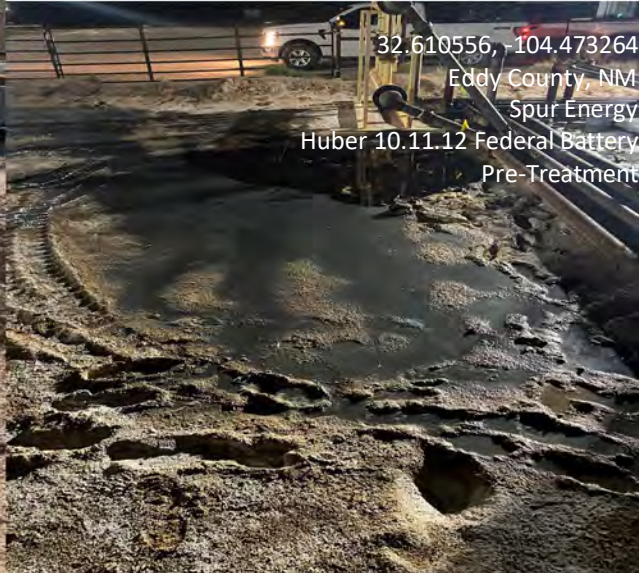
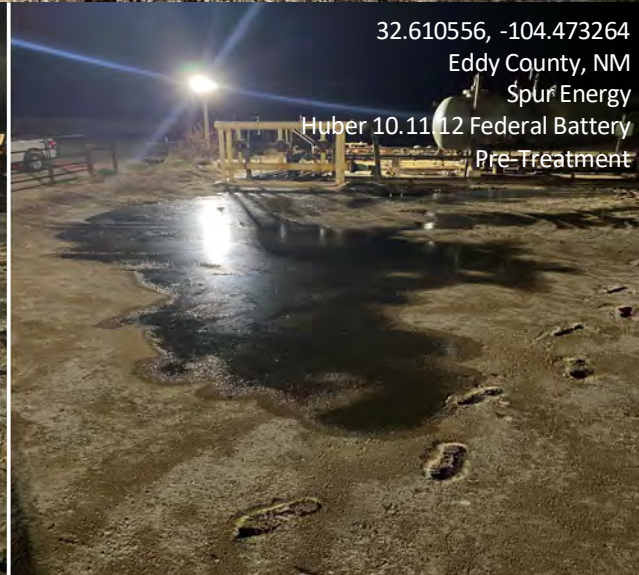
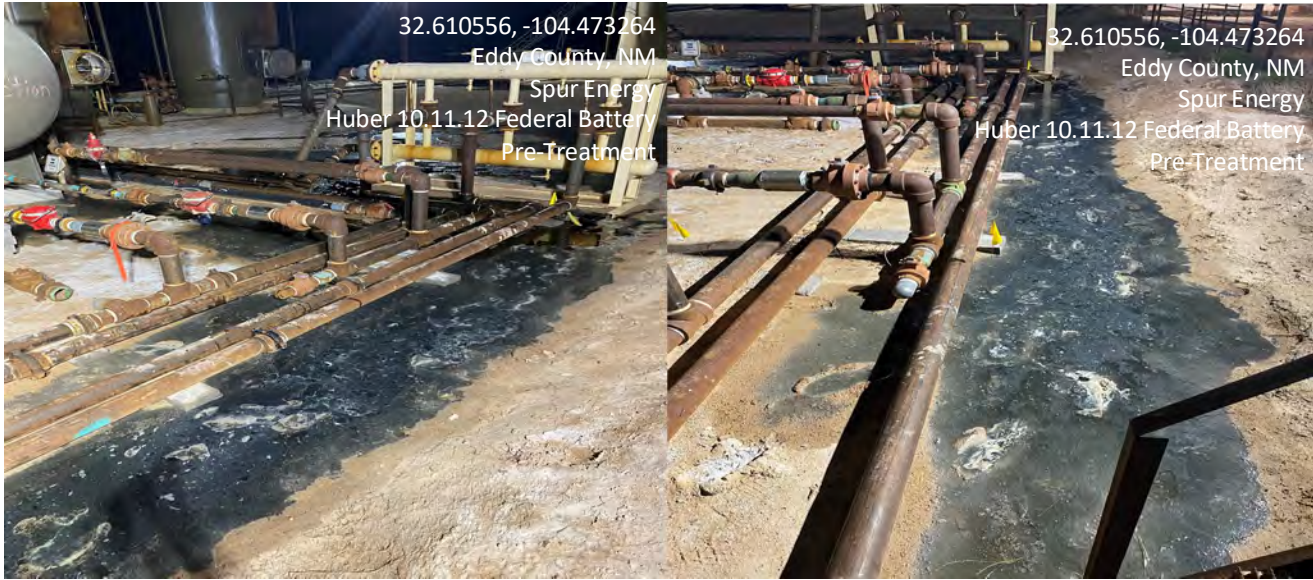
Pre Excavation

NAPP2303130162: On January 29, 2023, freezing temperatures caused a rupture in a four-inch water transfer line, leading to an overpressure situation and subsequent bursting. This resulted in the discharge of approximately 50 barrels of produced water into a lined containment area. Out of the released volume, 48 barrels were successfully recovered.

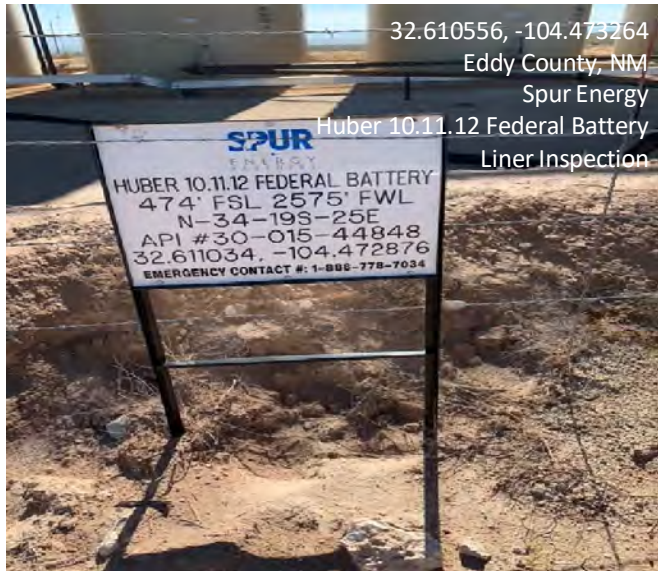
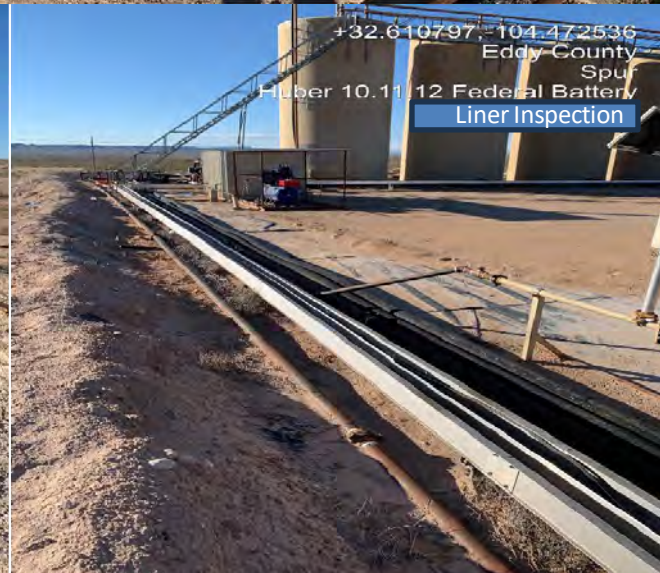
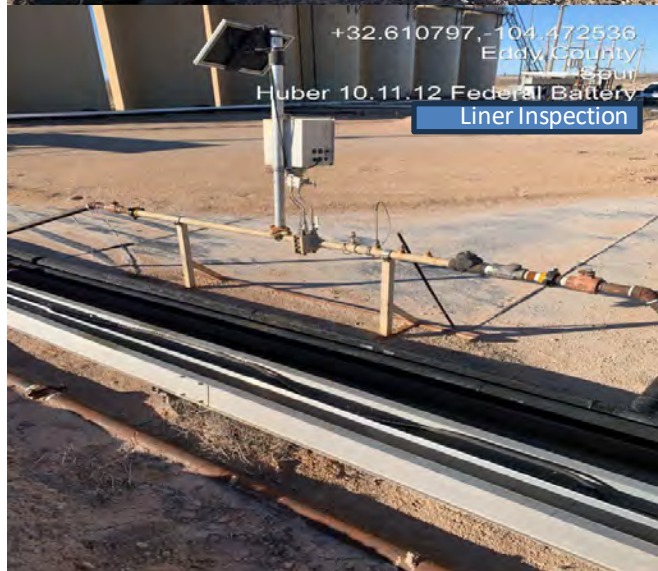
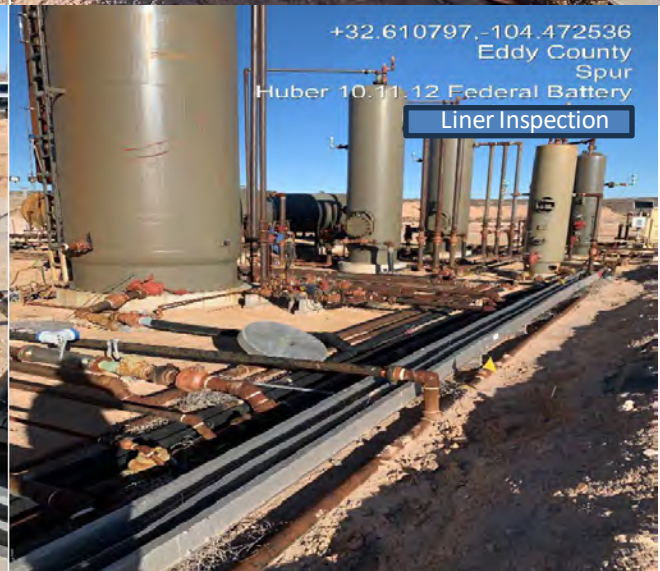
Liner Inspection

On November 17, 2023, following the submission of a 48-hour notification via email, Pima Environmental carried out an inspection of the liner at this site. Our assessment determined that the liner and containment system remained structurally sound and effectively contained the fluids. Detailed documentation, including the liner inspection form and photographic evidence, is available in Appendix C

Visualization	Yes	No	Comments
Is there a tear in the liner?		X	
Are there holes in the liner?		X	
Is the liner retaining any fluids?		X	
Does the liner have integrity to contain a leak?	X

After careful review, Pima requests that this incident NAPP2303130162 be closed. Spur has complied with the applicable closure requirements.
