Incident ID	nAPP2311157492
District RP	
Facility ID	
Application ID

State of New Mexico  
Oil Conservation Division

Based on laboratory analytical results and field activities conducted to date, Etech recommends Mewbourne Oil Company provide copies of this *Remediation Summary & Soil Closure Request* to the appropriate agencies and request closure be granted to the Greyhound Booster release site.

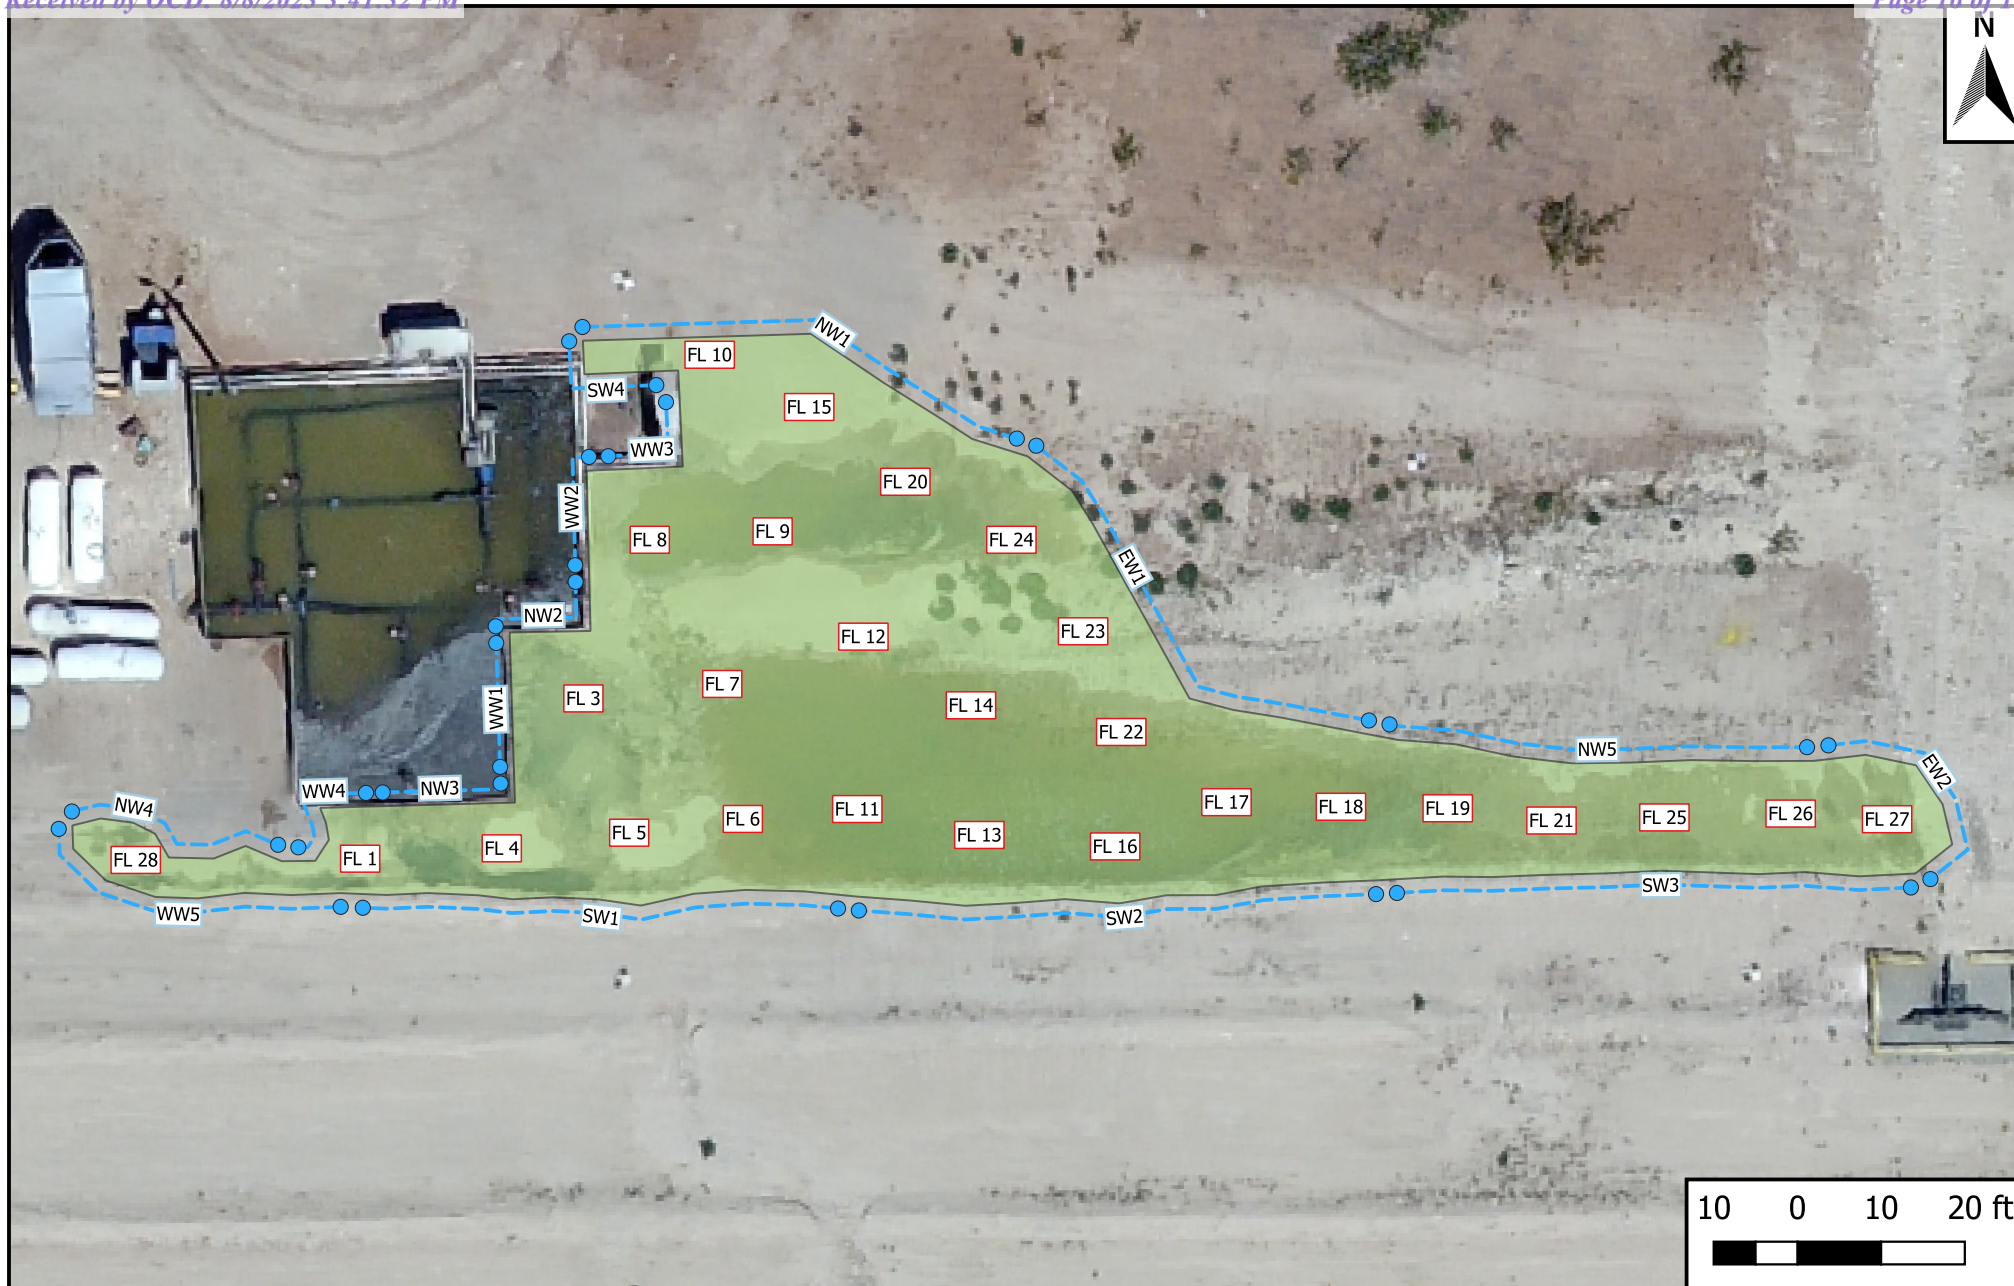
## **Figure 3**

### **Site & Sample Location Map**

- Excavation Extent
- Composite Floor Sample
- Composite Wall Sample

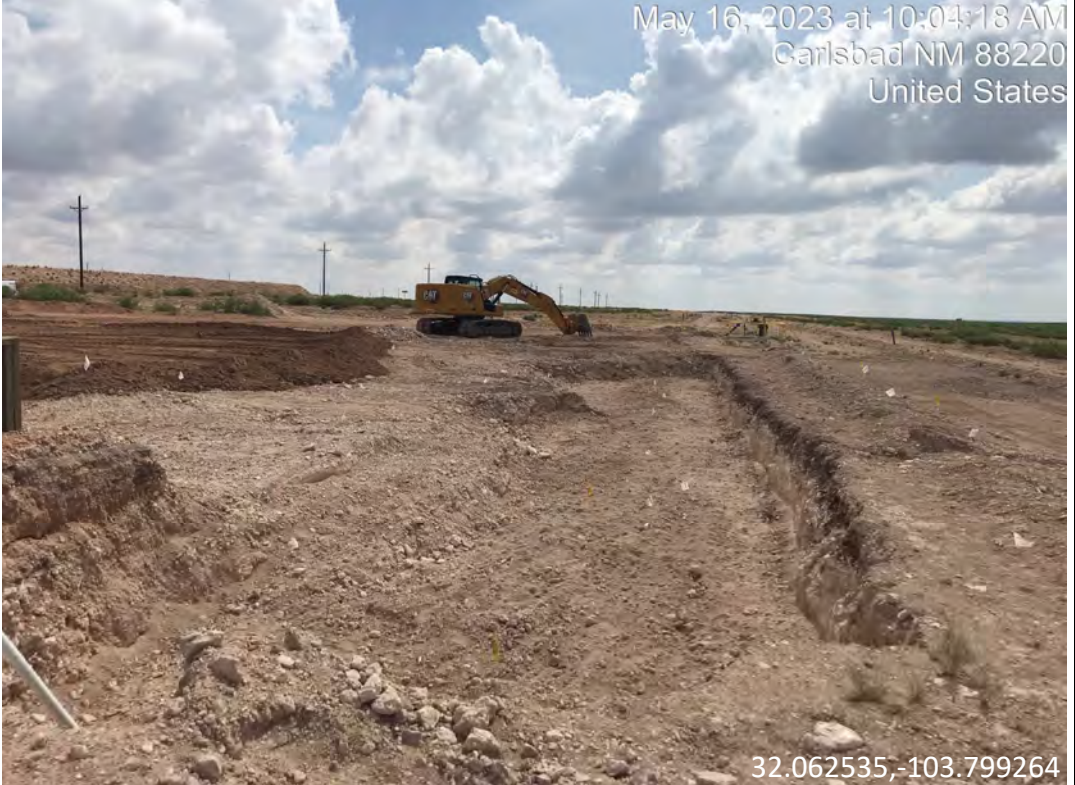
<b>Photo Number:</b> 6

<p>May 16, 2023 at 10:04:18 AM Carlsbad NM 88220 United States</p> <p>32.062535,-103.799264</p>
<b>Photo Direction:</b> East	
<b>Photo Description:</b>  View of the excavated area during backfill.

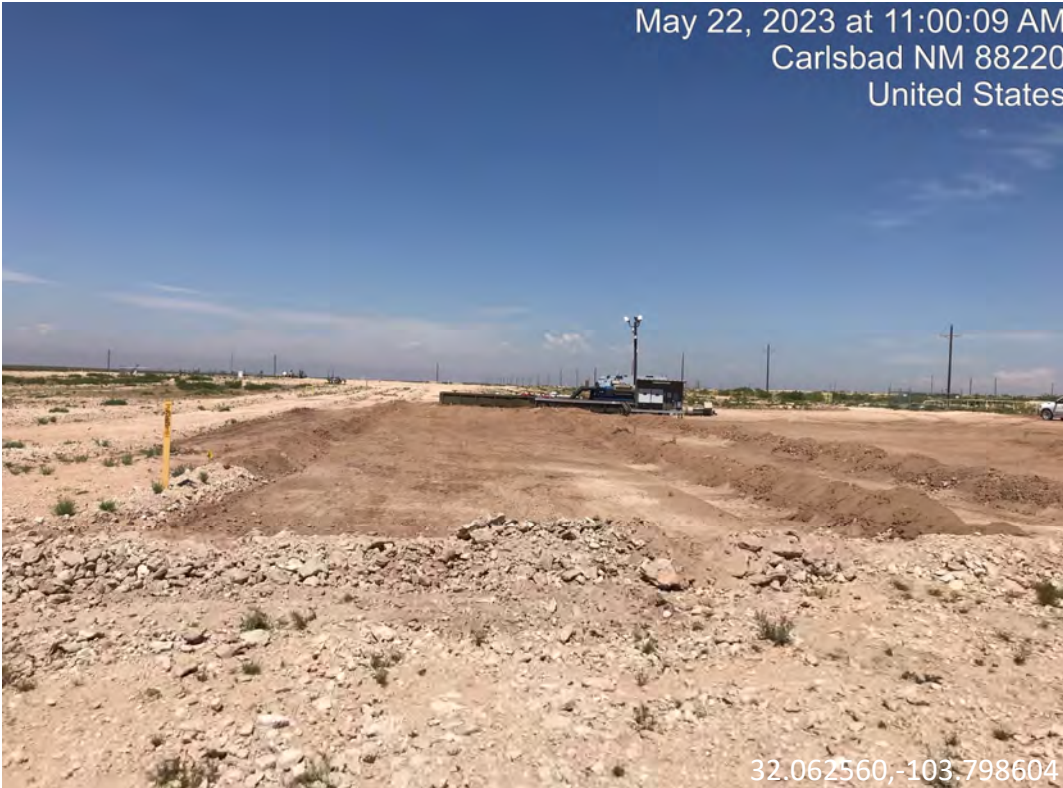
<b>Photo Number:</b> 8

<p>May 22, 2023 at 11:00:09 AM Carlsbad NM 88220 United States</p> <p>32.062560, -103.798604</p>
<b>Photo Direction:</b> West	
<b>Photo Description:</b>  View of the remediated area following backfill and regrading.
