Re: Release Characterization and Closure Report Devon Energy Production Company Red Bull 29 CTB 2 Release Unit Letter O, Section 29, Township 23 South, Range 35 East Lea County, New Mexico DOR: 11/12/2020 Incident ID: NRM2033657348

Tetra Tech, Inc. (Tetra Tech) was contacted by Devon Energy Production Company (Devon) to assess a release that occurred at the Red Bull 29 Central Tank Battery (CTB) 2 (Site) due to a pin hole leak in a water line. The release footprint is entirely on pad and is located in Public Land Survey System (PLSS) Unit Letter O, Section 29, Township 23 South, Range 35 East, in Lea County, New Mexico (Site). The approximate release point occurred at coordinates 32.271664°, -103.385705°, as shown on Figures 1 and 2.

Devon Energy Production Company

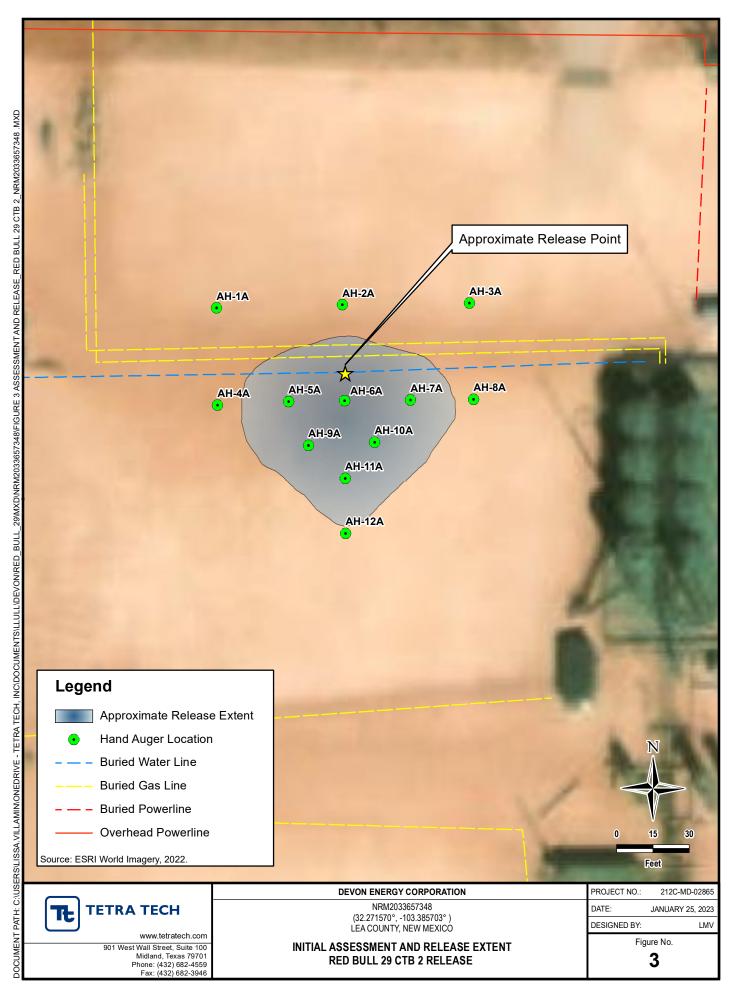
Figure 3 – Initial Assessment and Release Extent

On November 30, 2022, Tetra Tech conducted initial assessment activities to delineate the release extent and confirm the efficacy of the remedial activities conducted during the initial response. A total of twelve (12) hand auger borings (AH-1A through AH-12A) were installed to attempt to achieve vertical and horizontal delineation of the release footprint on pad. The sampling locations were placed in a grid like pattern encircling the release point and the associated subsurface water line. A total of six (6) hand augur borings (AH-1A through AH-4A, AH-8A, and AH-12A) were installed along the perimeter of the approximate release extent to a maximum depth of 1-foot bgs to establish the lateral extent of the release footprint. The remaining borings (AH-5A through AH-7A and AH-9A through AH-11A) were installed within the release footprint to a maximum depth of 2 feet bgs in an attempt to determine the extent of the vertical impact of the release. The approximate release extent and the locations of the 12 hand auger borings are indicated in Figure 3. Photographic documentation of the Site conditions at the time of the assessment is presented in Appendix D.

A total of thirteen (13) samples were collected from the twelve (12) borings and submitted to Cardinal Laboratories (Cardinal) in Hobbs, New Mexico to be analyzed for TPH (DRO and ORO) by EPA Method 8015, TPH Low Fraction (GRO) by EPA Method 8015D, BTEX by EPA Method 8260B, and chlorides by EPA Method 4500.0. A copy of the laboratory analytical report and chain-of-custody documentation are included in Appendix C.

Results from the November 30, 2022, soil sampling event are summarized in Table 1. Analytical results associated with samples collected during the assessment activities were below Site RRALs. The boring locations are indicated in Figure 3. Horizontal and vertical delineation was achieved during the assessment. The initial response remedial action was successful in removing the contaminant mass to meet the standards of Table I of 19.15.29.12 NMAC.

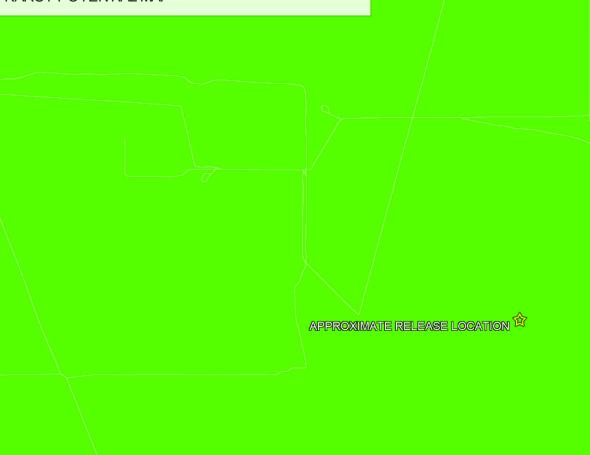
KARST POTENTIAL MAP

A site characterization was performed and no sinkholes, residences, schools, hospitals, institutions, churches, springs, private domestic water wells, playa lakes, wetlands, incorporated municipal boundaries, subsurface mines, or floodplains are located within the distances specified in 19.15.0029 New Mexico Administrative Code (NMAC). The Site is in an area of low karst potential.
