Incident ID	nAPP2317129194
District RP	
Facility ID	
Application ID

Site Assessment/Characterization

Based on laboratory analytical results and field activities conducted to date, Etech recommends Mewbourne Oil Company provide copies of this *Remediation Summary & Soil Closure Request* to the appropriate agencies and request closure be granted to the Chicago 9/8 Line release site.

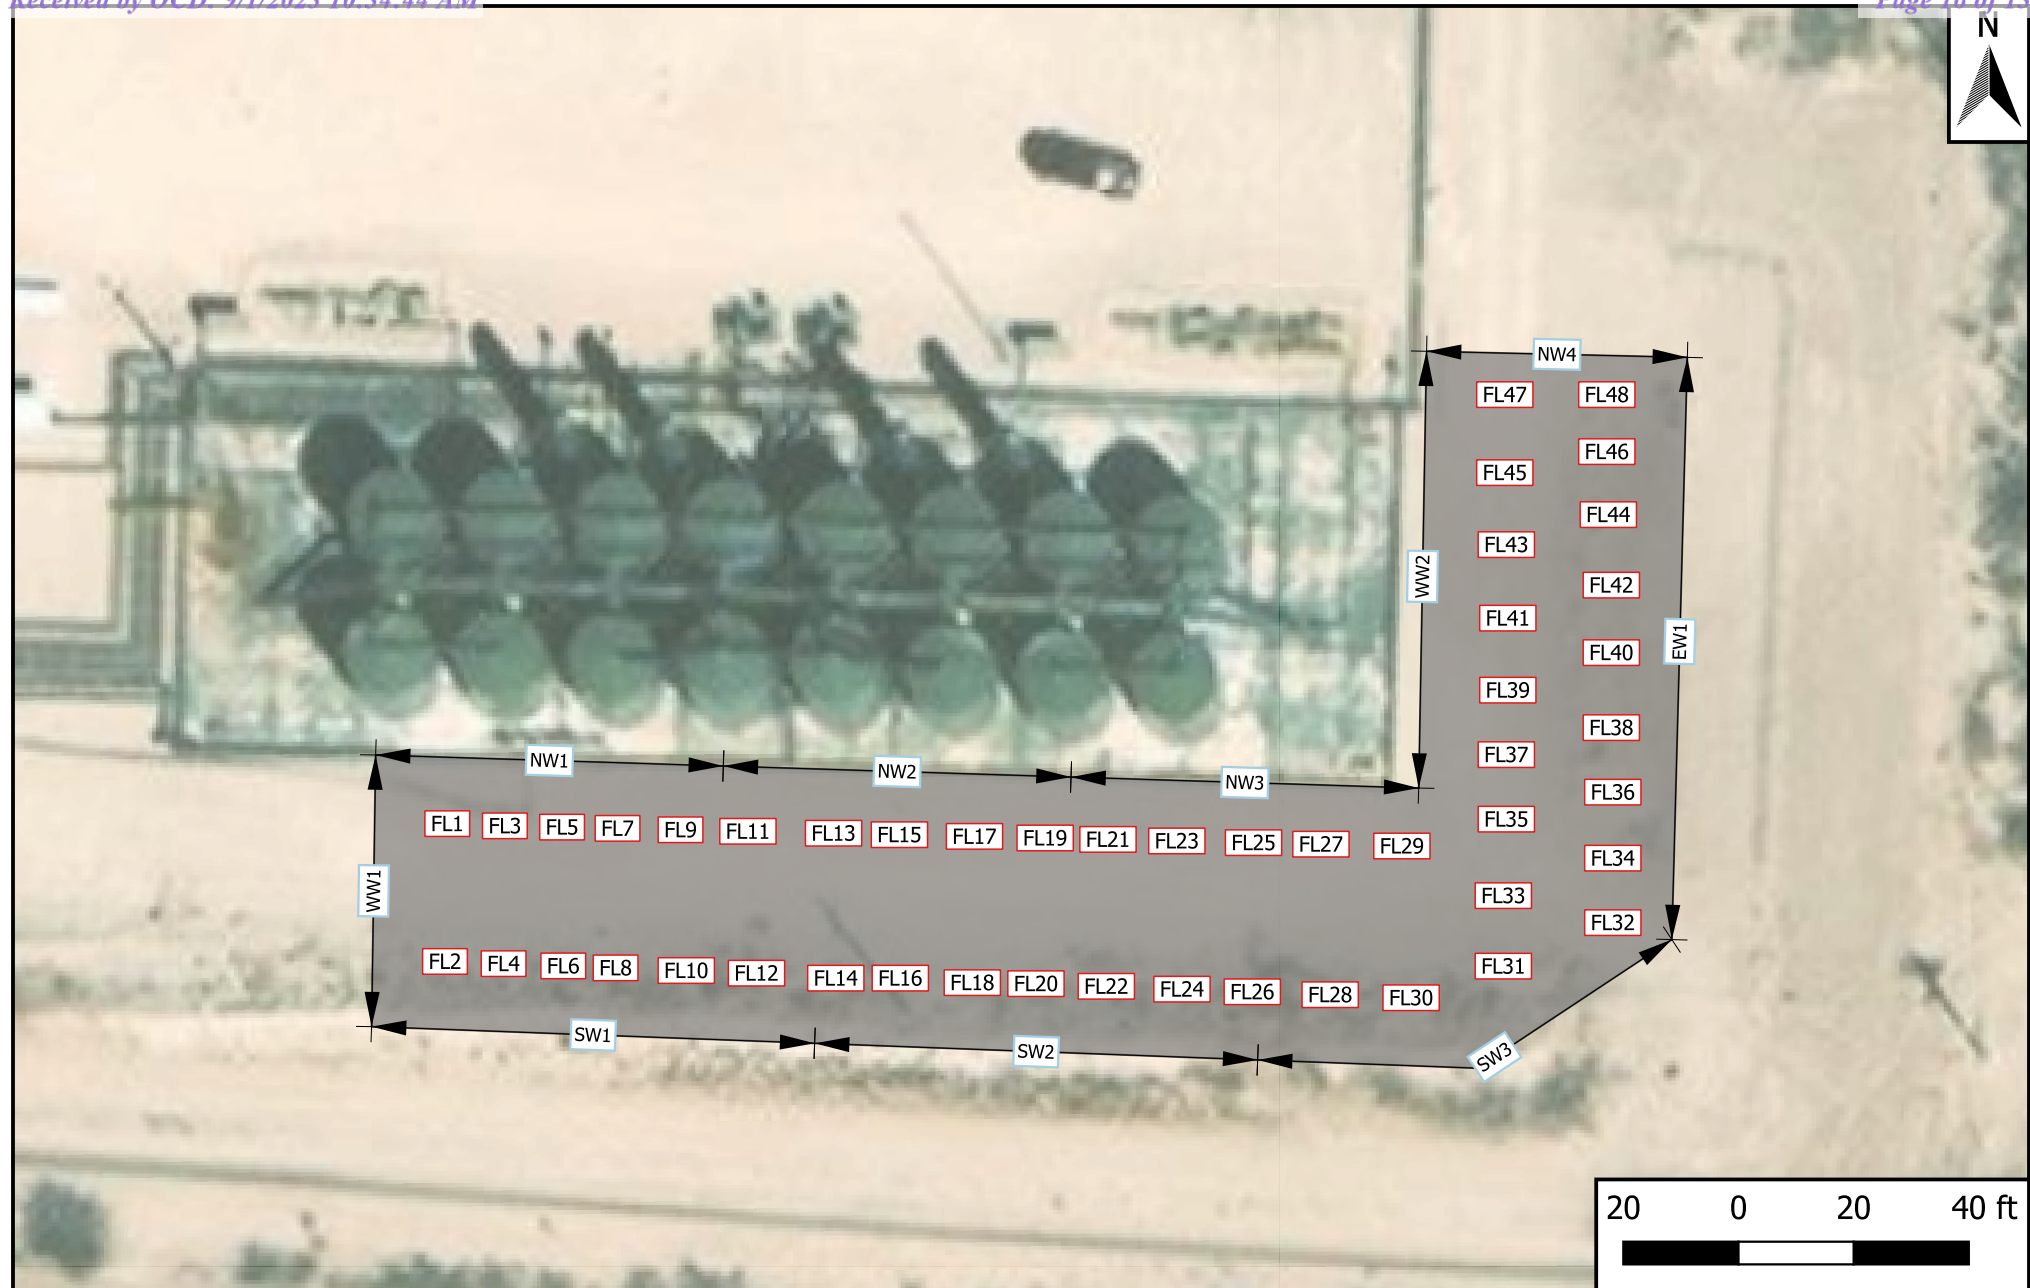
Figure 3

Site & Sample Location Map

- Excavation Extent
- Composite Floor Sample
- Composite Wall Sample

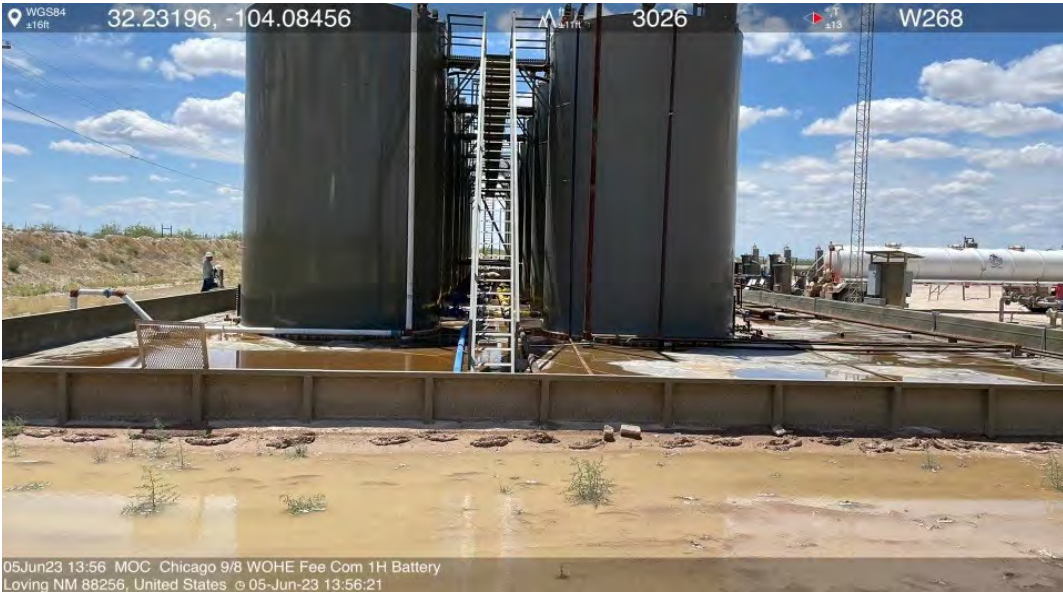
Photo Number: 3

Photo Direction: West	
Photo Description: View of the affected area.

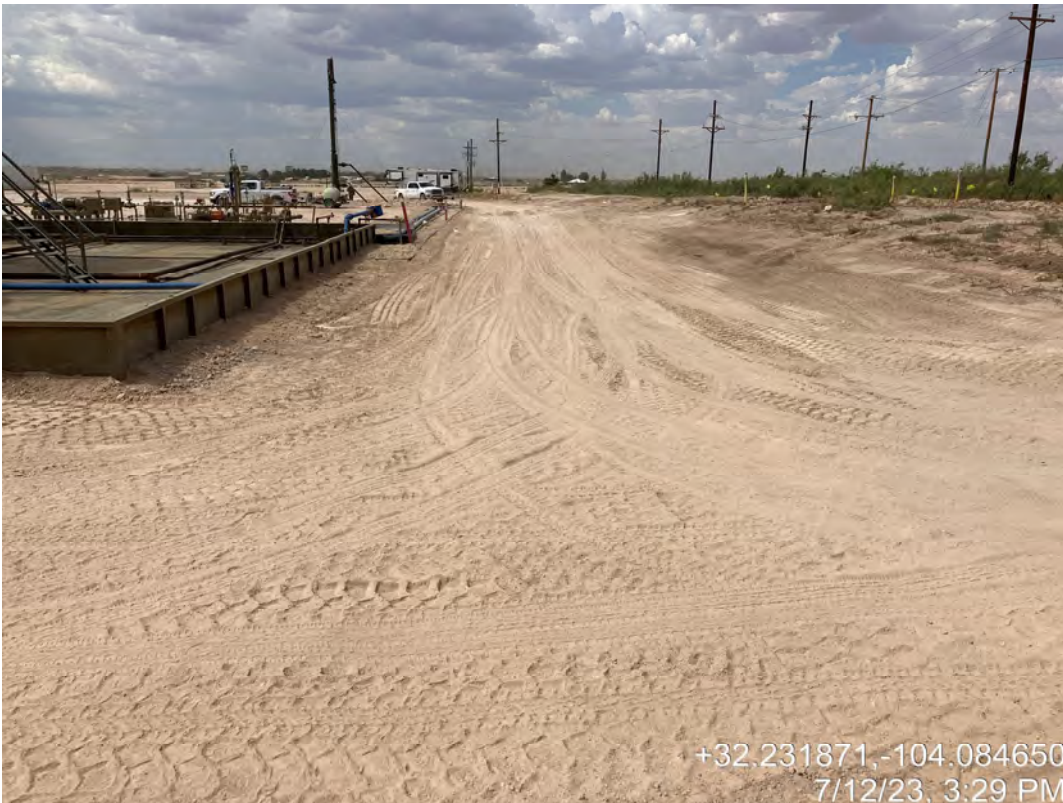
Photo Number: 10

<p>+32.231871,-104.084650 7/12/23, 3:29 PM</p>
Photo Direction: North	
Photo Description: View of the remediated area after backfill and regrading.
