Site Characterization - Water Sources/Courses Determination

Reclamation/Remediation Map

Figure 1

Site and Sample Location Mapu

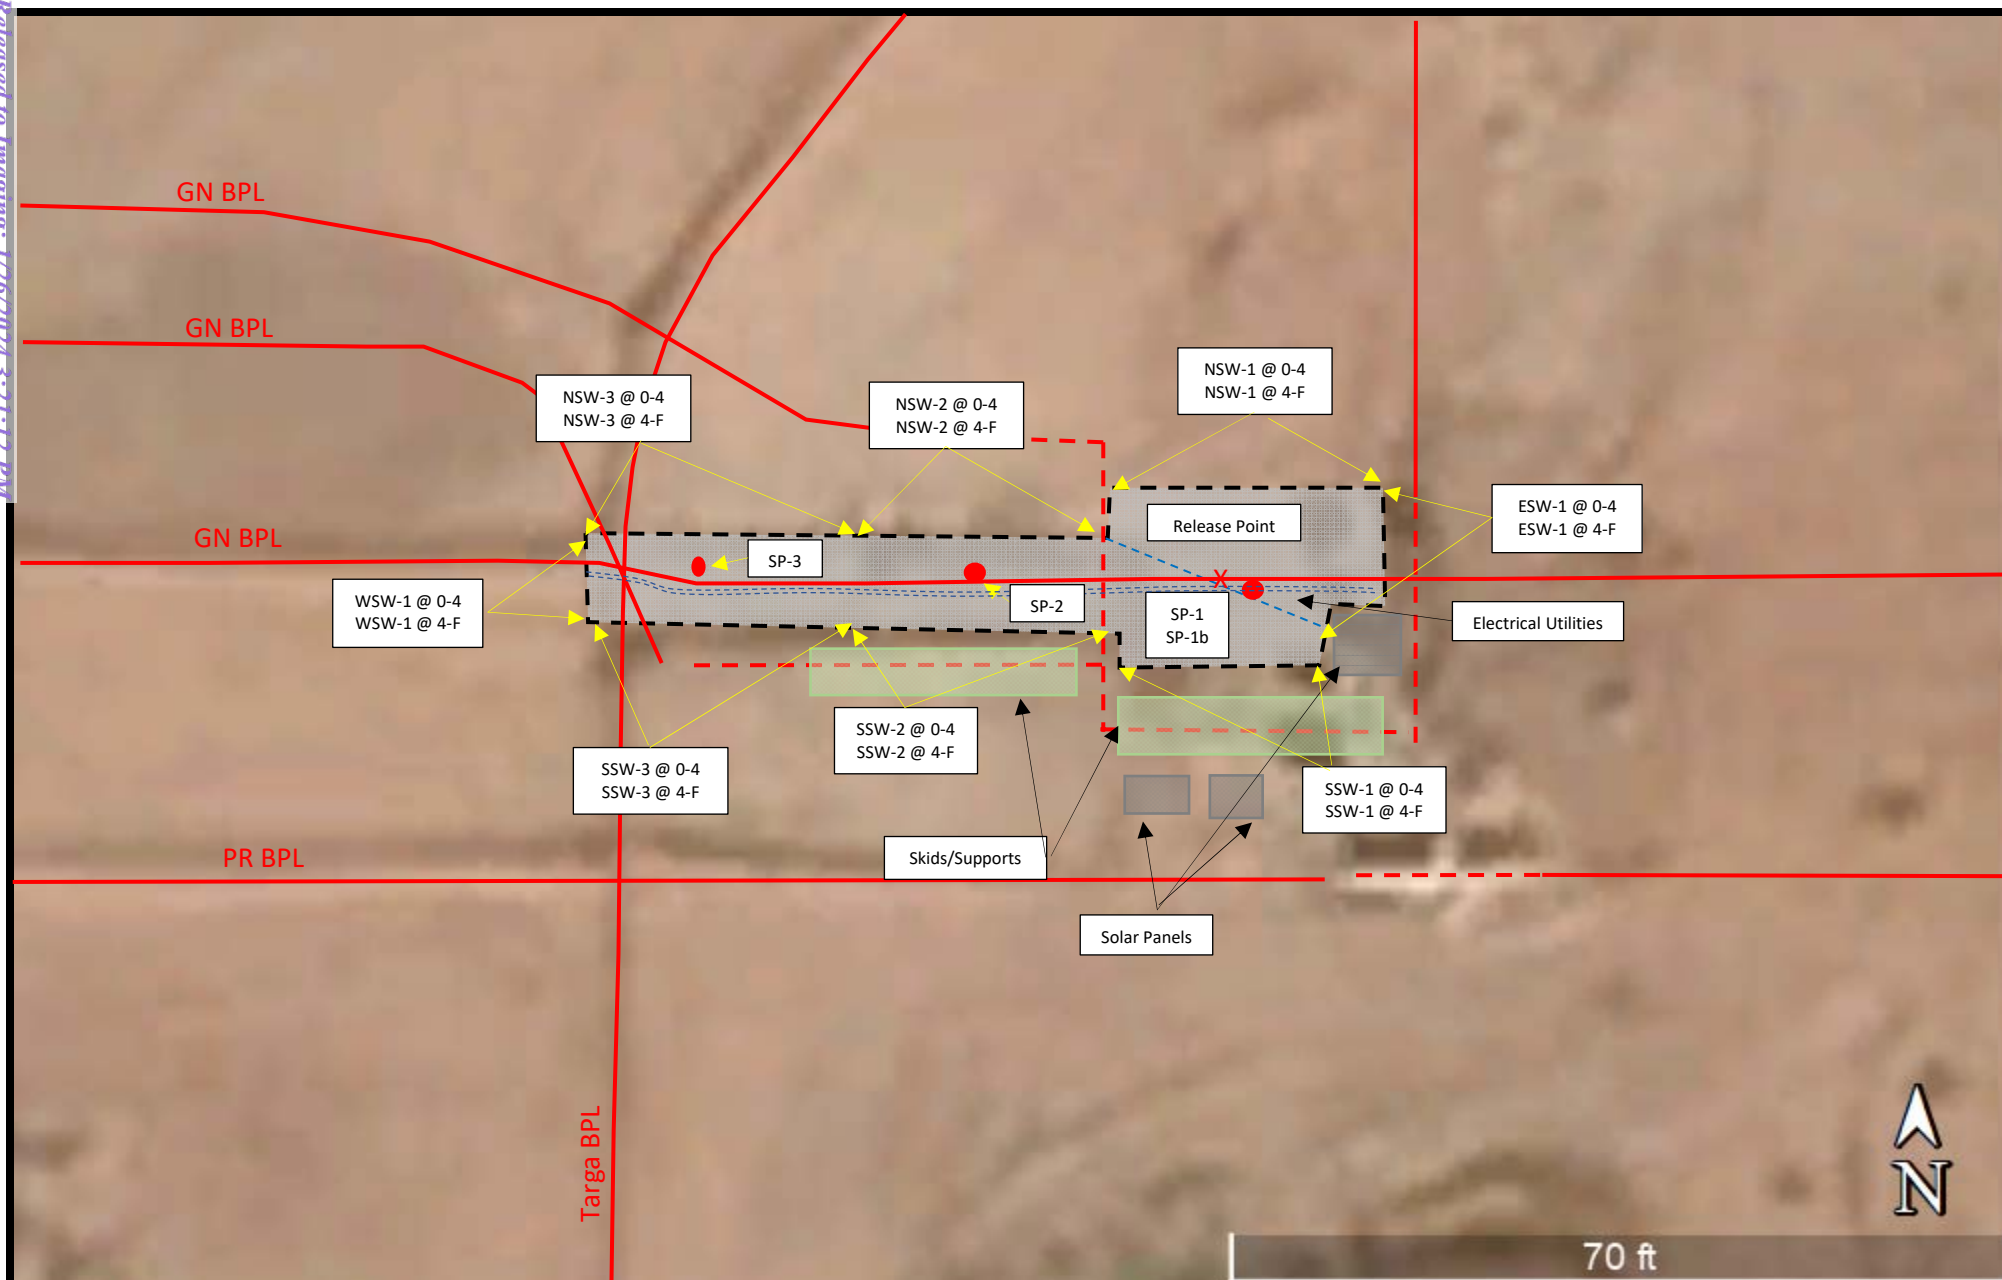
Legend:

- Sample Point
- Excavated Area
- Buried Pipeline
- - - Surface Pipeline
- - - Electrical

- Utilizing mechanical equipment, advance the floor of the current open excavation on the north side of the subject pipeline until laboratory analytical results from excavation confirmation soil samples indicate BTEX, TPH and chloride concentrations are below the NMOCD Closure Criteria (an estimated depth of 14 to 20 feet bgs). It should be noted that this omits certain data collected on September 26, 2023, which is inferred to not be representative of site conditions.

- The sidewalls of the current open excavation will be advanced toward the north, east and west until laboratory analytical results indicate BTEX, TPH and chloride concentrations are below the conditions of the Surface Use Agreement (SUA) and the NMOCD Closure Criteria. The sidewalls of the current open excavation will be advanced toward the south and west to the maximum extent practicable given the abundance and nature of above- and below-ground utilities including, but not limited to, a line cross of two (2) Goodnight buried pipelines and one (1) Targa buried high-pressure gas line toward the west, and above ground risers and associated skids consisting of SCADA equipment, multiple valves, tie-ins and solar panels toward the south.

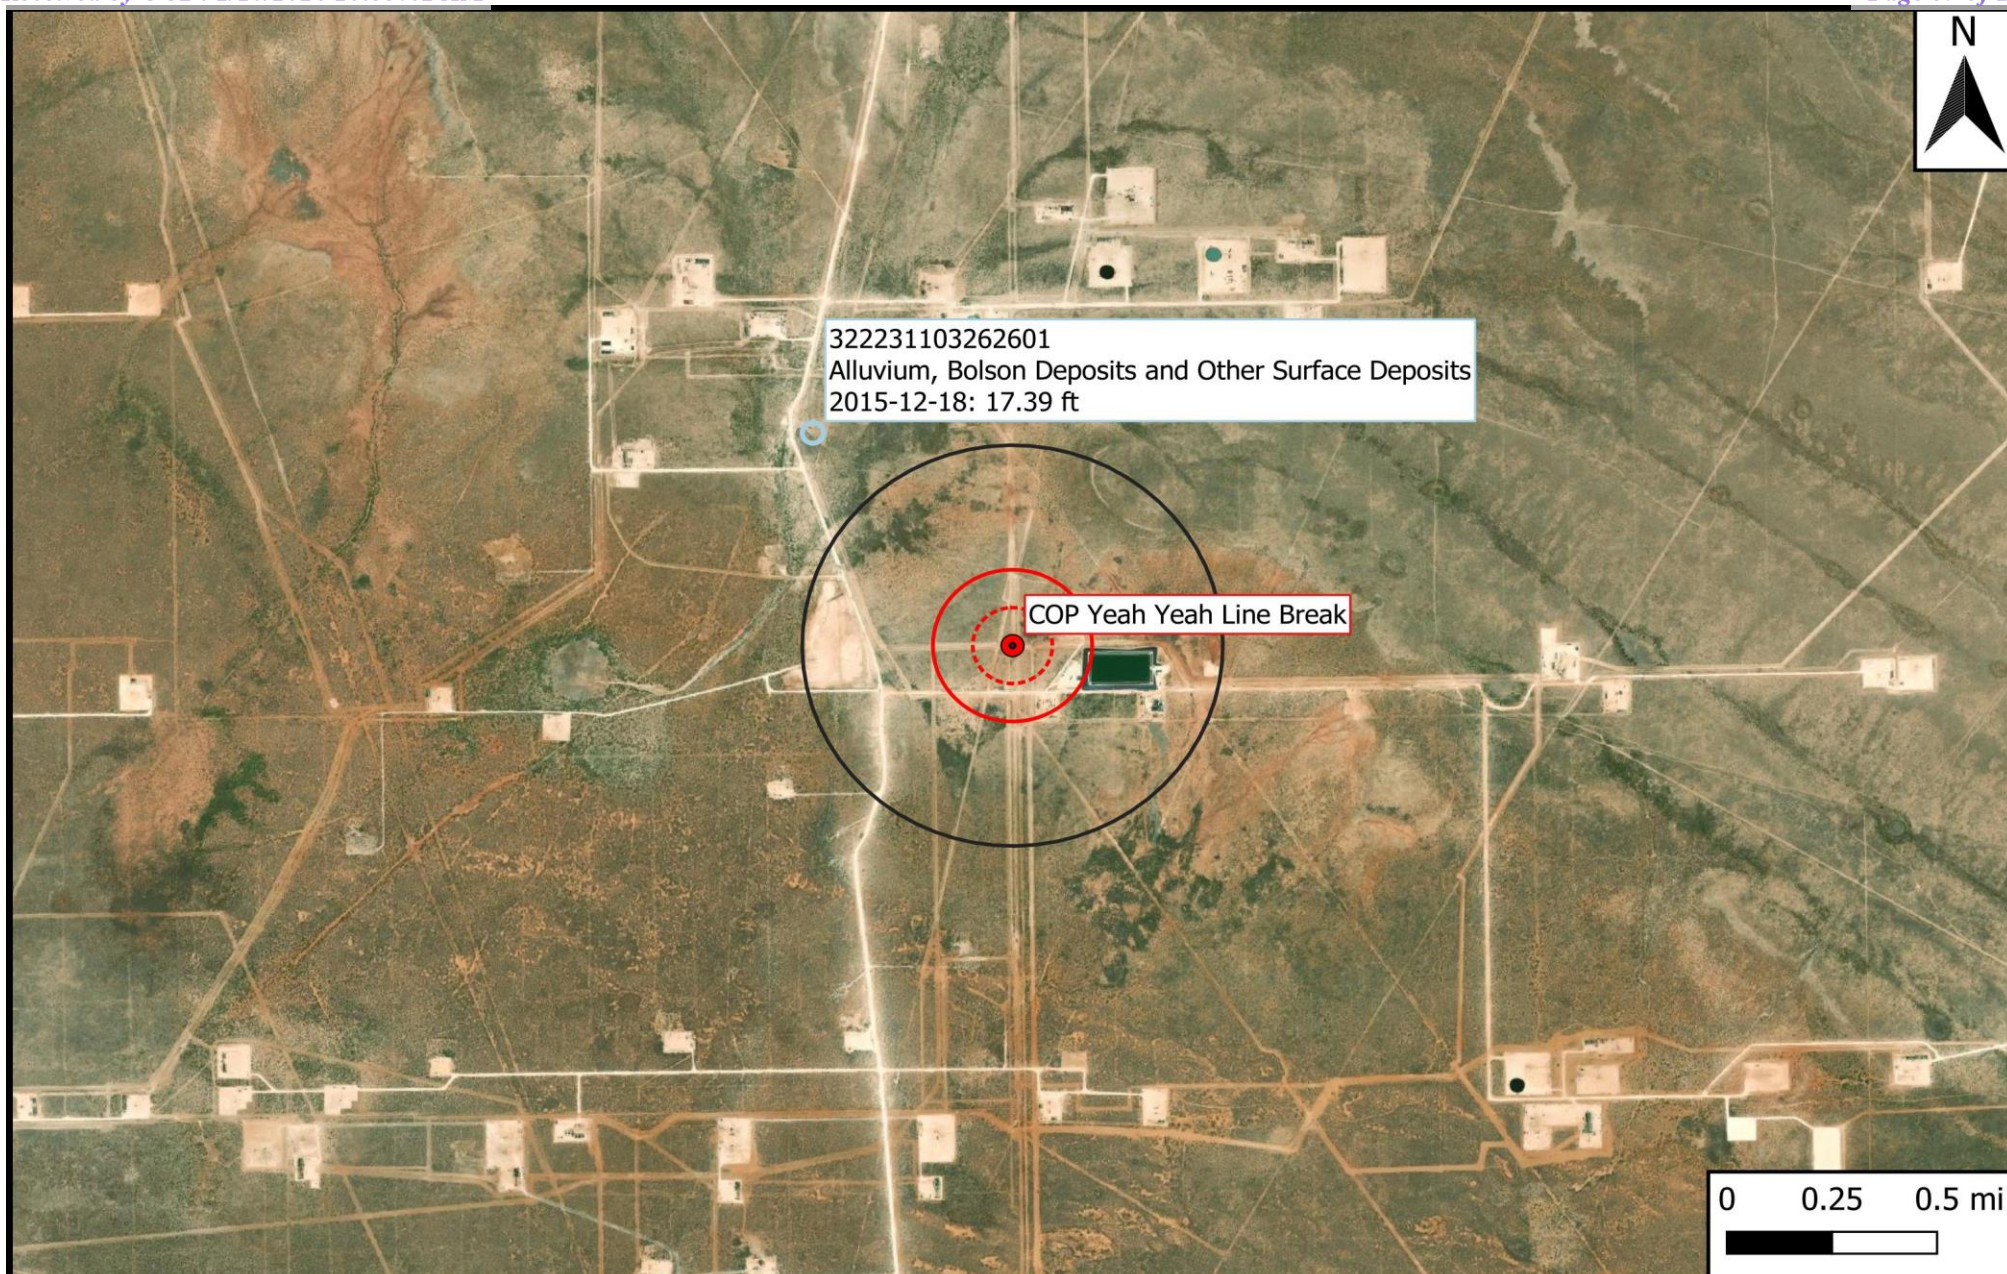
POINT OF DIVERSION SUMMARY

**Legend**

- Site Location
- Well - USGS
- ⋯ 500 Ft Radius
- ⋯ 1000 Ft Radius
- 0.5 Mi Radius
