January 10, 2023

**Re: Closure Report / Deferral Request
ConocoPhillips (Heritage COG Operating LLC)
Lychee BWS State Com #001H Release
Unit Letter O, Section 22, Township 21 South, Range 34 East
Lea County, New Mexico
Incident ID# NOY1815234060**

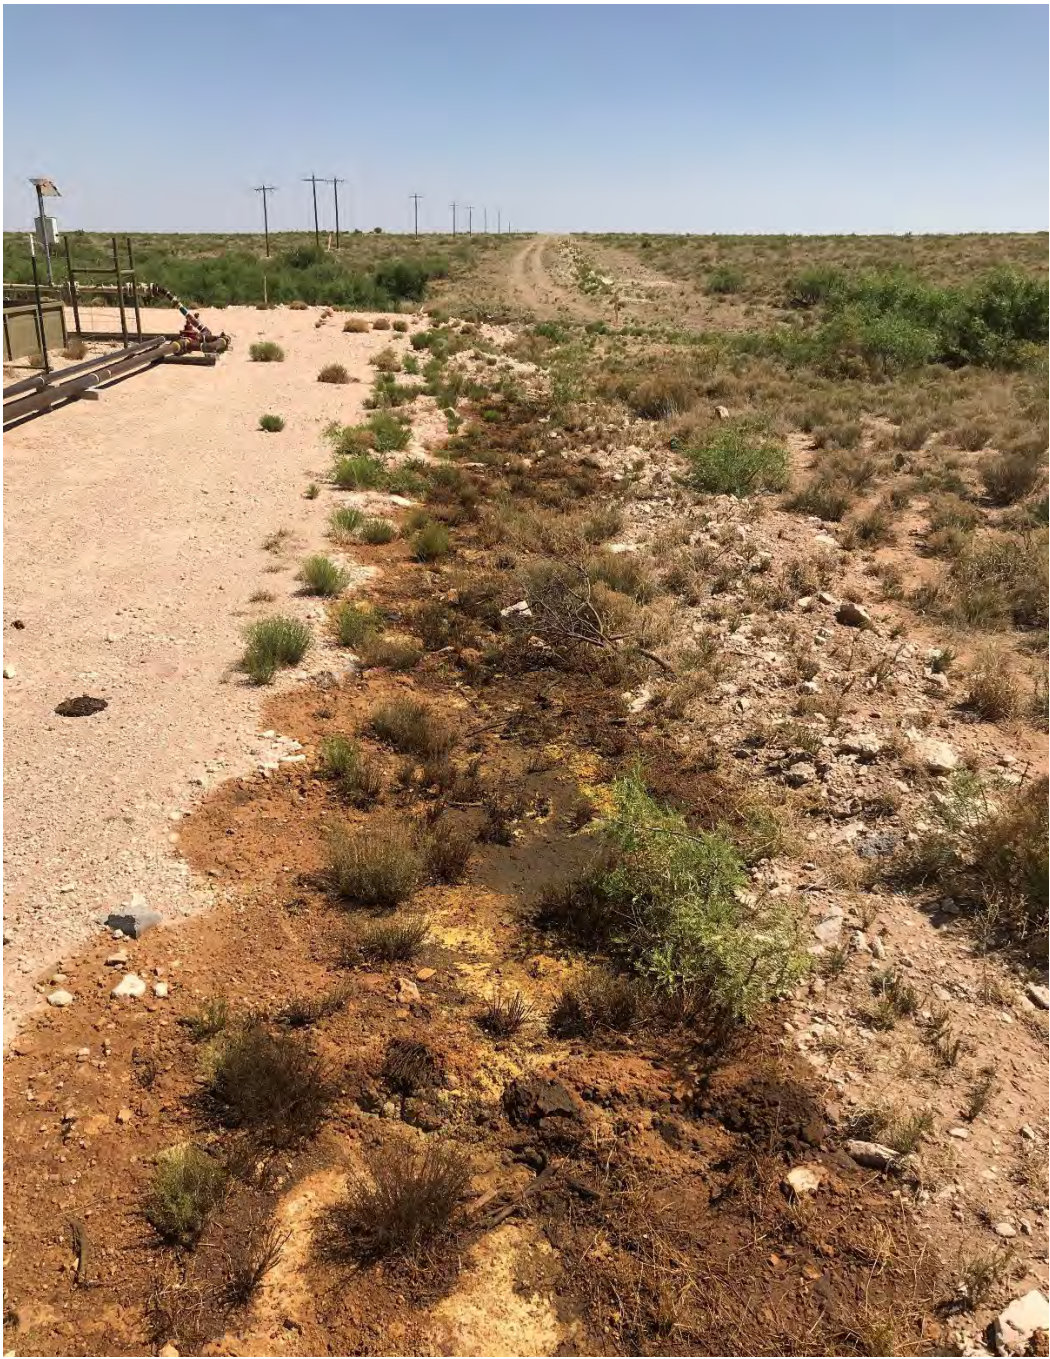
TETRA TECH, INC. PROJECT NO. 212C-MD-02846	DESCRIPTION	View south. View of release extent.	1
	SITE NAME	ConocoPhillips Lychee BWS State Com #001 Valve Release	5/29/2018

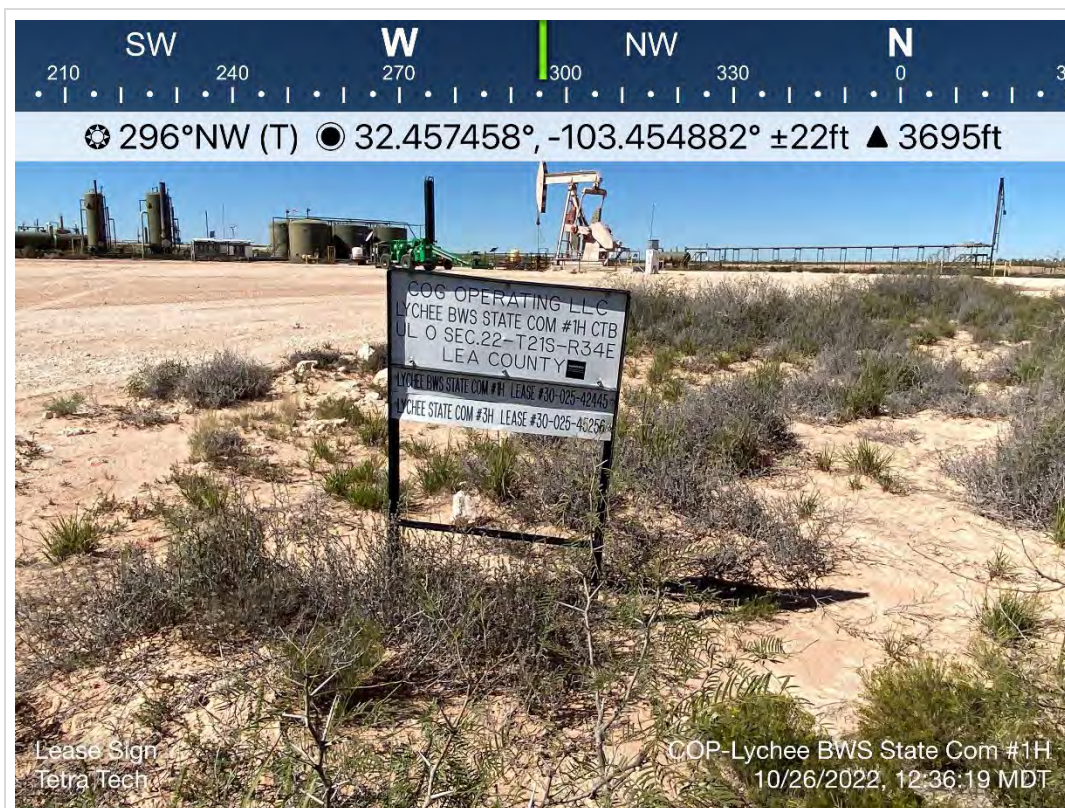
TETRA TECH, INC. PROJECT NO. 212C-MD-02846	DESCRIPTION	Site Signage. Lychee BWS State Com #001 Valve Release Site.	2
	SITE NAME	ConocoPhillips Lychee BWS State Com #001 Valve Release	10/26/2022

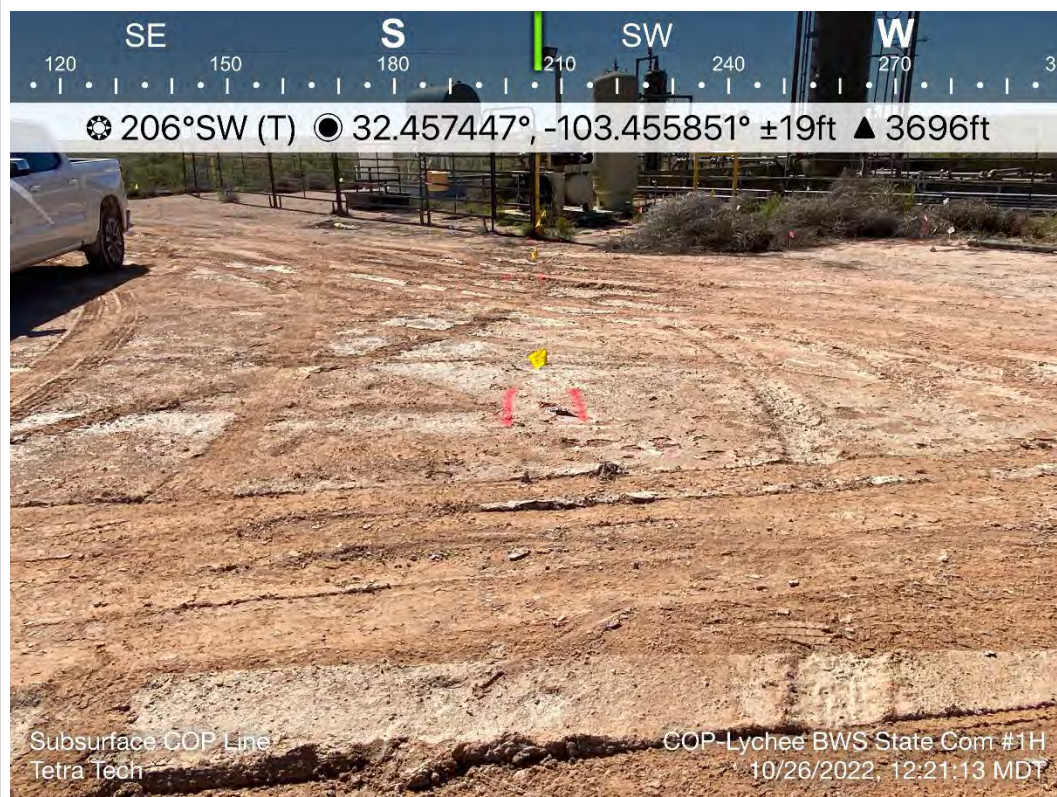
TETRA TECH, INC. PROJECT NO. 212C-MD-02846	DESCRIPTION	View south southwest. View of lease pad, production equipment and subsurface line.	3
	SITE NAME	ConocoPhillips Lychee BWS State Com #001 Valve Release	10/26/2022

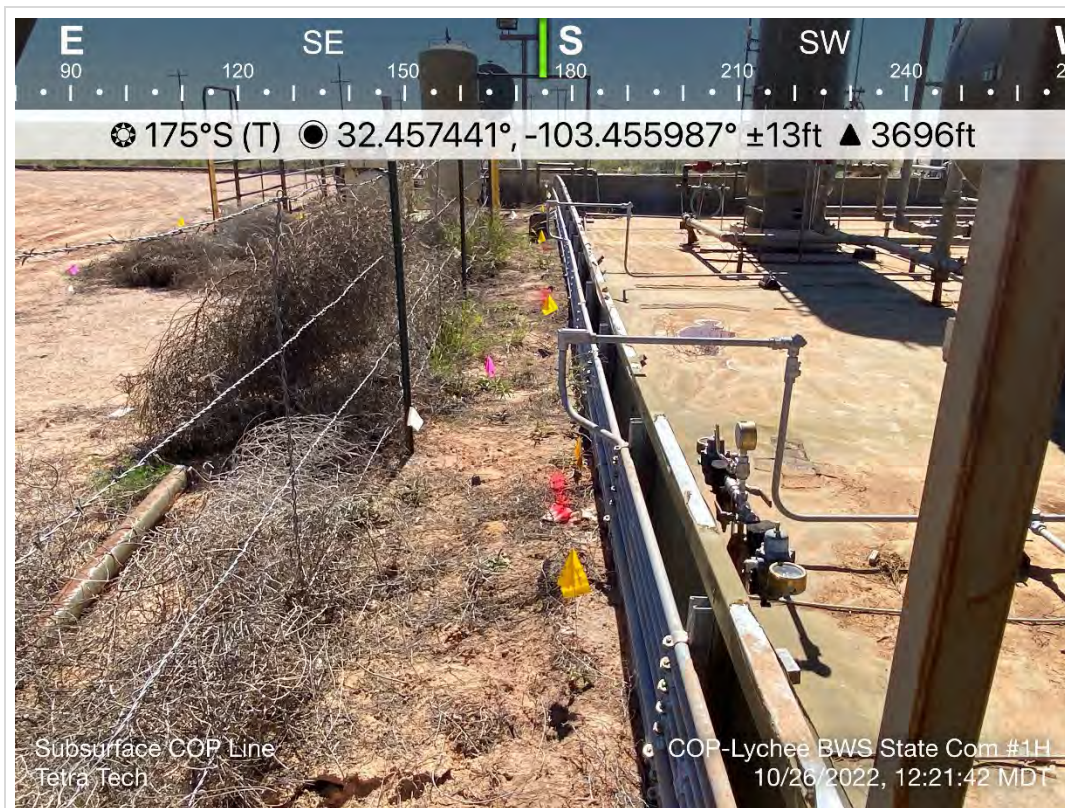
TETRA TECH, INC. PROJECT NO. 212C-MD-02846	DESCRIPTION	View south. View of production equipment and subsurface line.	4
	SITE NAME	ConocoPhillips Lychee BWS State Com #001 Valve Release	10/26/2022

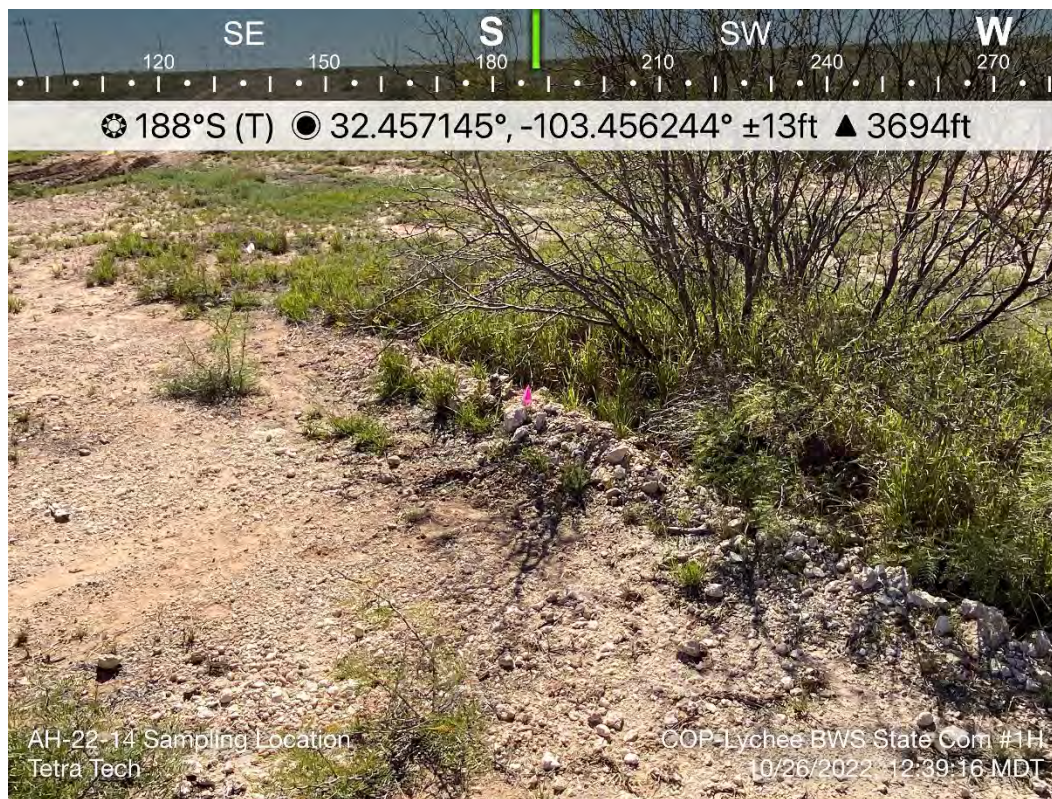
TETRA TECH, INC. PROJECT NO. 212C-MD-02846	DESCRIPTION	View south. View of approximate release. Vegetation present.	5
	SITE NAME	ConocoPhillips Lychee BWS State Com #001 Valve Release	10/26/2022

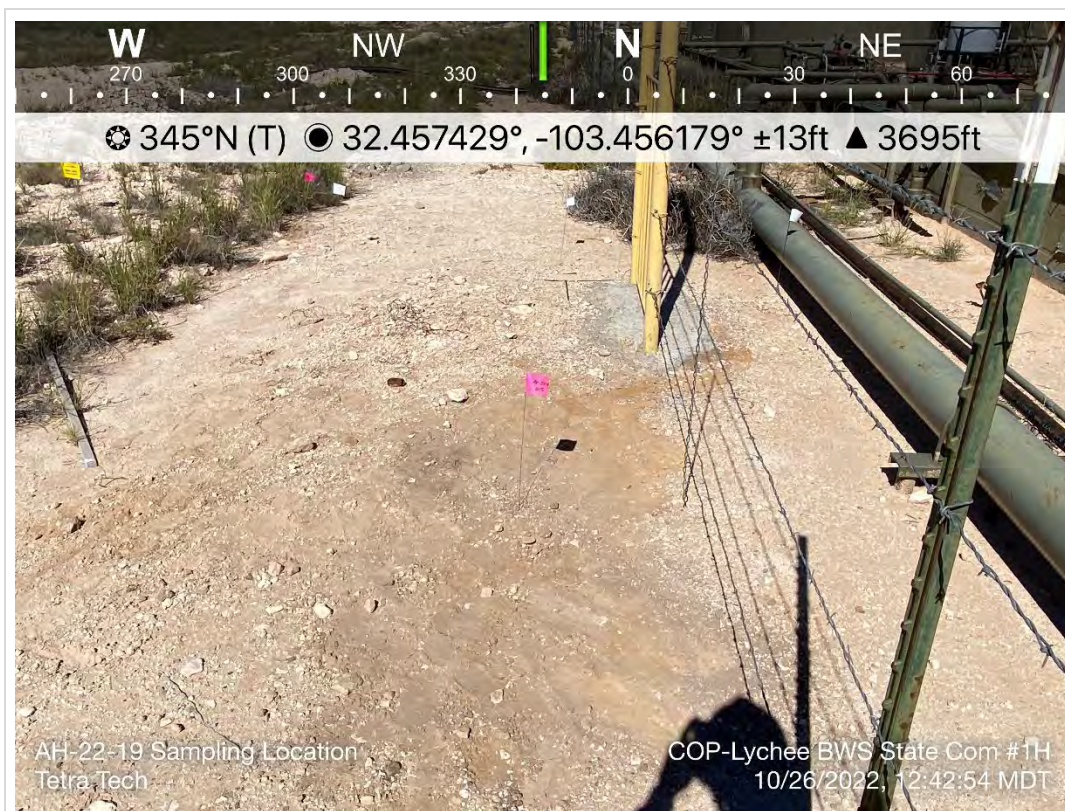
TETRA TECH, INC. PROJECT NO. 212C-MD-02846	DESCRIPTION	View north. Approximate release area. View of surface lines.	6
	SITE NAME	ConocoPhillips Lychee BWS State Com #001 Valve Release	10/26/2022

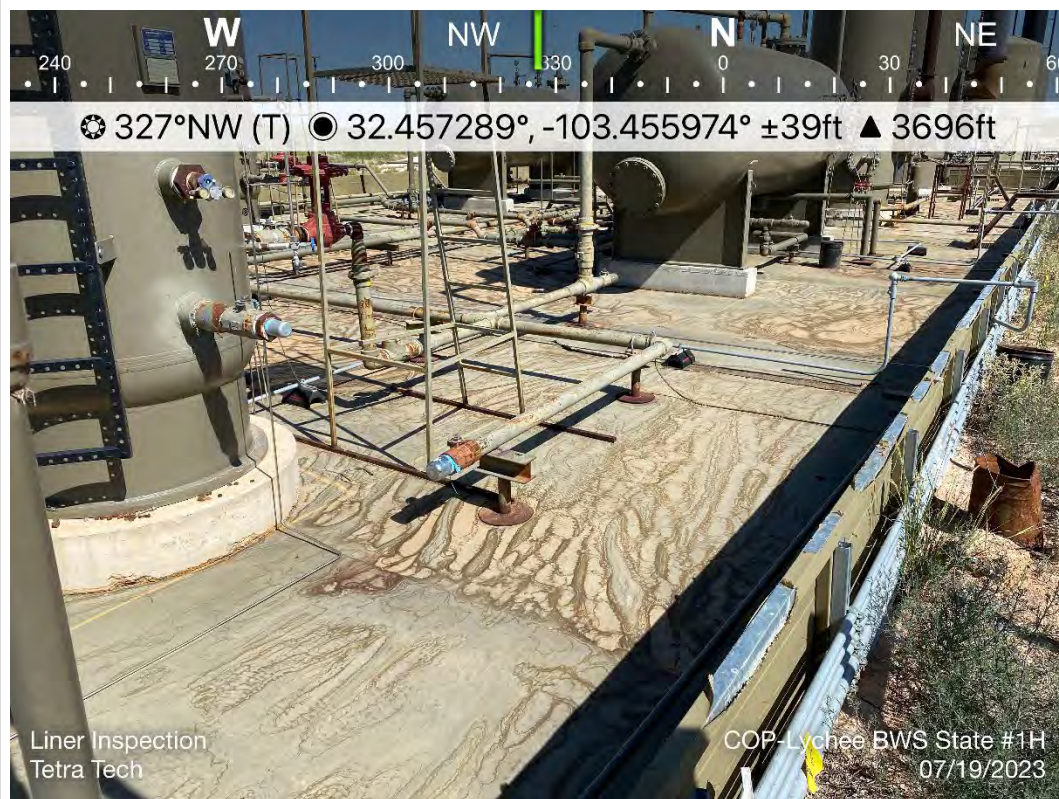
TETRA TECH, INC. PROJECT NO. 212C-MD-02846	DESCRIPTION	View northwest. View of approximate release extent inside facility. View of production equipment.	9
	SITE NAME	ConocoPhillips Lychee BWS State Com #001 Valve Release	7/19/2023

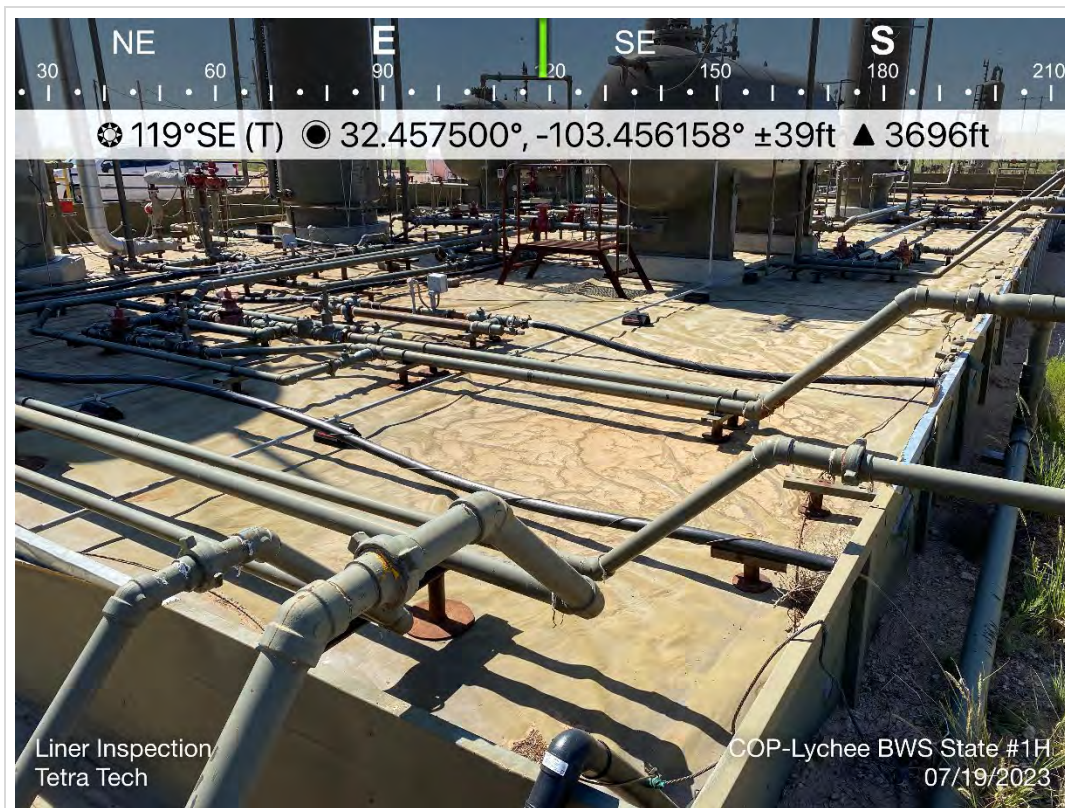
TETRA TECH, INC. PROJECT NO. 212C-MD-02846	DESCRIPTION	View east. View of approximate release extent inside facility. View of multiple steel lines. Liner integrity intact.	10
	SITE NAME	ConocoPhillips Lychee BWS State Com #001 Valve Release	7/19/2023

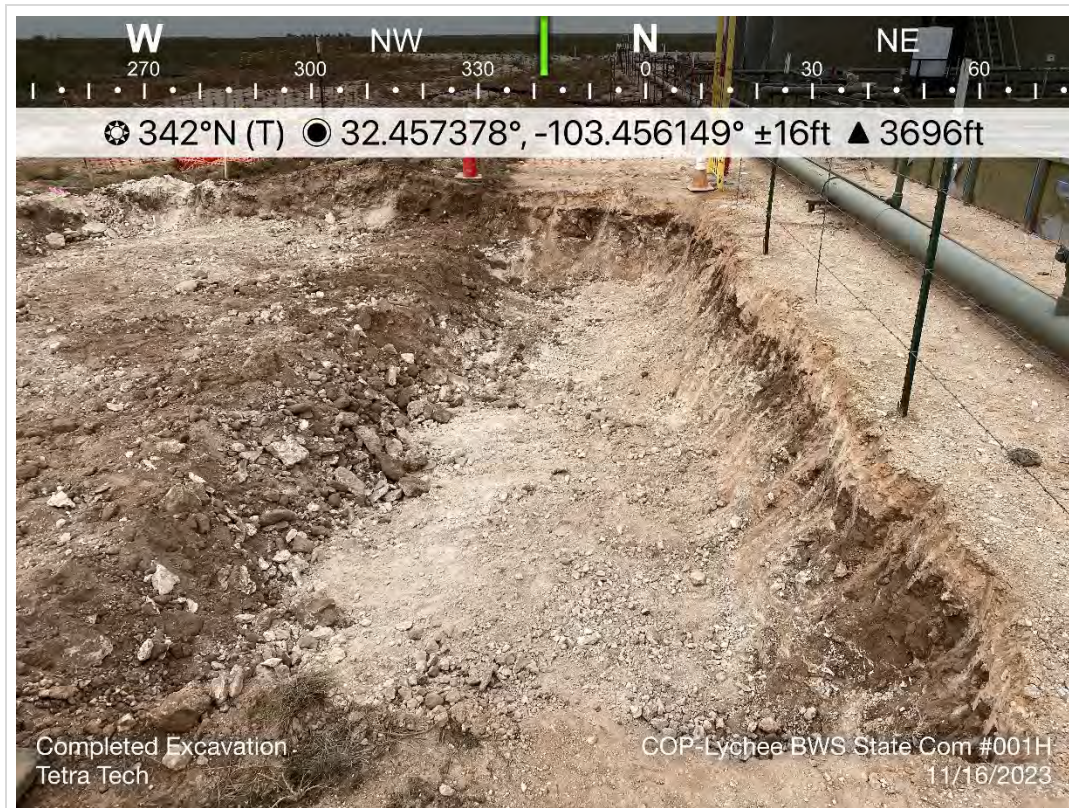
TETRA TECH, INC. PROJECT NO. 212C-MD-02846	DESCRIPTION	View north. View of remedial activities.	14
	SITE NAME	ConocoPhillips Lychee BWS State Com #001 Valve Release	11/16/2023

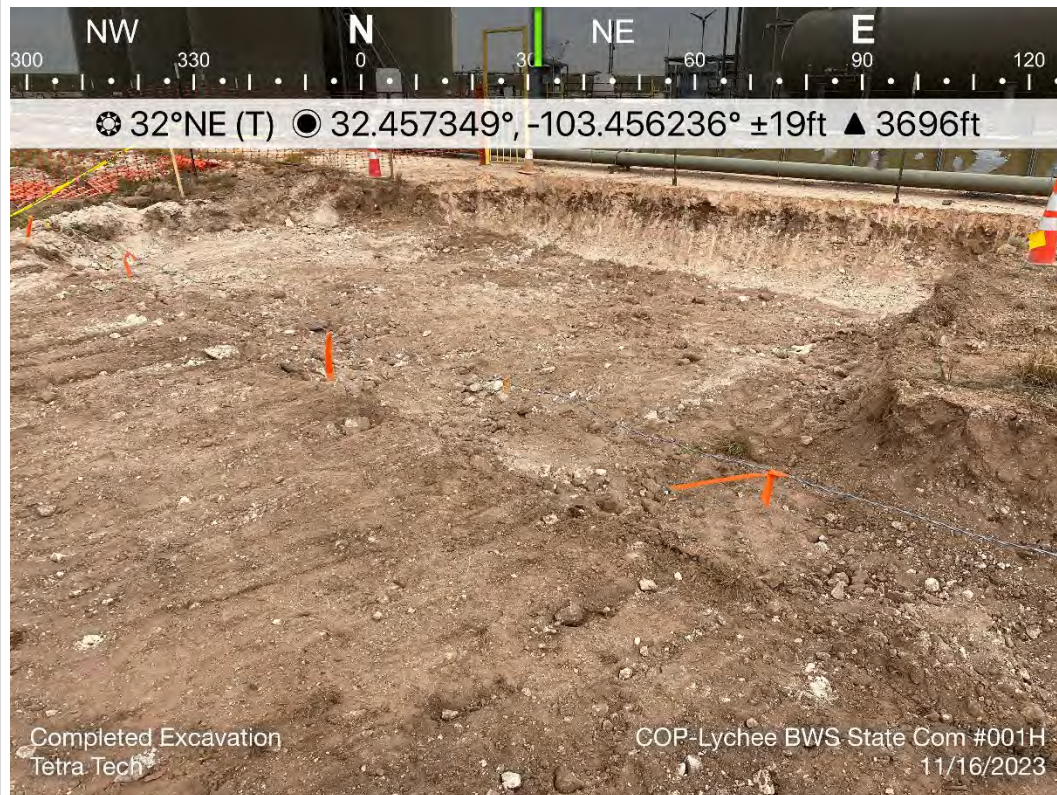
TETRA TECH, INC. PROJECT NO. 212C-MD-02846	DESCRIPTION	View north. View of remedial activities.	15
	SITE NAME	ConocoPhillips Lychee BWS State Com #001 Valve Release	11/16/2023

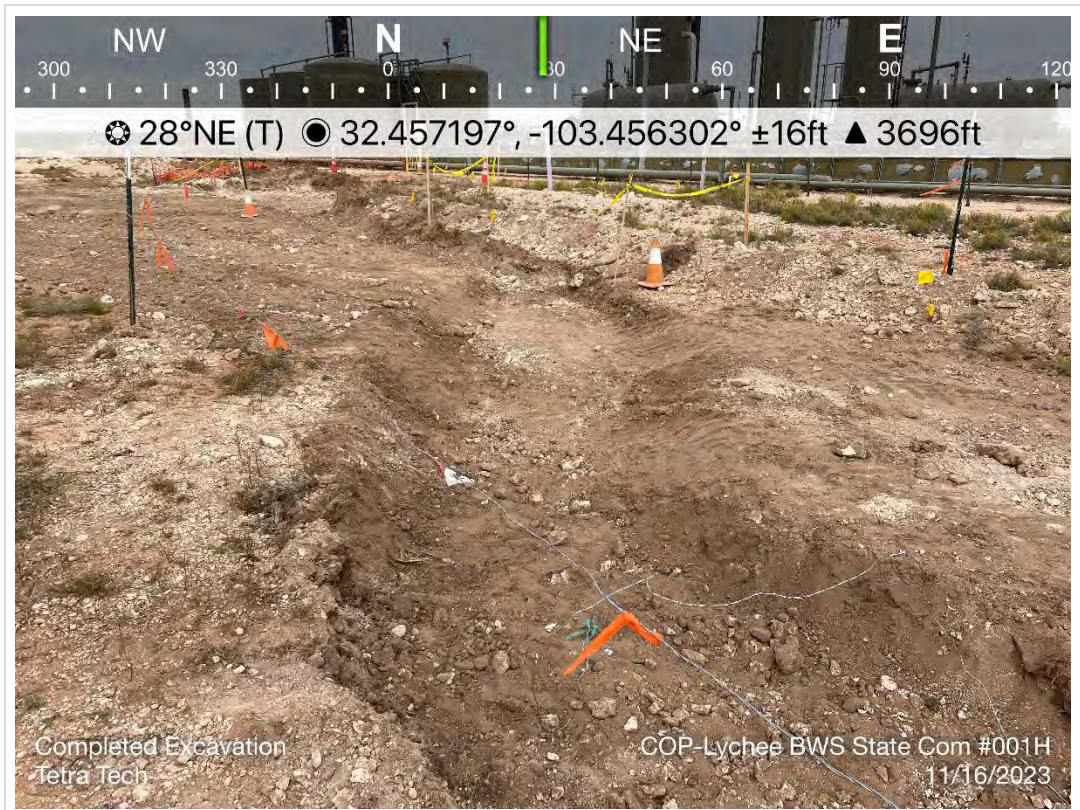
TETRA TECH, INC. PROJECT NO. 212C-MD-02846	DESCRIPTION	View north northeast. View of remedial activities.	16
	SITE NAME	ConocoPhillips Lychee BWS State Com #001 Valve Release	11/16/2023

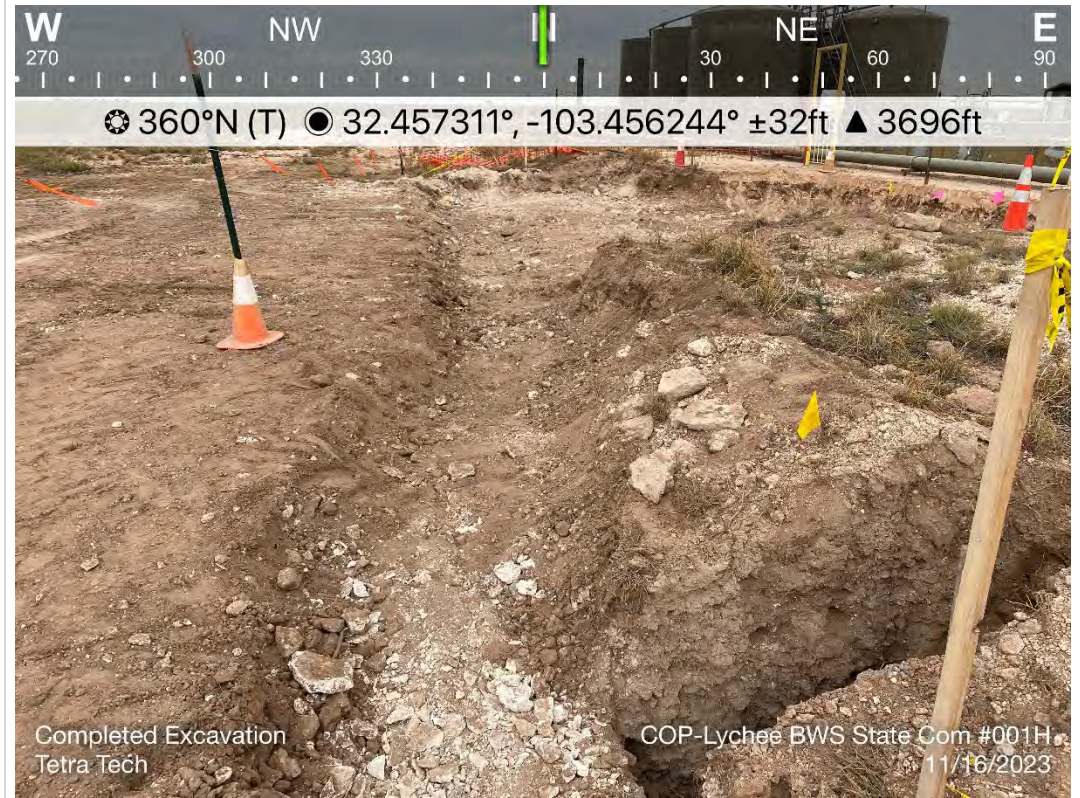
TETRA TECH, INC. PROJECT NO. 212C-MD-02846	DESCRIPTION	View north. View of remedial activities.	17
	SITE NAME	ConocoPhillips Lychee BWS State Com #001 Valve Release	11/16/2023

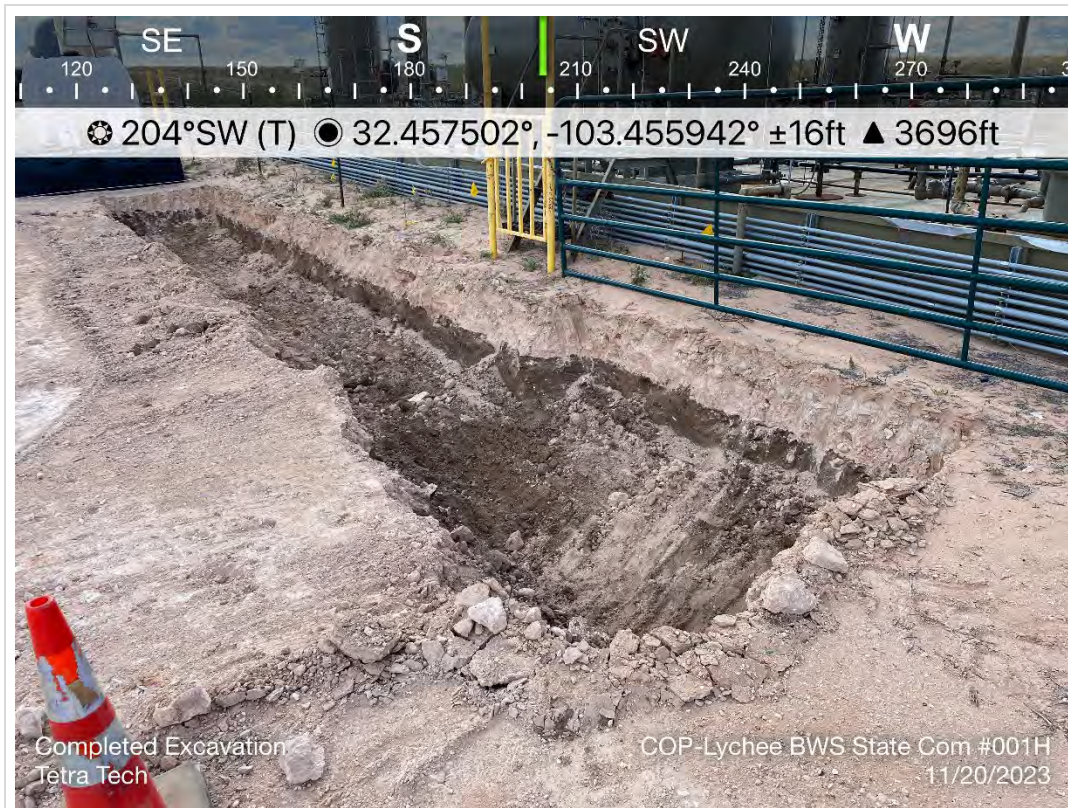
TETRA TECH, INC. PROJECT NO. 212C-MD-02846	DESCRIPTION	View south southwest. View of remedial activities.	18
	SITE NAME	ConocoPhillips Lychee BWS State Com #001 Valve Release	11/20/2023

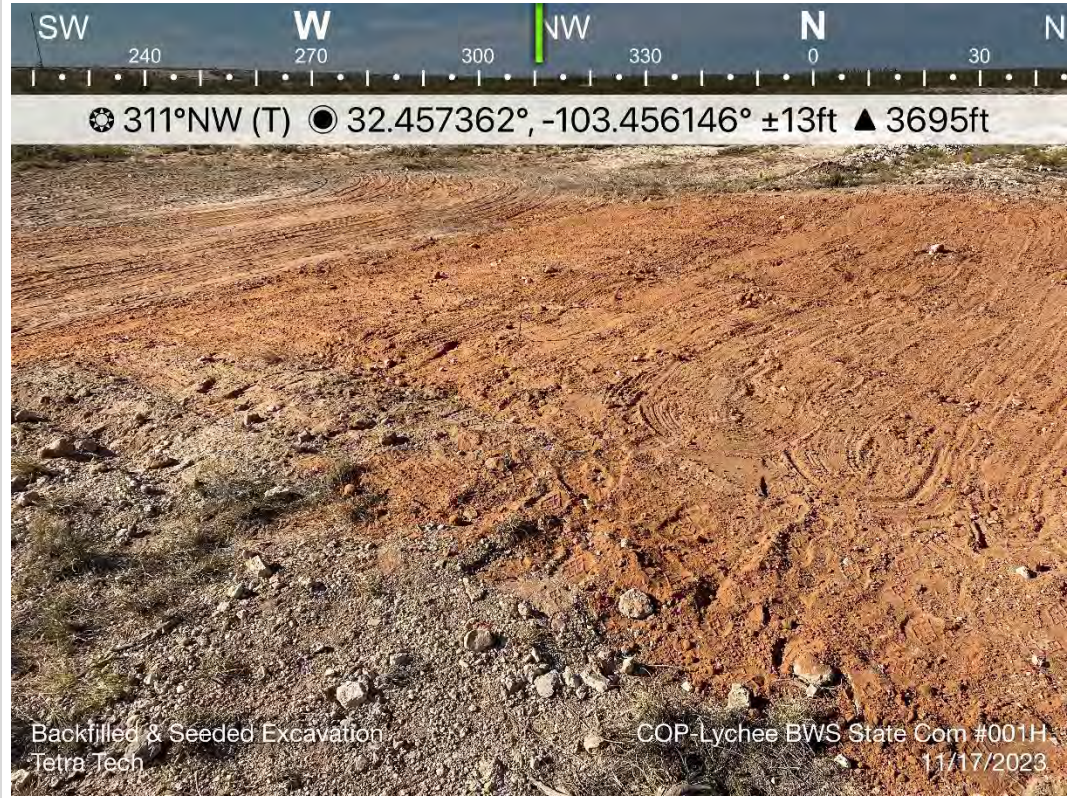
TETRA TECH, INC. PROJECT NO. 212C-MD-02846	DESCRIPTION	View northwest. View of backfilled area. View of reclamation activities.	17
	SITE NAME	ConocoPhillips Lychee BWS State Com #001 Valve Release	11/17/2023
