Re: Closure Request

Rojo 7811 Fee Com 10-13 Compressor Incident Number NAB1907837006 Lea County, New Mexico

Ensolum, LLC (Ensolum), on behalf of BTA Oil Producers, LLC (BTA), has prepared this *Closure Request* to document assessment, delineation, and soil sampling activities performed at the Rojo 7811 Fee Com 10-13 Compressor (Site). The purpose of the Site assessment, delineation, and soil sampling activities was to assess for the presence or absence of impacts to soil resulting from a historical fire and associated release at the Site. Based on field observations, field screening activities, and soil sample laboratory analytical results, BTA is submitting this *Closure Request*, describing Site assessment and delineation activities that have occurred and requesting closure for Incident Number NAB1907837006.

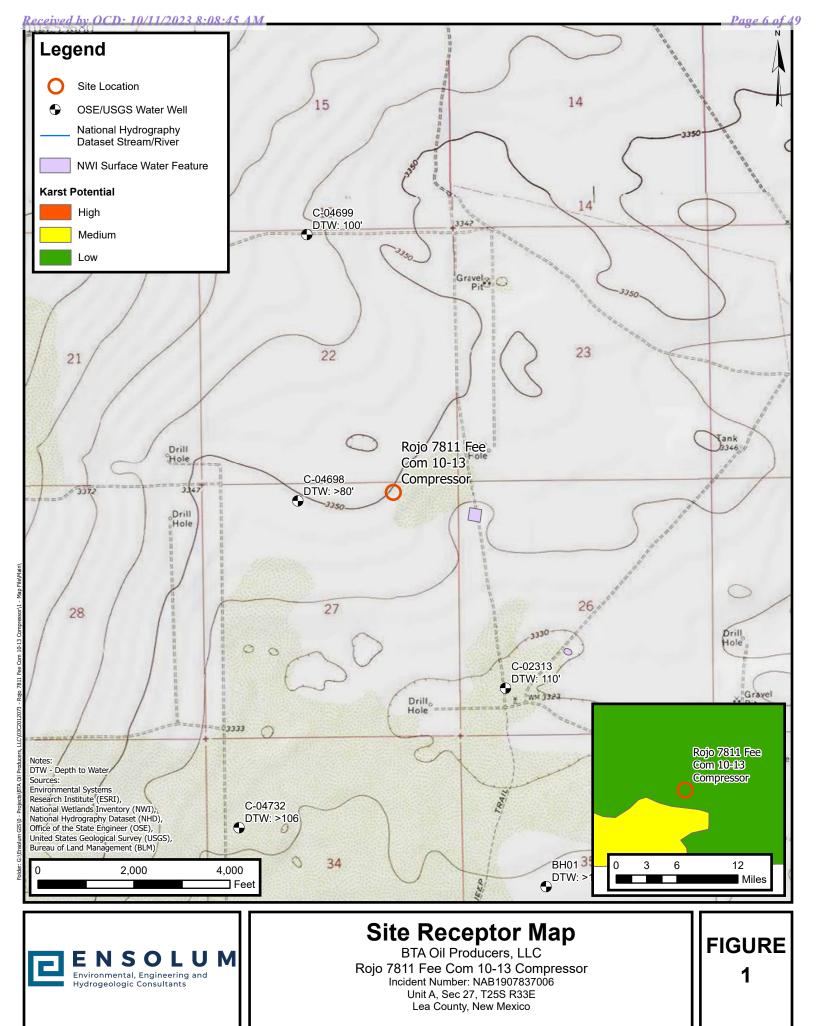
Figure 1 Site Receptor Map

The Site was characterized to assess the applicability of Table I, Closure Criteria for Soils Impacted by a Release, of Title 19, Chapter 15, Part 29 (19.15.29) of the New Mexico Administrative Code (NMAC). Results from the characterization desktop review are presented on page 3 of the Form C-141, Site Assessment/Characterization. Potential Site receptors are identified on Figure 1.

groundwater was encountered. All wells used for depth to groundwater determination are presented on Figure 1. The associated well records are included in Appendix A.

The closest continuously flowing or significant watercourse to the Site is a freshwater emergent wetland, located approximately 4,328 feet southeast of the Site. The Site is greater than 200 feet from a lakebed, sinkhole, or playa lake and greater than 300 feet from an occupied residence, school, hospital, institution, church, or wetland. The Site is greater than 1,000 feet to a freshwater well or spring and is not within a 100-year floodplain or overlying a subsurface mine. The Site is not underlain by unstable geology (low potential karst designation area). Site receptors are identified on Figure 1.

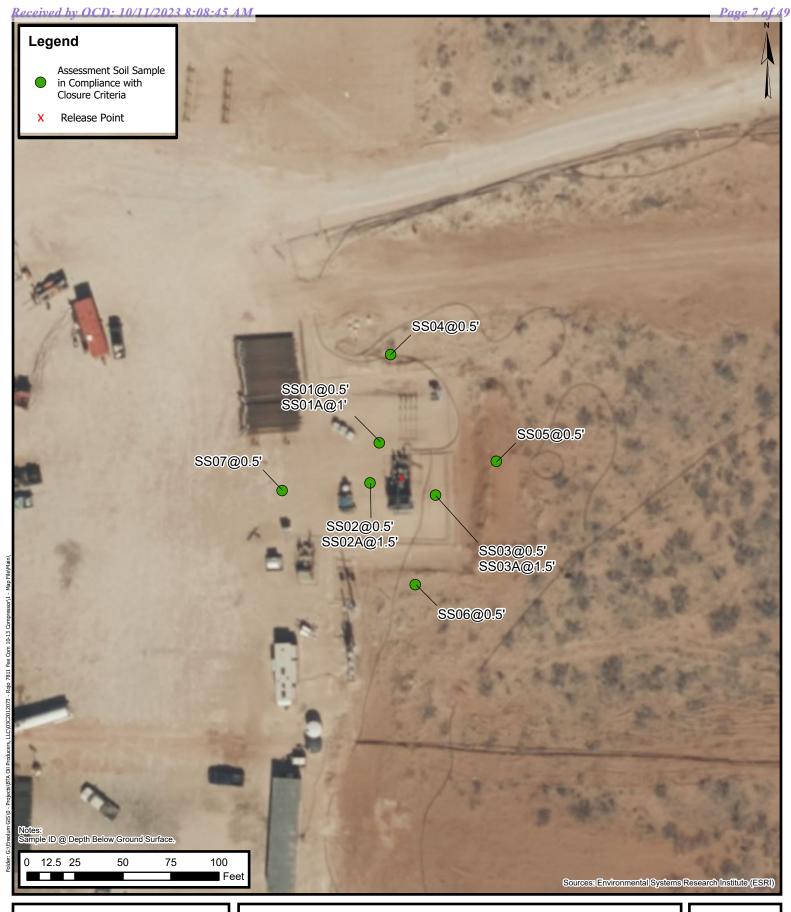
BTA Oil Producers, LLC Rojo 7811 Fee Com 10-13 Compressor Incident Number: NAB1907837006 Unit A, Sec 27, T25S R33E Lea County, New Mexico FIGURE 2

On August 31, 2023, Ensolum personnel were at the Site to evaluate the historical release based on information provided on the Form C-141 and visual observations. No visible indications of the historical release were observed during the Site visit. The compressor area had been reconfigured and several additional compressors were installed since the time of the release. Seven assessment soil samples (SS01 through SS07) were collected within and around the inferred release area, at a depth of approximately 0.5 feet bgs, to assess for the presence or absence of impacted soil resulting from the historical fire and release. The soil samples were field screened for volatile organic compounds (VOCs) utilizing a calibrated photoionization detector (PID) and chloride using Hach® chloride QuanTab® test strips. The soil sample locations were mapped utilizing a handheld Global Positioning System (GPS) unit and are depicted on Figure 2. Photographic documentation was completed during the Site visit and a photographic log is included as Appendix B.

Laboratory analytical results for assessment soil samples SS01 and SS03, collected within the inferred release area, indicated all COC concentrations were compliant with the Site Closure Criteria. Laboratory analytical results for assessment samples SS04 through SS07, collected around the inferred release area, were compliant with the most stringent Table I Closure Criteria and successfully defined the lateral extent of the release. Vertical delineation activities were warranted to further confirm the absence of impacted soil within the historical release area.

Assessment Soil Sample Locations BTA Oil Producers, LLC

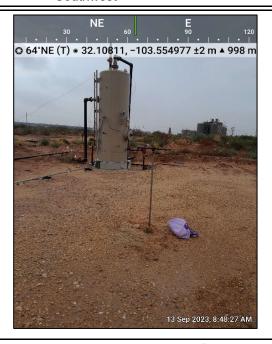
Photograph: 4 Date: 9/13/2023 Description: Release area during delineation activities

View: Northeast
