Re: Closure Report
South Lybrook 344H Surface Lay Flat Line Route
Sandoval County, New Mexico
Incident Number: NAPP2228036562

Ensolum, LLC (Ensolum), on behalf of Enduring Resources, LLC (Enduring), has prepared the following *Closure Report* to document the work performed to address the release of produced water within the South Lybrook 344H Surface Lay Flat Line Route (Site). Based on the activities described in this report, Ensolum recommends Enduring request closure and no further action for Incident Number NAPP2228036562.

2023 Soil Sample Locations

South Lybrook 344H Surface Lay Flat Line Route
Enduring Resources, LLC

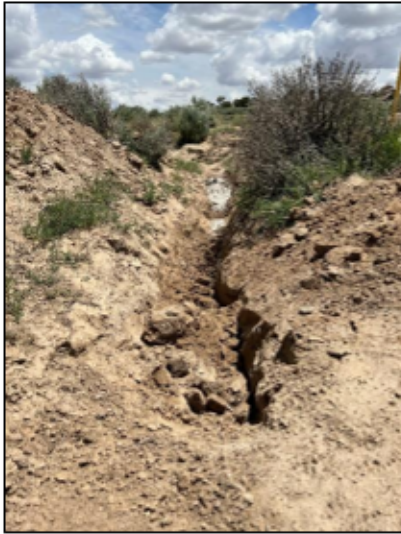
Photograph: 1 Date: 6/2/2023
Description: Hand dug area around HA11
View: Northeast

Ensolum personnel returned to the Site on May 23, 2023 to field screen chloride concentrations in the soil near HA11. Results indicated that chloride concentrations remained elevated in soil at depths of 1 to 2 feet bgs. To address the residual chloride concentrations at this location, Ensolum personnel removed impacted soil up to a depth of 2 feet bgs near HA11 using a hand shovel on June 2, 2023. In total, approximately one cubic yard of soil was removed for disposal at the landfarm operated by Envirotech, Inc. and located in San Juan County, New Mexico. This area was backfilled with a mixture of clean soil and finely powdered gypsum. On June 27, 2023, Ensolum personnel returned to the Site and advanced one hand auger boring to 2.5 feet bgs to reassess chloride concentrations at location HA11. Laboratory analytical results from sample "HA11@2.5" indicated that no chloride was detected above laboratory reporting limits.

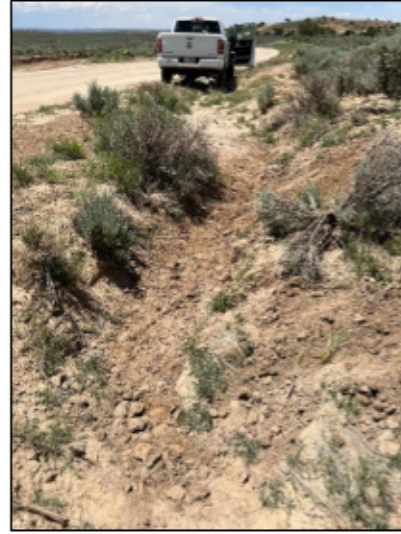
Photograph: 2 Date: 6/2/2023
Description: Backfilled area around HA11
View: Southeast

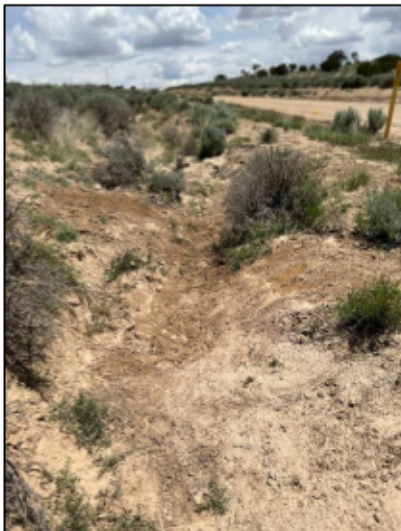
Photograph: 3 Date: 6/2/2023
Description: Backfilled area around HA11
View: Northeast

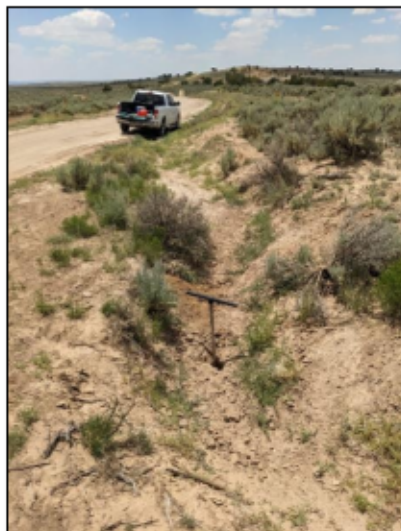
Photograph: 4 Date: 6/27/2023
Description: Auger location - Sample HA11 @2.5'
View: Southeast

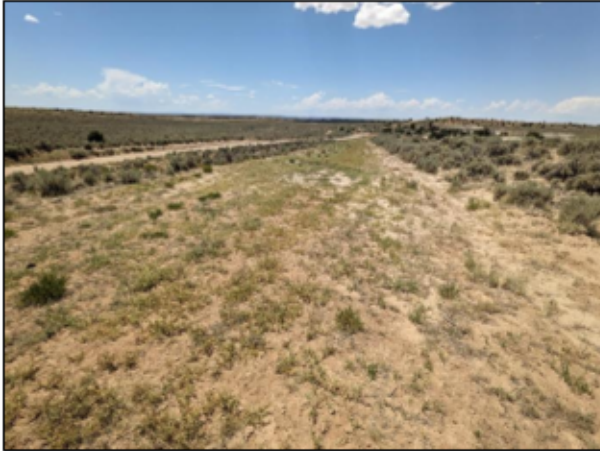
Photograph: 5 Date: 6/26/2023
Description: Pipeline ROW vegetation in release area
View: Looking south from release point

Vegetation within the ROW was monitored in July 2023 to assess the percentage of cover and relative health of impacted areas as compared to adjacent unimpacted vegetation. Photograph 5 was taken within the affected area of the ROW and Photograph 6 was taken in an adjacent, unaffected area. As seen in the photographs, vegetation quality and coverage is similar both within and outside of the release area, indicating that vegetation was not significantly impacted by the release. Photographs 7 and 8 show areas where the release migrated outside of the ROW towards the ditch and roadway southeast of the release point. Similar to the affected area of the ROW, the more mature vegetation in the area closer to the ditch did not appear to be impacted by the release. Photographs of the current vegetation are included in Appendix A.

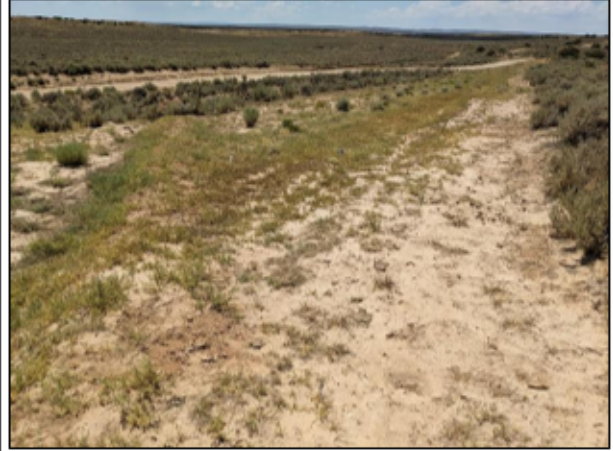
Photograph: 6 Date: 6/26/2023
Description: Pipeline ROW vegetation outside release
View: South

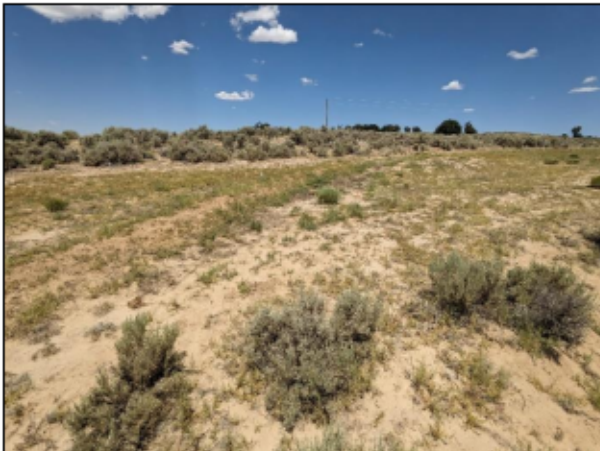
Photograph: 7 Date: 6/26/2023
Description: Release migrated out of ROW into ditch
View: Northeast

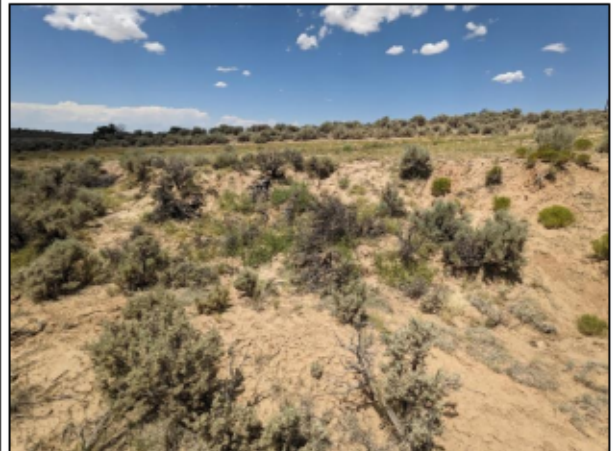
Photograph: 8 Date: 6/26/2023
Description: Vegetation outside ROW to the east
View: Northwest
