**Re: Site Assessment, Remediation, and Closure Report**  
**Right Meow 31 CTB 5**  
**API No. N/A**  
**GPS: Latitude 32.256124, Longitude -103.718063**  
**UL M, Section 31, T23S, R32E**  
**Eddy County, NM**  
**NMOCD Ref. No. NAPP2321162164**

Pima Environmental Services, LLC. (Pima) has been contracted by Devon Energy Production Company (Devon) to perform a spill assessment, remediation activities, and submit this closure report for a produced water release that occurred at the Right Meow 31 CTB 5 (Right Meow). The initial C-141 was submitted on August 21, 2023 (Appendix C). This incident was assigned Incident ID NAPP2321162164 by the New Mexico Oil Conservation Division (NMOCD).

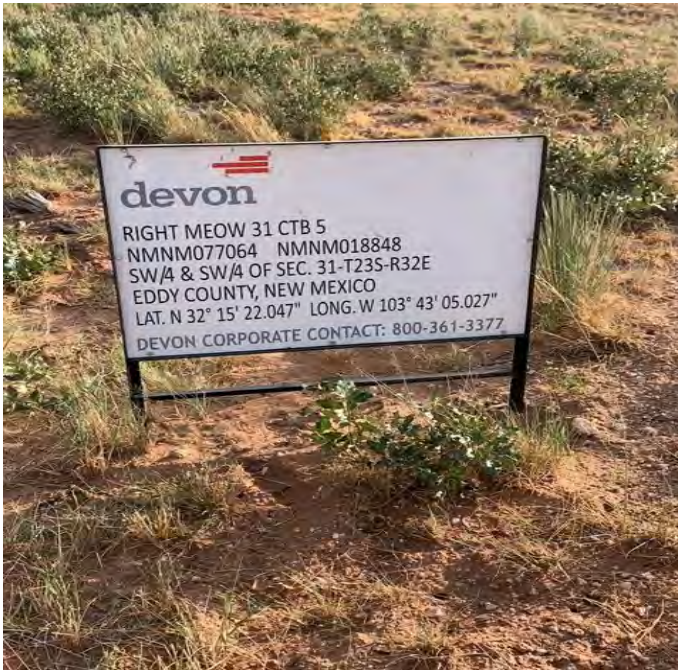
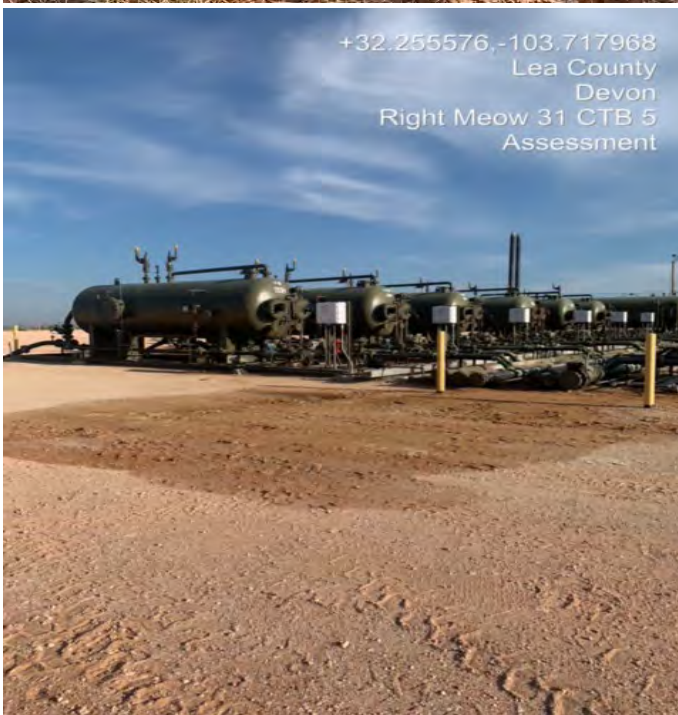
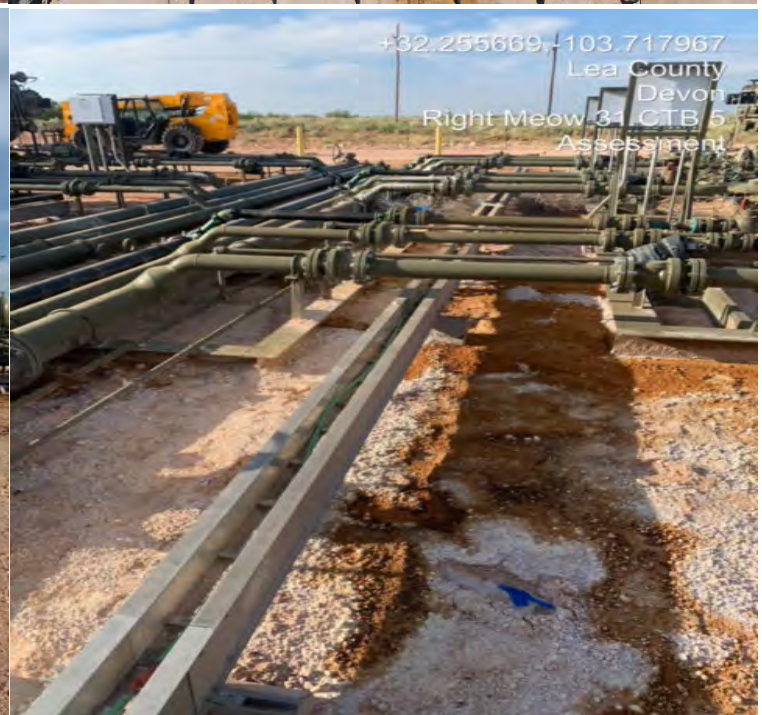
**Site Assessment**

Based on the sample results, the bottoms and sidewalls were below NMOCD Closure Criteria 19.15.29 NMAC. See Appendix D for Photographic Documentation.
