Closure Report

Merchant Central Battery
Lea County, New Mexico
Incident # NAPP2318123847

Subject: **Closure Report**
Merchant Central Battery
Lea County, New Mexico
Incident # NAPP2318123847

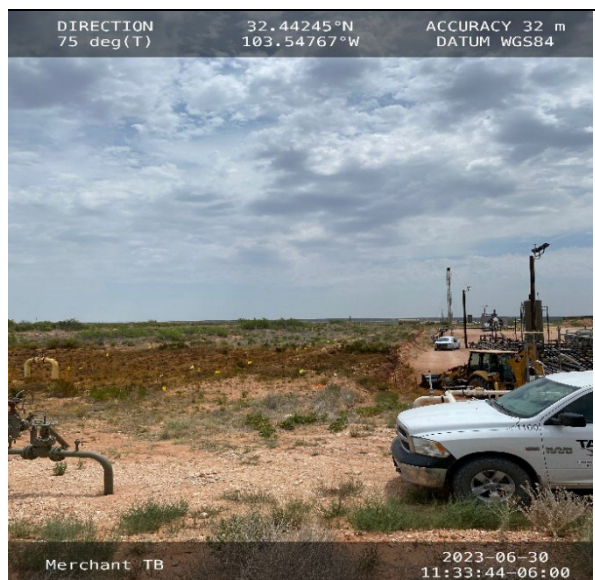
Photograph No.1 Description:

Initial release in adjacent pasture

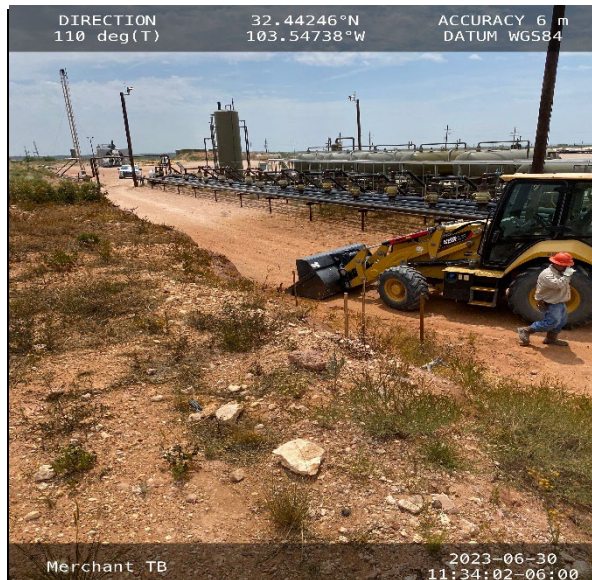
Photograph No.2 Description:

Initial release on the pad location
