Incident ID	nAPP2319833354
District RP	
Facility ID	
Application ID

Site Assessment/Characterization

Remediation Plan

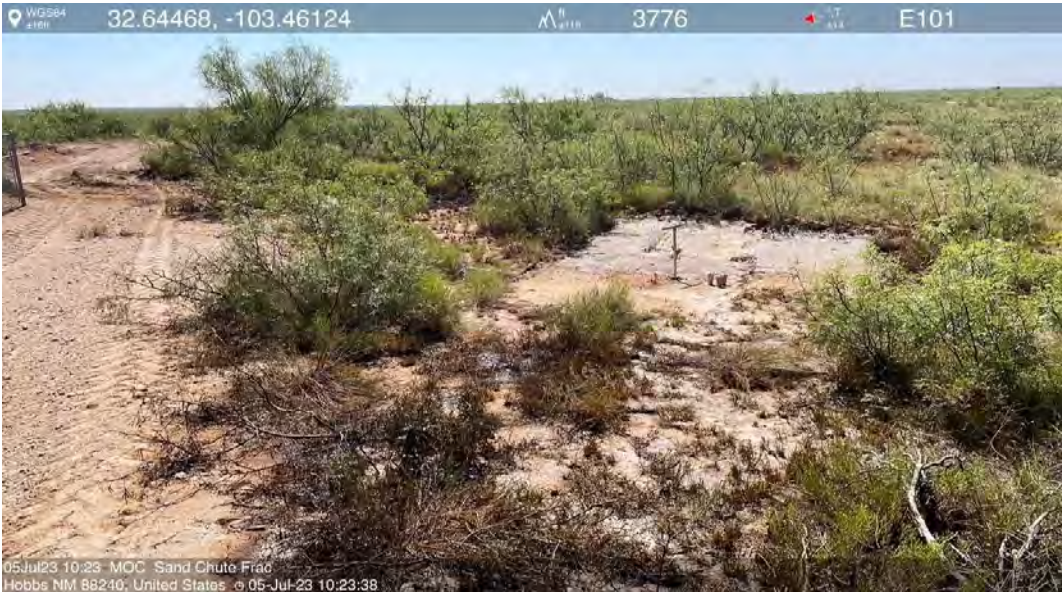
Photo Number: 3

Photo Direction: East	
Photo Description: View of the affected area.

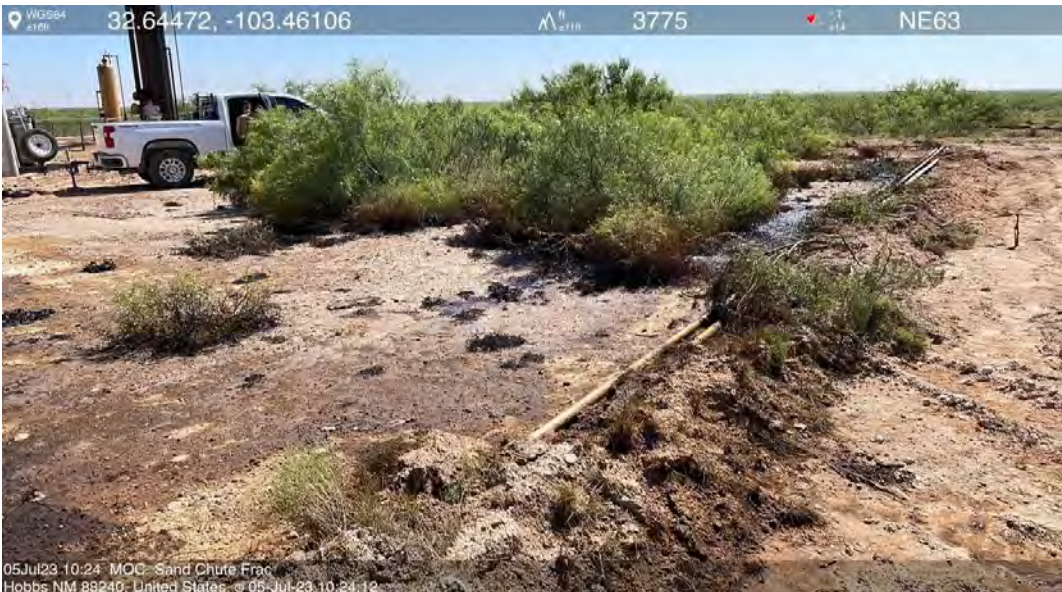
Photo Number: 4

Photo Direction: East-Northeast	
Photo Description: View of the affected area.

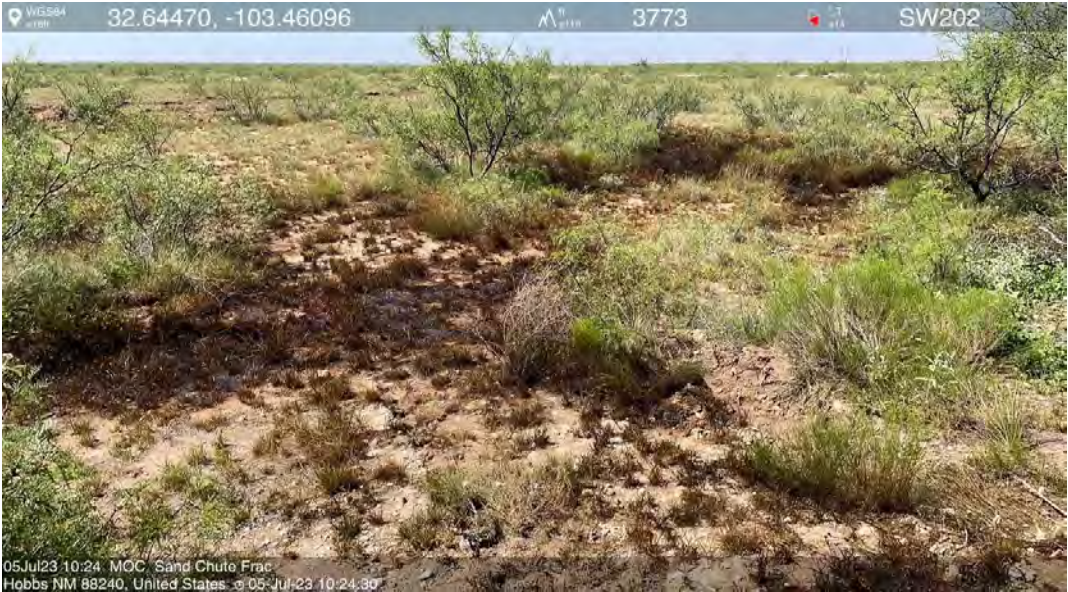
Photo Number: 5

Photo Direction: South-Southwest	
Photo Description: View of the affected area.

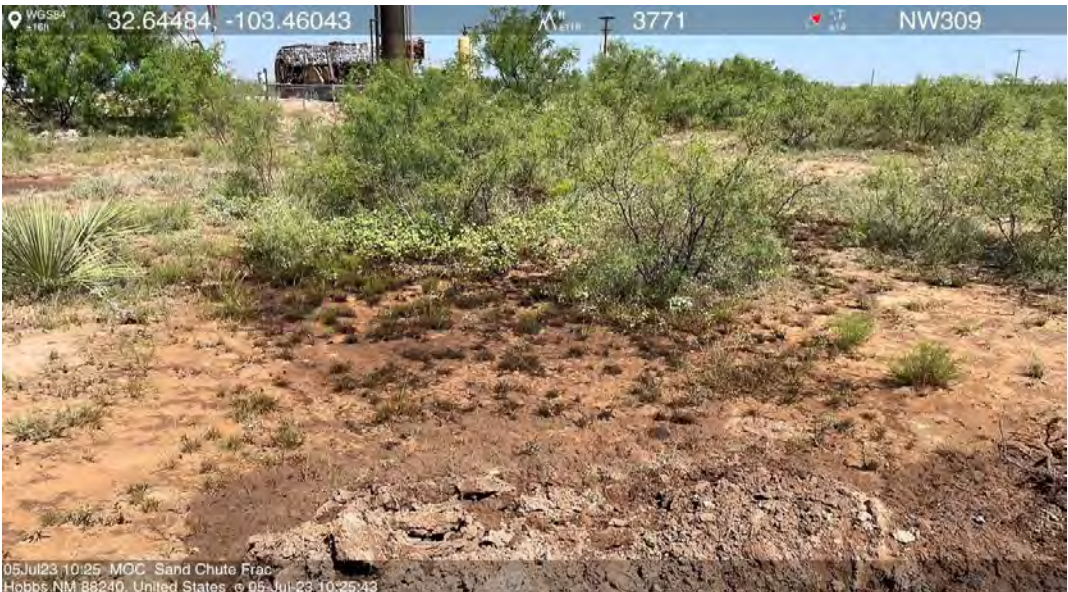
Photo Number: 6

Photo Direction: Northwest	
Photo Description: View of the affected area.

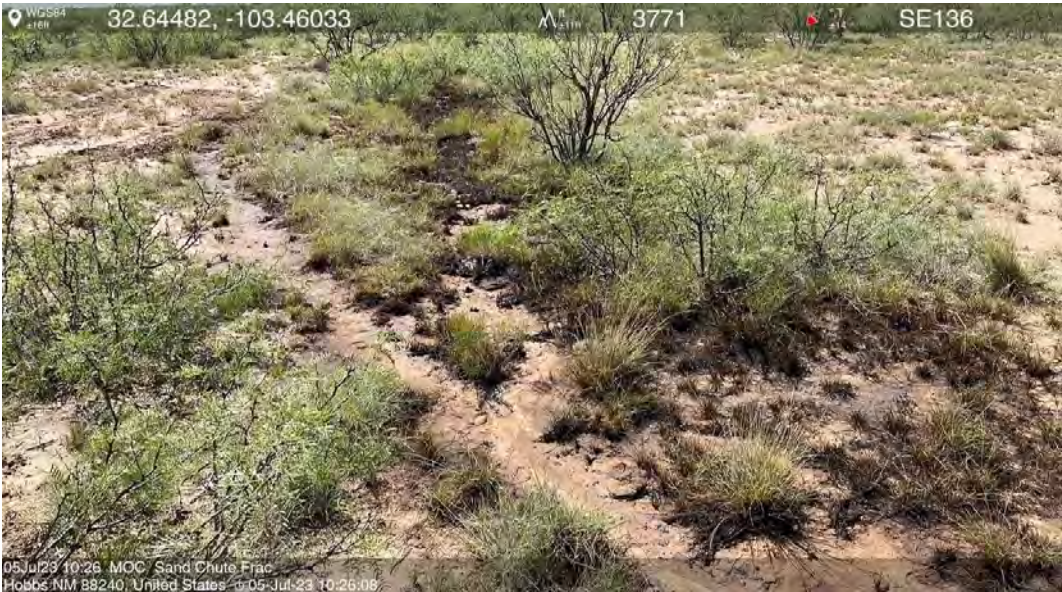
Photo Number: 7

Photo Direction: Southeast	
Photo Description: View of the affected area.

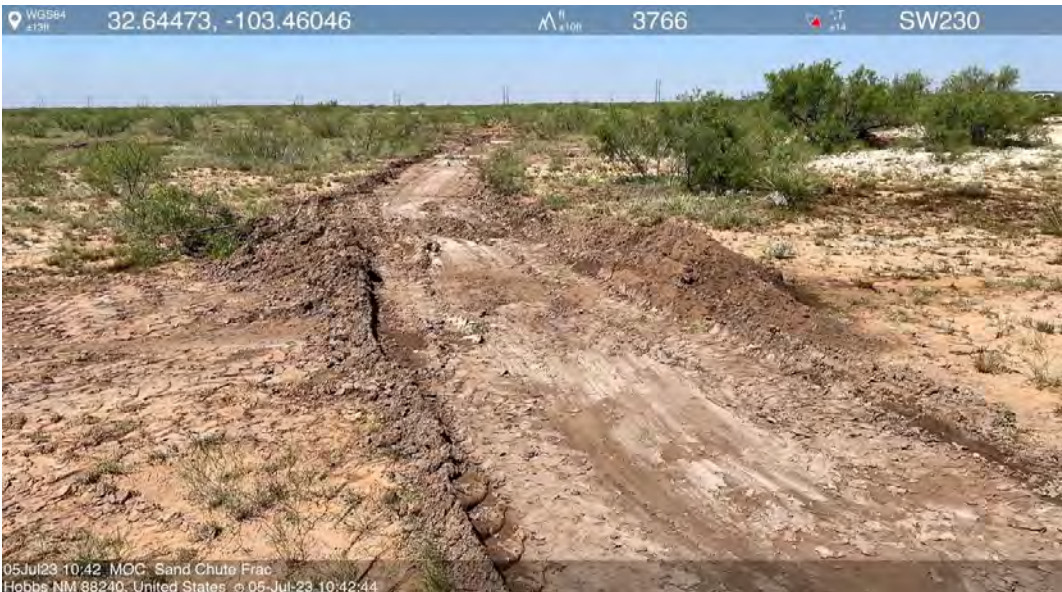
Photo Number: 8

Photo Direction: Southwest	
Photo Description: View of the affected area.

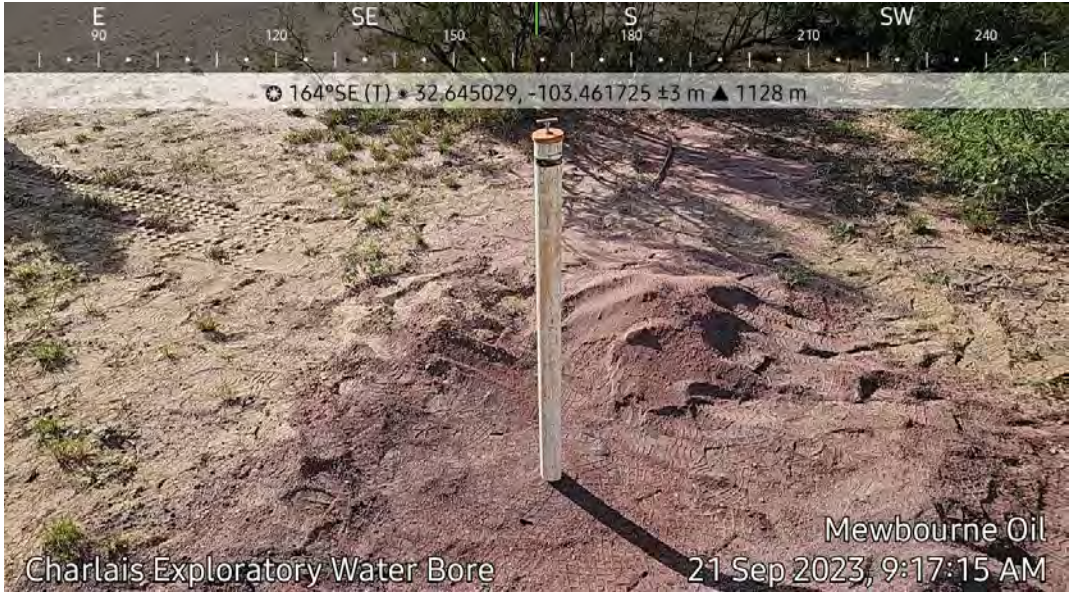
Photo Number: 9

Photo Direction: South-Southeast	
Photo Description: View of soil boring BH-1.

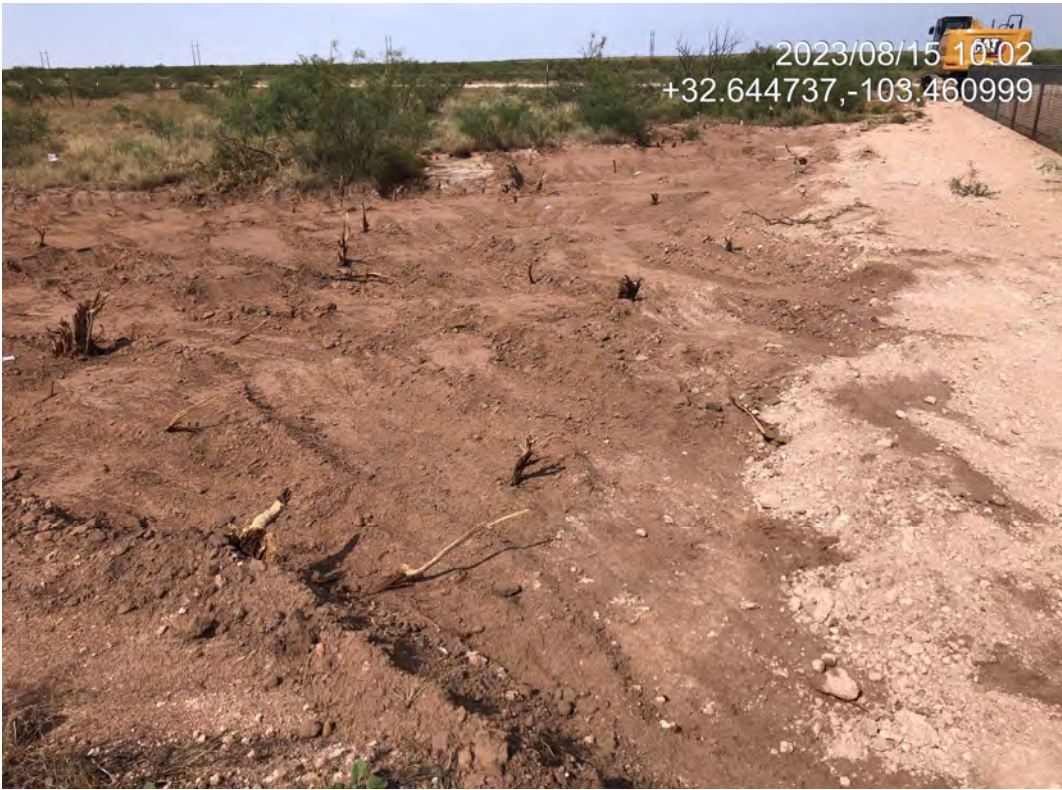
Photo Number: 11

Photo Direction: West	
Photo Description: View of the excavated area.

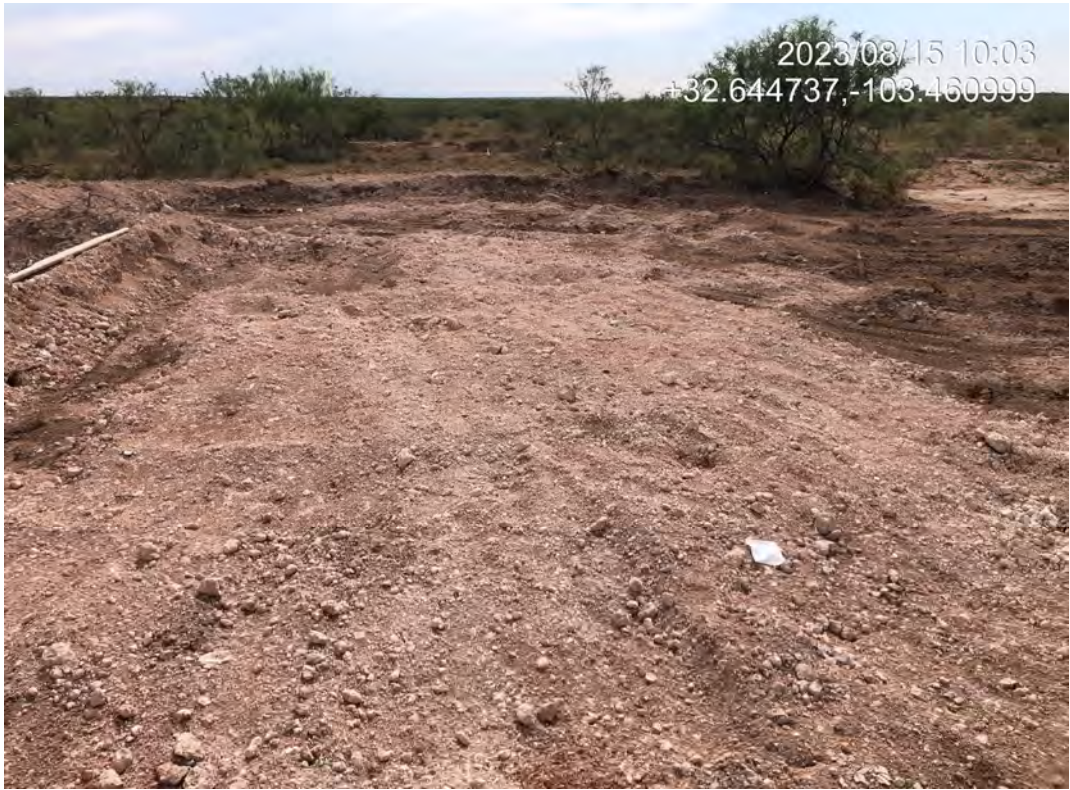
Photo Number: 13

Photo Direction: East	
Photo Description: View of the excavated area.

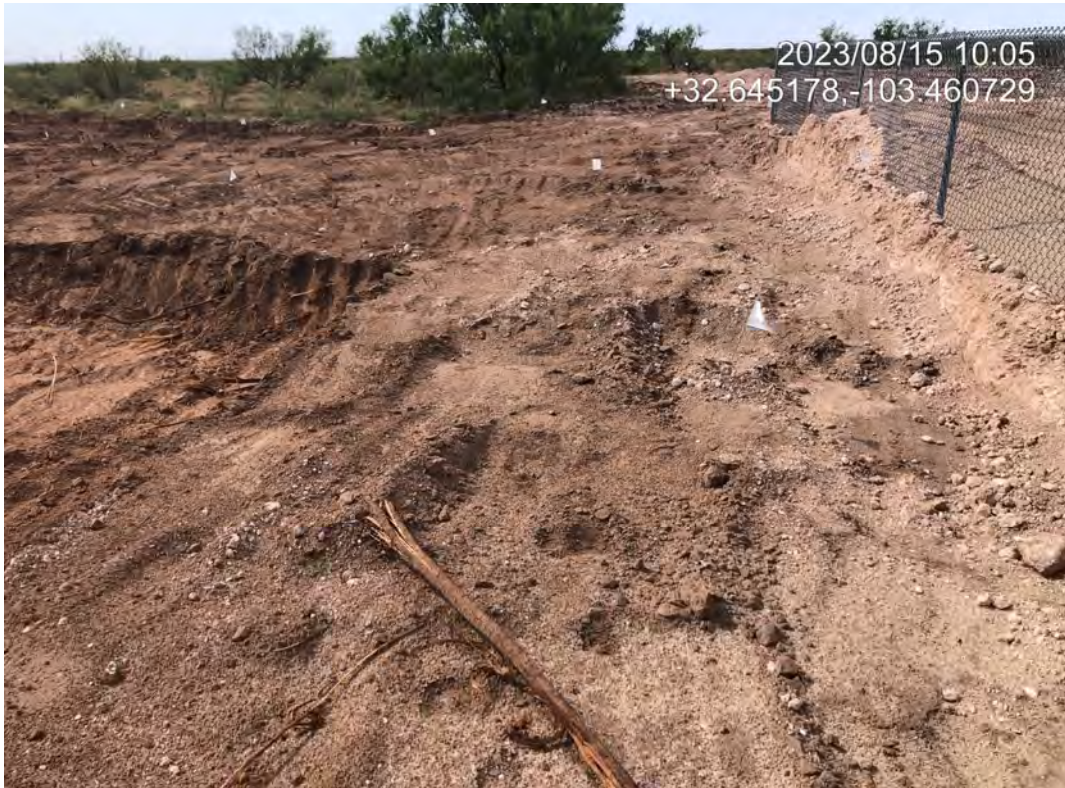
Photo Number: 15

Photo Direction: South	
Photo Description: View of the excavated area.

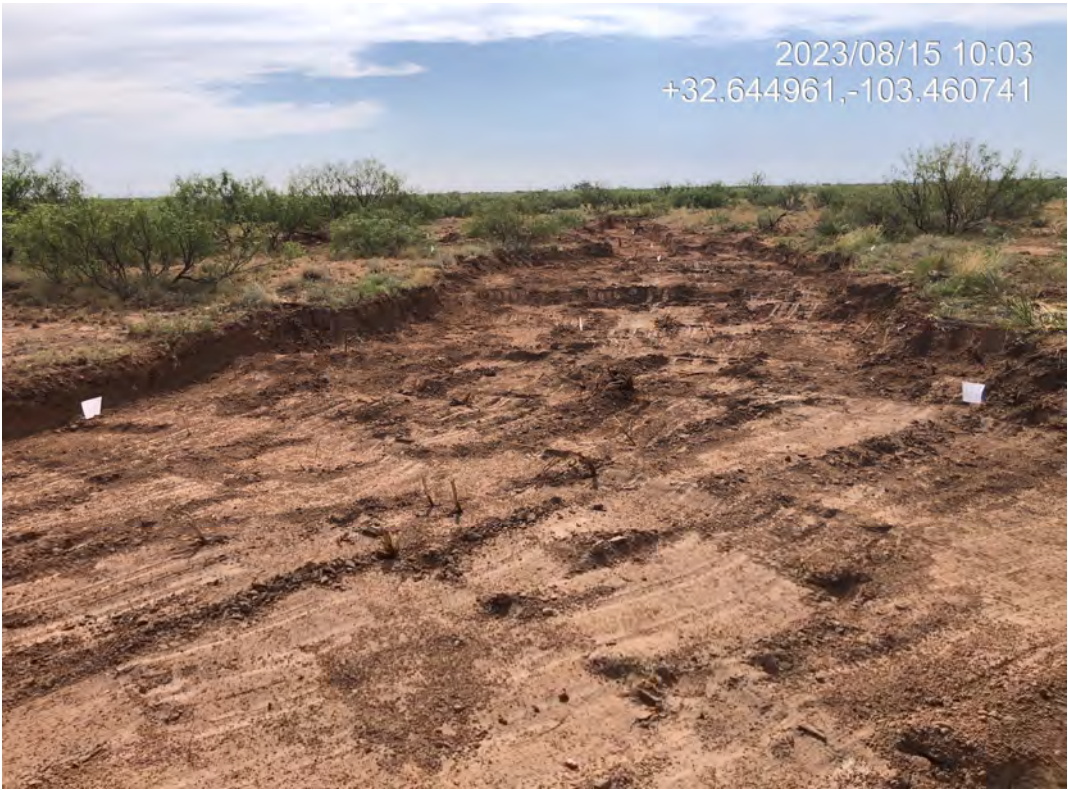
Photo Number: 17

Photo Direction: Southeast	
Photo Description: View of the excavated area.

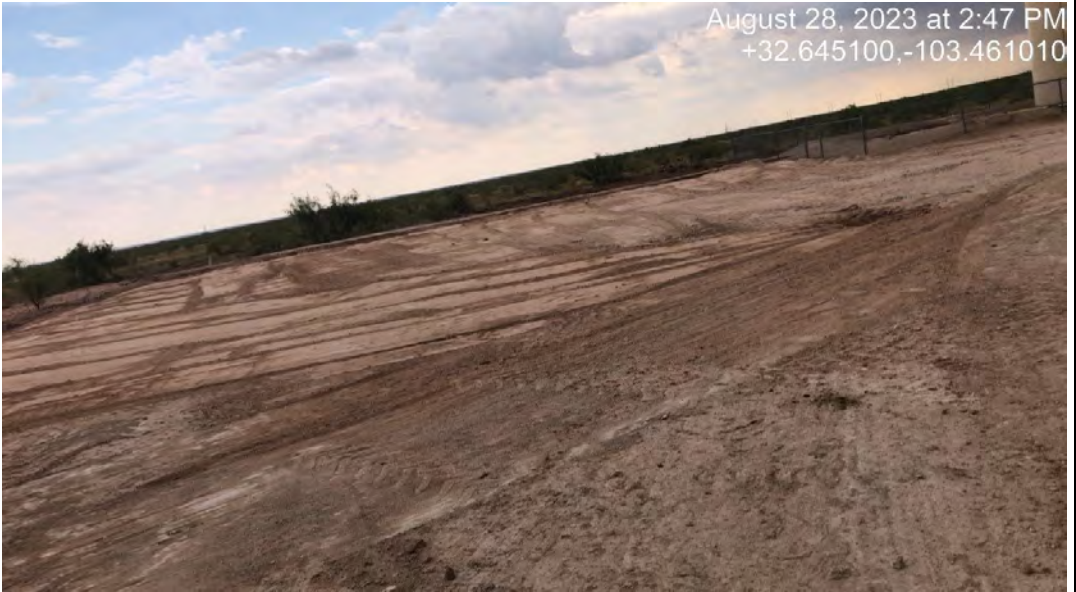
Photo Number: 19

Photo Direction: South	
Photo Description: View of the remediated area after backfill and regrading.

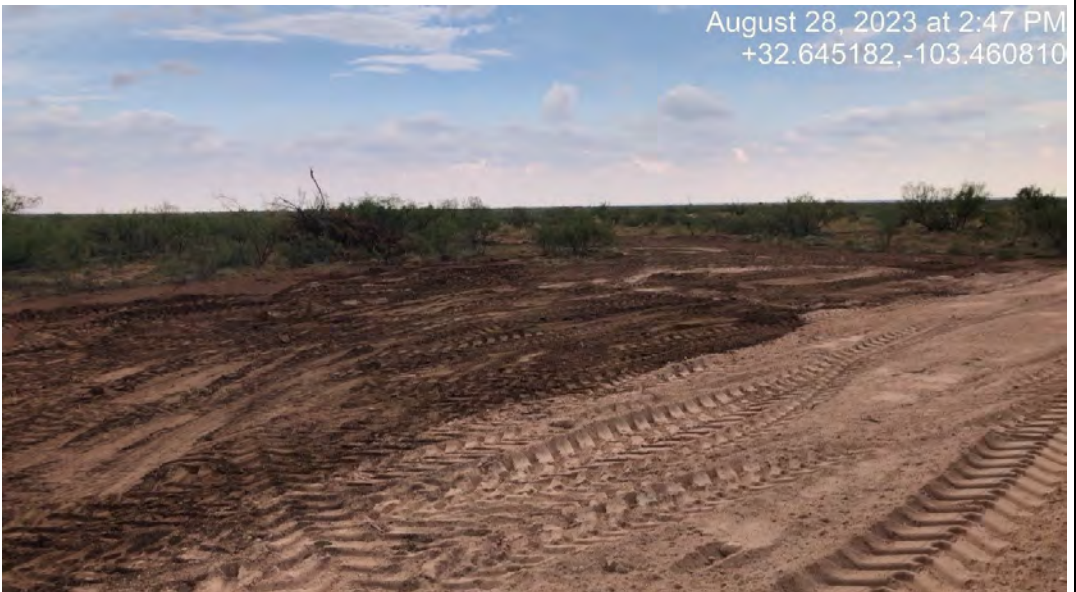
Photo Number: 20

Photo Direction: Southeast	
Photo Description: View of the remediated area after backfill and regrading.

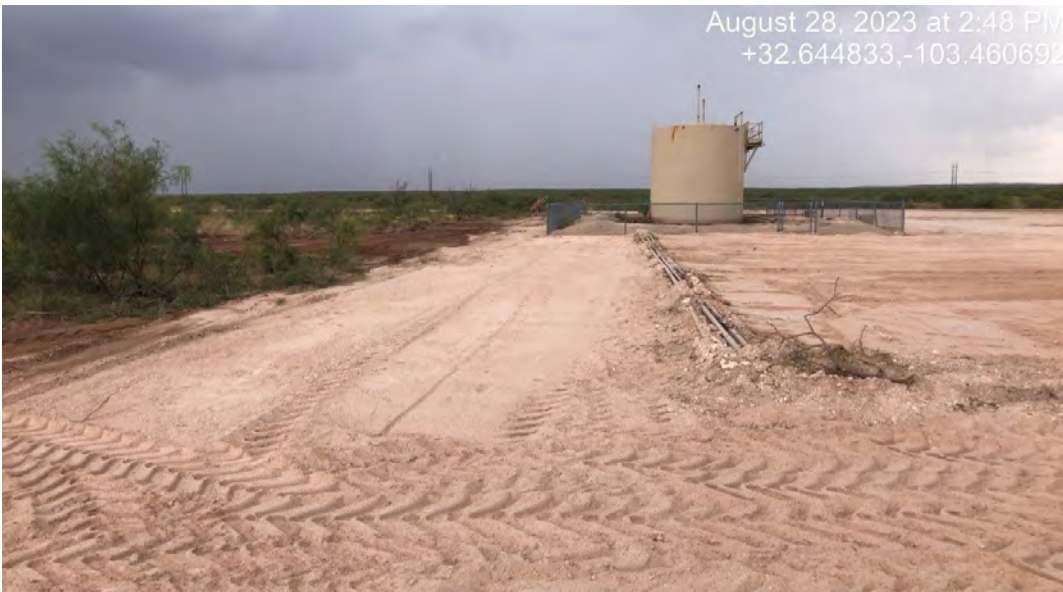
Photo Number: 22

Photo Direction: West	
Photo Description: View of the remediated area after backfill and regrading.
